PROJECT MEMORANDUM
SCE WEST OF DEVERS UPGRADE PROJECT

To: John Forsythe, Project Manager, CPUC
From: Vida Strong, Aspen Project Manager
Date: July 1, 2021
Subject: Monitoring Report #167: June 21 to 27, 2021

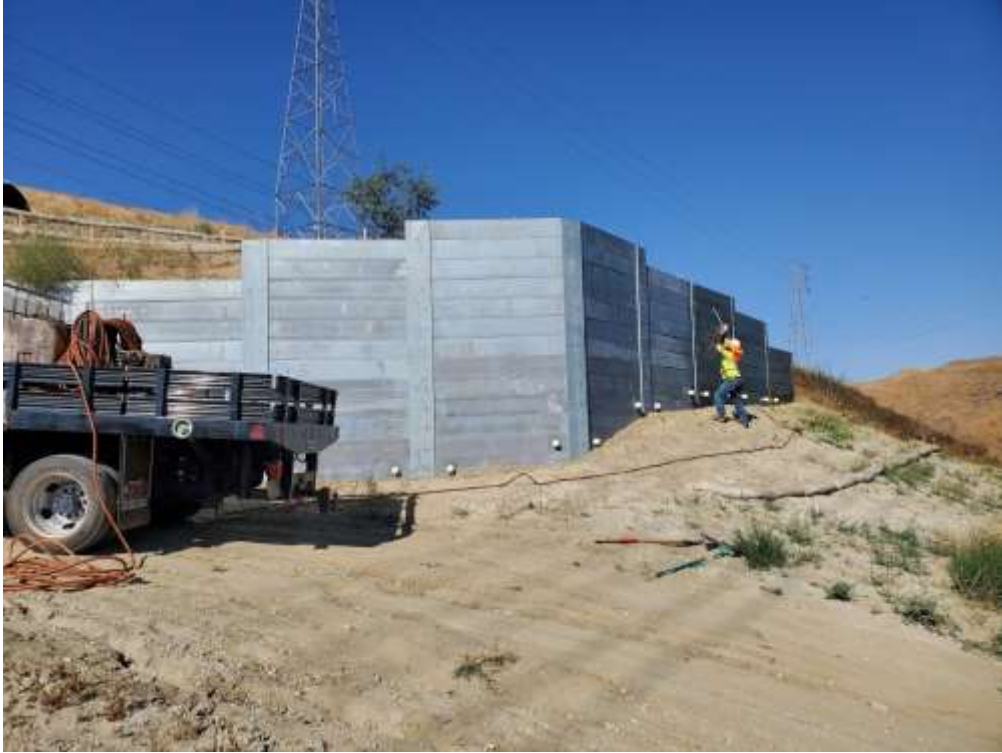
Photo 1 – Natina application to soldier pile wall at Construction Area 2N11, Segment 2 (June 21, 2021).

2. No work activities associated with Segment 1 occurred during the subject monitoring period.
3. Work activities associated with Segment 2 included: Hilfiker wall excavation activities at Construction Areas 2N12 and SWA-2-2N12-2-MPR-43; soil cement berm and bollard installation activities at Construction Area 2N18; and Natina application to the soldier pile wall at Construction Area 2N11 (see Photo 1).

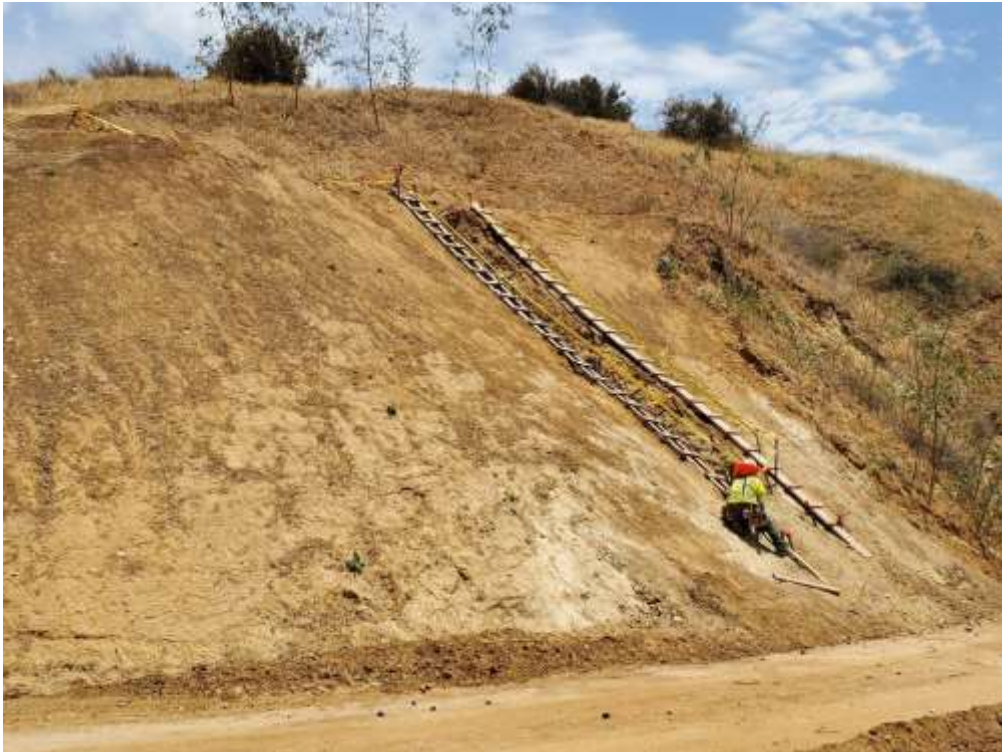
Photo 2 – V-ditch installation at Construction Area 3X62, Segment 3 (June 22, 2021).

4. Work activities associated with Segment 3 included: Site restoration and foundation compaction at Construction Areas 3X32, 3X35, 3X36, 3X38, and 3X39; gabion basket installation at Construction Area 3X65; hand weeding at Construction Areas 3X14, 3X17, 3X20, 3X21, 3X23 through 3X27, 3X56, 3X64, and WA-3-3N64-MPR-38; guard structure removal at Construction Areas GS-3-3X55-3X53-MPR-23, WA-3-3X55-3X53-MPR-45, and GS-3X53-3X55; Natina application to the soldier pile walls at Construction Areas 3X31 through 3X33, 3X36, and 3X37; BMP maintenance at Construction Areas 3X59, 3X61, 3X62, and 3X64; and v-ditch installation at Construction Areas 3X46 and 3X62 (see Photo 2).

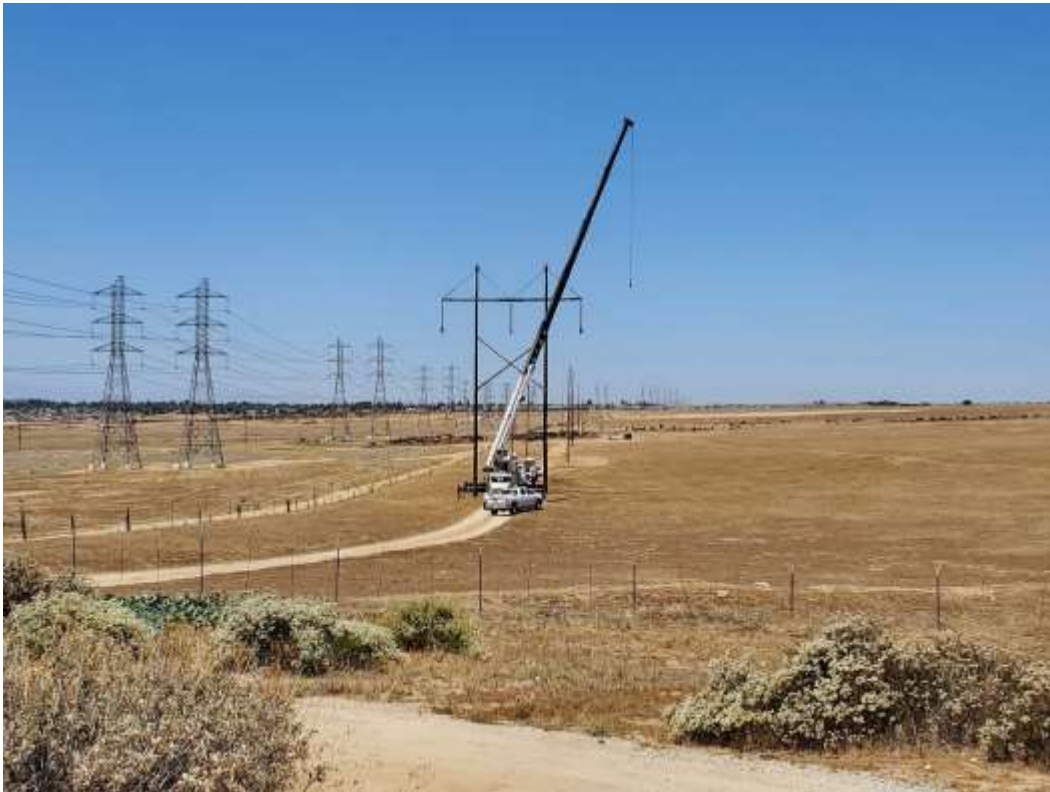
Photo 3 – H-frame pole wreck-out activities at Construction Area 4X16, Segment 4 (June 21, 2021).

5. Work associated with Segment 4 (including Construction Areas 4X12 and 4X13 within Morongo Lands as reported by SCE) included: H-frame pole wreck-out, backfilling, and right-of-way clean-up at Construction Areas 4X09 through 4X22 (see Photo 3), 4X57, 4N58, M20-T3, PP123328, PP123333, PP123340, and PP123349 through PP123353; Natina application to soldier pile wall at Construction Area 4X13; and v-ditch rip rap application at Construction Area 4X03.

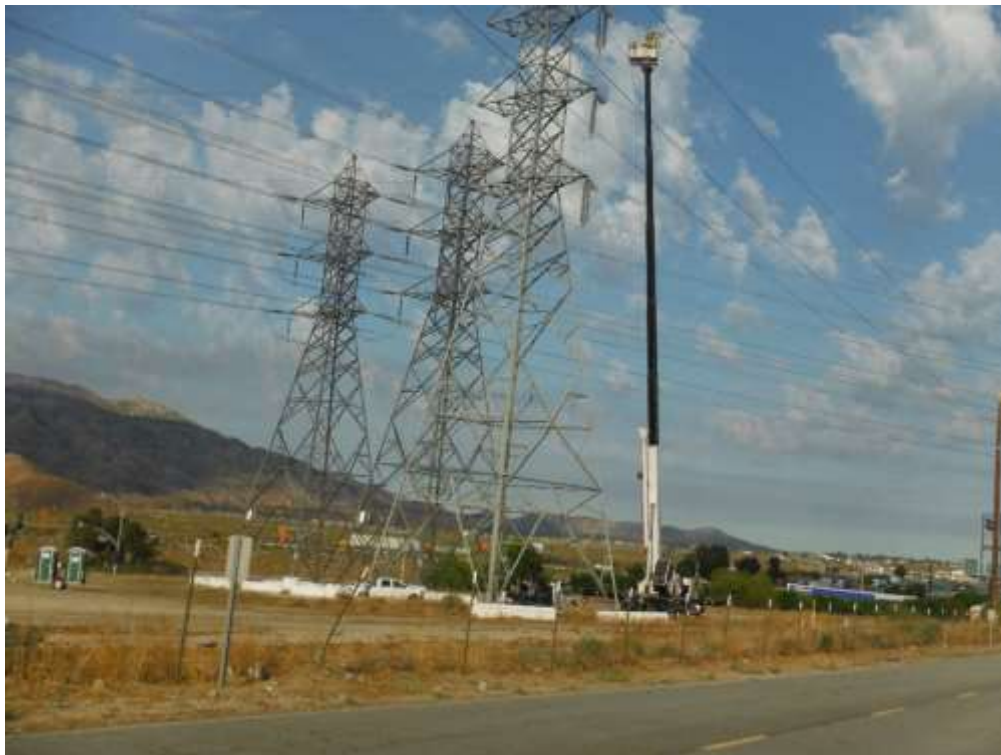
Photo 4 – Wire wreck-out activities at Construction Area 5X29, Segment 5 (June 24, 2021) (Photo courtesy of SCE).

6. Work associated with Segment 5 (including sites within Morongo lands as reported by SCE) included: Wire wreck-out activities (ground and helicopter) at Construction Areas M14-T1 through M14-T3, M15-T2 through M15-T4, 5X29 (see Photo 4), 5X30, and 5X48 (M16-T2); traveler removal at Construction Areas M14-T1 through M14-T4, M15-T1 through M15-T4, M16-T2 through M16-T4, 5X29 (M13-T3), and 5X30; snub removal wreck-out activities at Construction Area WSS-5X15-5X16-2; foundation wreck-out and tower shearing at Construction Areas 5X01, 5X03, 5X04, 5X06 (see Photo 5), 5X08, 5X10, 5X11, 5X14, WSS-5X15-5X16, 4175196E, 4175196E, and M10-T2; and v-ditch installation at Construction Area 5X54.

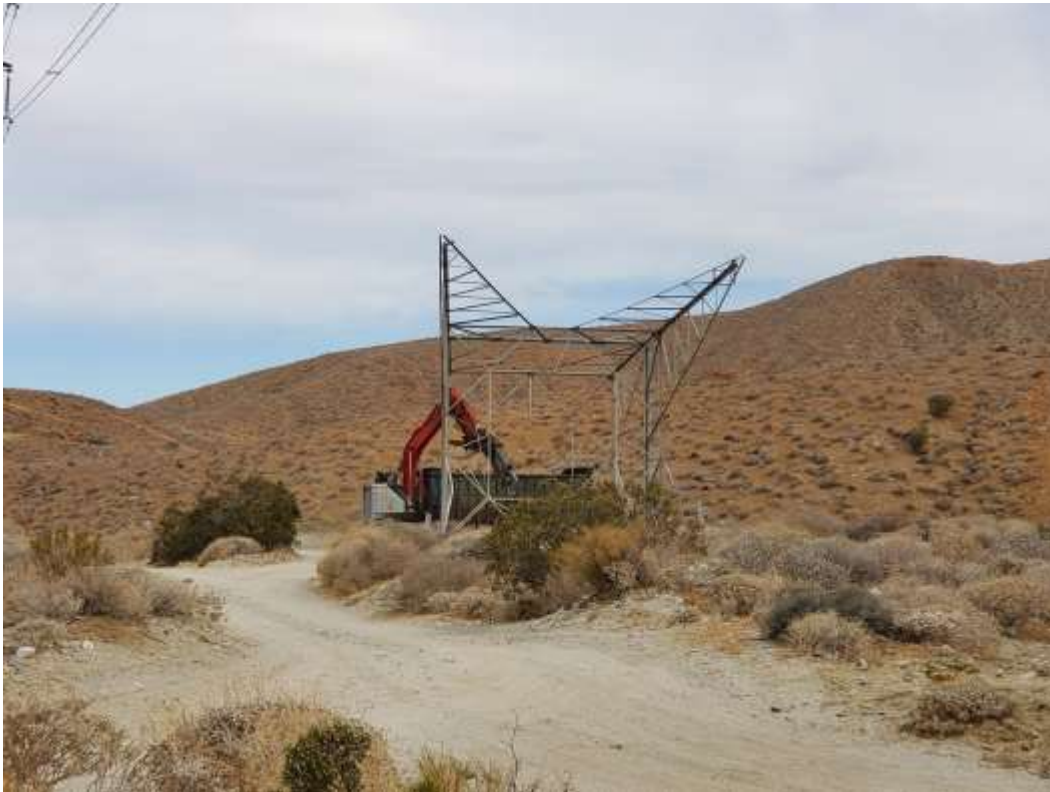
Photo 5 – Tower shearing at Construction Area 5X06, Segment 5 (June 22, 2021).

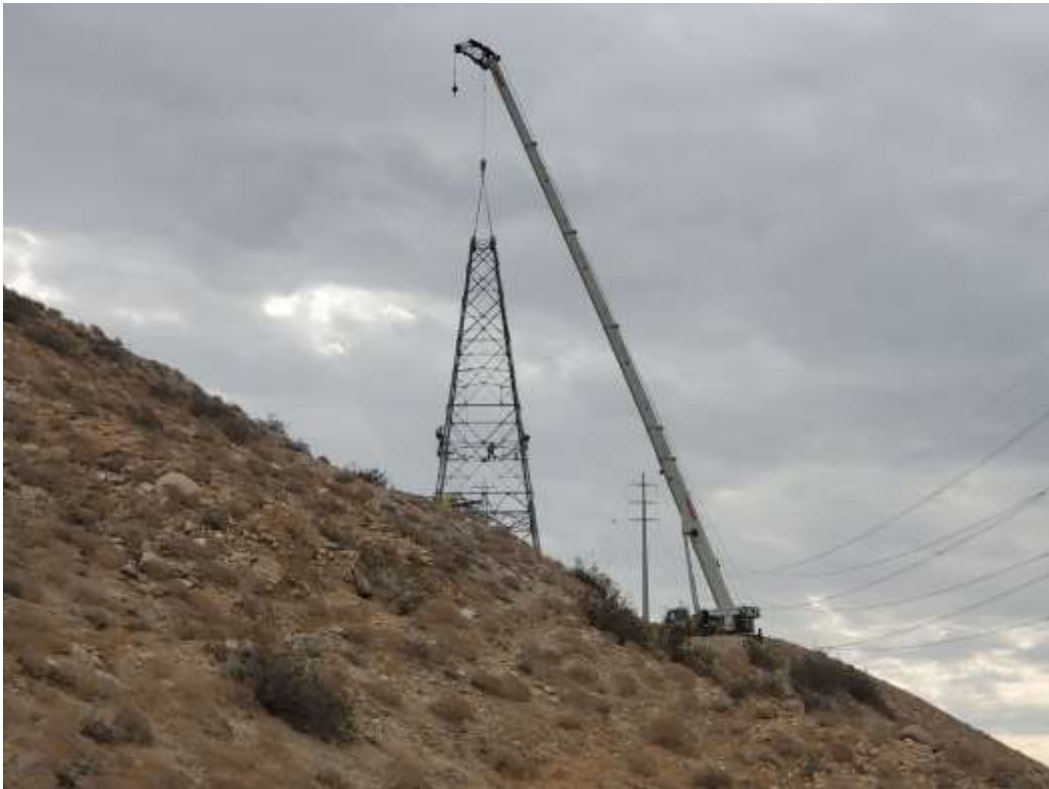
Photo 6 – Tower wreck-out at Construction Area 6N31, Segment 6 (June 22, 2021).

7. Work associated with Segment 6 (non-BLM lands) included: Tower wreck-out activities at Construction Areas 6N29, 6N30, 6N31, and M65-T1; foundation wreck-out and tower shearing at Construction Area M65-T2; Natina application on soldier pile wall at Construction Area 6N30; nest deterrent removal at Construction Area 6X09-6X10; and hydroseed watering at Construction Areas M60-T3, M61-T1, M62-T3, T252, 6X11 through 6X14, 6N15, 6S15, 6N16, 6S16, 6N17, 6S17, 6S18, 6N18, 6X19 through 6X24, 6N25, 6S25, 6S26, WSS-6-6S26-1-MPR-29, 6N27, 6S27, 6S28, 6N28, 6S28A, 6S29, 6S30, 6S30A, 6S31A, 6S32, 6S33, 6S34, 6S35, 6S36, 6S37, 6N37, 6S38, 6N38, 6S39, 6N39, 6S40, 6N40, and 6X41 through 6X48.
