PROJECT MEMORANDUM
SCE WEST OF DEVERS UPGRADE PROJECT

To: John Forsythe, Project Manager, CPUC
From: Vida Strong, Aspen Project Manager
Date: August 19, 2021
Subject: Monitoring Report #174: August 9 to 15, 2021

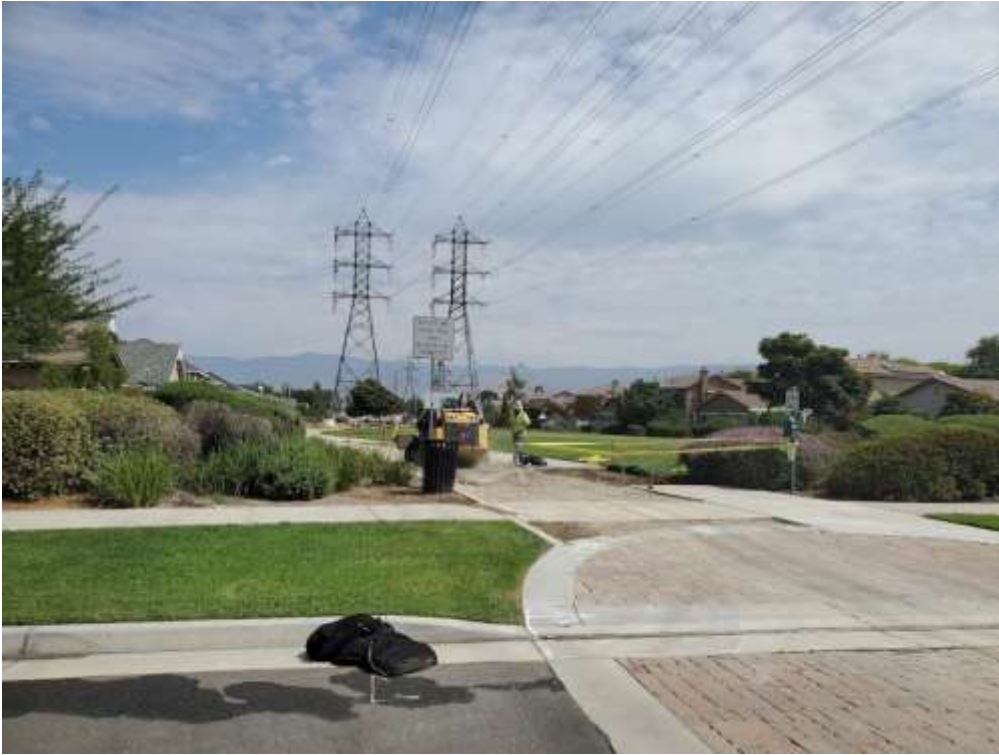
Photo 1 – Concrete replacement activities at Construction Area 1X13, Segment 1 (August 11, 2021).

2. Work associated with Segment 1 included concrete removal and replacement activities at entrances to Construction Areas 1X12 through 1X18 (see Photo 1).

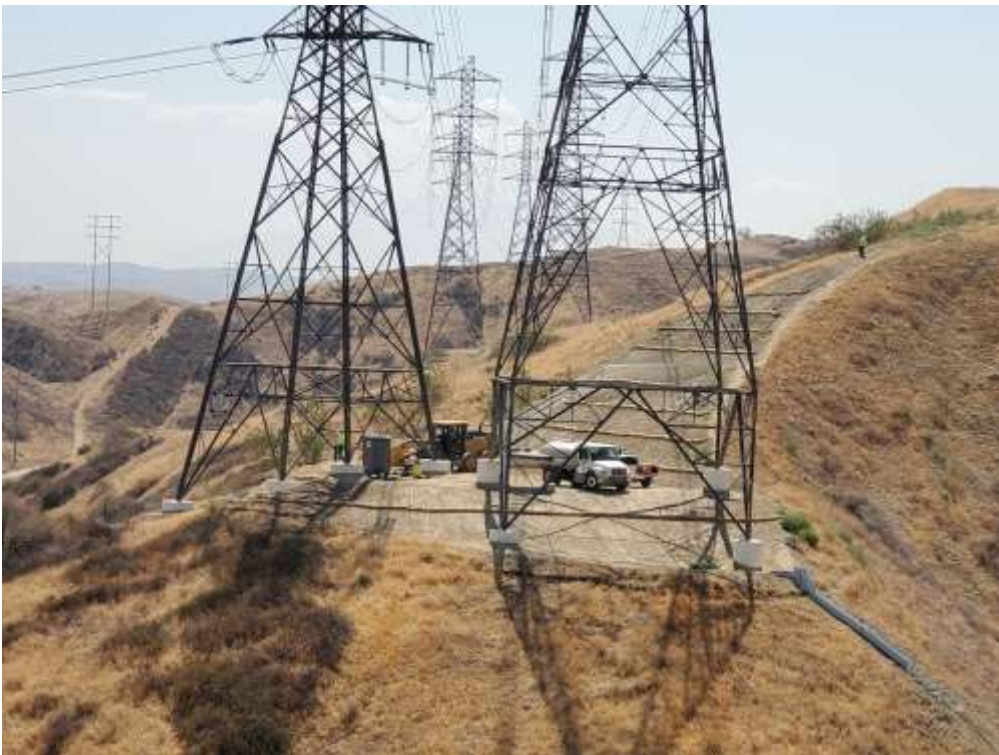
Photo 2 – Water bar installation at Construction Area 3X65, Segment 3 (August 9, 2021).

3. Work associated with Segment 2 included equipment demobilization from Construction Area 2N01-WSS.
4. Work associated with Segment 3 included: Soil import and grading at Construction Areas 3X06-3X07 and 3X37; right-of-way clean-up at Construction Areas 3X22 and 3X28; water bar installation at Construction Areas 3X62 and 3X65 (see Photo 2); anchor removal and gravel clean-up at Construction Area 3X06-3X07; access road maintenance from Construction Area 3X65 to Mountain View Avenue; and BMP replacement at Construction Areas 3X08, 3X42, and 3X46.

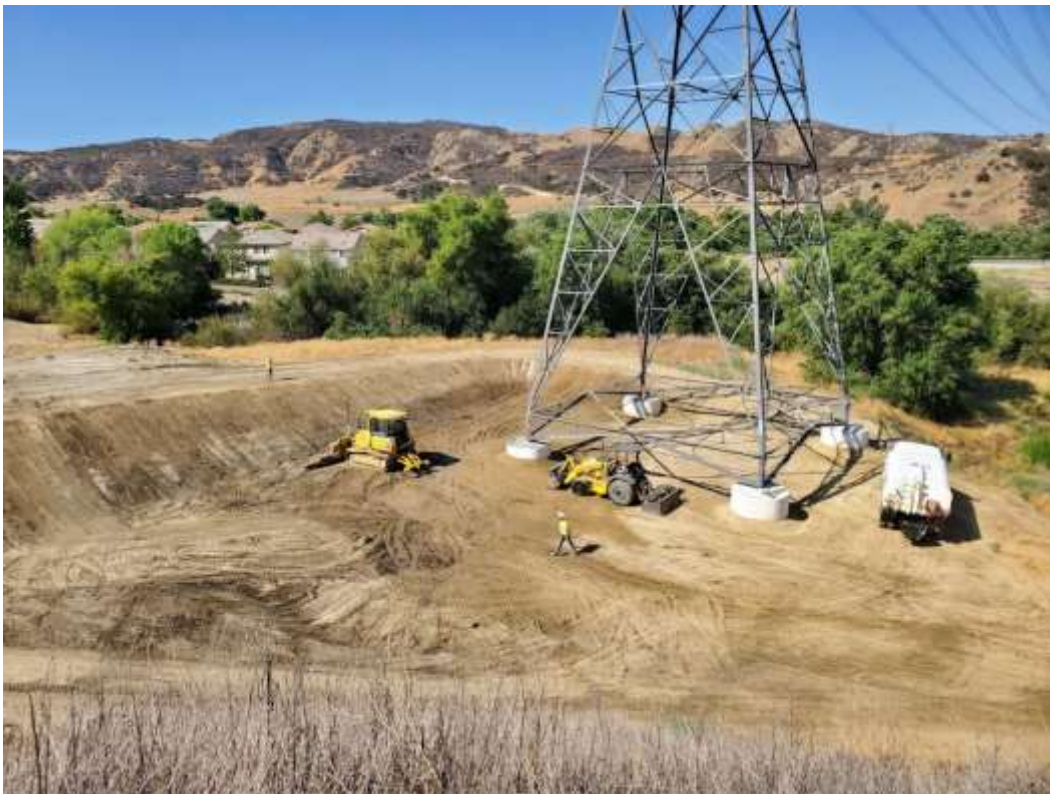
Photo 3 – Site restoration activities at Construction Area 4S60, Segment 4 (August 9, 2021).

5. Work associated with Segment 4 included: Site restoration and foundation compaction at Construction Areas 4S58, 4N58, 4S59, and 4S60 (see Photo 3); vegetation removal at Construction Area 4N58; pole removal and backfilling at Construction Areas 4X56 and PP123295; foundation removal and tower shearing at Construction Areas 4X44 through 4X48 and M25-T4; foundation slurry backfilling activities at Construction Area 4X44-1 (see Photo 4); and BMP maintenance and installation at Construction Areas 4X03 and 4S60.

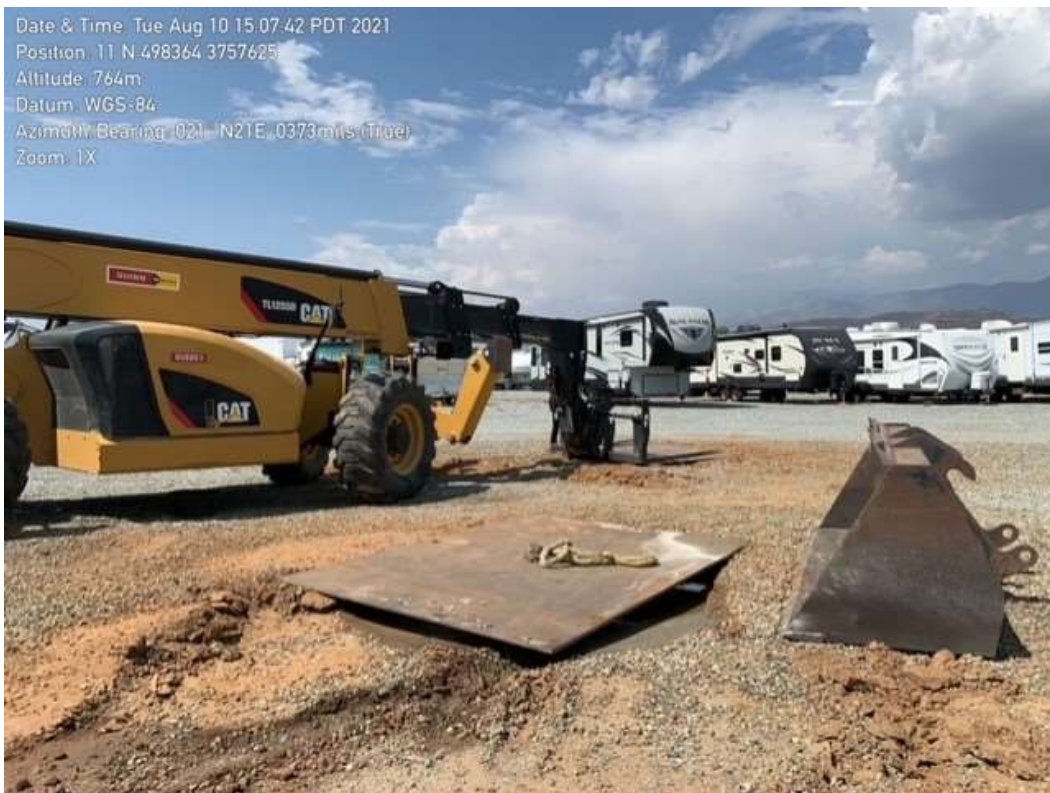
Photo 4 – Foundation slurry backfill at Construction Area 4X44-1, Segment 4 (August 10, 2021) (Photo courtesy of SCE).

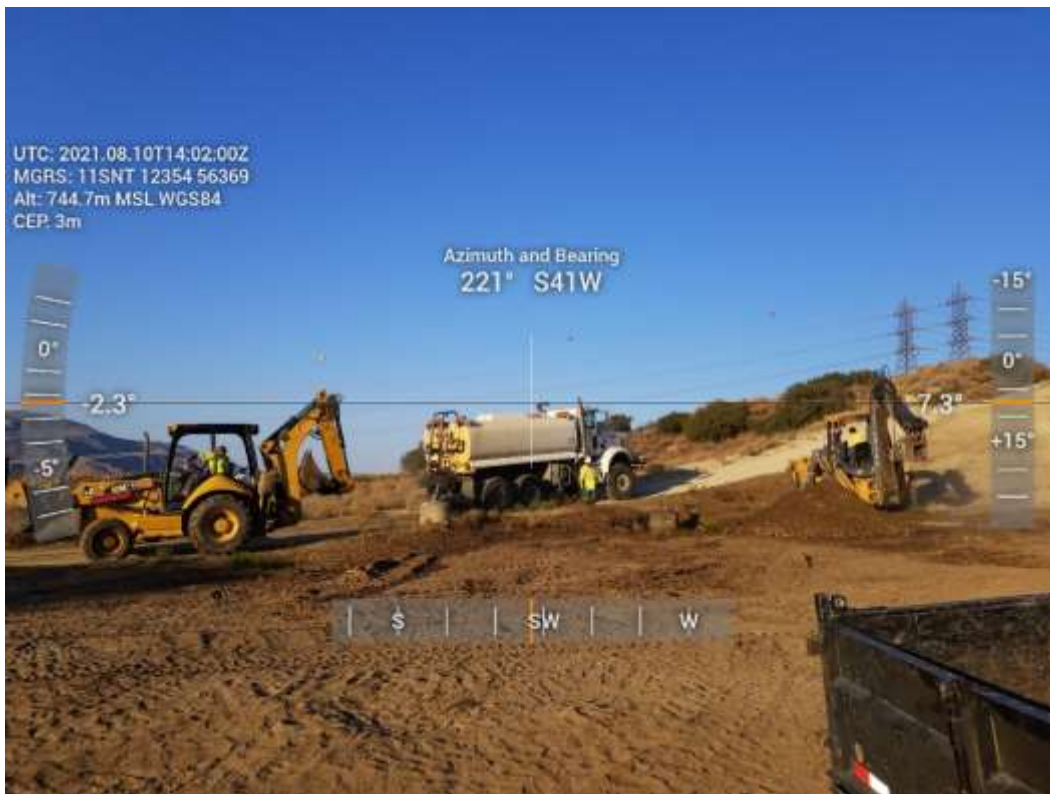
Photo 5 – Foundation wreck-out at Construction Area M76-T4, Segment 5 (August 10, 2021) (Photo courtesy of SCE).

6. Work associated with Segment 5 included foundation wreck-out and tower shearing at Construction Areas 5X46, 5X48, 5X49, M15-T2 through M15-T4, M75-T1, M75-T2, WSS-M74-T4, M74-T3, and M76-T4 (see Photo 5), and hydroseed watering at Construction Areas 5X01 through 5X03, 5X05 through 5X14, and 5X37 through 5X47.

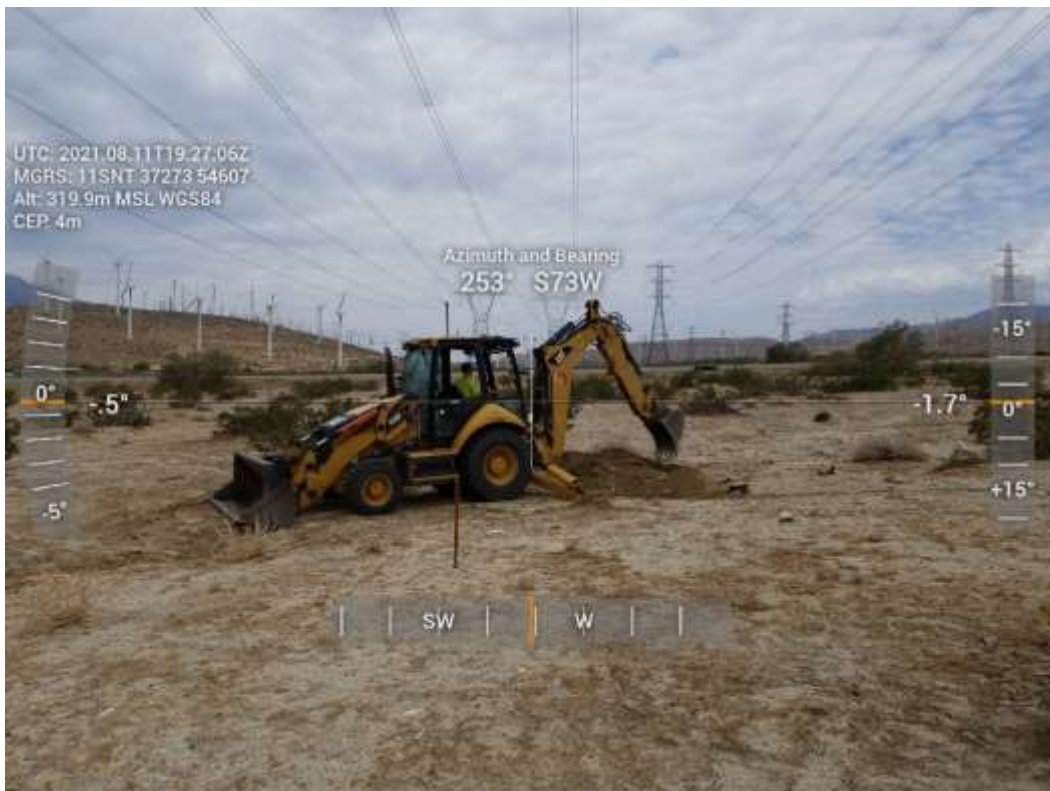
Photo 6 – Anchor removal at Construction Area 6S15, Segment 6 (August 11, 2021) (Photo courtesy of SCE).

7. Work associated with Segment 6 (non-BLM lands) included anchor removal at Construction Area 6S15 (see Photo 6), and hydroseed watering at Construction Areas 6X22 through 6X24, 6N25, 6S25, WSS-6-6N26-6N27, 6S27, 6N27, 6S28, 6N28, 6S28A, 6S29, 6S30, 6S30A, 6S31, 6S31A, 6S32, 6S33, 6N34, 6S35, 6N35, 6S36, T235, and 6X37 through 6X48.
