PROJECT MEMORANDUM
PG&E WINDSOR SUBSTATION PROJECT

To: Eric Chiang, Project Manager, CPUC
From: Vida Strong, Aspen Project Manager
Date: August 10, 2017
Subject: Monitoring Report #27 – July 31, 2017 to August 6, 2017

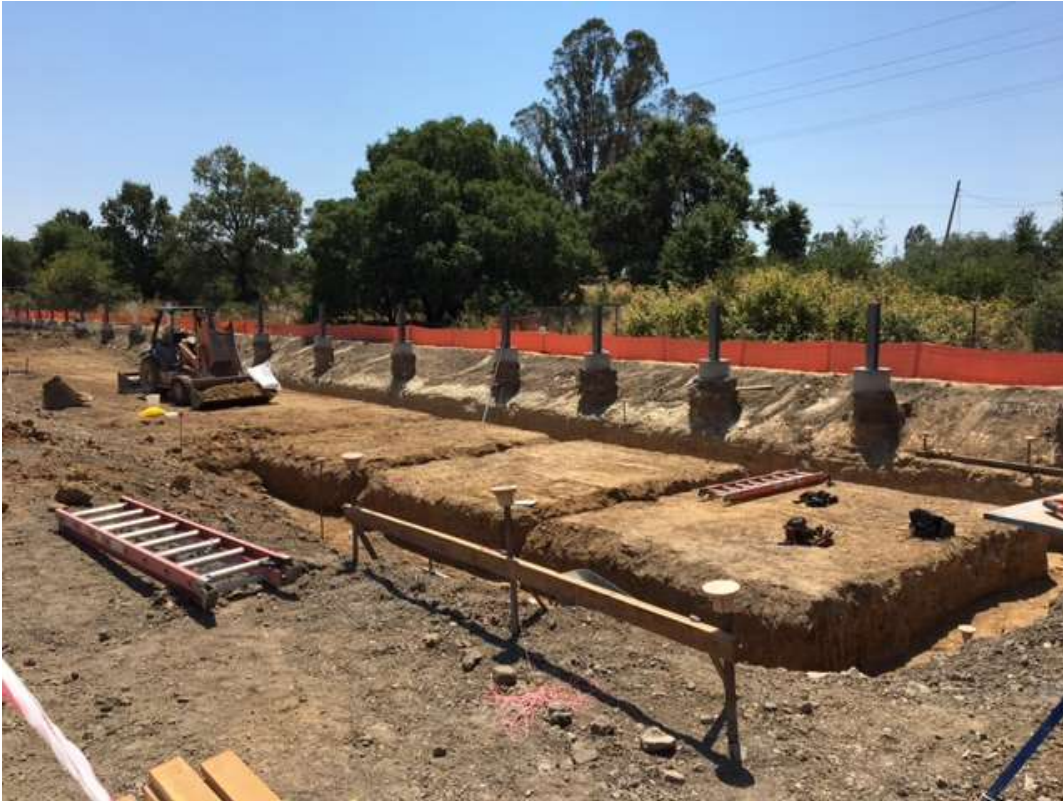
Construction of the SPCC pond along the western side of the site continued with excavation and hauling of spoils offsite.

Figure 1 – SPCC pond excavation on west side of site – view southwest, August 1, 2017.

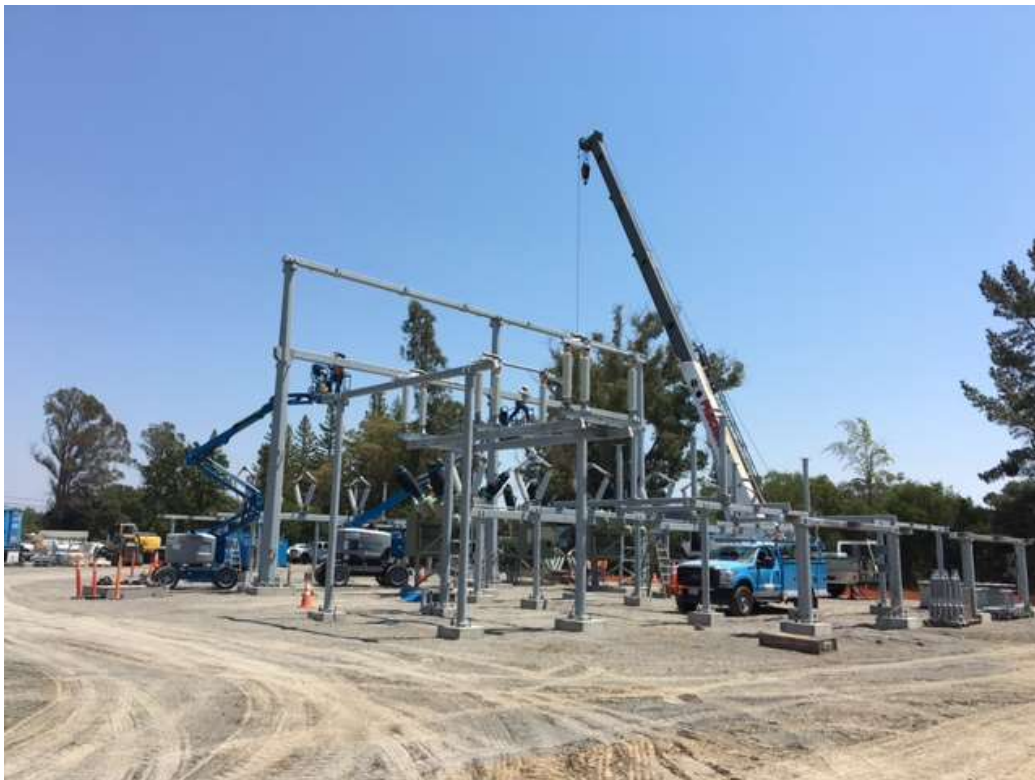
On the southwest side of the site, installation of circuit breakers on foundations occurred, as well as installation of switches on dead-end structures with the use of a crane.

Figure 2 – Preparing to install switches on dead-end structures – view southeast, August 1, 2017.

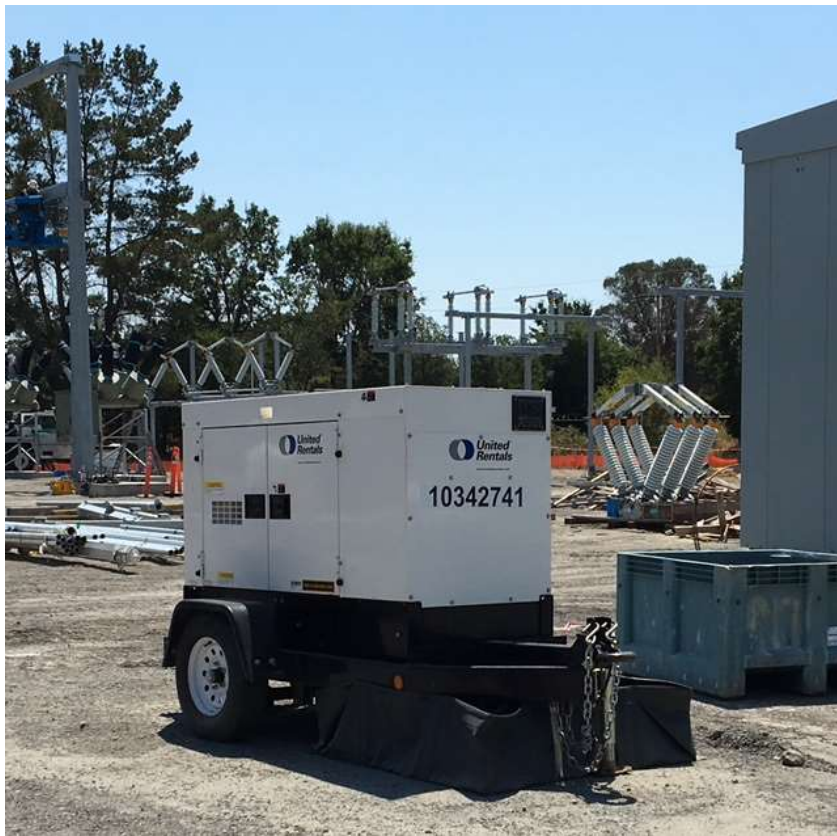
2. The CPUC EM noted one compliance concern. A generator that was being used by the PG&E GC crew did not have adequate secondary containment (see Figure 3). The CPUC EM informed the PG&E EI and the PG&E EI of the issue and adequate containment was installed August 2.

Figure 3 – Generator in need of additional secondary containment – view southwest, August 1, 2017.

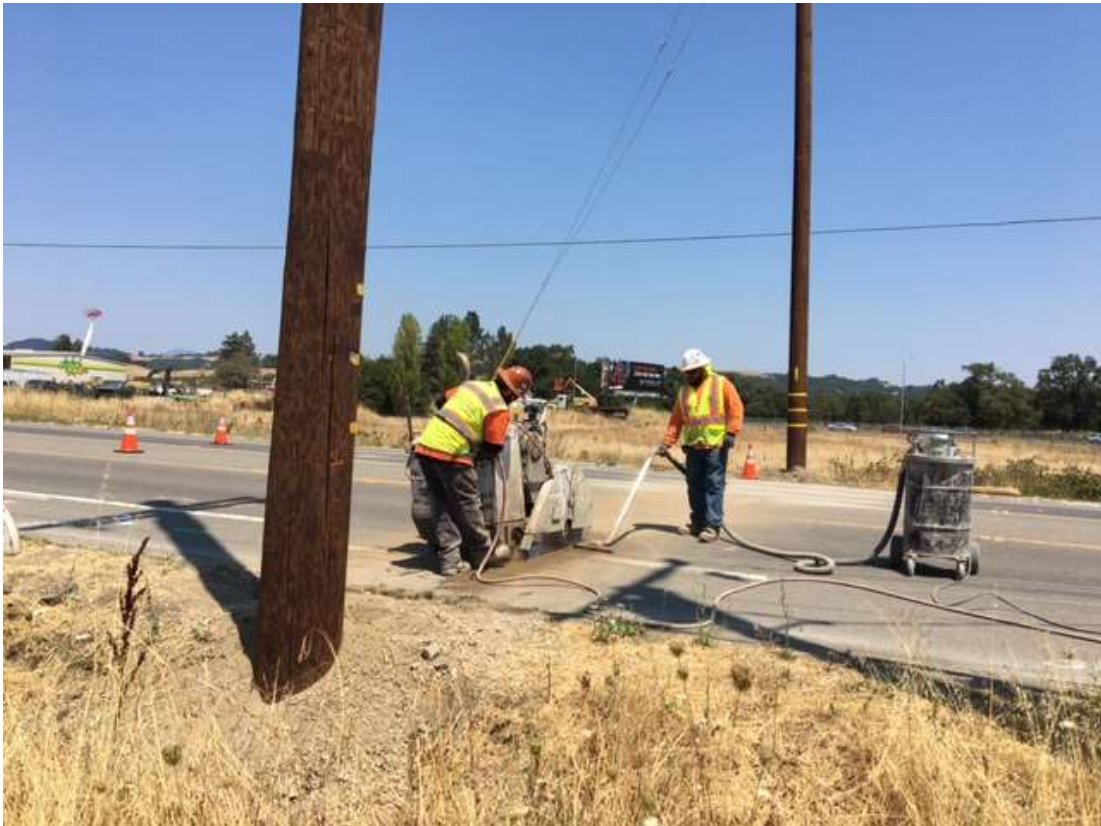
On Tuesday, August 1, construction activities began on the Old Redwood Highway underground crossing. A crew saw cut the asphalt between Poles a9 and b9. A wet-vac was used to capture the water and mud created by the saw cutting activity. A trench was then excavated across the road and conduit installed. All work was performed on the asphalt roadway with no impacts to the roadside drainages and the wetland on the east side of the roadway.

At the time of the CPUC EM's site visit on August 1, crews were saw cutting the asphalt across Old Redwood Highway (see Figure 4). Traffic controls were in place and both lanes remained open, but were shifted so that crews had space to work. Traffic was stopped if equipment or crews needed to cross the road.

Figure 4 – Saw cutting across Old Redwood Highway – view east, August 1, 2017.
