California Public Utilities Commission <i>Mitigation Monitoring, Compliance, and Reporting Program</i>
	Cleveland National Forest Power Line Replacement Projects Compliance Status Report: 019 June 11, 2017

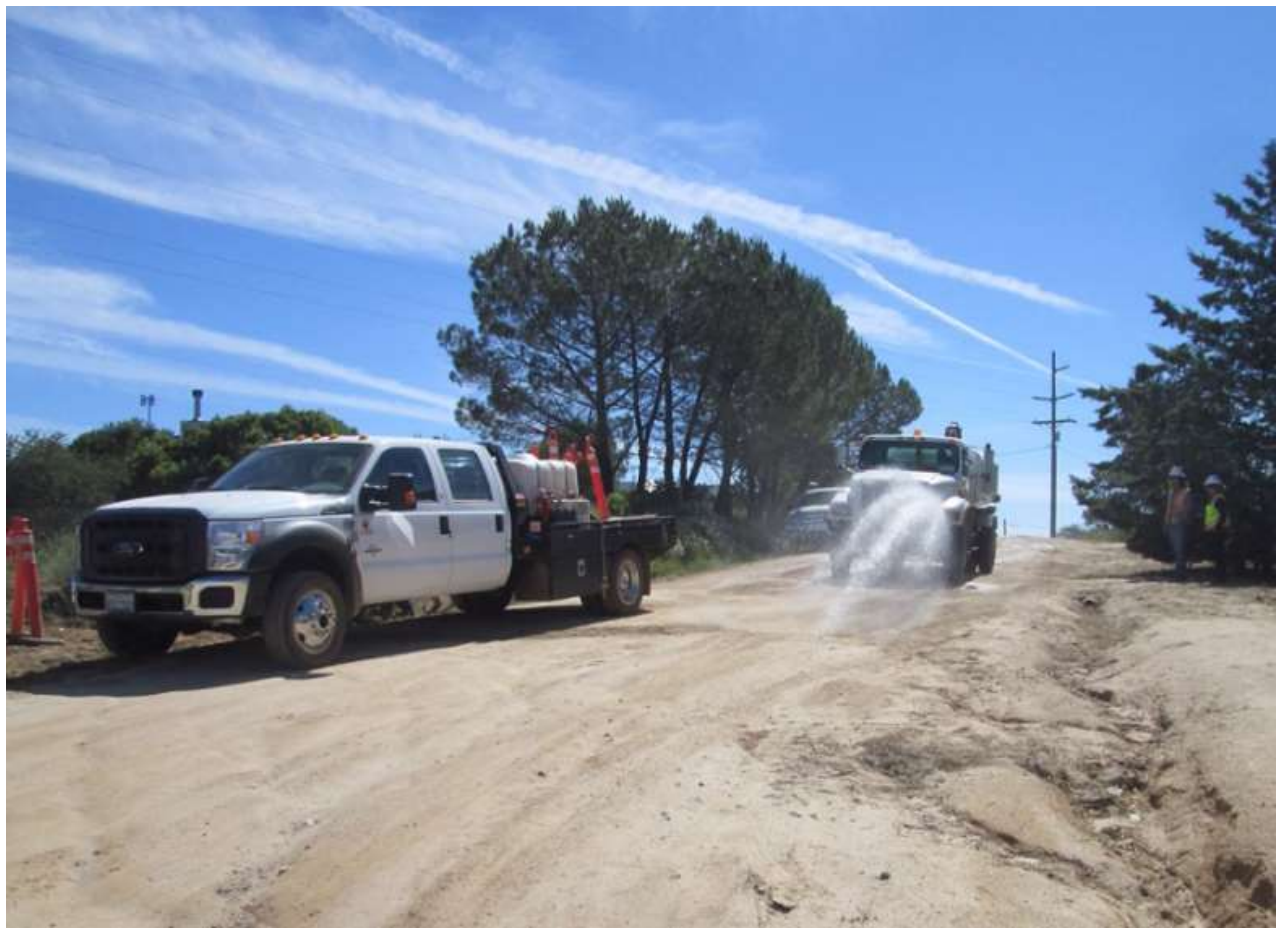
Photo 1: During conventional pole hole drilling at Z44263 (TL 6931), crews watered the access road for dust control in accordance with APM AIR-02.

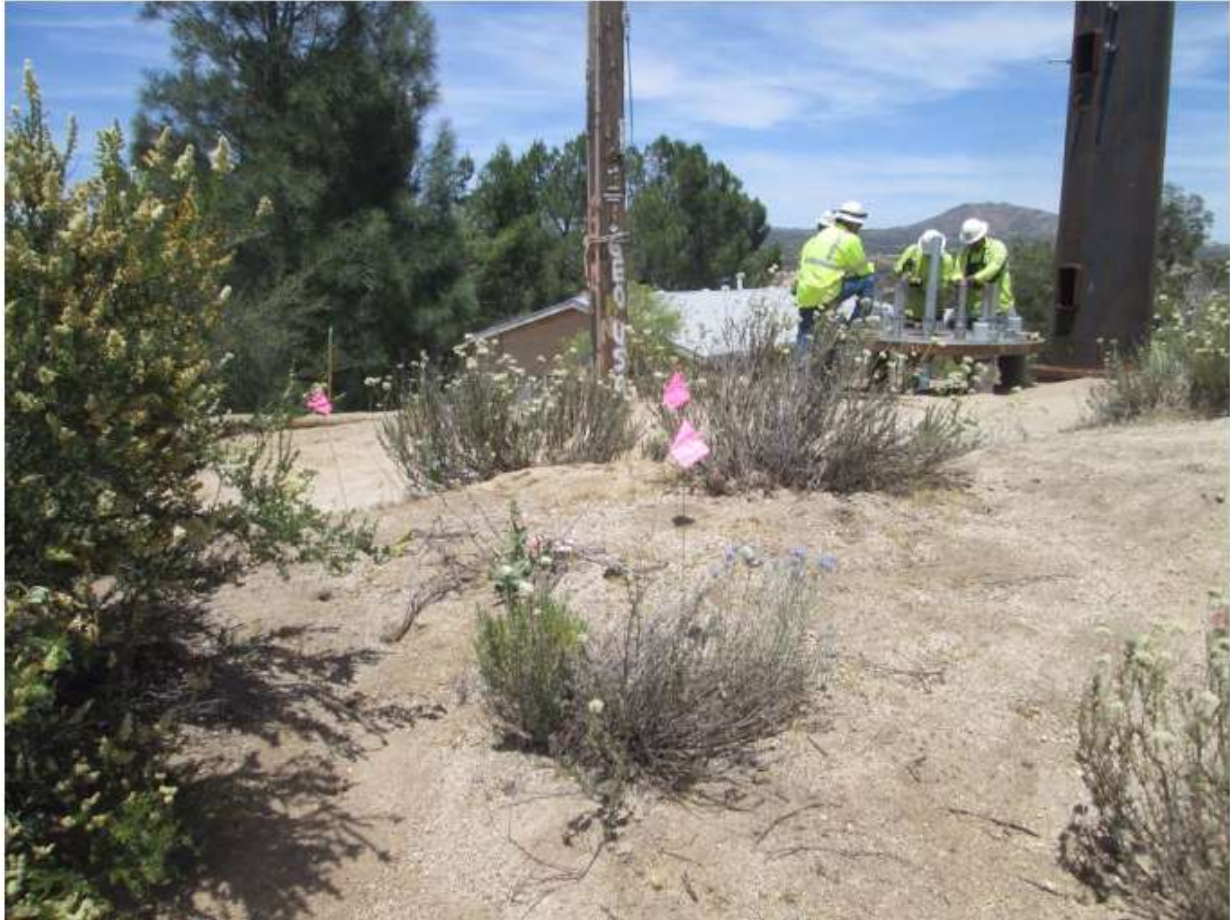
Photo 2: During foundation setting at Z44293 (TL 6931), designated plants were flagged for avoidance in accordance with MM BIO-13 and MM BIO-14.

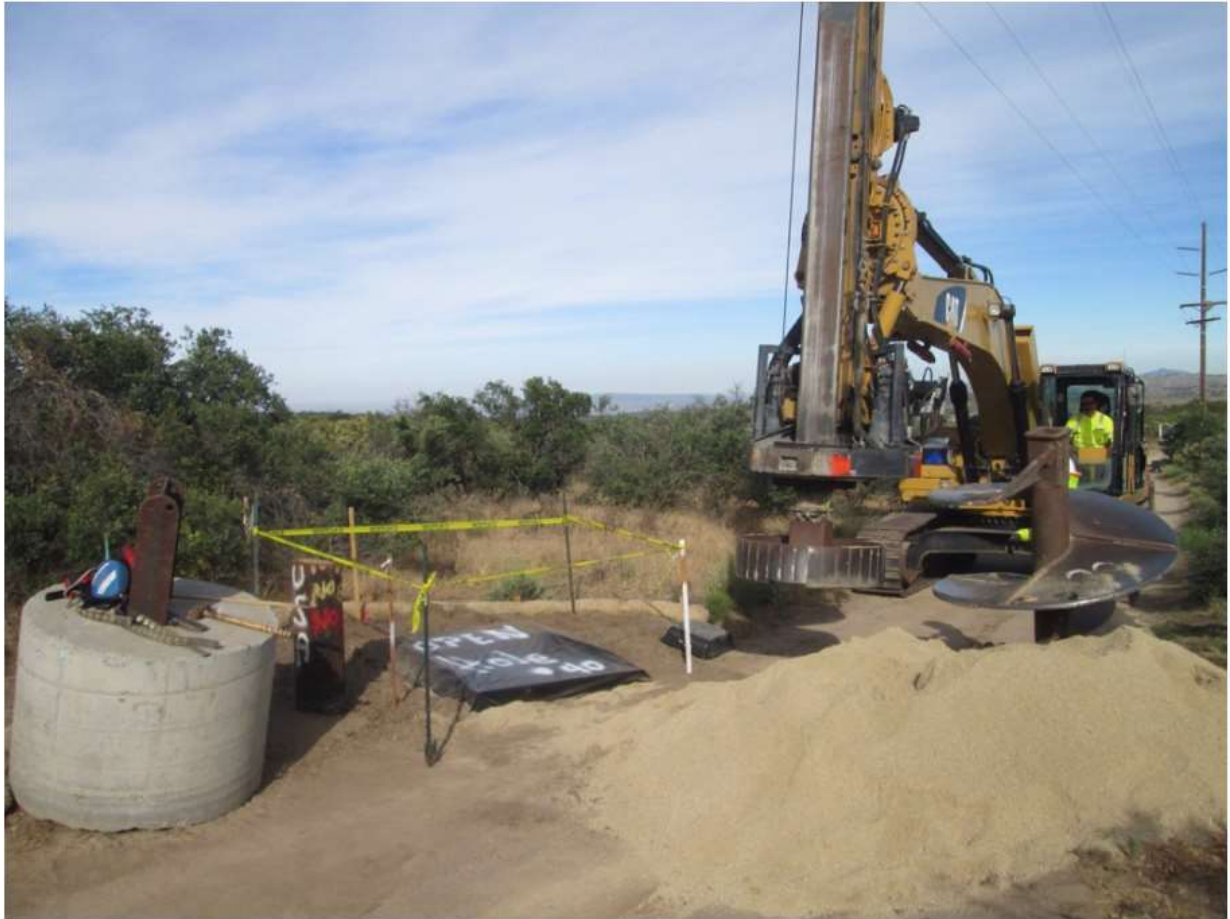
Photo 3: After completion of conventional drilling for pole P46409 (TL 6931), the hole was securely covered for safety and to prevent wildlife entrapment in accordance with MM BIO-23.

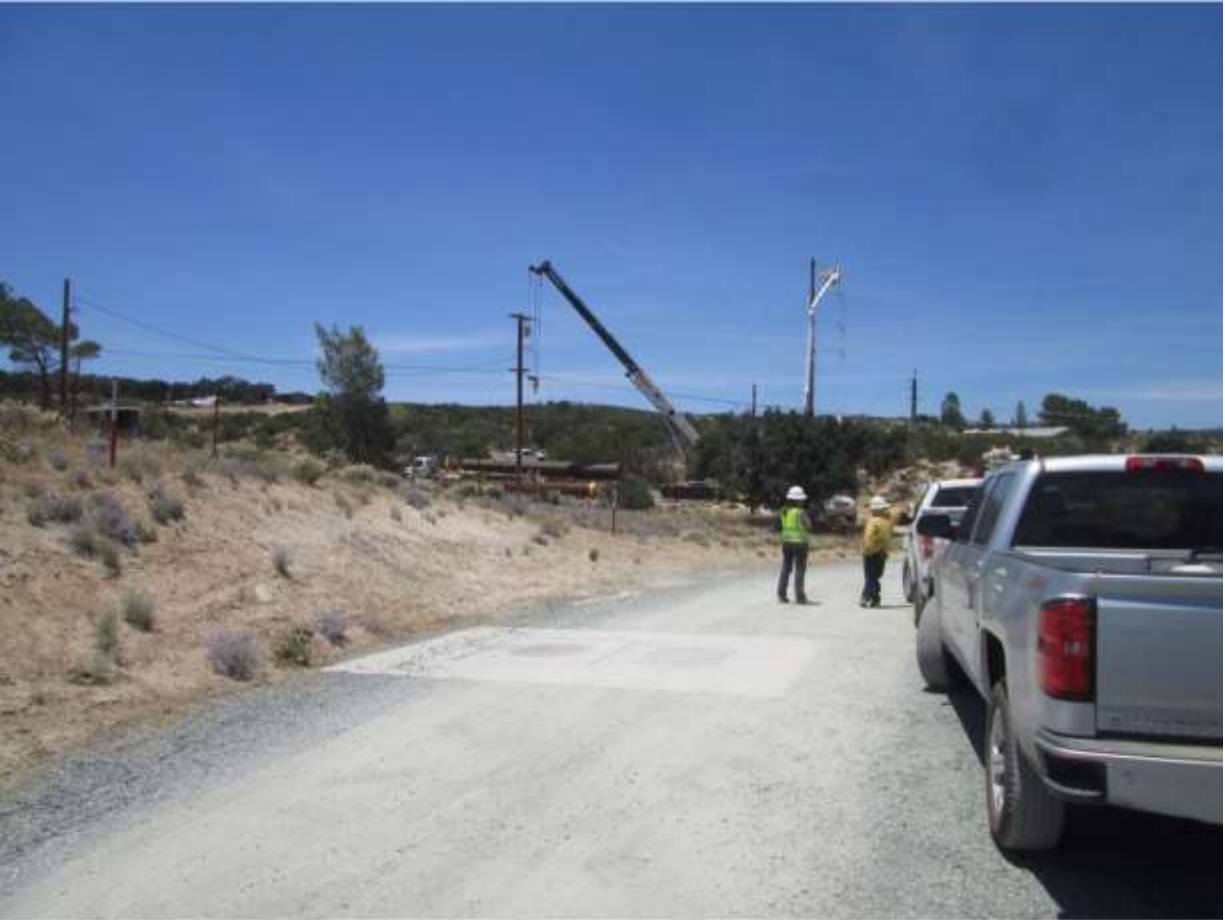
Photo 4: During installation of grounding and staging of a steel replacement pole at Z44294 (TL 6931), a biological monitor was observed spot checking the activity in accordance with MM BIO-3 and MM BIO-22, and a fire patrol was observed inspecting the site for compliance with the CFPPP (MM FF-1).

During construction activities, construction fire patrols were observed inspecting sites for compliance with the Construction Fire Prevention/Protection Plan (CFPPP) (MM FF-1) (See Photo 4—Attachment A). Crews were observed carrying the required activity-specific fire tools and equipment (a 5 gallon backpack pump, round point shovel, Pulaski, and 2A10BC fire extinguisher).

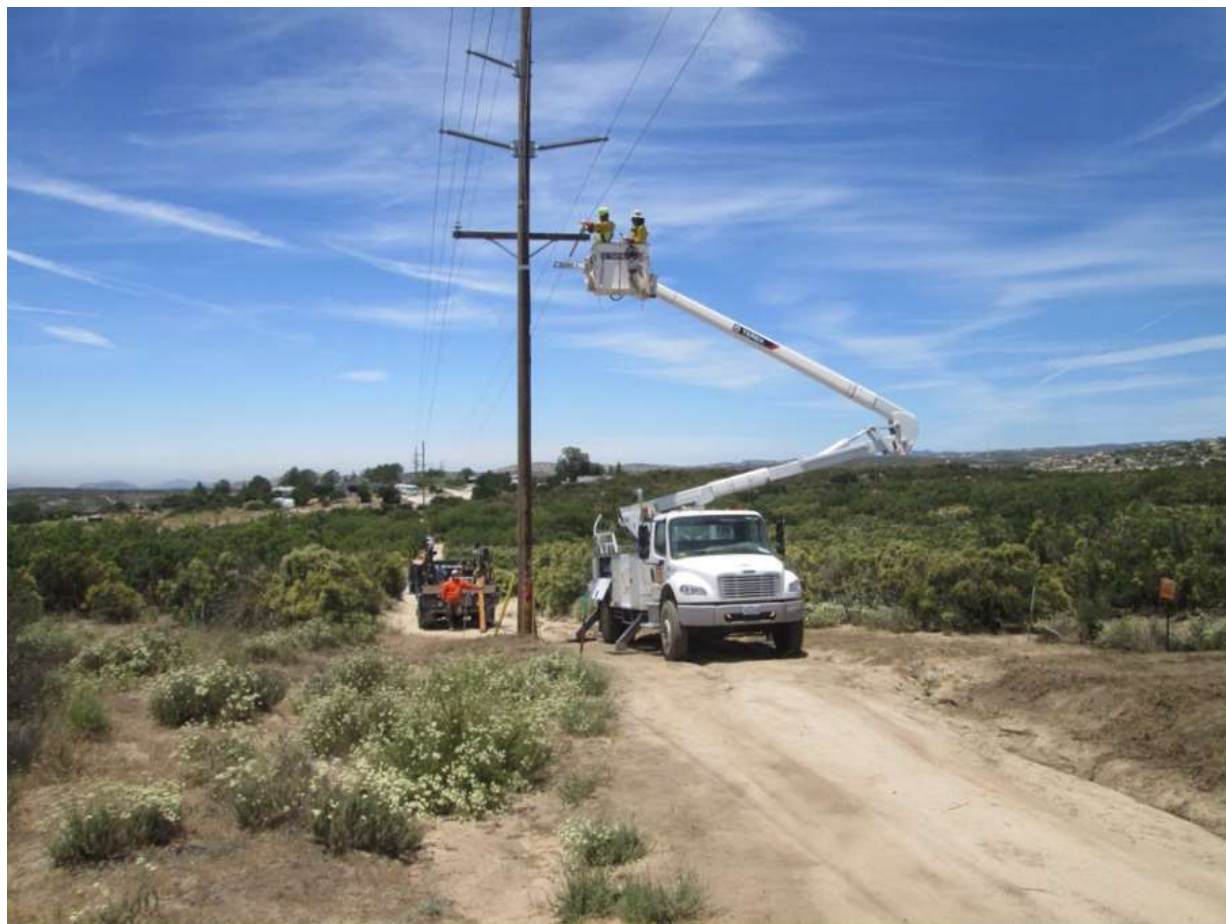
Photo 5: Construction crew observed spreading wire at Z44267 (TL 6931) to allow the overhead space necessary for pole hole drilling. Crews were observed staying within existing access roads and delineated work spaces (MM BIO-1).

Crews continued to conduct micropile and direct-bury/conventional foundation work such as drilling and grouting, and were observed assembling, installing and removing wood poles along TL 6931 this reporting period. During foundation setting, designated special status plants were observed flagged for avoidance in accordance with MM BIO-13 and MM BIO-14 (See Photo 2—Attachment A) and upon completion of conventional drilling activities, excavated holes were observed being covered for safety and to prevent wildlife entrapment in accordance with MM BIO-23 (See Photo 3—Attachment A). In accordance with MM BIO-28 and the Project's Nesting Bird Management Plan, approved avian biologists were observed monitoring active nests and monitoring construction activity to ensure nesting buffer restrictions were adhered to along the right-of-way. Signage indicating active nest buffer conditions was observed posted. During installation of grounding and staging of replacement poles, biological monitors were observed spot checking the activity in accordance with MM BIO-3 and MM BIO-22 (See Photo 4—Attachment A). During overhead work and drilling/installation activities, crews were observed staying within existing access roads and delineated work spaces (MM BIO-1) (See Photo 5—Attachment A).

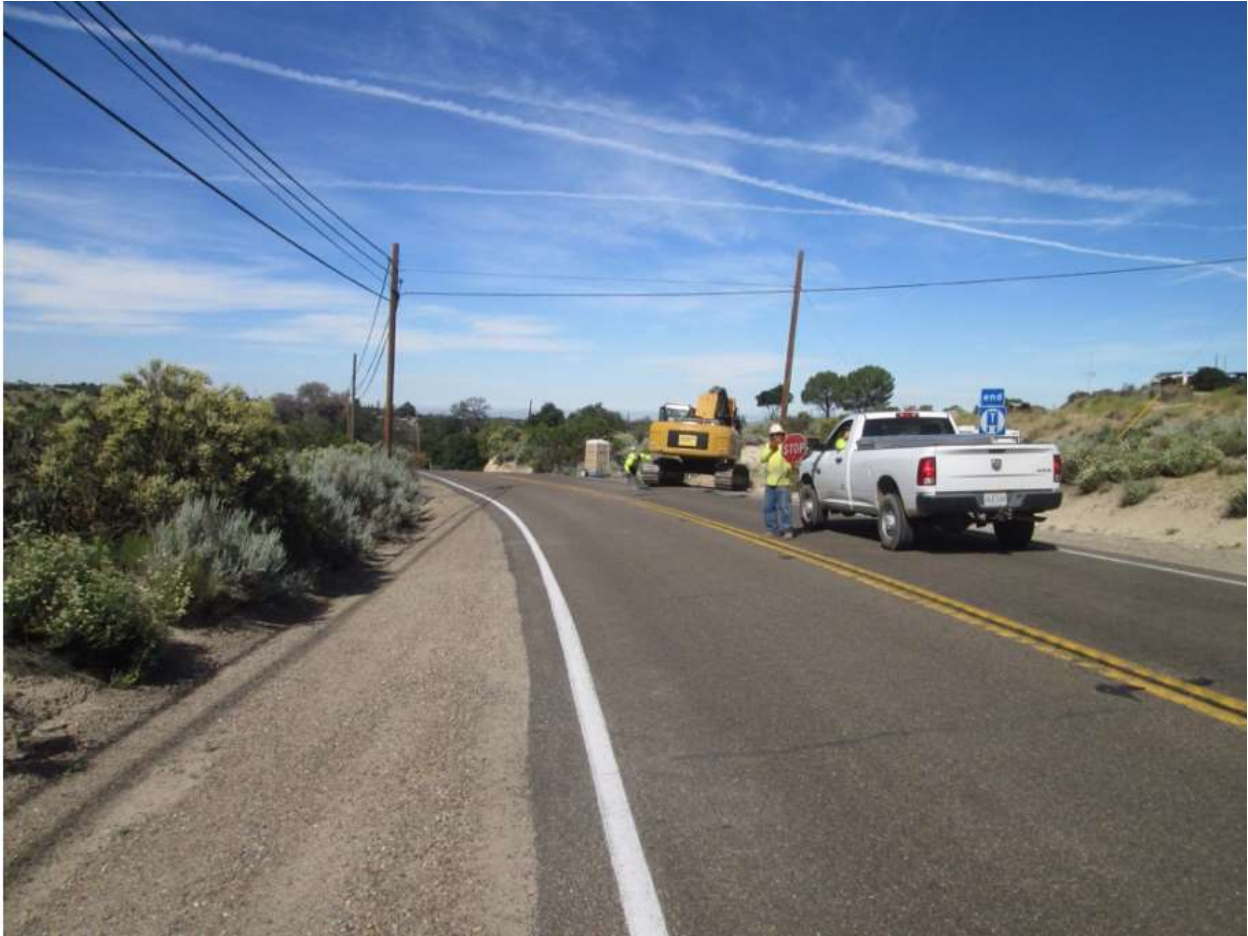
Photo 6: During the transport of a drill from Z44266 to Z44263 (TL 6931), traffic control flag persons were utilized to direct traffic around the equipment while traveling along a section of Highway 94 in accordance with APM TRANS-02.

Implementation of traffic control measures to support overhead line work and transportation of equipment was continued to be observed this reporting period. Traffic control measures such as placement of signage and cones as well as flagpersons directing traffic along sections of Highway 94 were implemented in accordance with APM TRANS-02 (See Photo 6—Attachment A).
