<p><b>California Public Utilities Commission</b>  <b><i>Mitigation Monitoring, Compliance, and Reporting</i></b>  <b><i>Program</i></b></p>
	<p><b>Cleveland National Forest Power Line Replacement</b>  <b>Projects</b></p> <p><b>Compliance Status Report: 054</b></p> <p><b>October 14, 2018</b></p>

This compliance status report covers construction activities from October 1, 2018 through October 14, 2018.

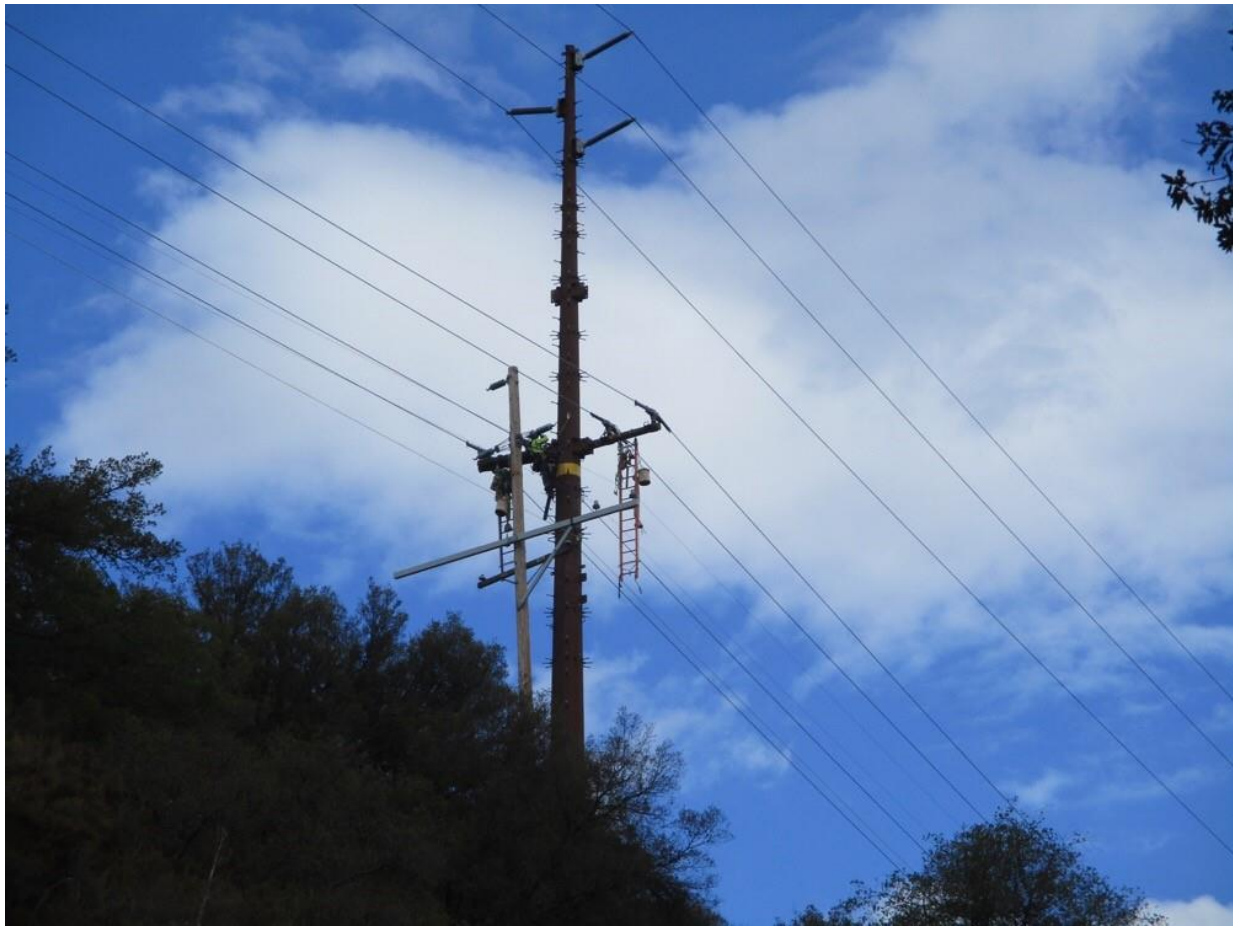
**Photo 1:** A CPUC ECM observed a wire stringing construction crew dead-ending new 12 kV conductor wire at Pole Z118111 along TL 682.

During this reporting period at TL 682, CPUC ECMs observed construction crews excavating new pole holes, cutting existing/old steel poles and removing them, spreading wire and installing new poles, sagging and dead-ending newly installed distribution lines (See Photo 1 – Attachment A), staging equipment in preparation for fiber optic line stringing, conducting helicopter external load operations, re-contouring old work areas, managing sediment spoils, and maintaining erosion control best management practices (BMPs). At TL 6957, crews were observed drilling, installing rebar, grouting, proof-testing, and capping for micropile foundations, installing grounding, cutting existing/old steel poles and removing them, and installing new poles and conducting helicopter external load operations (See Photo 2 – Attachment A). At C 157 crews were observed excavating new pole holes (See Photo 6 – Attachment A), letting down de-energized lines and installing new poles, installing grounding, wrecking out old wire, removing old poles, stringing new wire, sagging and clipping wire, and conducting helicopter external load operations. At TL 629C, crews were observed clearing vegetation and installing erosion control BMPs (See Photo 4 – Attachment A), perforating, drilling, and installing gravel for new pole holes, drilling and proof testing for micropile foundations, and conducting helicopter external load operations.

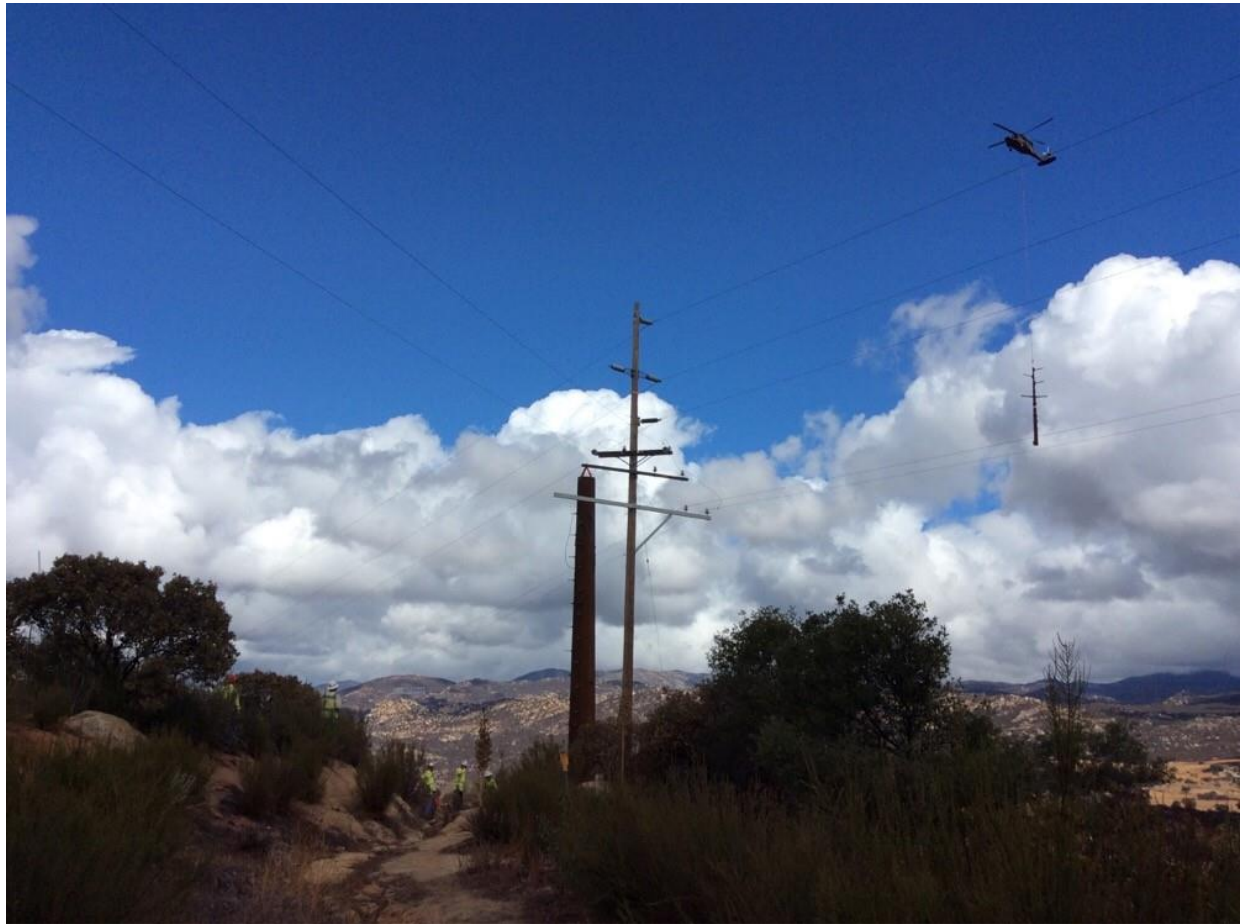
**Photo 2:** A crew observed installing a new steel pole top at Pole Z571421 (TL 6957).

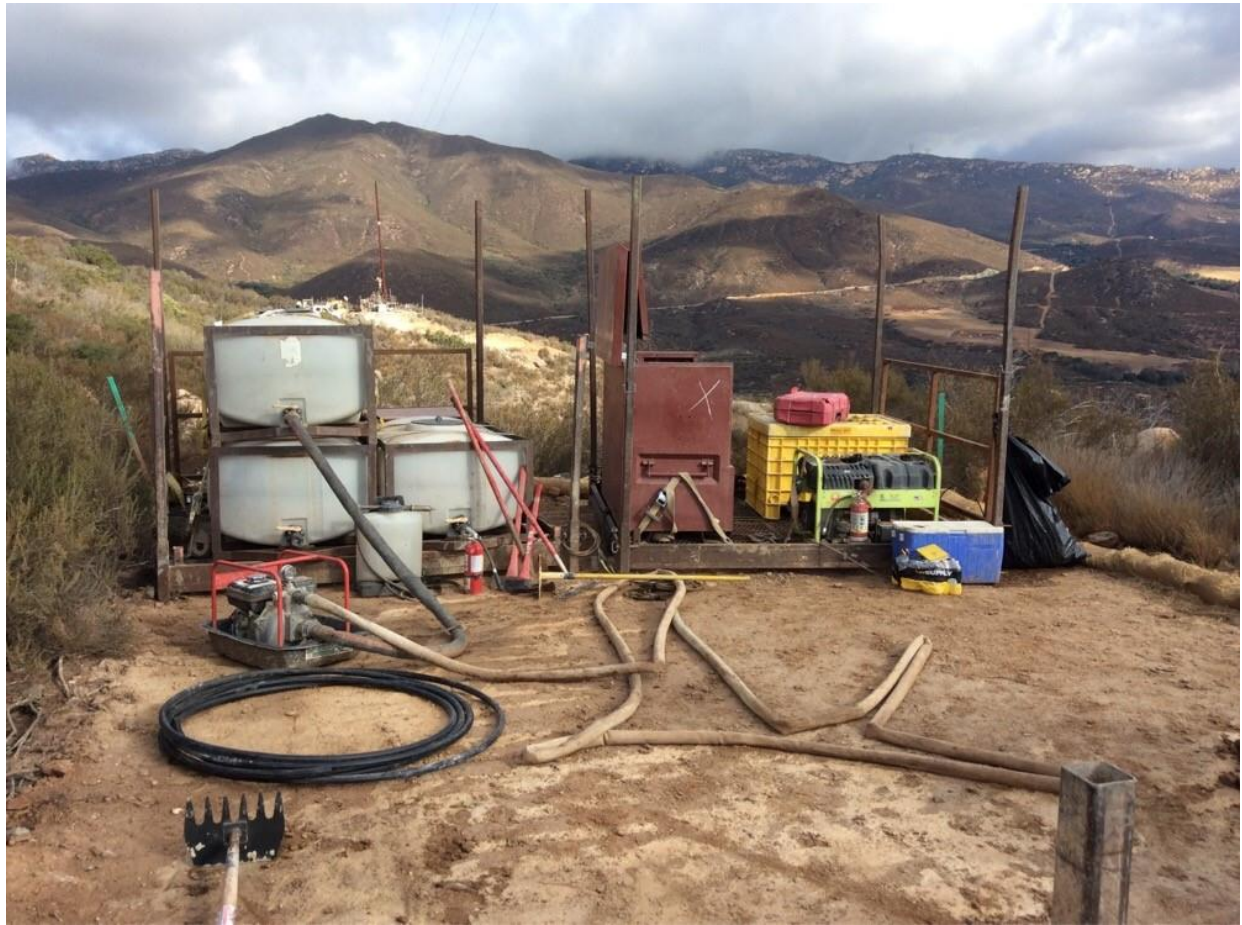
**Photo 3:** While inspecting a micropile drill site at Pole Z571459 (TL 6957), the ECM observed a water pump staged over a drip pan to prevent the release of hazardous materials onto the ground in accordance with the Spill Response and Prevention Plan and MM PHS-2. In addition, a complete set of fire tools (5-gallon backpack pump, round point shovel, Pulaski, and 2A10BC fire extinguisher) was staged within 50 feet of work activities in accordance with the Construction Fire Prevention/Protection Plan (CFPPP), MM FF-1, and APM HAZ-04, and a trash bag was used to contain trash throughout the day in accordance with MM BIO-26.

CPUC ECMs observed fire patrols inspecting sites for compliance with the Construction Fire Prevention/Protection Plan (CFPPP) and MM FF-1 throughout the reporting period (See Photo 6 – Attachment A). Dedicated fire patrols were observed on-site for hot work such as the cutting of old steel poles, for overhead work with energized lines such as wire spreading, and were observed conducting 1 hour fire watches at those sites after work completion. Construction crews were observed staging a set of fire tools (5-gallon backpack pump, round point shovel, Pulaski, and 2A10BC extinguisher) within 50 feet of work activities, and staging the required activity-specific fire tools and equipment based on the days stated fire conditions as described in the CFPPP Fire Prevention Matrices (See Photos 3, 4, and 6 – Attachment A).

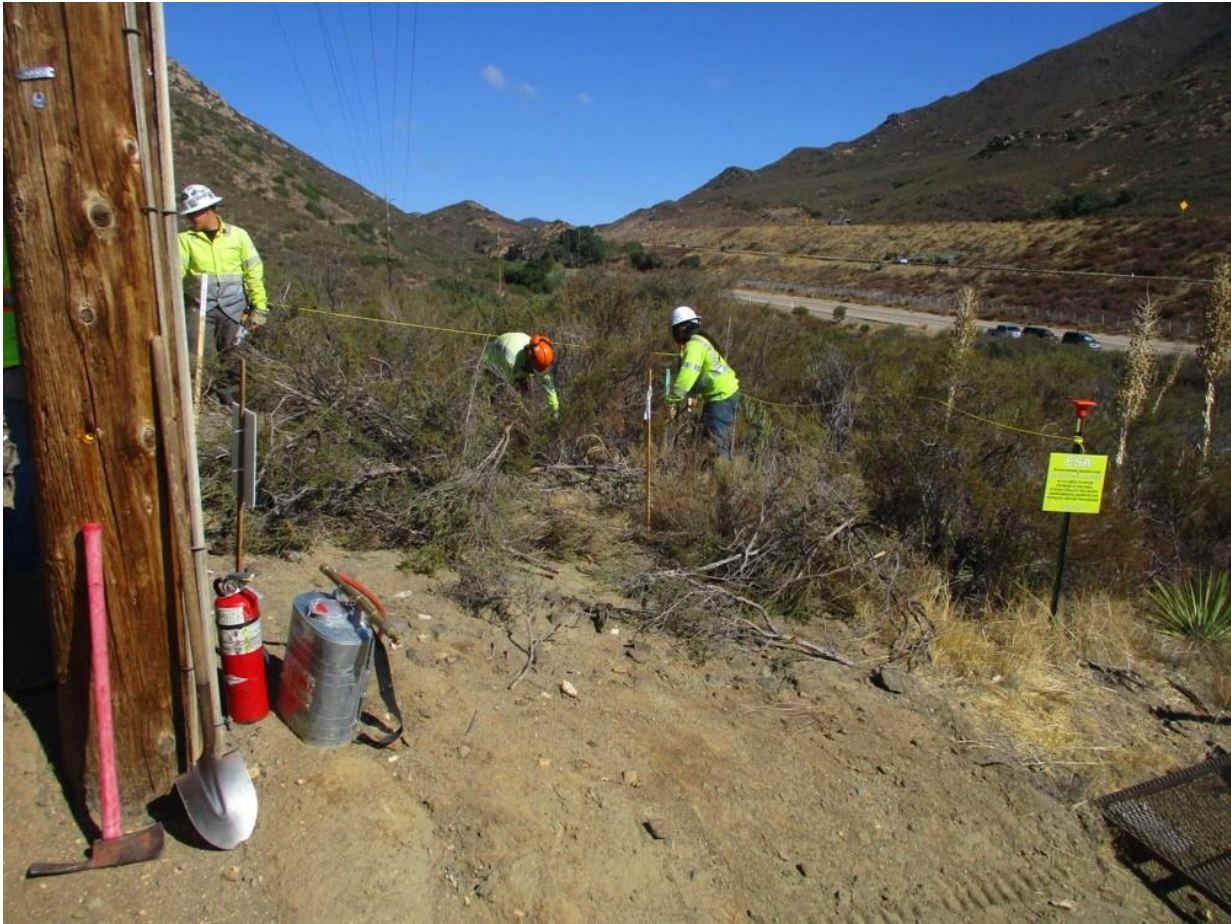
**Photo 4:** During vegetation clearing at Pole Z40510 (TL 629C), the construction crew staged a set of fire tools within 50 feet of work activities in accordance with the CFPPP, MM FF-1, and MM HAZ-04. The work space was surrounded by a ESA (rope and signage) and archeological and Native American monitors were present on-site during work activities in accordance with the Historic Properties Management Plan (HPMP), MM CUL-1, APM CUL-03, and APM CUL-04, and APM CUL-05.

(HPMP), MM CUL-1, MM CUL-3, APM CUL-04, and APM CUL-05 (See Photos 4 and 6 – Attachment A).

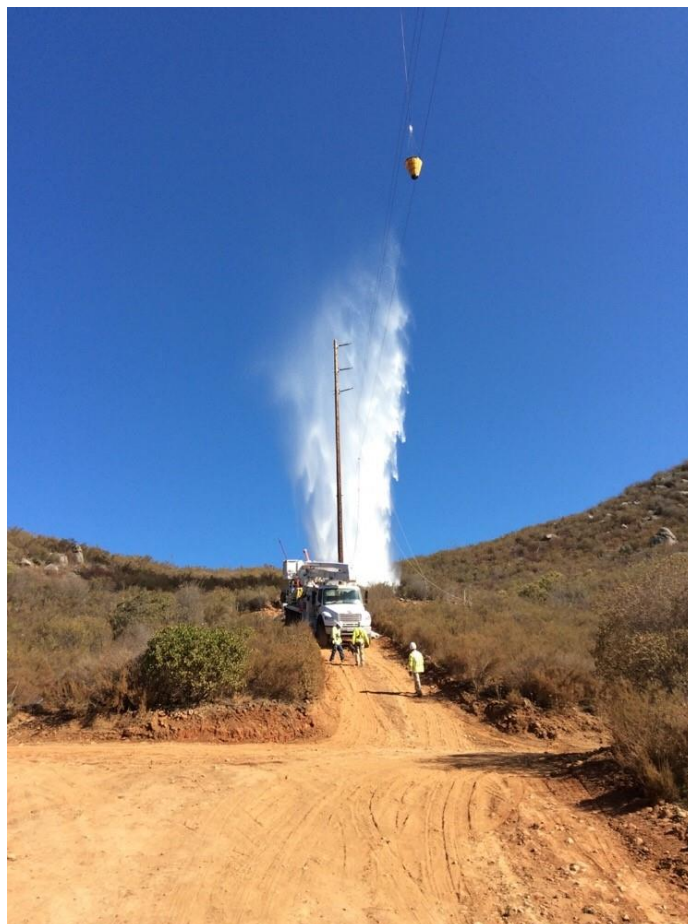
**Photo 5:** In order to minimize dust emissions from helicopter rotor wash during pole setting at Pole Z571449 (TL 6957), water was dropped on the site prior to pole delivery in accordance with APM AIR-05.

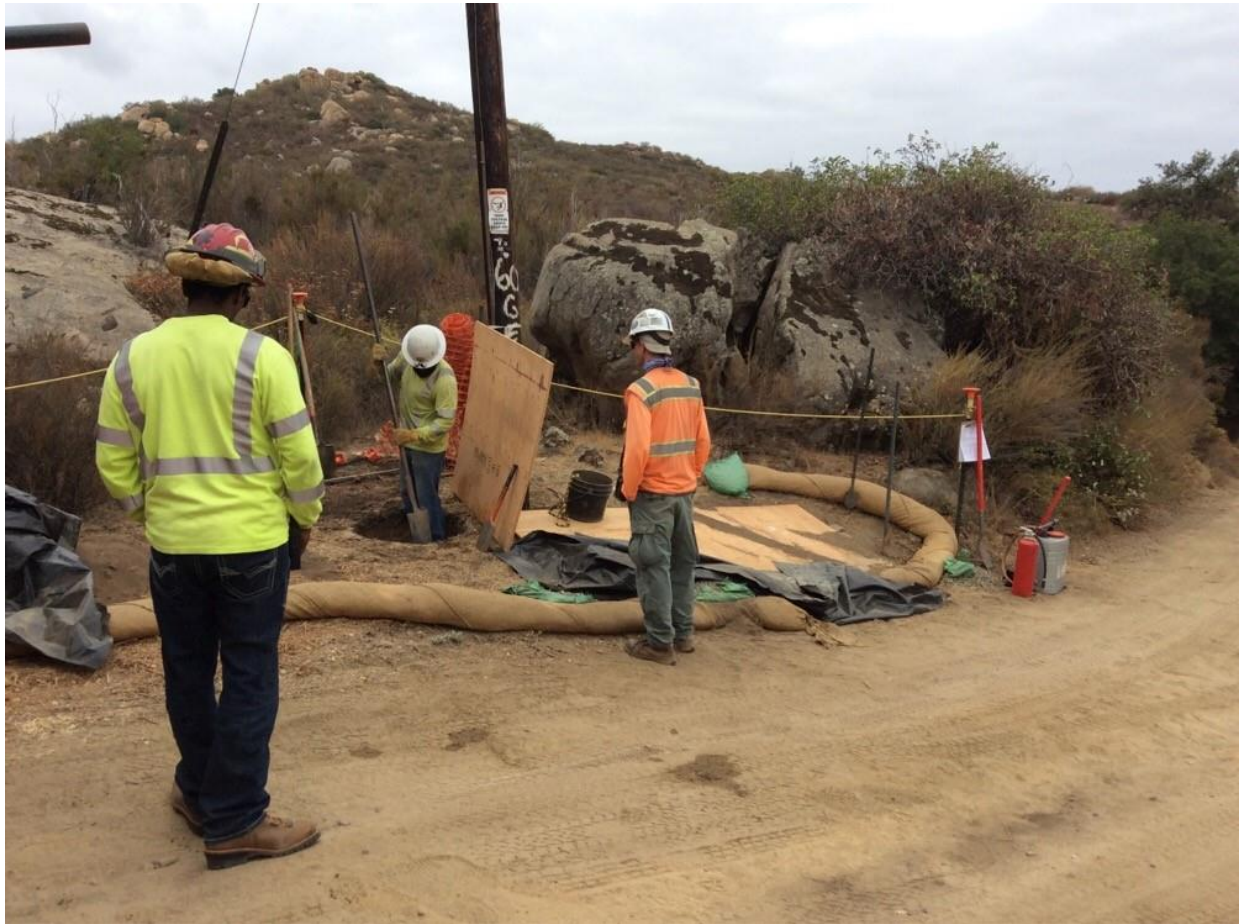
**Photo 6:** In accordance with the HPMP, MM CUL-1, and APM CUL-04, an Archaeological Monitor (pictured) and Cultural Monitor (present but out of frame) were present during pole hole excavation at Pole P278749 (C 157). A Fire Patrol was also present in accordance with the CFPPP.
