<p>California Public Utilities Commission <i>Mitigation Monitoring, Compliance, and Reporting</i> <i>Program</i></p>
	<p>Cleveland National Forest Power Line Replacement Projects</p> <p>Compliance Status Report: 055</p> <p>October 28, 2018</p>

SUMMARY

This compliance status report covers construction activities from October 15, 2018 through October 28, 2018.

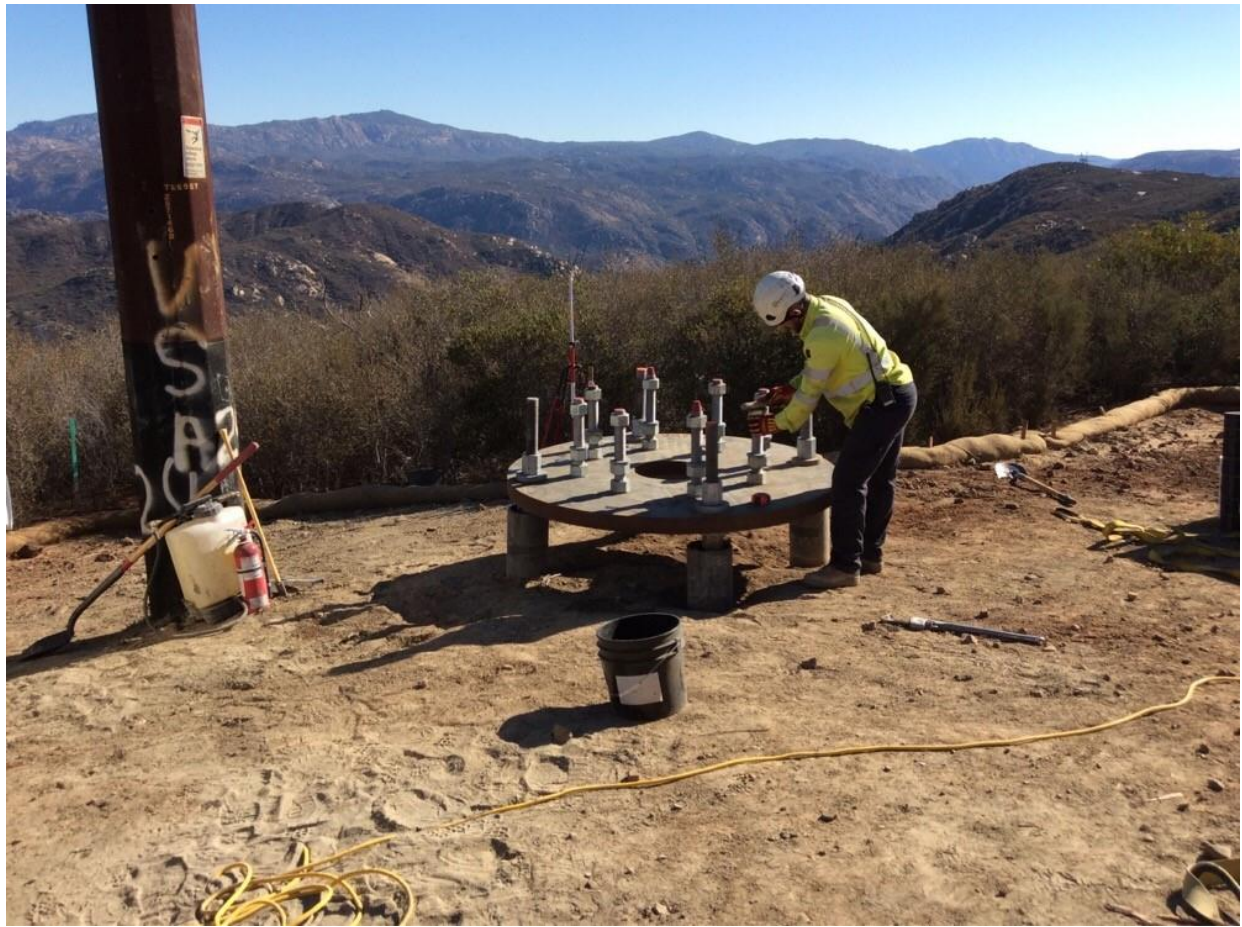
Photo 1: A construction worker observed installing a micropile foundation cap at Pole Z571460 (TL 6957). A complete set of fire tools, including a 5 gallon backpack pump, round point shovel, Pulaski, and 2A10BC fire extinguisher, were located on-site in accordance with the CFPPP (MM FF-1) and APM HAZ-04.

During this reporting period at TL 6957, CPUC ECMs observed construction crews drilling, setting rebar, grouting, and capping for micropile foundations (See Photo 1 – Attachment A); trenching and installing grounding; spreading and transferring wire to create overhead space needed for helicopter operations at pole locations; conducting wire work, framing poles, setting new poles, and transferring wire to new poles; and conducting helicopter operations. At TL 629C, crews were observed mobilizing equipment and setting up drill platforms, drilling, setting rebar, grouting, and proof-testing for micropile foundations; trenching and installing grounding (See Photo 2 – Attachment A); perforating new pole holes, drilling and excavating new direct bury pole holes (See Photo 3 – Attachment A), and grading dirt spoil into existing access roads; clearing vegetation and installing sediment control Best Management Practices (BMPs) to ready sites for construction (See Photo 4 – Attachment A); conducting helicopter operations; trimming oak trees for pole and line clearance; spreading transmission and distribution lines, lowering fiber optic lines, and framing and installing new steel poles (See Photo 5 – Attachment A). At TL 682, crews were observed removing poles and pole anchors (See Photo 6 – Attachment A), conducting helicopter operations, and performing quality control inspections remotely with a drone.

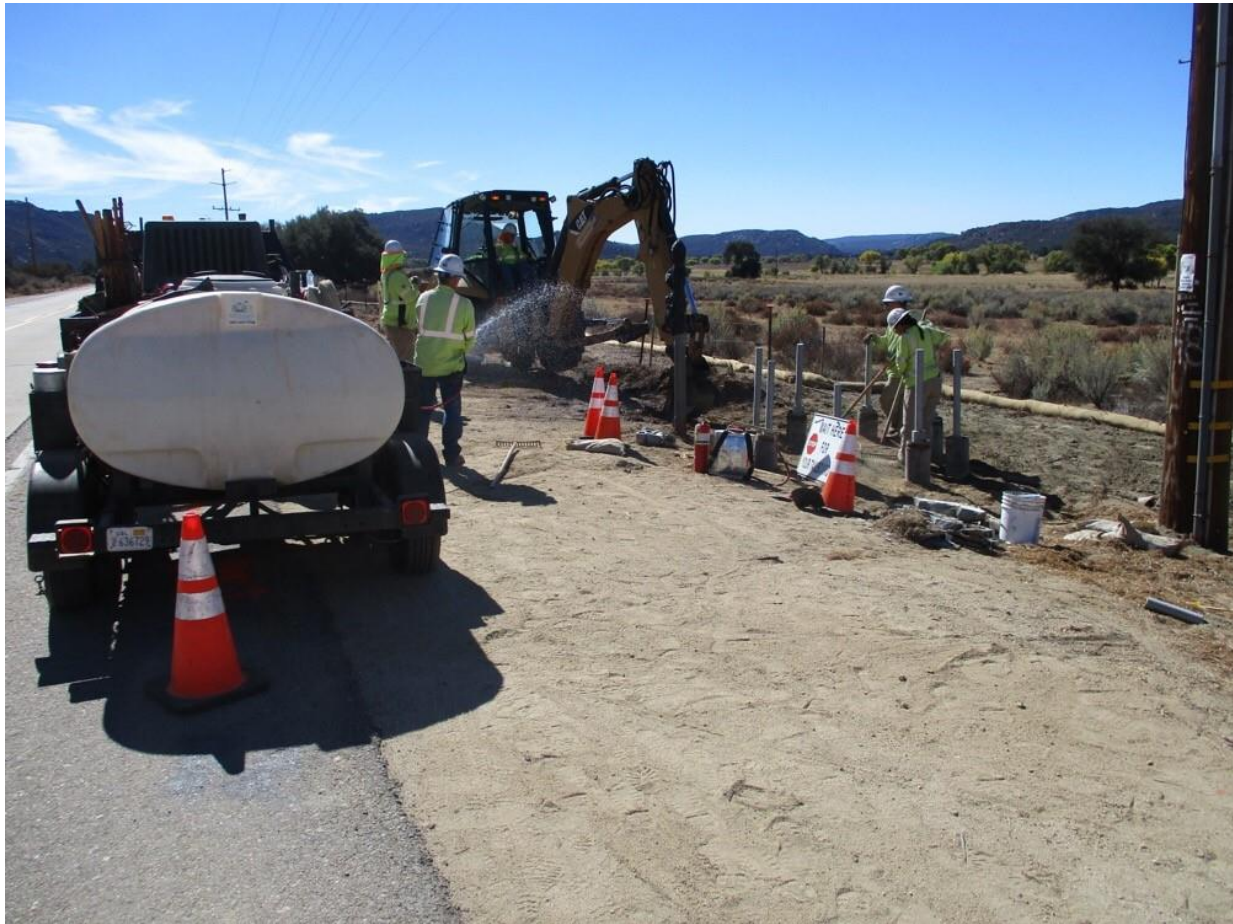
Photo 2: A construction crew observed trenching for the installation of grounding at Pole Z40535 (TL 629C). As required by the CFPPP (MM FF-1) for trenching work during fire conditions for the day, the construction crew was equipped with 150 gallons of water (with pump and hose), and was observed watering the area to prevent ignition. The area was also watered to reduce dust emissions in accordance with APM AIR-02 and APM AIR-05.

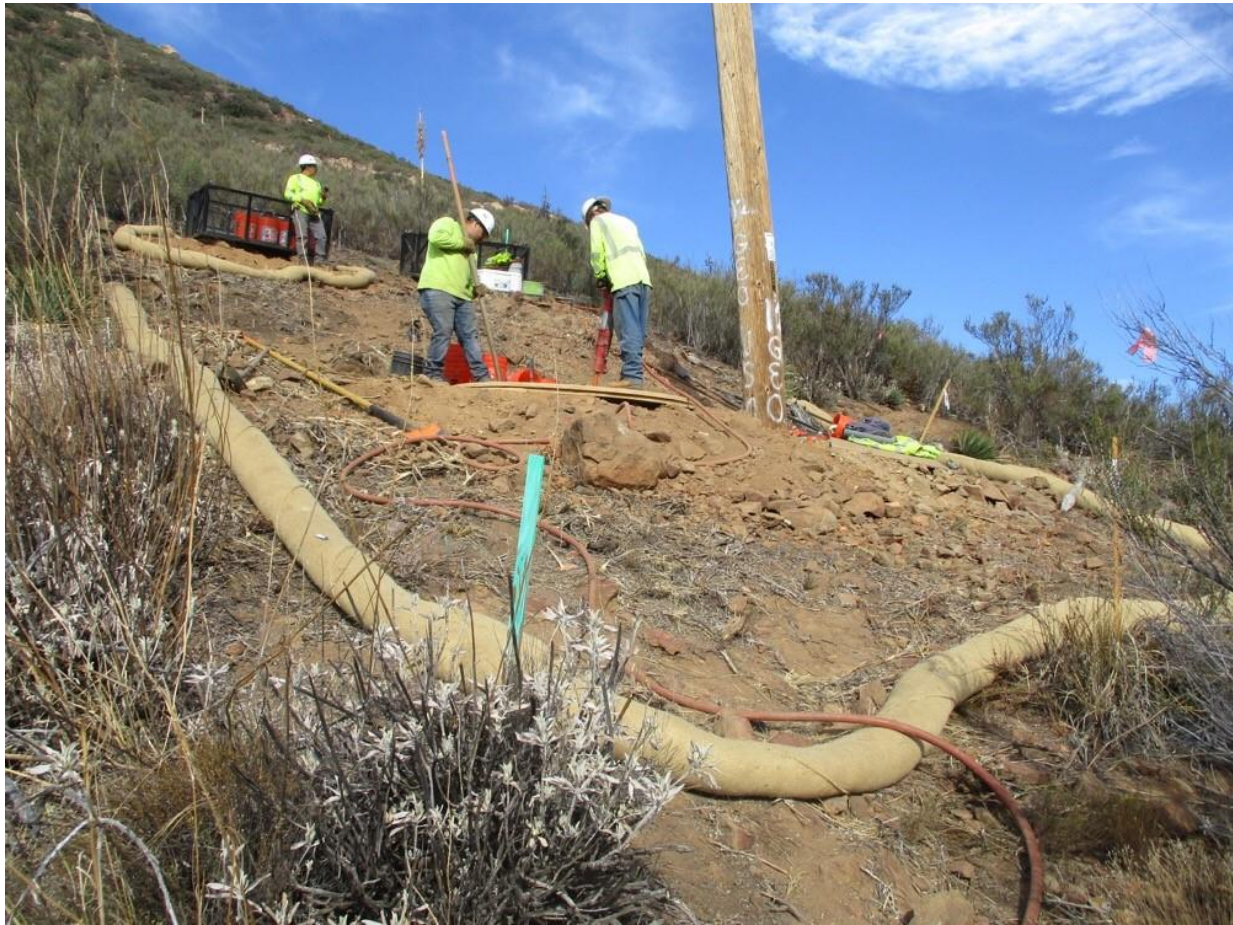
Photo 3: A construction crew observed excavating a direct-bury pole hole at Pole Z40464 (TL 629C). Sediment control BMPs (fiber rolls) were observed along the downslope side of the workspace to prevent off-site erosion in accordance with the ECP and SWPPP (MM HYD-1, APM HYD-09, MM BIO-7).

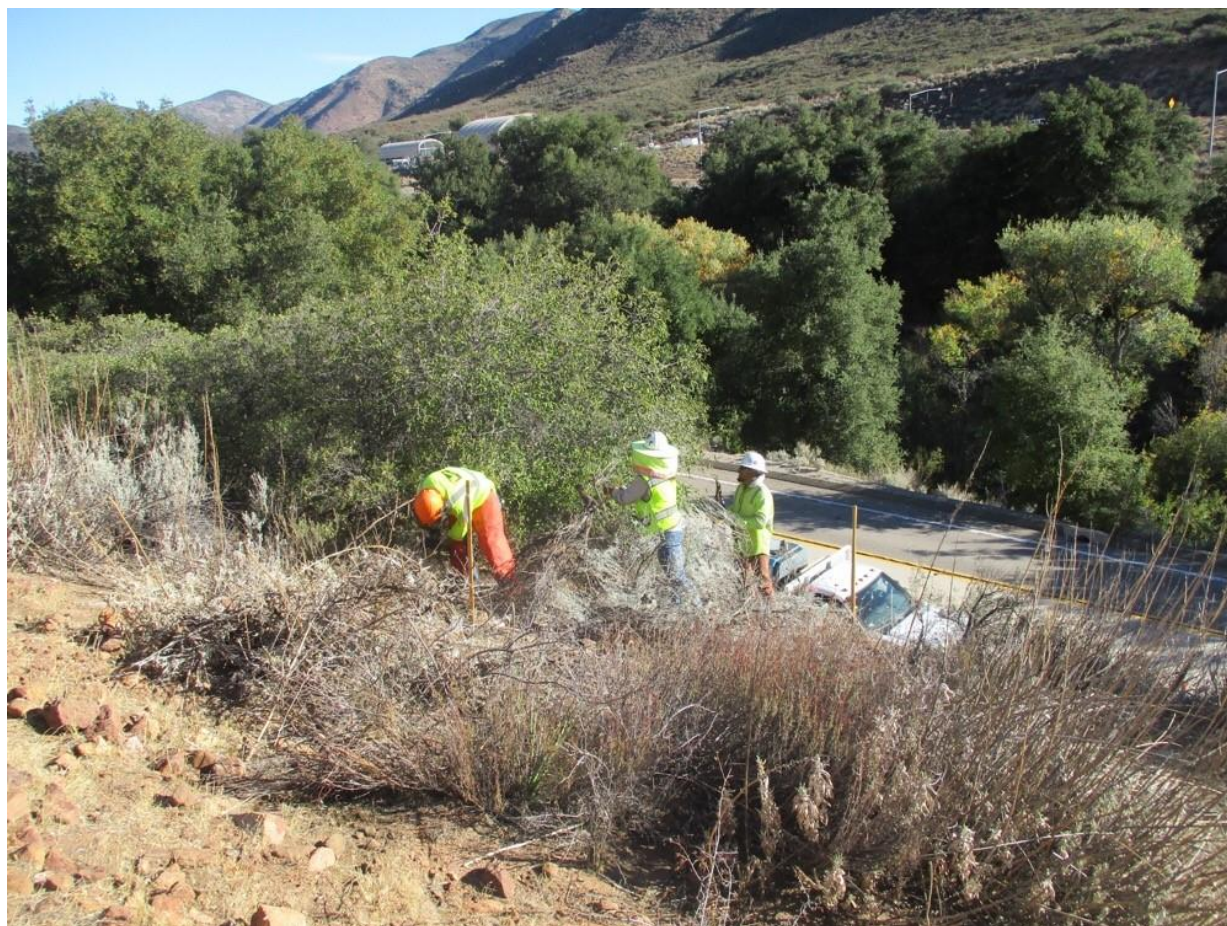
Photo 4: A construction crew observed clearing vegetation within the approved workspace for Pole Z40423 (TL 629C). A biological monitor was present on site for the vegetation clearing work in accordance with MM BIO-3, and was observed communicating with the construction crew about the delineated workspace limits to ensure all impacts to vegetation occurred within the approved workspace in accordance with MM BIO-1.

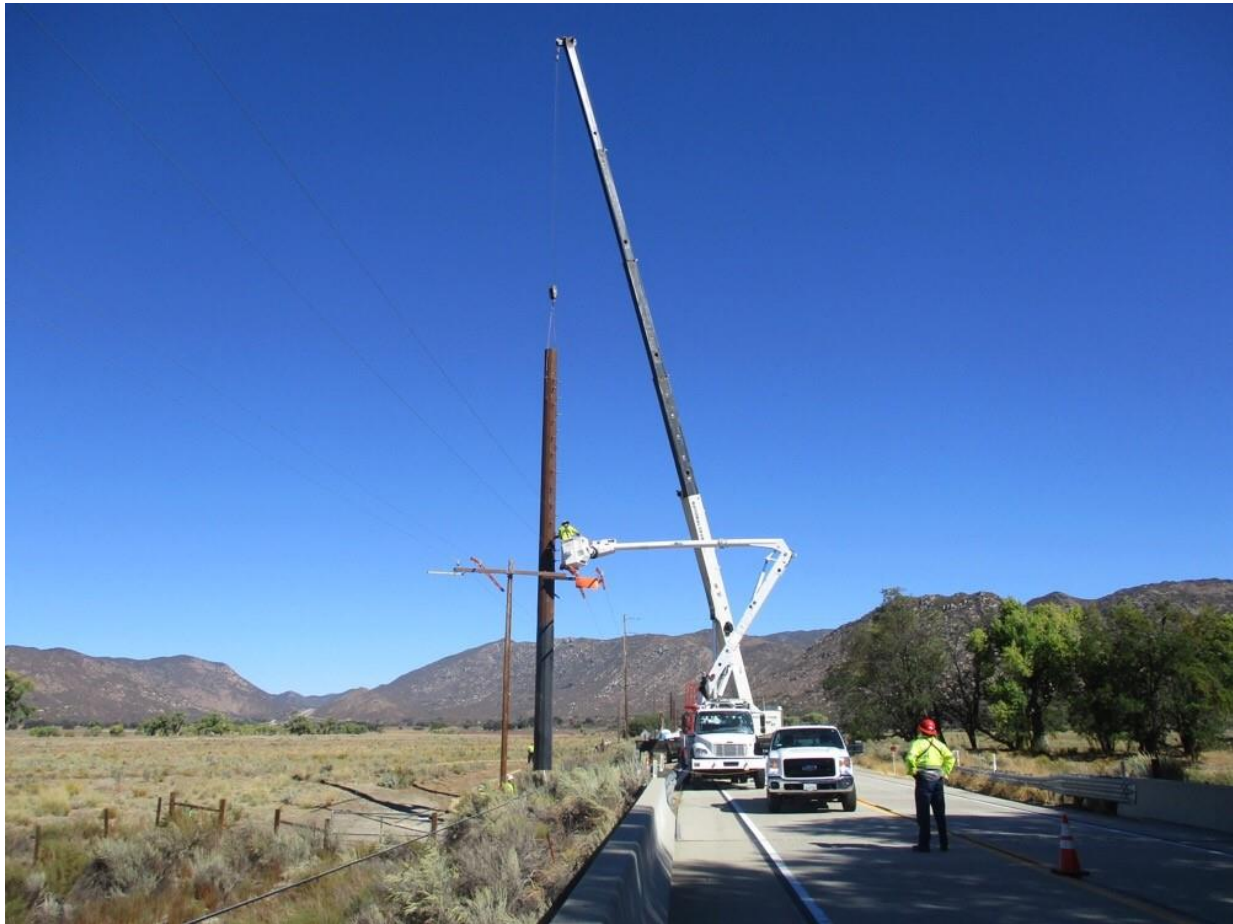
Photo 5: A construction crew spreading wire and installing a new pole at Pole Z40556 (TL 629C). A dedicated fire patrol was present for the work with energized lines in accordance with the CFPPP for the day's stated fire conditions. Traffic control personnel were observed implementing a lane closure along Old Highway 80, and utilizing a pilot car to guide motorists around the construction activity in accordance with APM TRANS-02.

Traffic control measures were observed being implemented along Highway 76 (TL 682), Lyons Valley Road and Carveacre Road (TL 6957), and Old Highway 80, Buckman Springs Road, and Old Buckman Springs Road (TL 629C) in accordance with APM TRANS-02. Signage and cones were used for shoulder closers (See Photo 5 – Attachment A), and flaggers were utilized to temporarily hold traffic when needed, or when helicopter operations crossed or occurred next to public roadways. A pilot car was observed being utilized along Old Highway 80 (TL 629C) to control one-way traffic and to lead motorists around construction activities.

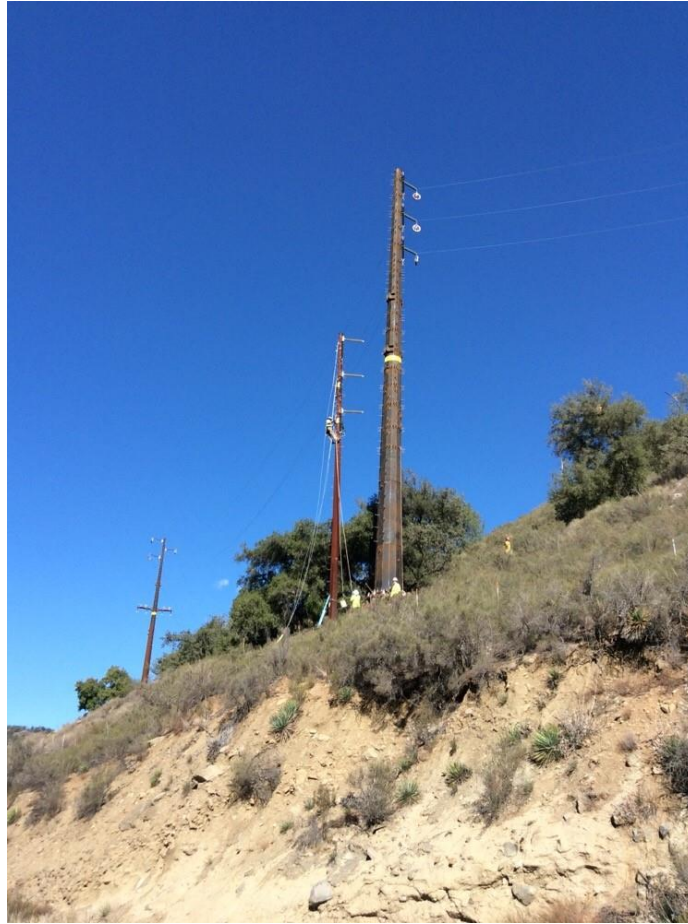
Photo 6: A construction crew observed cutting an existing/old steel pole for removal at Pole Z118088 (TL 682). A dedicated fire patrol was present on-site for the hot work as required by the CFPPP (MM FF-1) for the day's stated fire conditions.
