<p>California Public Utilities Commission <i>Mitigation Monitoring, Compliance, and Reporting Program</i></p>
	<p>Cleveland National Forest Power Line Replacement Projects</p> <p>Compliance Status Report: 006</p> <p>December 11, 2016</p>

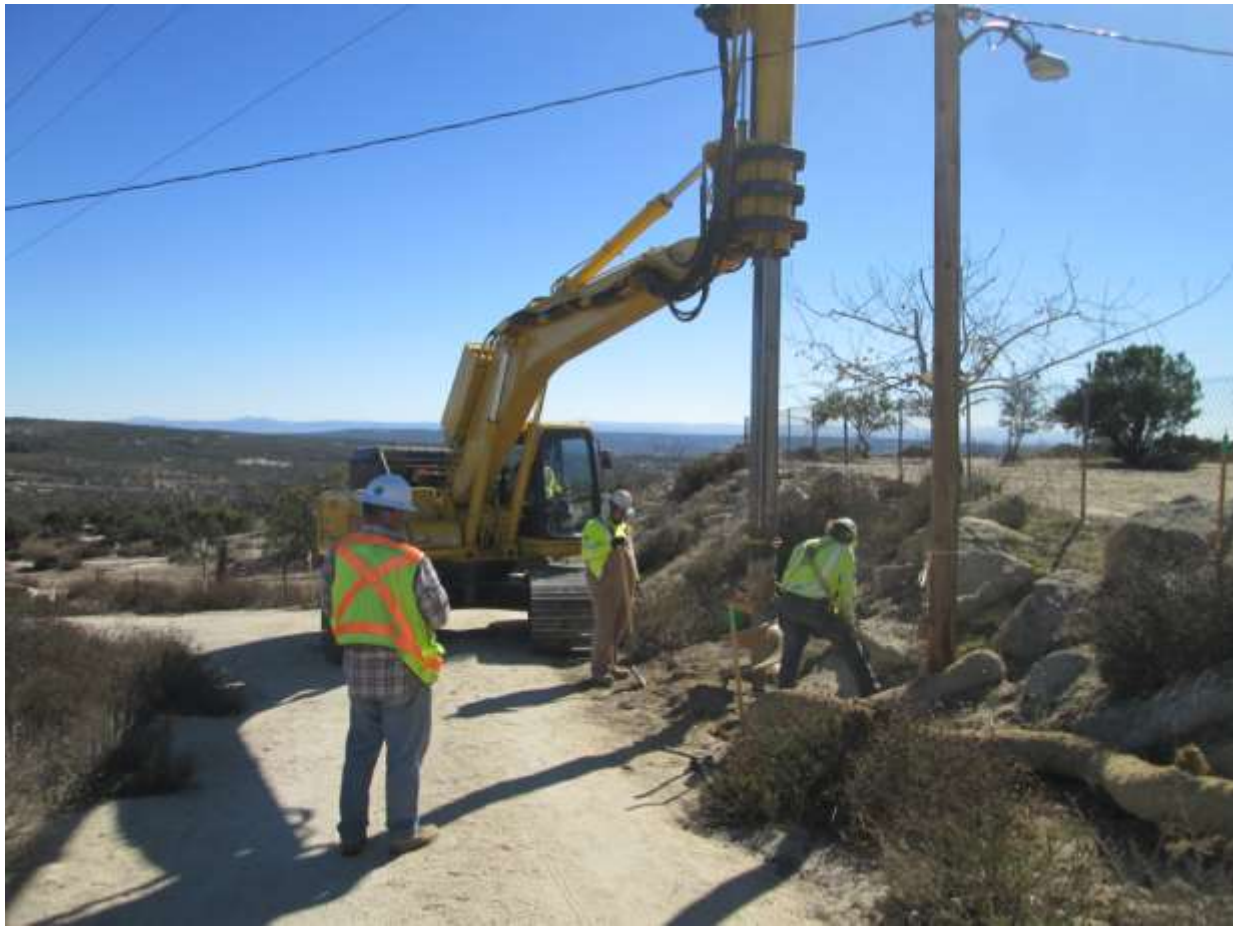
Photo 1: Crews were observed auguring a new pole location along TL 629E. Biological monitoring presence was observed in accordance with MM BIO-3.

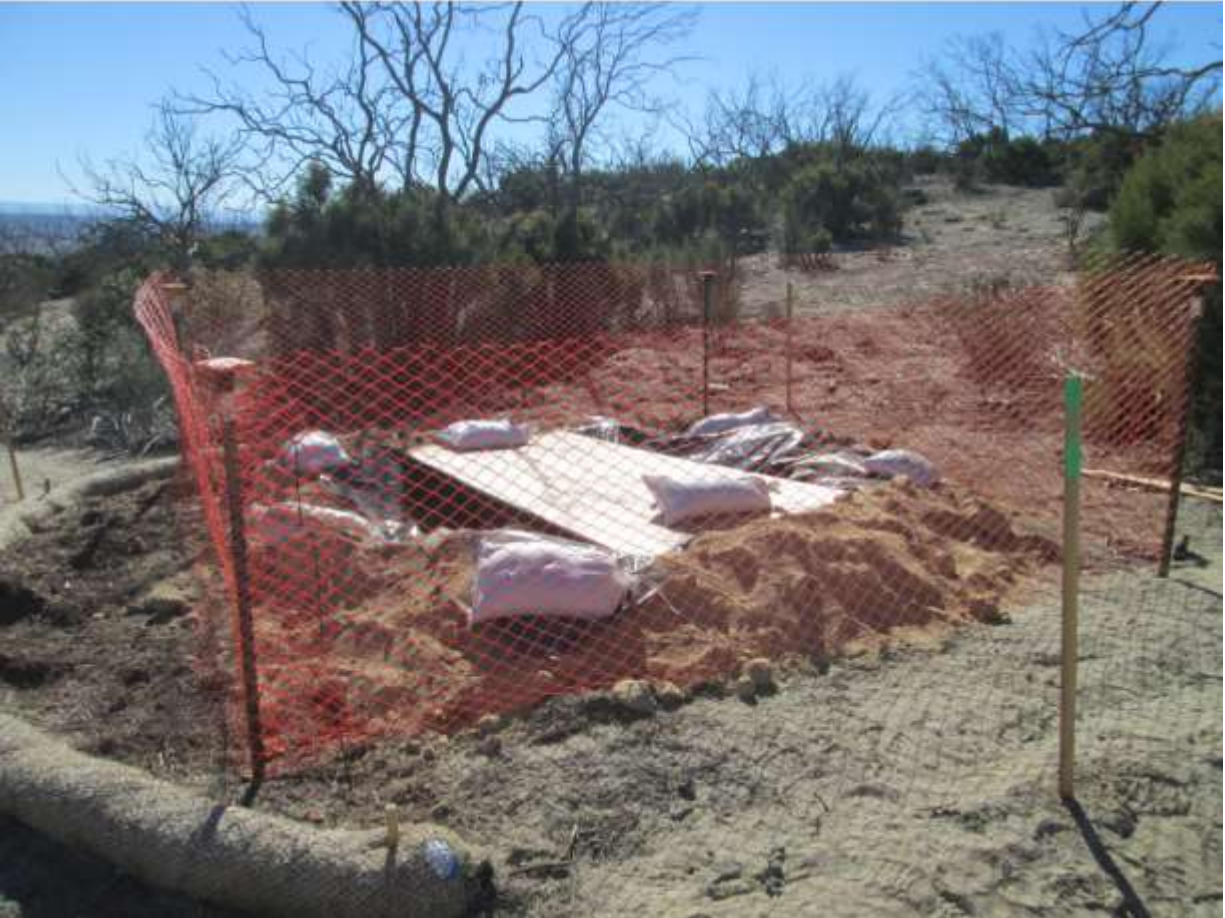
Photo 2: Upon completion of auguring along TL 629E, open holes were observed covered to prevent wildlife entrapment in accordance with MM BIO-23.

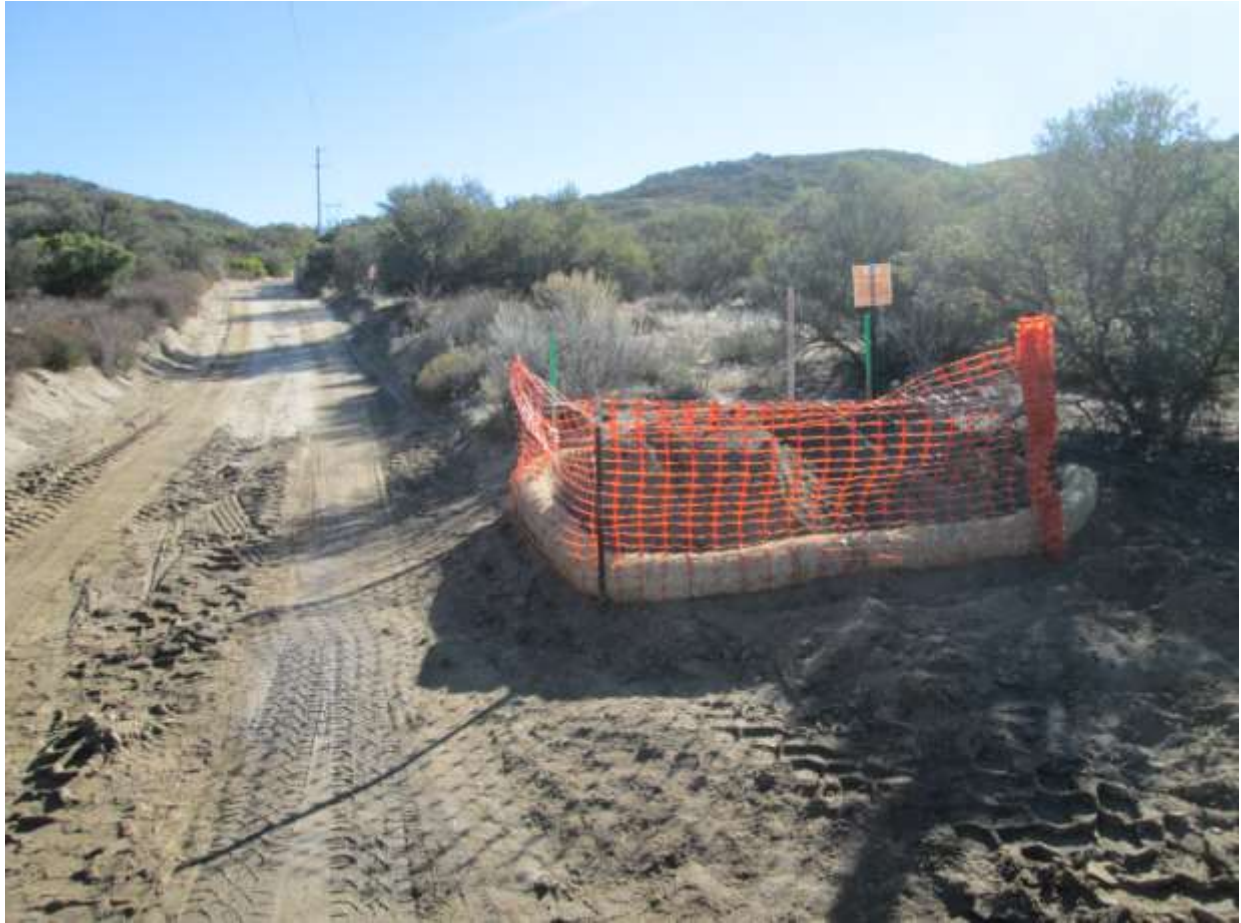
Grading at several work sites was observed this reporting period. Topsoil was salvaged in accordance with MM BIO-4 and the Habitat Restoration Plan. Topsoil stockpiles were secured with orange construction fencing and fiber rolls in accordance with the Erosion Control Plan and project SWPPP (See Photo 3—Attachment A).

Photo 3: Topsoil was observed salvaged along TL 629E (adjacent to Pole Z44176, above) in accordance with MM BIO-4 and the Habitat Restoration Plan. Stockpiles were surrounded by fiber rolls in accordance with the Erosion Control Plan and project SWPPP.

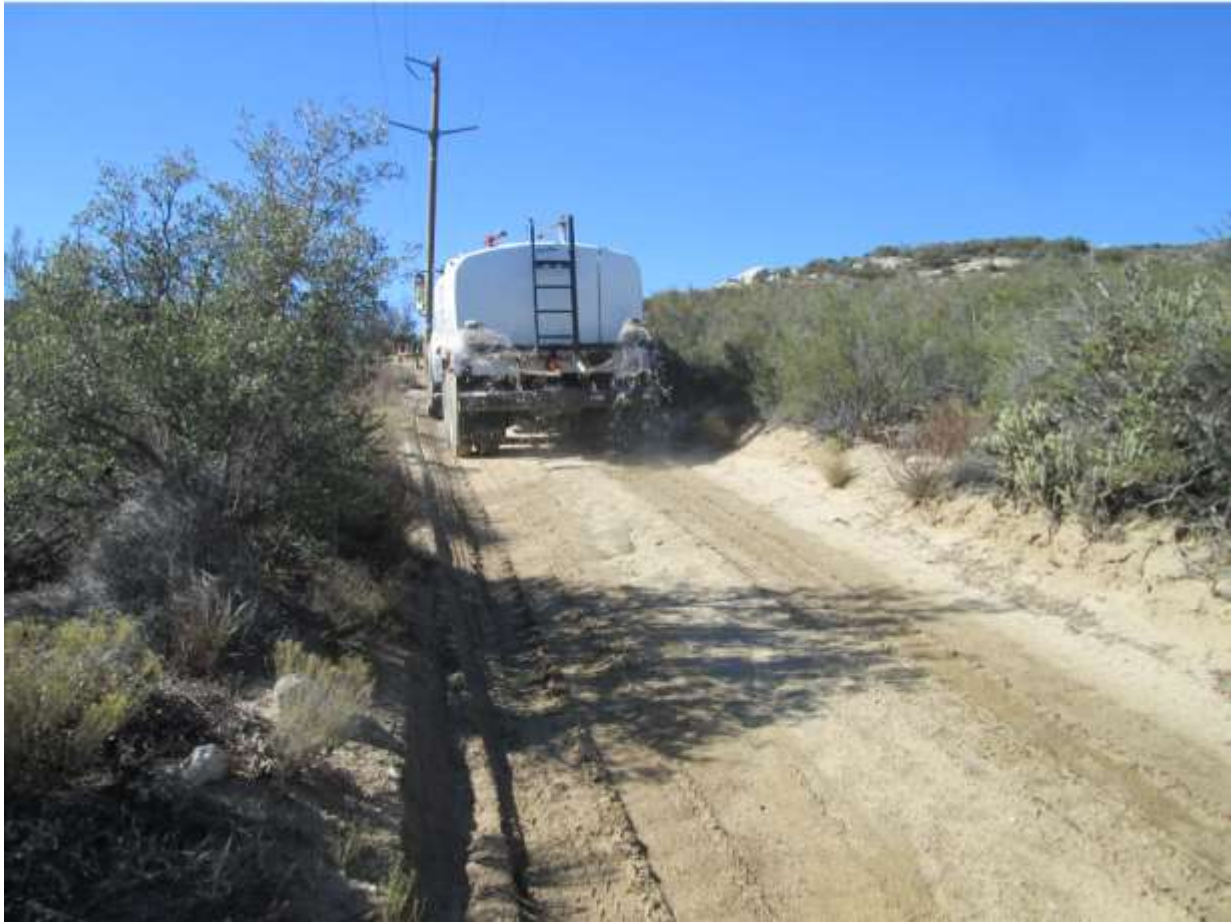
Water application was continued to be observed along the TL 629E right-of-way access roads and work areas to minimize fugitive dust emissions in accordance with MM AIR-02 (See Photo 4—Attachment A). Access roads included signage providing reminders of the project speed limits (APM AIR-03) and rock aprons/rumble plates were observed installed at intersections of unpaved access roads and paved roads to prevent sediment track out (APM AIR-05) in accordance with the SWPPP (APM HYD-05, MM BIO-7, and MM HYD-1) (See Photo 5—Attachment A).

Photo 4: Water trucks were observed applying water to work areas and access roads along TL 629E to minimize fugitive dust in accordance with APM AIR-02.

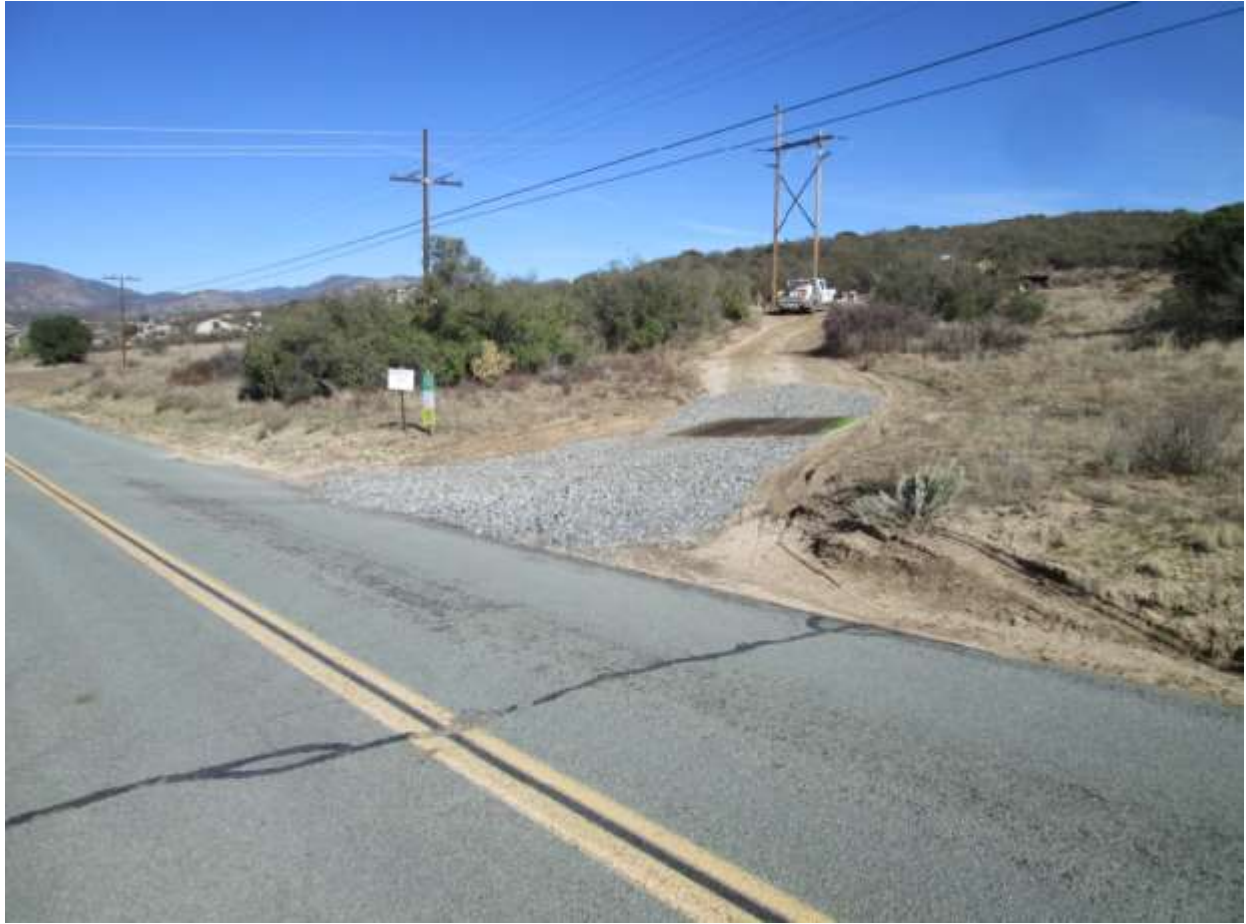
Photo 5: A rock apron and rumble plate were observed at an entrance to the TL 629E ROW in order to minimize sediment track out onto paved roadways in accordance with the SWPPP (APM HYD-05, MM BIO-7, and MM HYD-1).

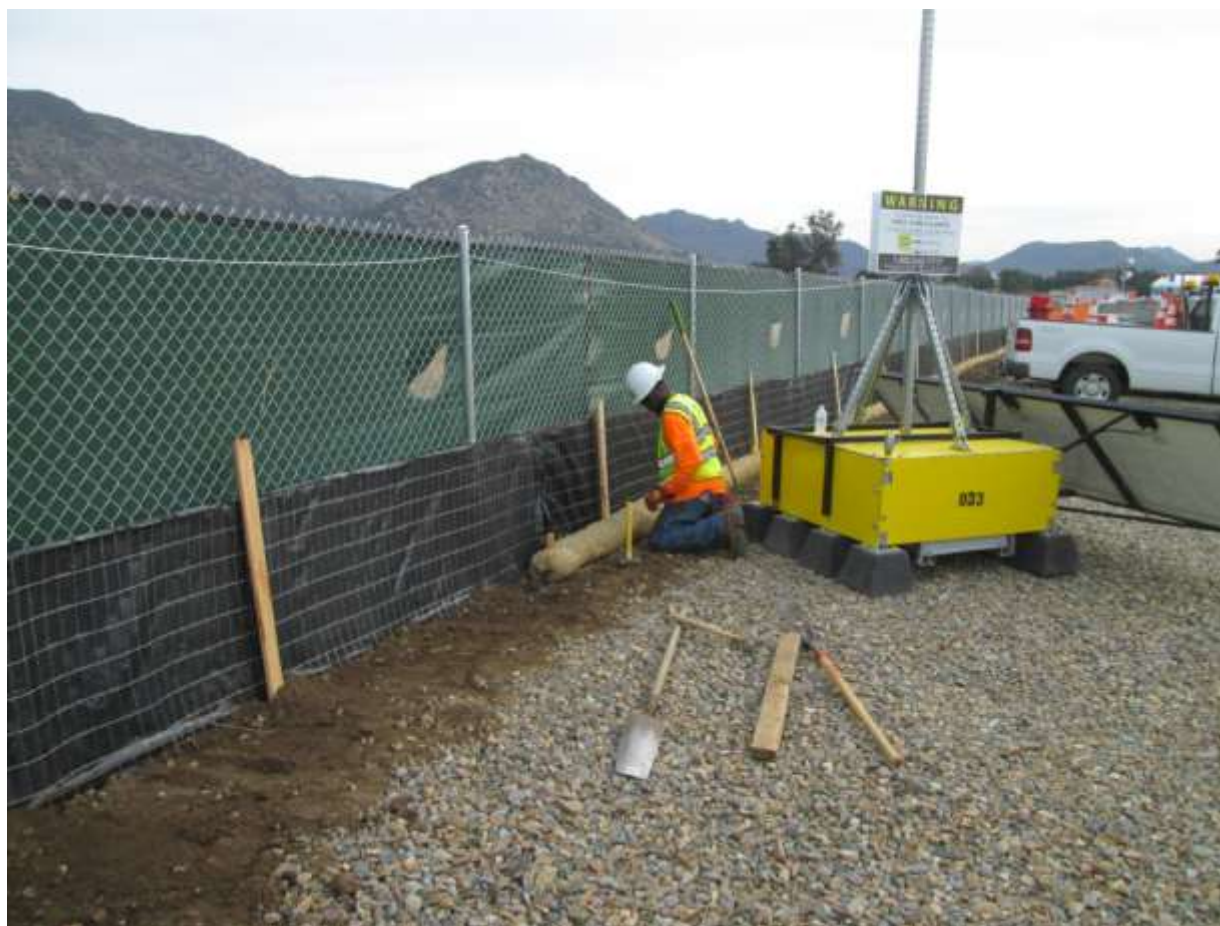
The Anderson, Merrigan, Japatul and Kitchen Creek staging yards have all been established and being utilized to support construction activities. Protective exclusion fencing for arroyo toad was installed along the perimeter fence of the Anderson Staging Yard this reporting period per United States Fish and Wildlife Service and California Department of Fish and Wildlife coordination (See Photo 6—Attachment A).

Photo 6: Construction crews were observed installing arroyo toad exclusion fence along the inside perimeter fence at the Anderson Staging Yard in accordance with the Streambed Alteration Agreement.
