California Public Utilities Commission <i>Mitigation Monitoring, Compliance, and Reporting</i> <i>Program</i>
	Cleveland National Forest Power Line Replacement Projects Compliance Status Report: 103 September 6, 2020

This compliance status report covers construction activities from August 24 through September 6, 2020.

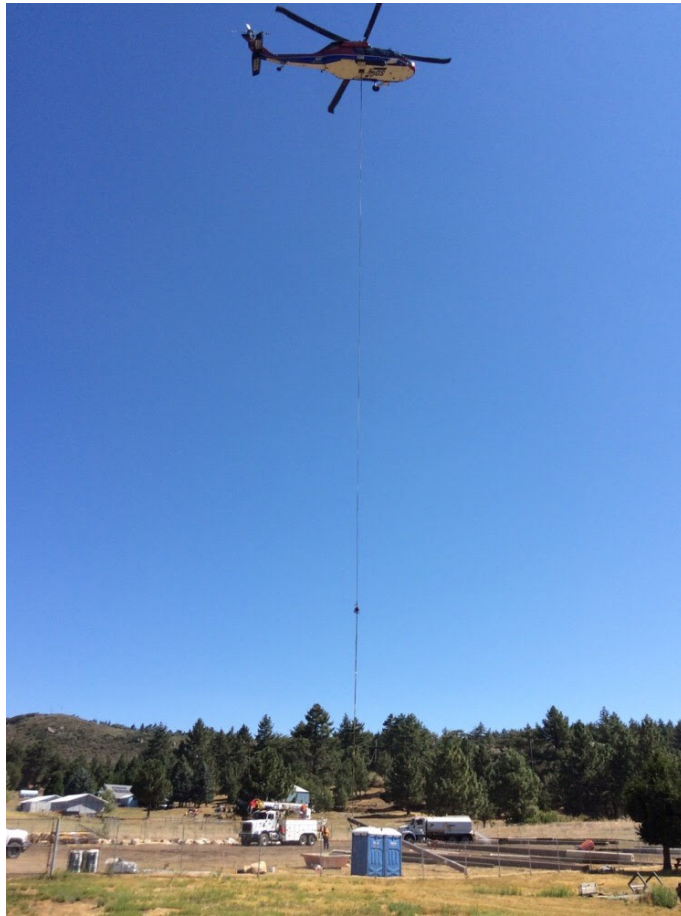
Photo 1: A water tender was observed applying water to the surface at Morris Ranch Staging Yard (C 440) before and during helicopter activities to minimize dust emissions from rotor wash in accordance with APM AIR-02 and the Aviation Safety Plan (MM PHS-5).

To prevent fugitive dust emissions during project activities, crews were observed applying water along unpaved access roads and in work areas in accordance with APM AIR-02 and during helicopter operations in accordance with the Aviation Safety Plan (MM PHS-5) (see Photo 1 – Attachment A). Haul trucks used for dirt export were observed utilizing load covers to prevent dust emissions in accordance with APM AIR-02, and construction personnel were observed maintaining posted speeds of 15 miles per hour on unpaved access roads in accordance with APM AIR-03 and MM BIO-24.

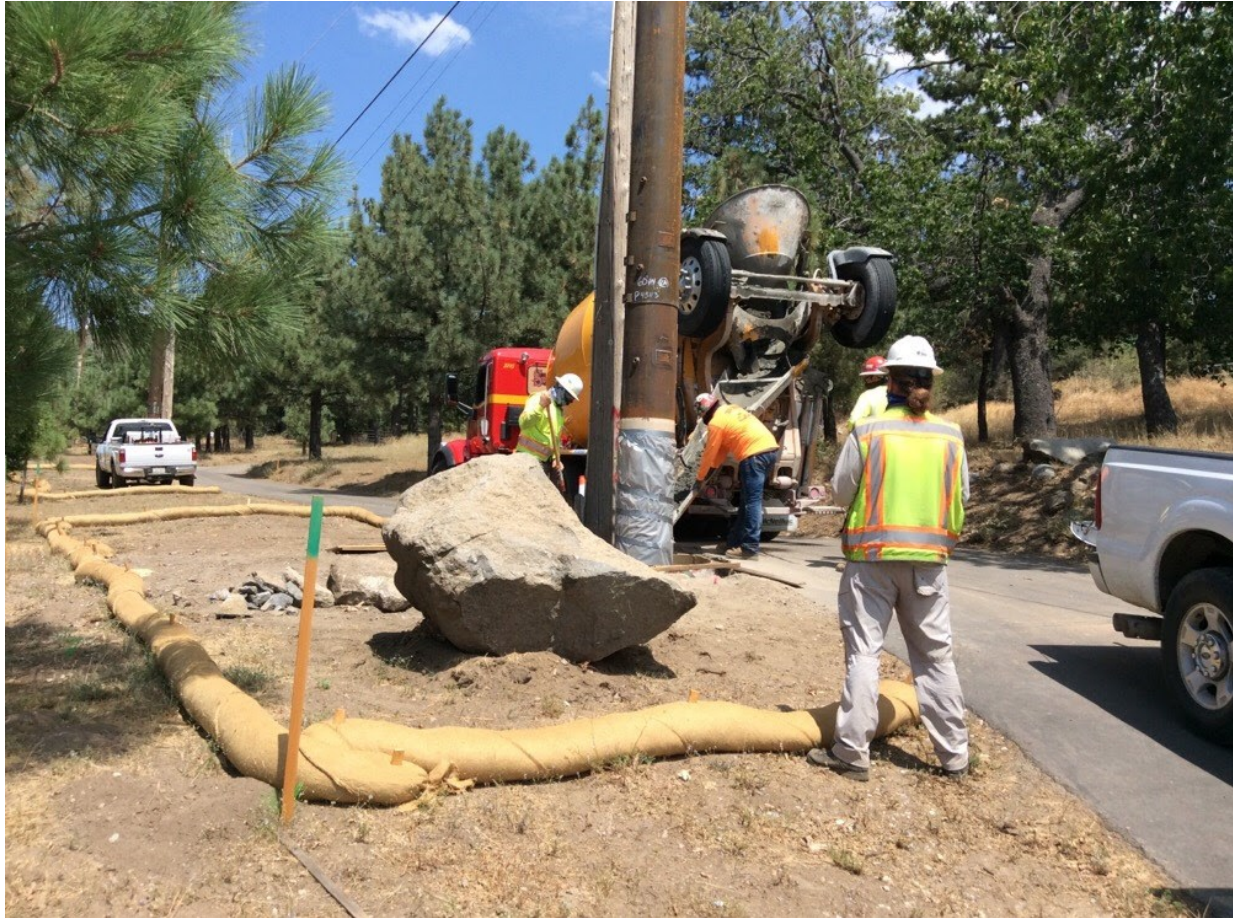
Photo 2: A crew was observed pouring concrete at Pole P45113 (C 440). A Biological Monitor was observed monitoring construction activities along the alignment to ensure compliance with mitigation measures, applicant proposed measures, and permit conditions in accordance with MM BIO-22.

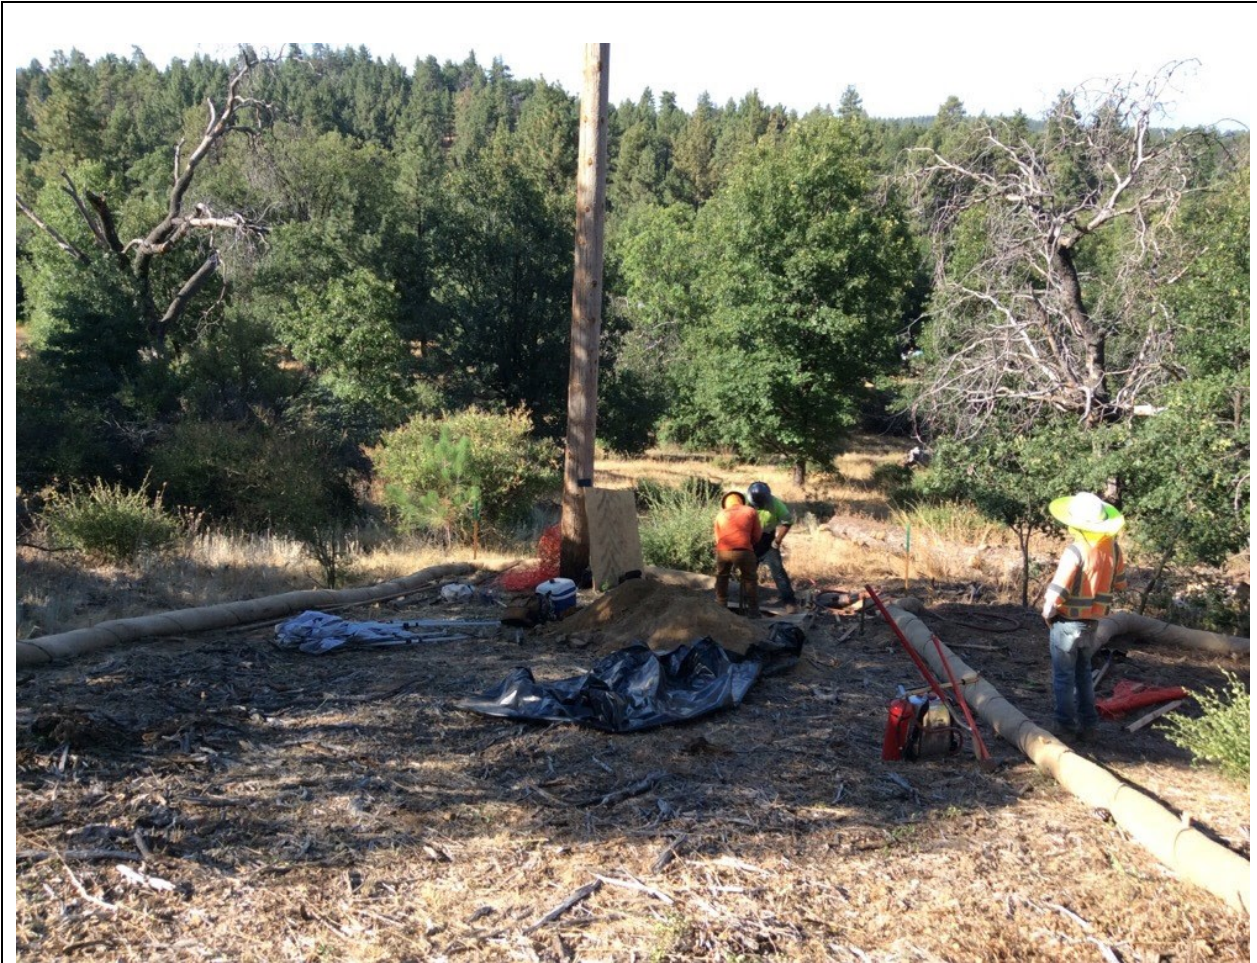
Photo 3: In accordance with APM CUL-08, a Paleontological Monitor was observed monitoring excavations at locations with underlying Potential Fossil Yield Classification Class 3 geologic deposits where new poles were unable to be installed in the same location as the existing poles along C 440.

monitoring excavations at locations with underlying sensitive geologic deposits in accordance with APM CUL-08 (see Photo 3 – Attachment A).

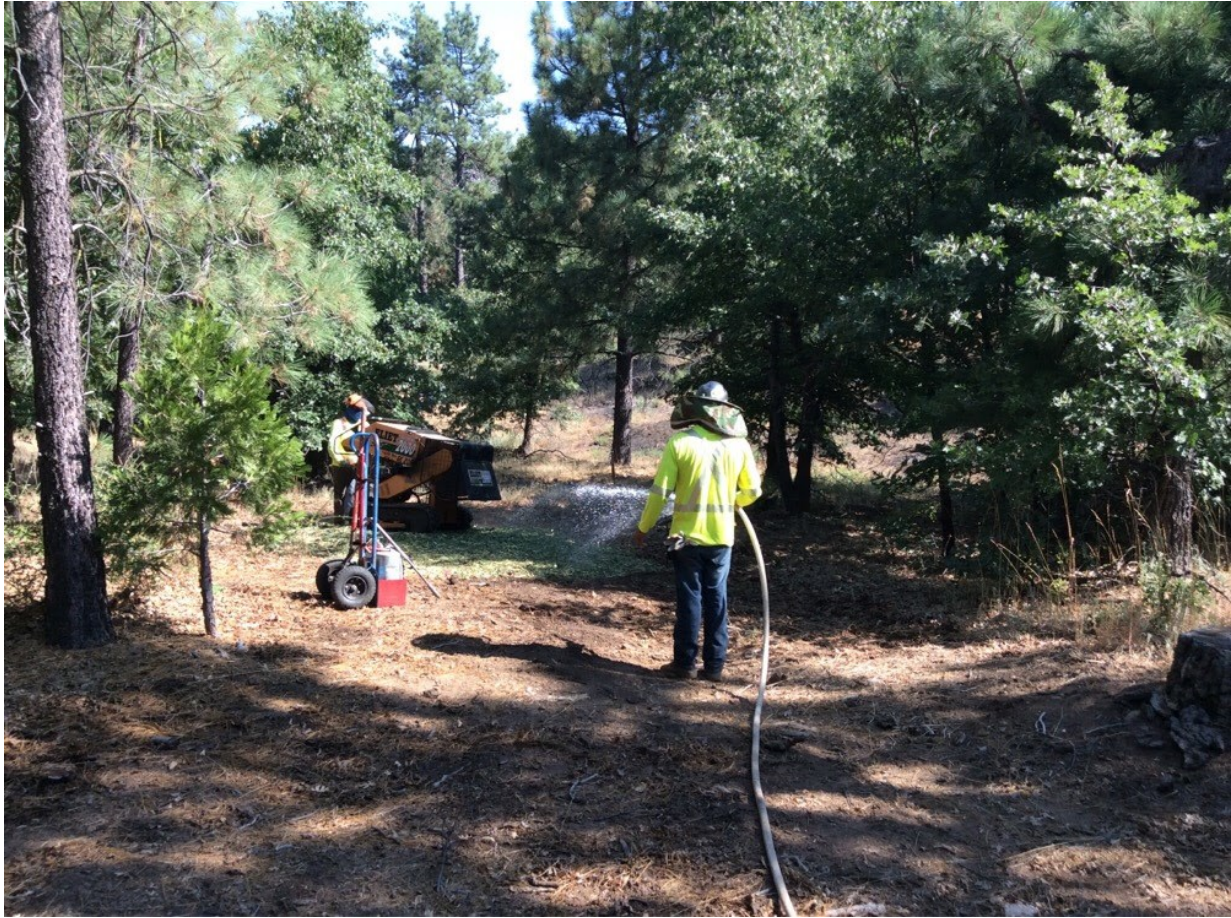
Photo 4: During vegetation chipping at Pole P260427 (C 440), a full set of fire tools was observed within 50 feet of the activity, at least 100 gallons of water with pump and hose were observed on site, and a crew member was observed wetting down the area in accordance with the CFPPP Fire Prevention Matrix for chipping on USFS land with a PAL C.

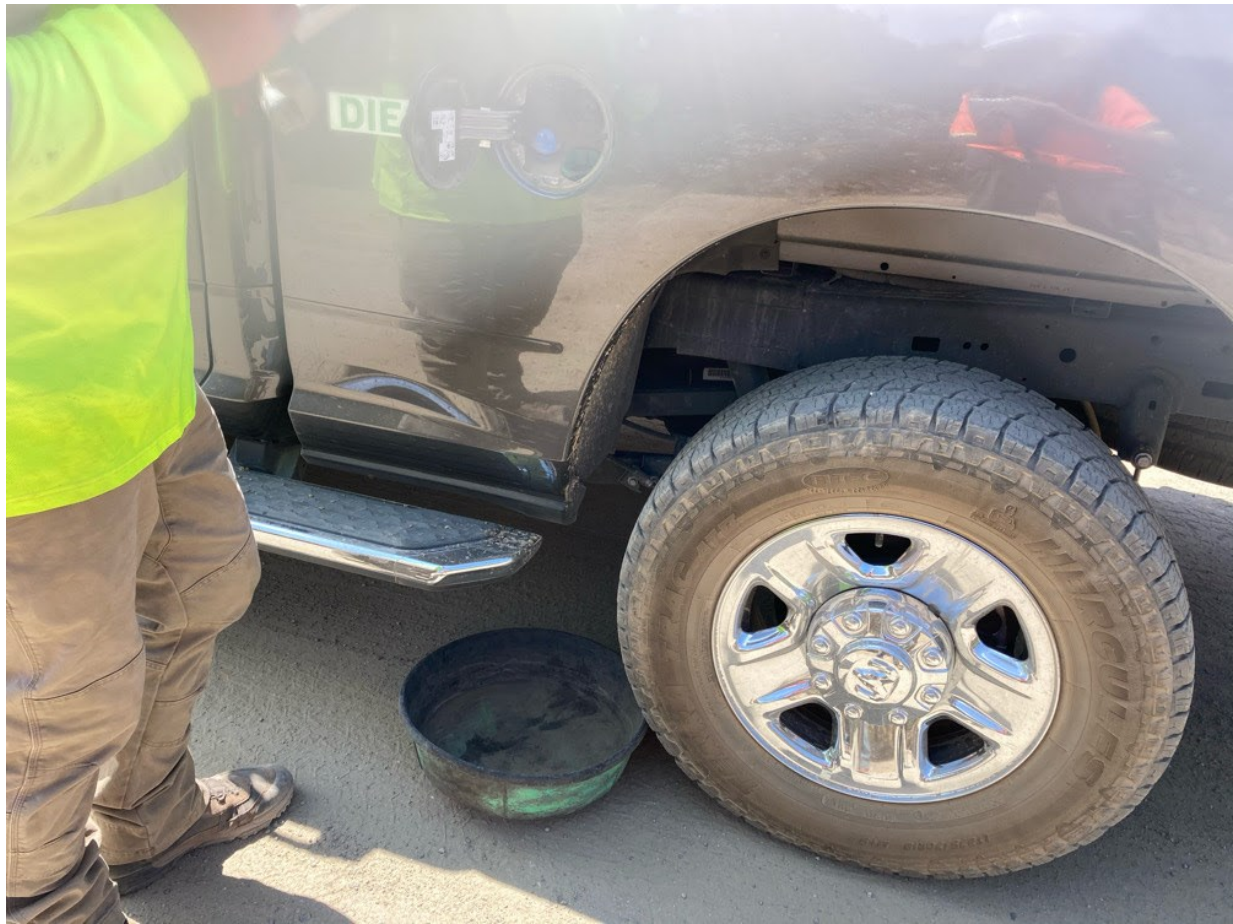
Photo 5: A drip pan was used during truck refueling along C 79B to prevent leaks and spills from being discharged into the soil in accordance with MM PHS-2 and the SRNP.

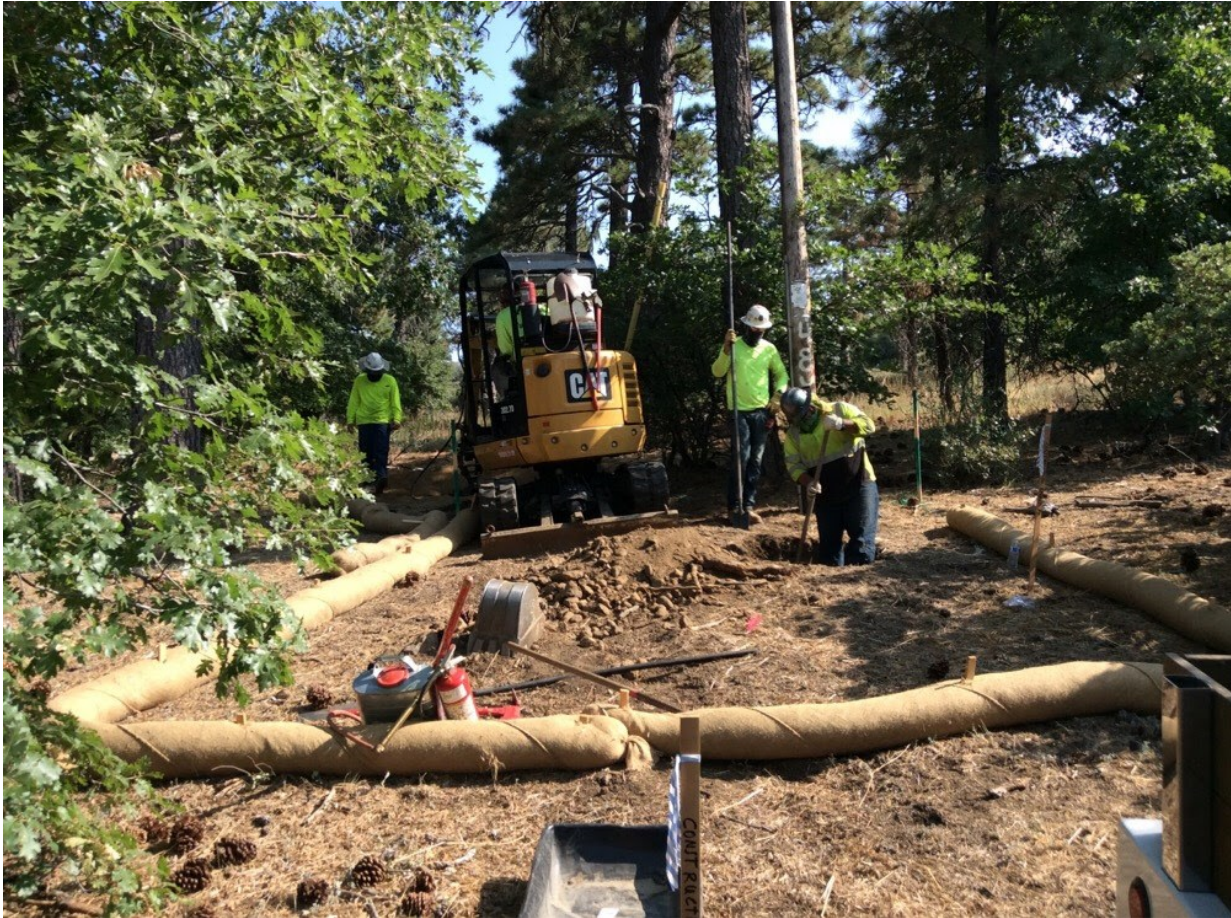
Photo 6: A crew was observed digging a direct bury pole hole and digging an anchor excavation at Pole P40245 (C 440). Site-specific erosion control BMPs were observed in good condition in accordance with the ECP, SWPPP (MM HYD-1 and MM BIO-7), and APM HYD-09.
