<b>California Public Utilities Commission</b> <b><i>Mitigation Monitoring, Compliance, and Reporting</i></b> <b><i>Program</i></b>
	<b>Cleveland National Forest Power Line Replacement</b> <b>Projects</b>  <b>Compliance Status Report: 109</b>  <b>November 29, 2020</b>

This compliance status report covers construction activities from November 16 through November 29, 2020.

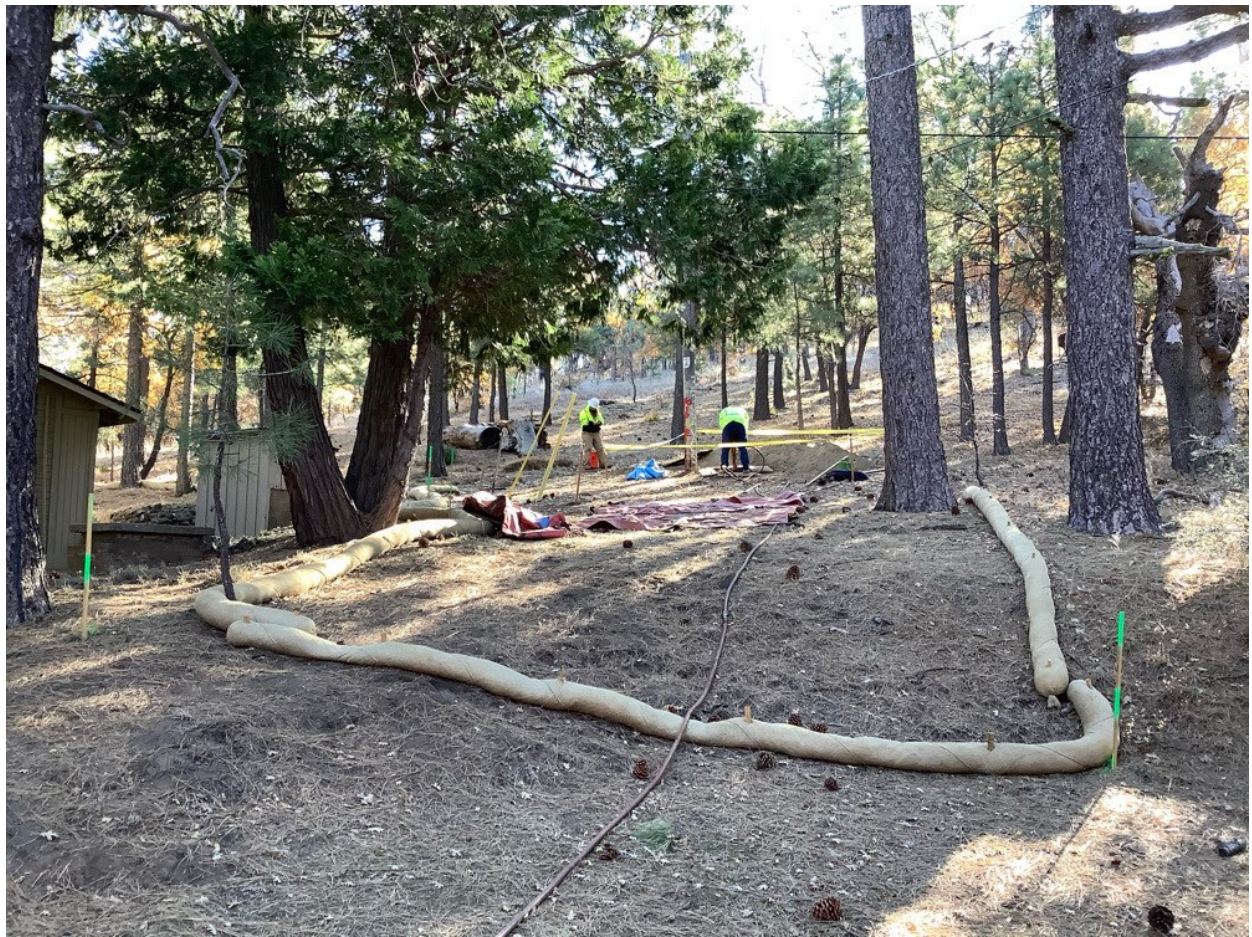
**Photo 1:** During pole hole digging at Pole P40352 (C 440), crew members and equipment were observed within clearly delineated work limits in accordance with MM BIO-1.

Approved workspaces were observed delineated with staking and flagging, and work crews were observed adhering to work space limits and staying on approved access roads in accordance with MM BIO-1 (see Photo 1 – Attachment A). Workers were observed having completed the Worker Environmental Awareness Program (WEAP), as shown by project hard hat stickers in accordance with MM BIO-2. Biological monitors were observed conducting full-time monitoring of initial ground-disturbing activities, such as vegetation removal, in accordance with MM BIO-3, and monitoring all other construction activities to ensure compliance with mitigation measures, applicant proposed measures, and permit conditions in accordance with MM BIO-22. In accordance with MM BIO-14 and MM BIO-16, Environmentally Sensitive Area (ESA) signs and flagging were observed installed around areas with special-status species, and ESAs were observed being avoided by crews. Excavations were observed covered to prevent wildlife entrapment in accordance with MM BIO-23 (see Photo 2 – Attachment A), and crews were observed containing trash at work areas in accordance with MM BIO-26. Habitat restoration activities were observed to be conducted in accordance with MM BIO-4 and the Habitat Restoration Plan (HRP) (see Photo 3 – Attachment A).

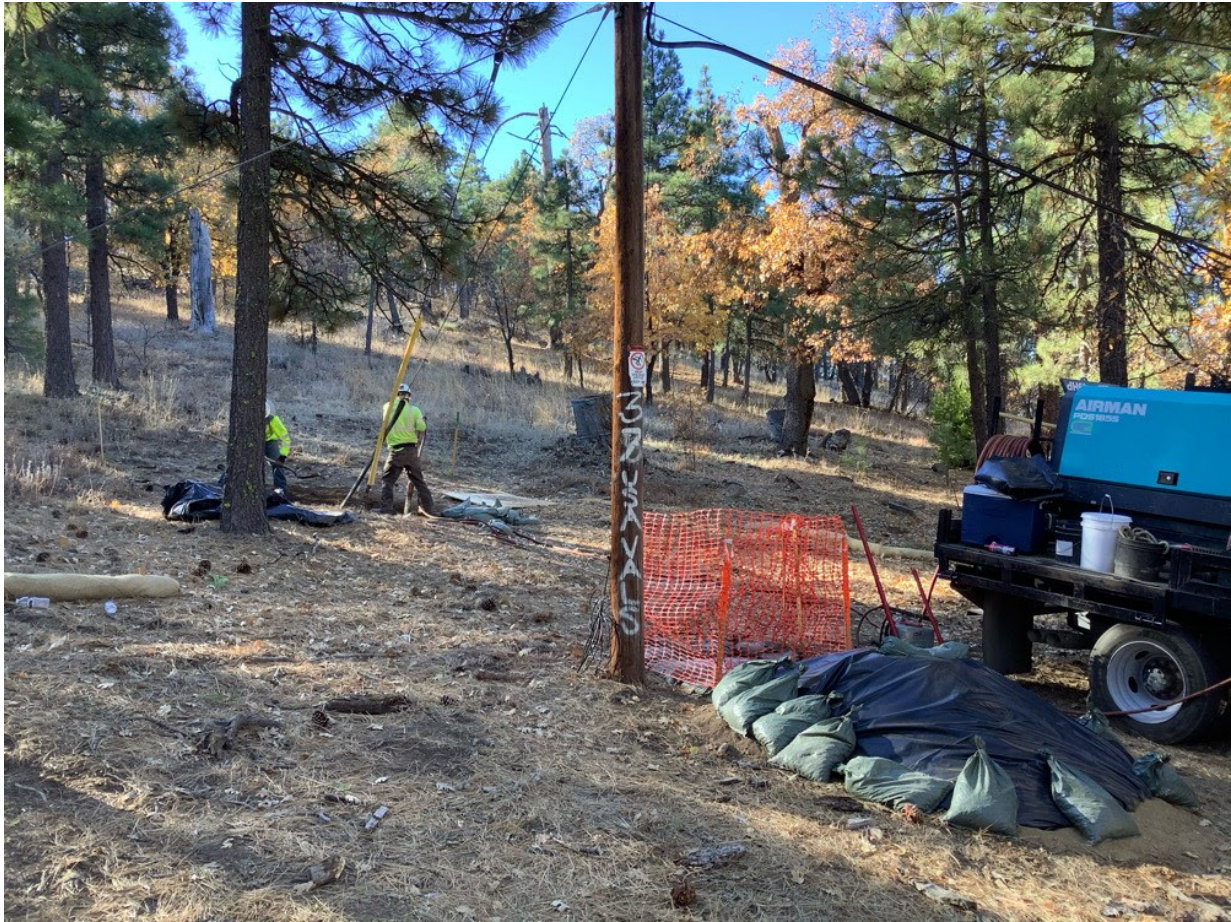
**Photo 2:** During anchor excavation at Pole P40354 (C 440), the pole hole was observed to be securely covered to prevent wildlife entrapment in accordance with MM BIO-23. Additionally, the associated spoils stockpile was observed to be covered in accordance with the ECP, the SWPPP, and APM HYD-09.

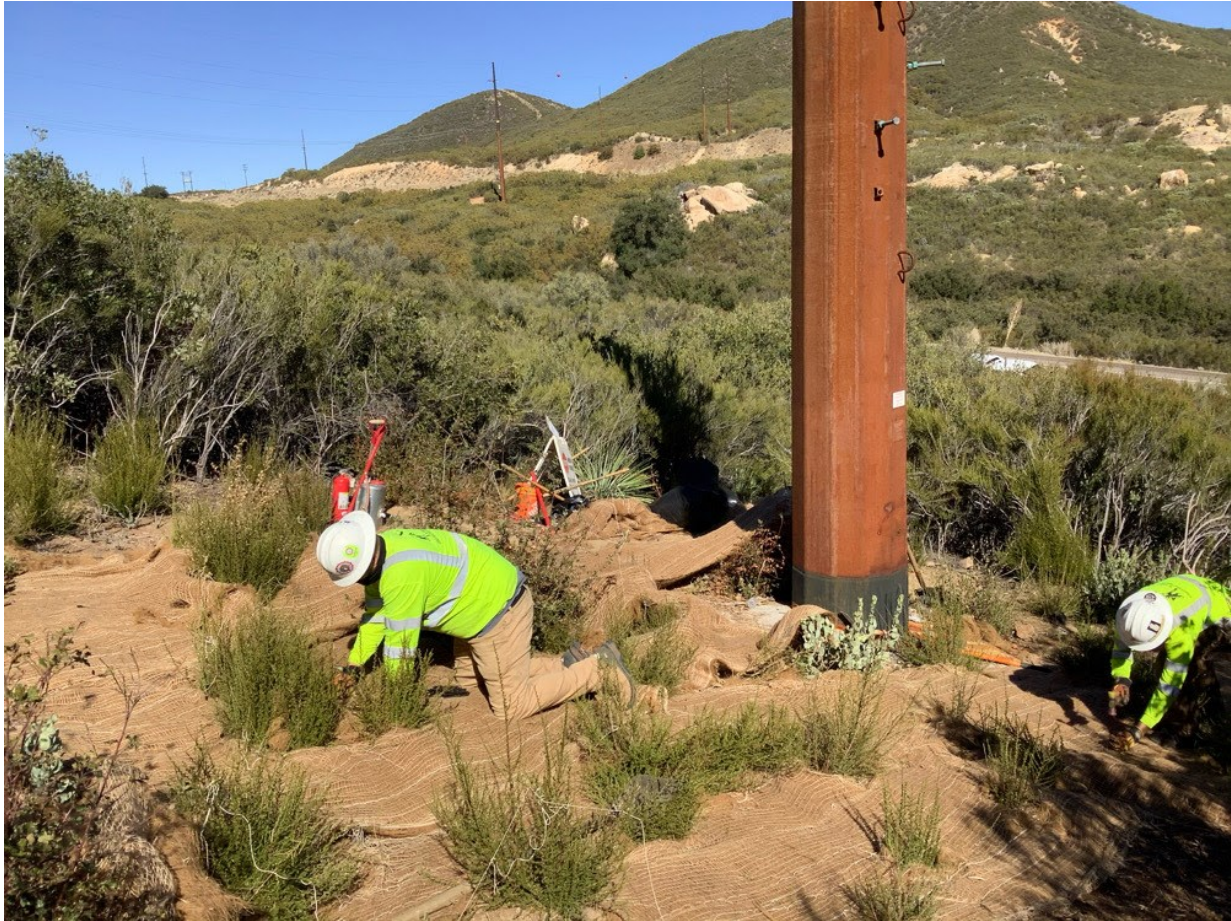
**Photo 3:** A crew was observed installing jute netting at Pole Z40256 (TL 629A) as part of habitat restoration activities in accordance with MM BIO-4 and the HRP.

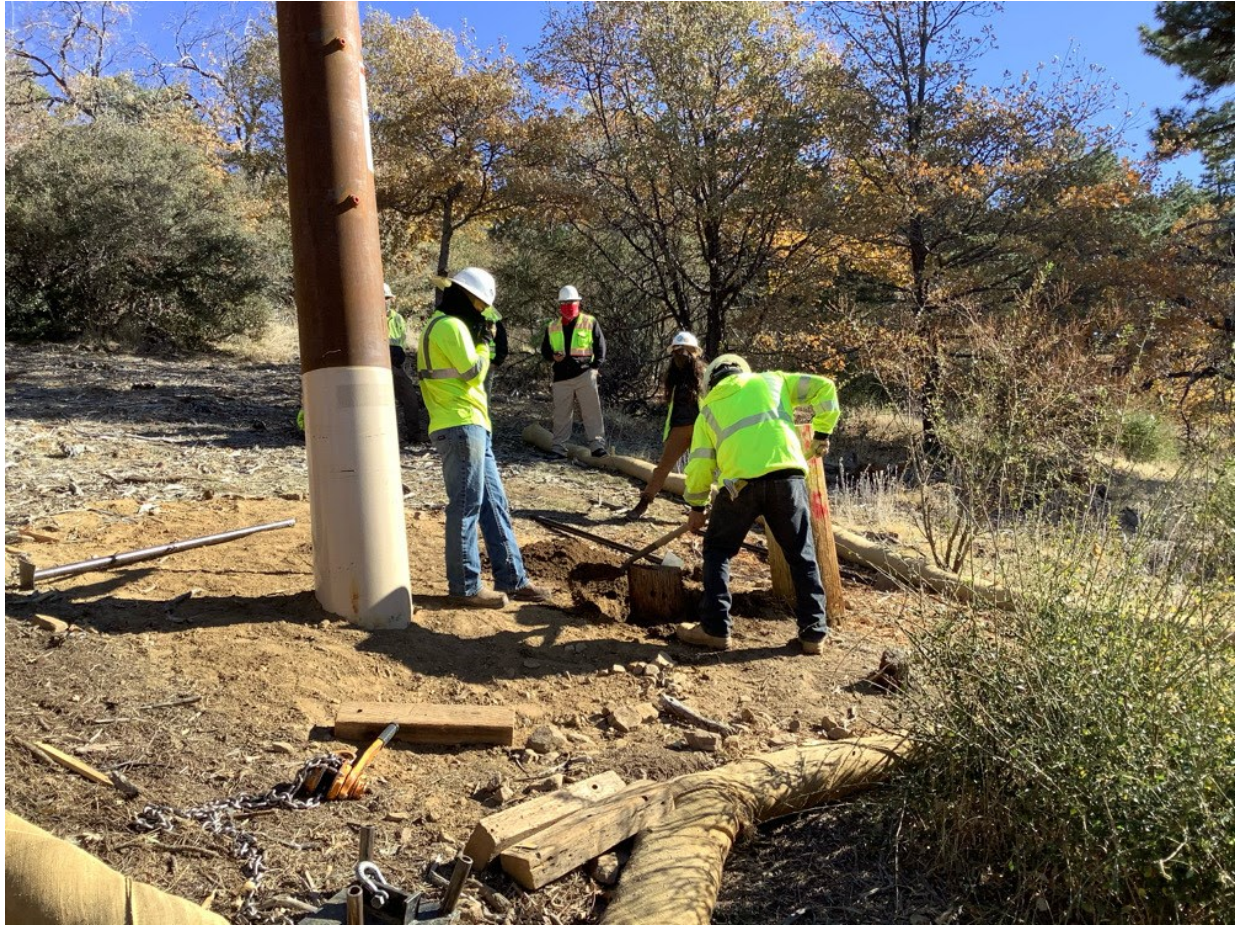
**Photo 4:** Archaeological and Cultural Monitors were observed monitoring pole butt removal on C 440 in accordance with the HPMP, MM CUL-1, MM CUL-3, and APM CUL-04.

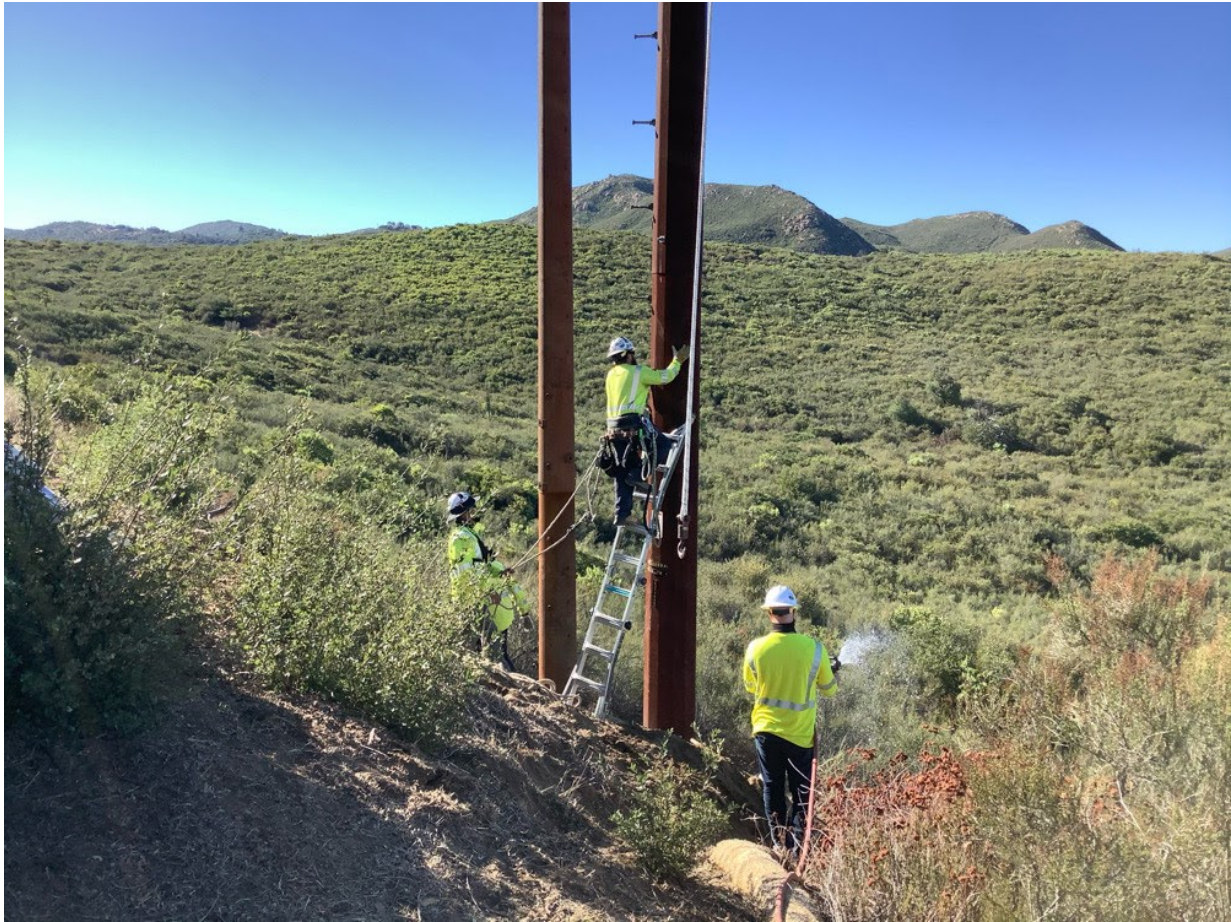
**Photo 5:** A Dedicated Fire Patrol was observed wetting the area prior to steel pole cutting at Pole P258494 (C 79B) in accordance with the CFPPP for hot work on NFS land with a PAL C.

In accordance with the Construction Fire Prevention/Protection Plan (CFPPP) (MM FF-1), San Diego Gas & Electric (SDG&E) and their construction contractors were observed communicating Fire Potential Index (FPI) and Project Activity Levels (PALs) to work crews at daily tailboard meetings, during which daily fire requirements and restrictions for work on private land and on National Forest System (NFS) land were discussed. All project-related vehicles and equipment were equipped with a full set of fire tools (each set containing a 5-gallon backpack pump, round point shovel, Pulaski, and 2A10BC fire extinguisher). Construction crews were observed staging a set of fire tools within 50 feet of work activities as required by APM HAZ-04 and implementing other fire prevention measures as required by the CFPPP, and appropriate Fire Patrols were observed on site during activities that required their presence (see Photo 5 – Attachment A). Fire boxes were observed at staging yards and stocked with the required firefighting tools.

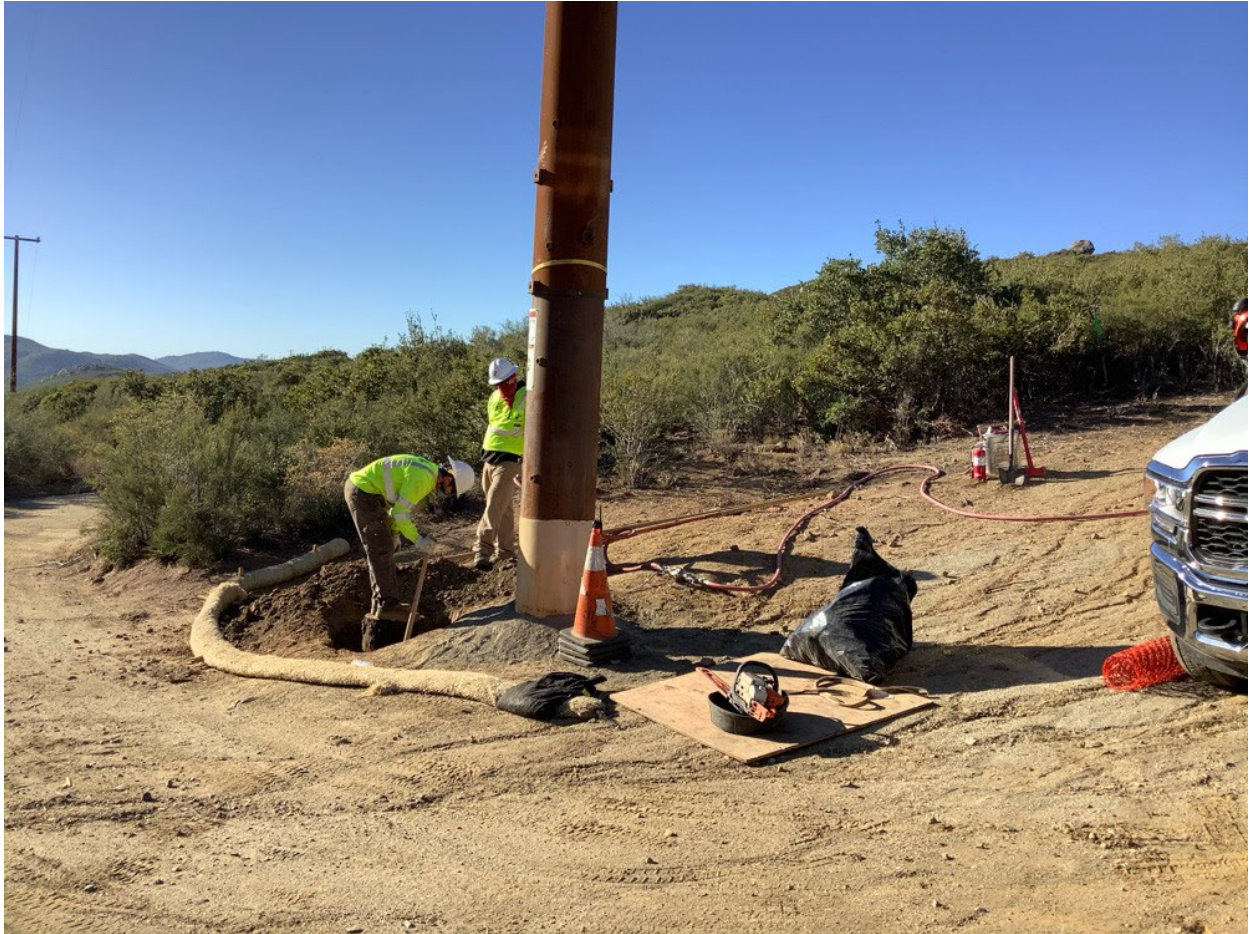
**Photo 6:** During pole butt removal at Pole P258545 (C 79B), a chain saw was observed to be staged in a drip pan to prevent leaks or spills from being discharged onto the ground in accordance with MM PHS-2 and the SRNP.

To prevent leaks and spills from being discharged into the soil in accordance with the Spill Response and Notification Plan (SRNP) and MM PHS-2, construction crews were observed implementing spill prevention BMPs, such as using drip pans under staged equipment (see Photo 6 – Attachment A) and beneath equipment during mechanical work and refueling, staging spill kits at work sites, using double-walled fuel tanks or implementing secondary containment beneath staged fuel tanks, and cleaning up spills and disposing of contaminated soils in the designated and properly labeled hazardous waste barrels.
