California Public Utilities Commission <i>Mitigation Monitoring, Compliance, and Reporting</i> <i>Program</i>
	Cleveland National Forest Power Line Replacement Projects Compliance Status Report: 110 December 13, 2020

This compliance status report covers construction activities from November 30 through December 13, 2020.

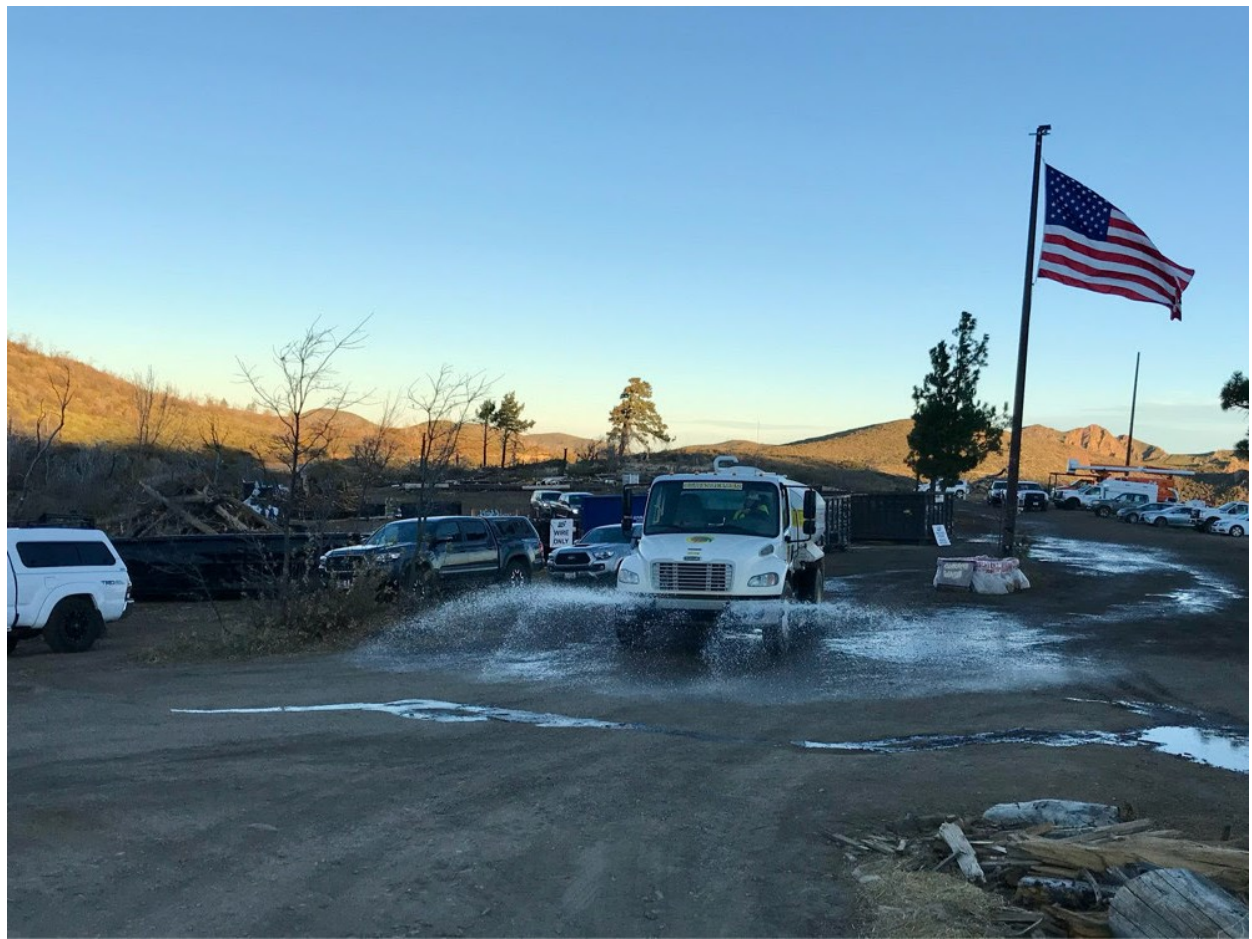
Photo 1: A water tender was observed applying water to the surface at Shrine Camp Staging Yard (C 440) in the morning to reduce dust emissions during crew egress in accordance with APM AIR-02.

To prevent fugitive dust emissions during project activities, crews were observed applying water along unpaved access roads and in work areas in accordance with APM AIR-02 (see Photo 1 – Attachment A) and during helicopter operations in accordance with the Aviation Safety Plan (MM PHS-5). Haul trucks used for dirt export were observed utilizing load covers to prevent dust emissions in accordance with APM AIR-02, and construction personnel were observed maintaining posted speeds of 15 miles per hour on unpaved access roads in accordance with APM AIR-03 and MM BIO-24.

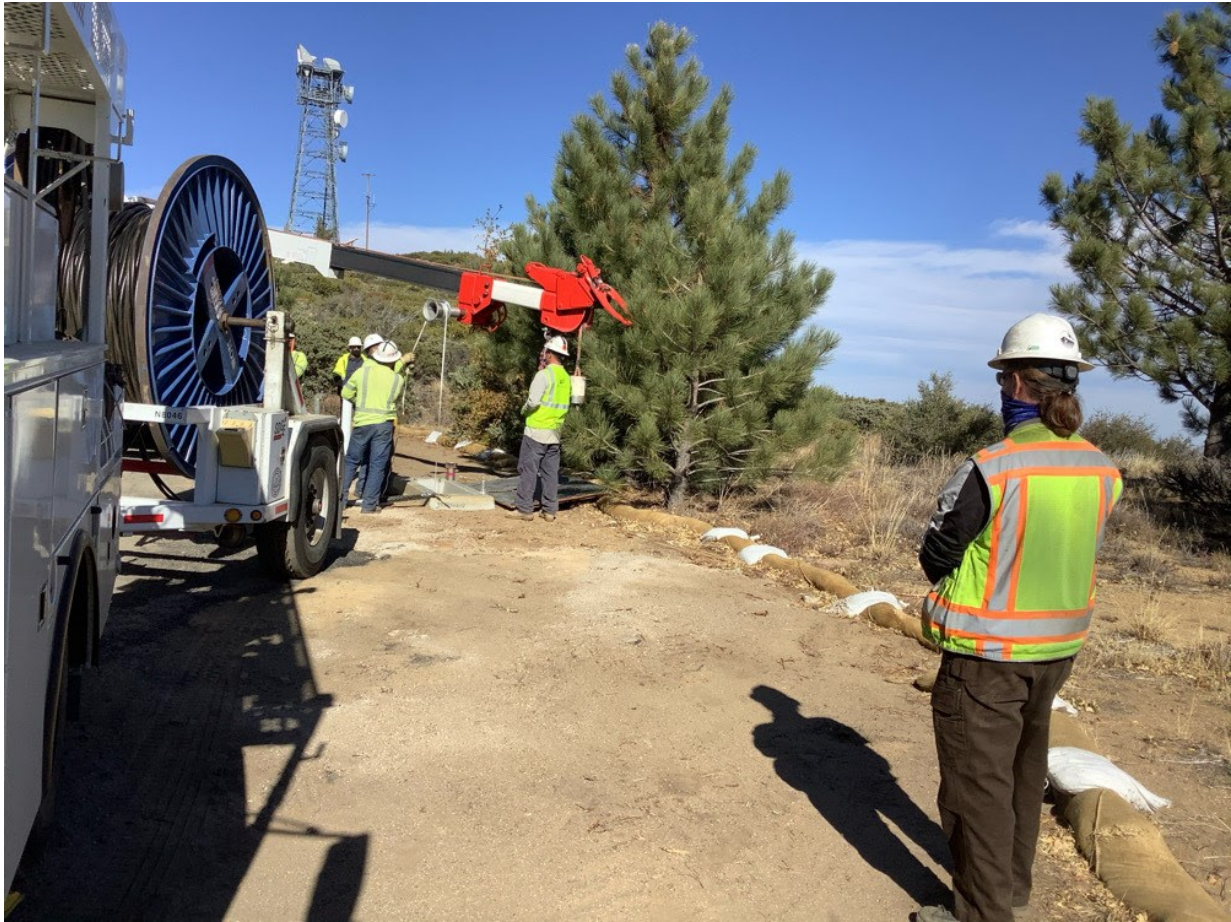
Photo 2: A Biological Monitor was observed monitoring underground cable pulling (C 440) to ensure compliance with mitigation measures, applicant proposed measures, and permit conditions in accordance with MM BIO-22.

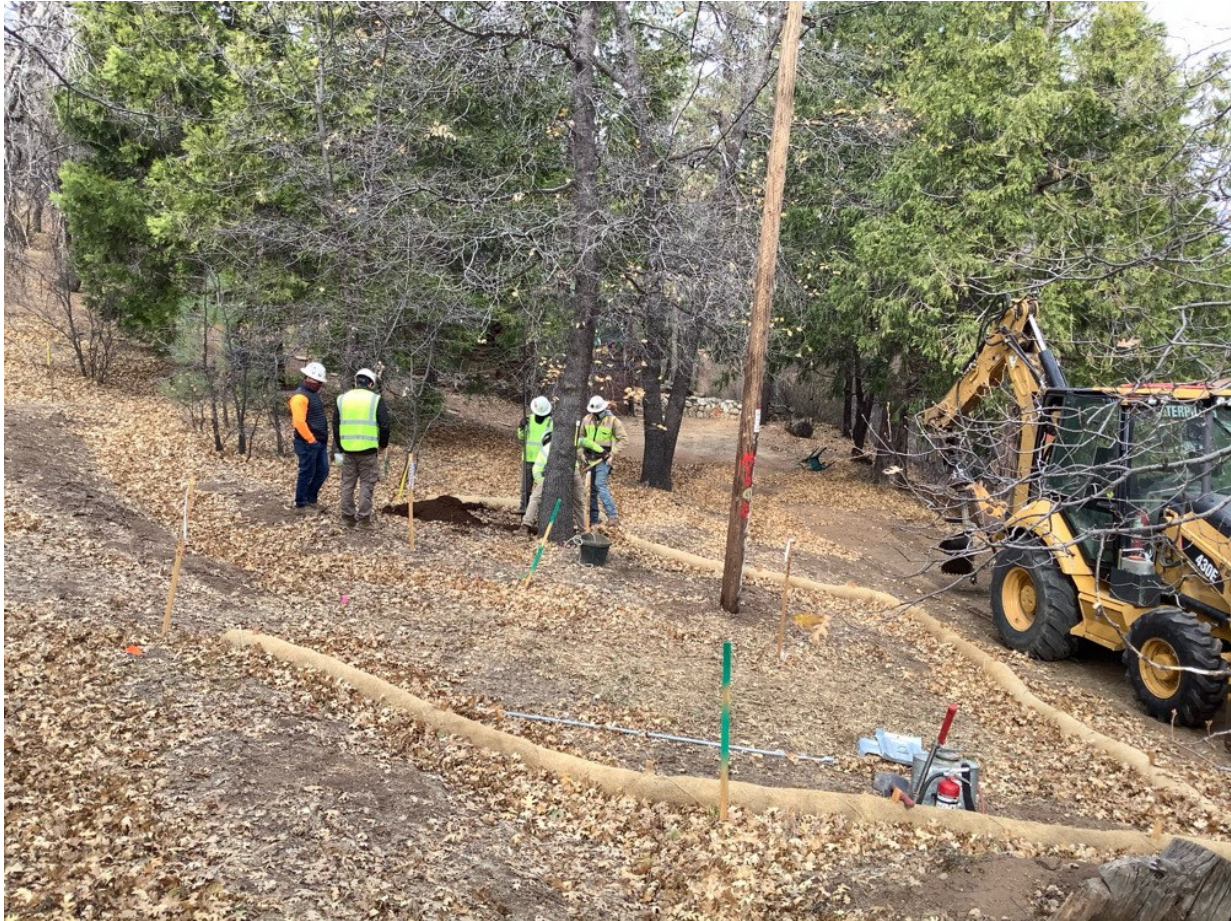
Photo 3: Archaeological and Cultural Monitors were observed monitoring anchor excavation along C 440 in accordance with the HPMP, MM CUL-1, MM CUL-3, and APM CUL-04.

CPUC ECMs observed cultural resource monitors, including archaeological and Native American monitors, monitoring construction activities that occurred within or adjacent to identified archaeological or cultural resource site boundaries in accordance with the Historic Properties Management Plan (HPMP), MM CUL-1, MM CUL-3, and APM CUL-04 (see Photo 3 – Attachment A). Cultural ESAs were marked to prevent construction access to areas with cultural and/or historical resources in accordance with the HPMP, and work crews were observed respecting cultural ESA boundaries.

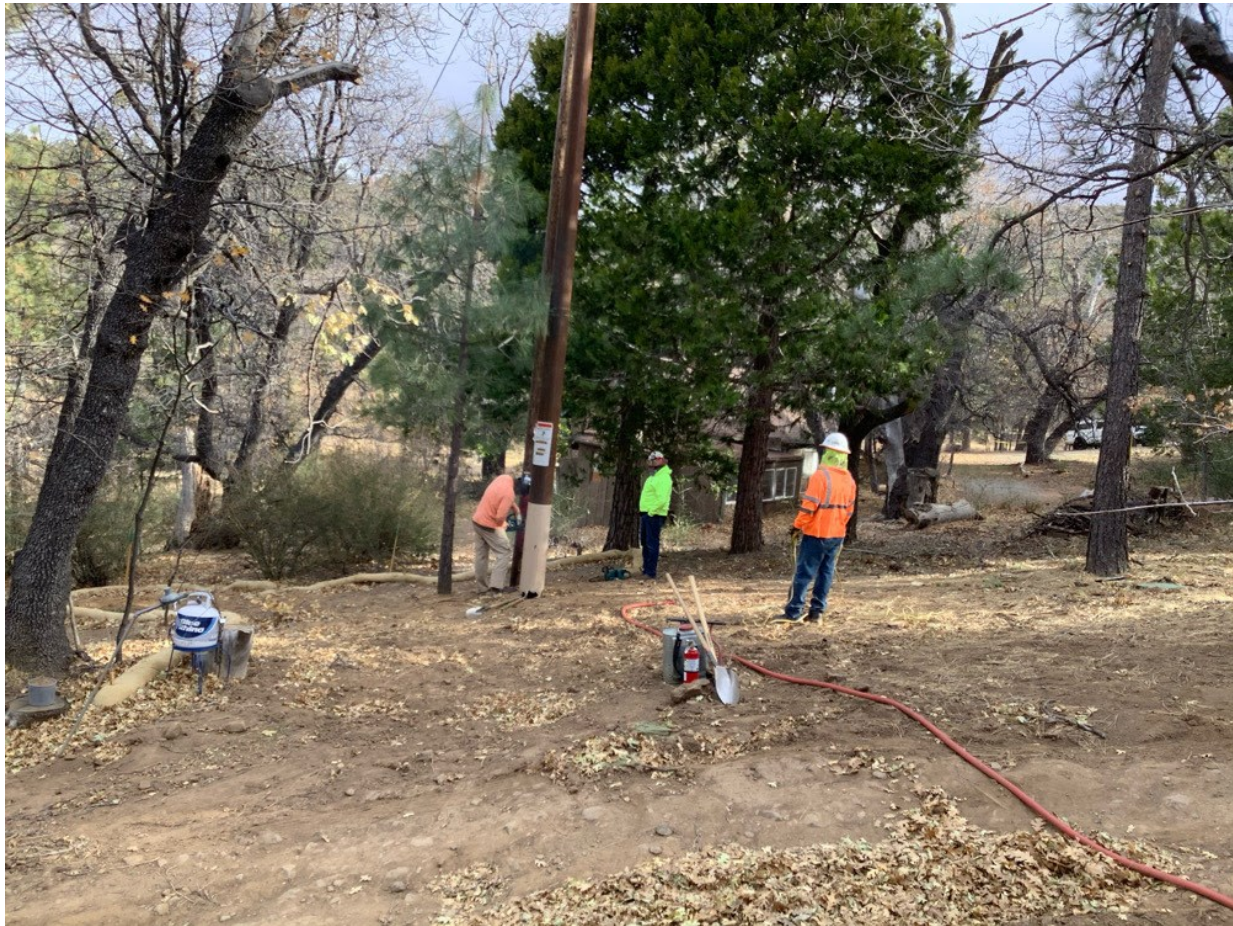
Photo 4: A crew was observed using a battery-powered chain saw to fell an old wooden pole at Pole P40443 (C 440). A full set of fire tools was observed within 50 feet of the activity in accordance with APM HAZ-04 and the CFPPP for hand tool use on NFS land with a PAL C.

In accordance with the Construction Fire Prevention/Protection Plan (CFPPP) (MM FF-1), San Diego Gas & Electric (SDG&E) and their construction contractors were observed communicating Fire Potential Index (FPI) and Project Activity Levels (PALs) to work crews at daily tailboard meetings, during which daily fire requirements and restrictions for work on private land and on National Forest System (NFS) land were discussed. All project-related vehicles and equipment were equipped with a full set of fire tools (each set containing a 5-gallon backpack pump, round point shovel, Pulaski, and 2A10BC fire extinguisher). Construction crews were observed staging a set of fire tools within 50 feet of work activities as required by APM HAZ-04 (see Photo 4 – Attachment A) and implementing other fire prevention

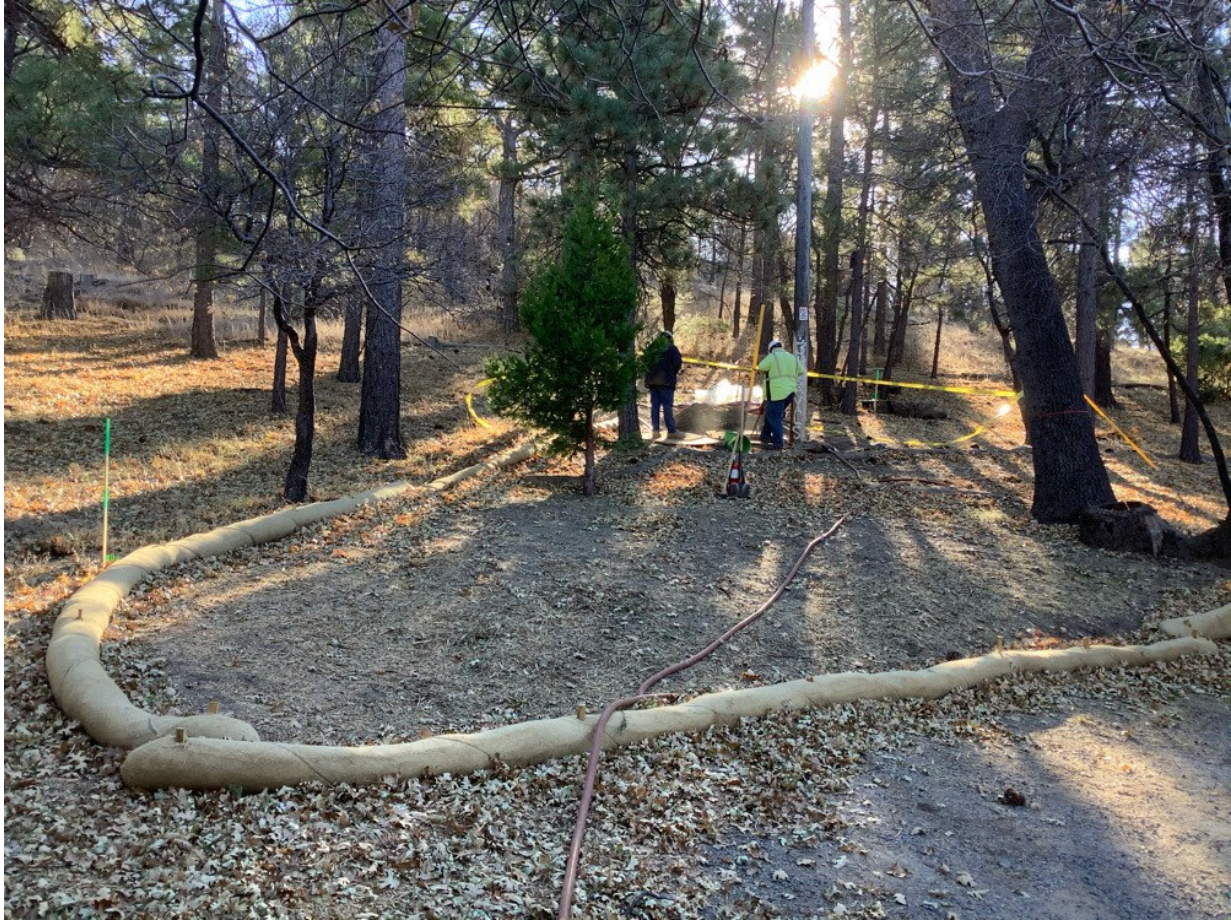
Photo 5: During pole hole excavation at Pole P40351 (C 440), erosion control BMPs were observed in good condition in accordance with APM HYD-09, the ECP, and the SWPPP (MM HYD-1 and MM BIO-7).

To prevent impacts to hydrology and water quality, site-specific sediment and erosion control BMPs were observed being implemented and maintained along project alignments in accordance with the project Erosion Control Plan (ECP), Stormwater Pollution Prevention Plan (SWPPP; MM HYD-1 and MM BIO-7), and APM HYD-09 (see Photo 5 – Attachment A). Other BMPs in the SWPPP, such as hydromulch application, concrete waste containment, street sweeping, and access road entrance stabilization (see Photo 6 – Attachment A) were also observed along the alignments. Hydrological resources were flagged for avoidance, and work activities occurred outside of hydrological resources in accordance with APM HYD-06.

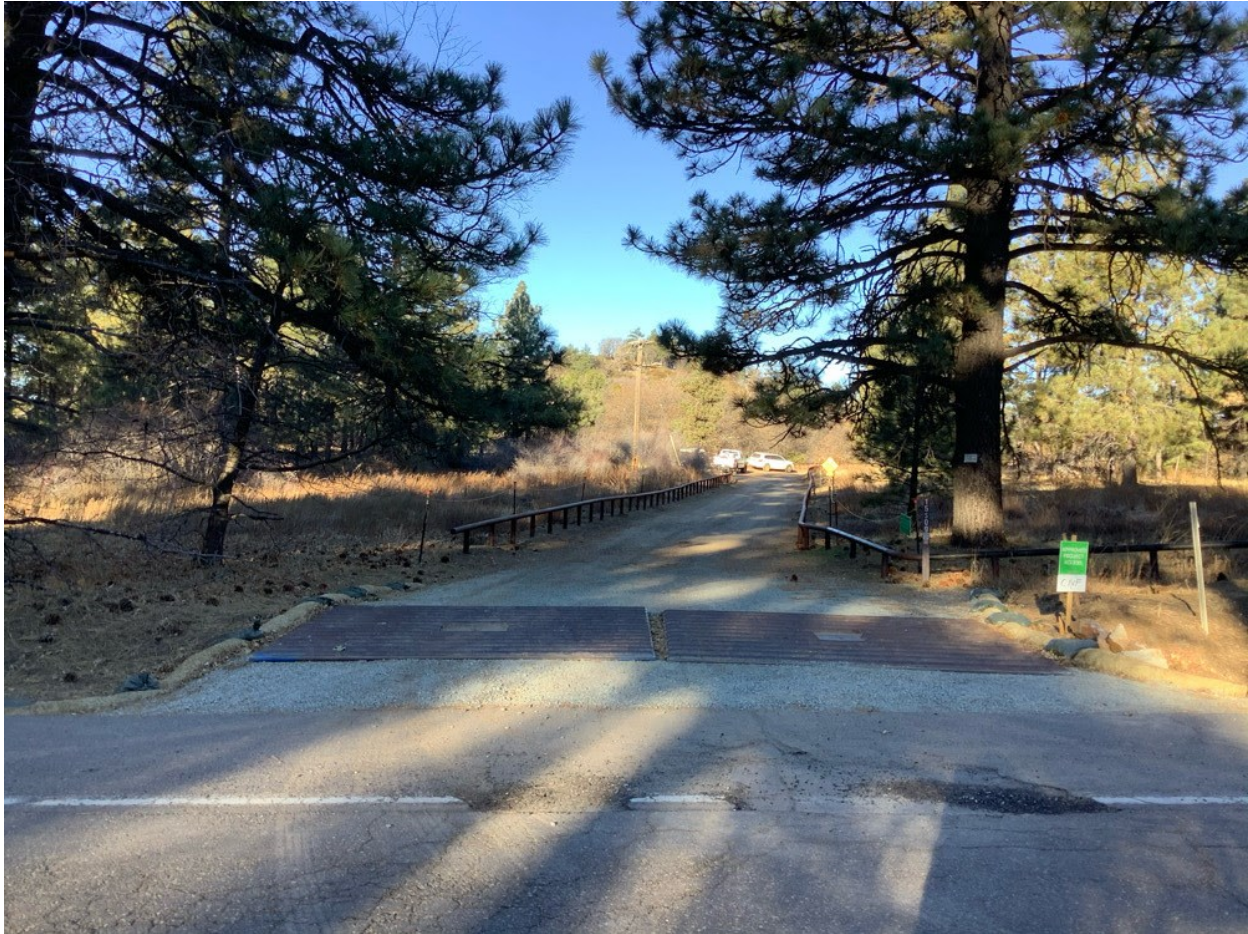
Photo 6: The entrance to Escondido Ravine Road (C 440) was observed to be stabilized with gravel and shaker plates to reduce trackout in accordance with the SWPPP (MM HYD-1 and MM BIO-7).
