<b>California Public Utilities Commission</b> <b><i>Mitigation Monitoring, Compliance, and Reporting Program</i></b>
	<b>Cleveland National Forest Power Line Replacement Projects</b>  <b>Compliance Status Report: 063</b>  <b>February 24, 2019</b>

This compliance status report covers construction activities from February 11, 2019 through February 24, 2019.

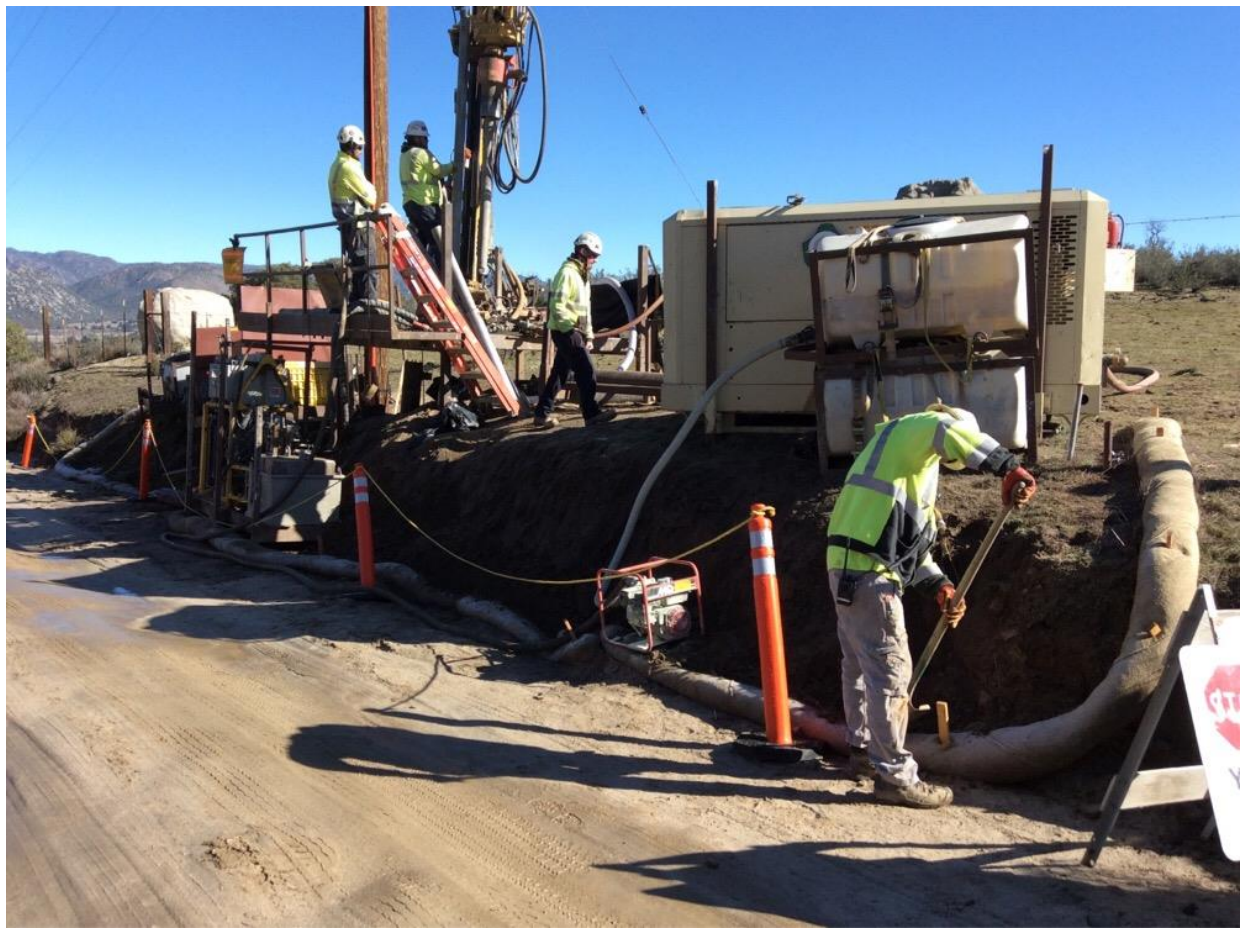
**Photo 1:** A construction crew was observed conducting sediment and erosion control BMP maintenance at Pole Z40990 (TL 6958) during micropile foundation drilling in accordance with the Erosion Control Plan and SWPPP.

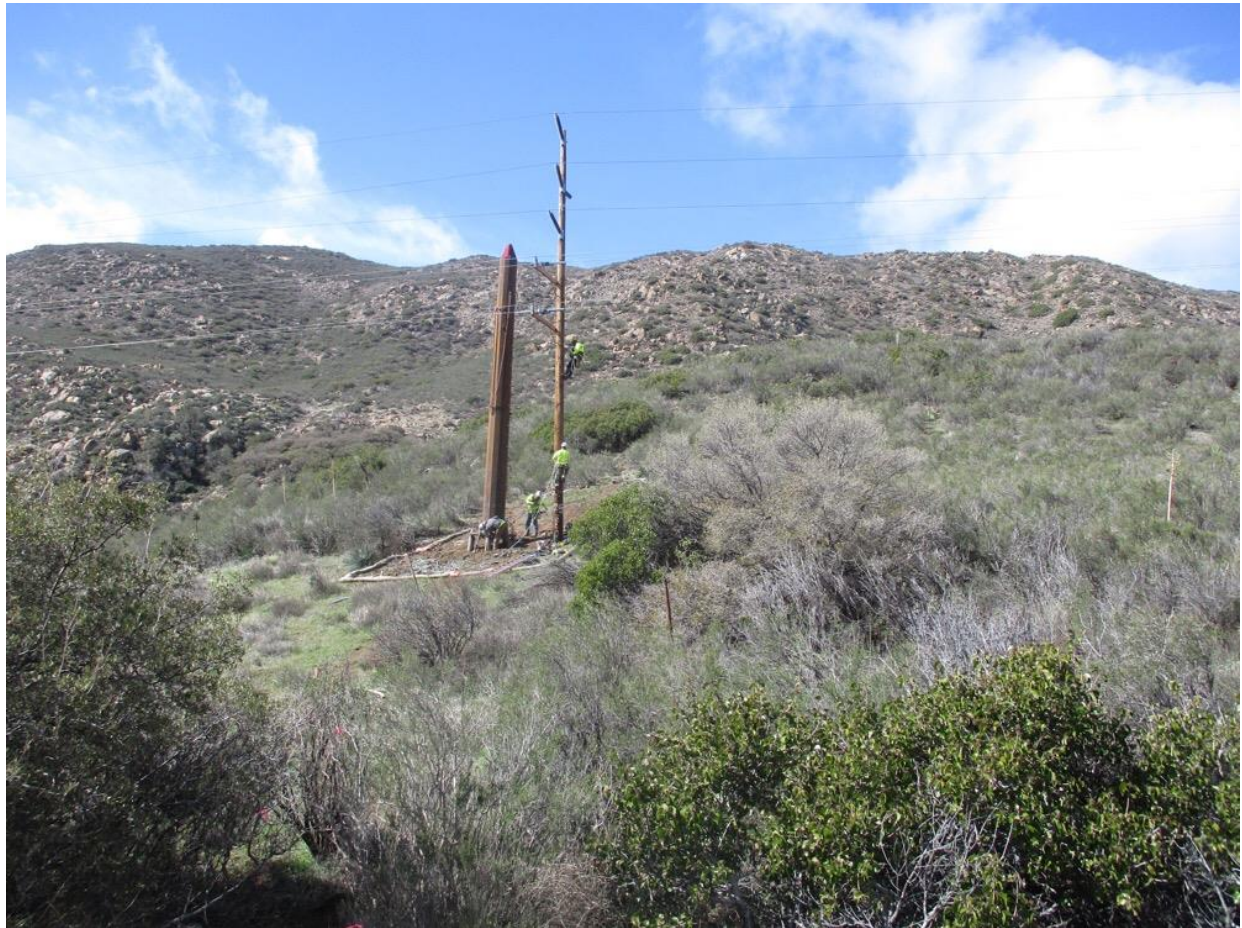
**Photo 2:** A construction crew was observed installing a pole base recently delivered via helicopter external load and preparing to receive the pole top at Z40511 (TL 629C).

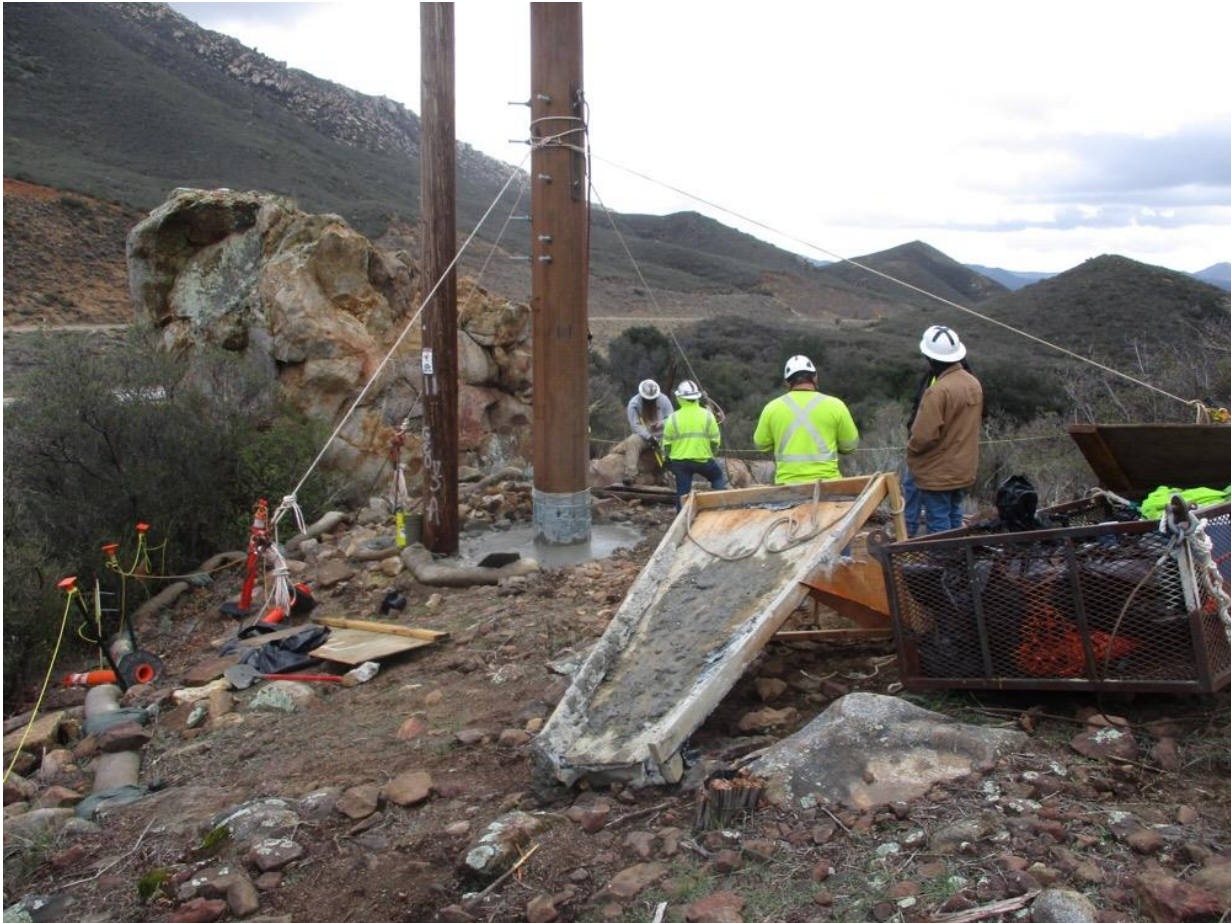
**Photo 3:** BMPs were implemented during direct bury foundation pouring at Z40425 (TL 629C) including fiber rolls and concrete waste containment to prevent excess concrete and waste from being discharged onto the ground in accordance with APM HYD-01.

To prevent impacts to hydrology and water quality, site-specific sediment and erosion control BMPs were observed being implemented and maintained along project alignments in accordance with the project Erosion Control Plan (ECP) and Storm Water Pollution Prevention Plan (SWPPP) (MM HYD-1, MM BIO-7) and APM HYD-09. Fiber rolls and silt fencing were observed being used as perimeter controls at pole replacement sites, along underground alignments, and in staging yards, and rattle plates and rock aprons were observed at the entrances/exits of staging yards and project access roads. CPUC ECMs observed a street sweeper cleaning up construction debris from grinding activities on Buckman Springs Road in accordance with the SWPPP (see Photo 5 – Attachment A). Crews were observed covering soil stockpiles to prevent erosion, and covering staged equipment, materials, and waste containers at staging yards in accordance with the project SWPPP. During grouting and concrete pouring activities, concrete washout containers were used for concrete wash and waste to prevent concrete from being discharged onto the ground in accordance with APM HYD-01 (see Photo 3 – Attachment A).

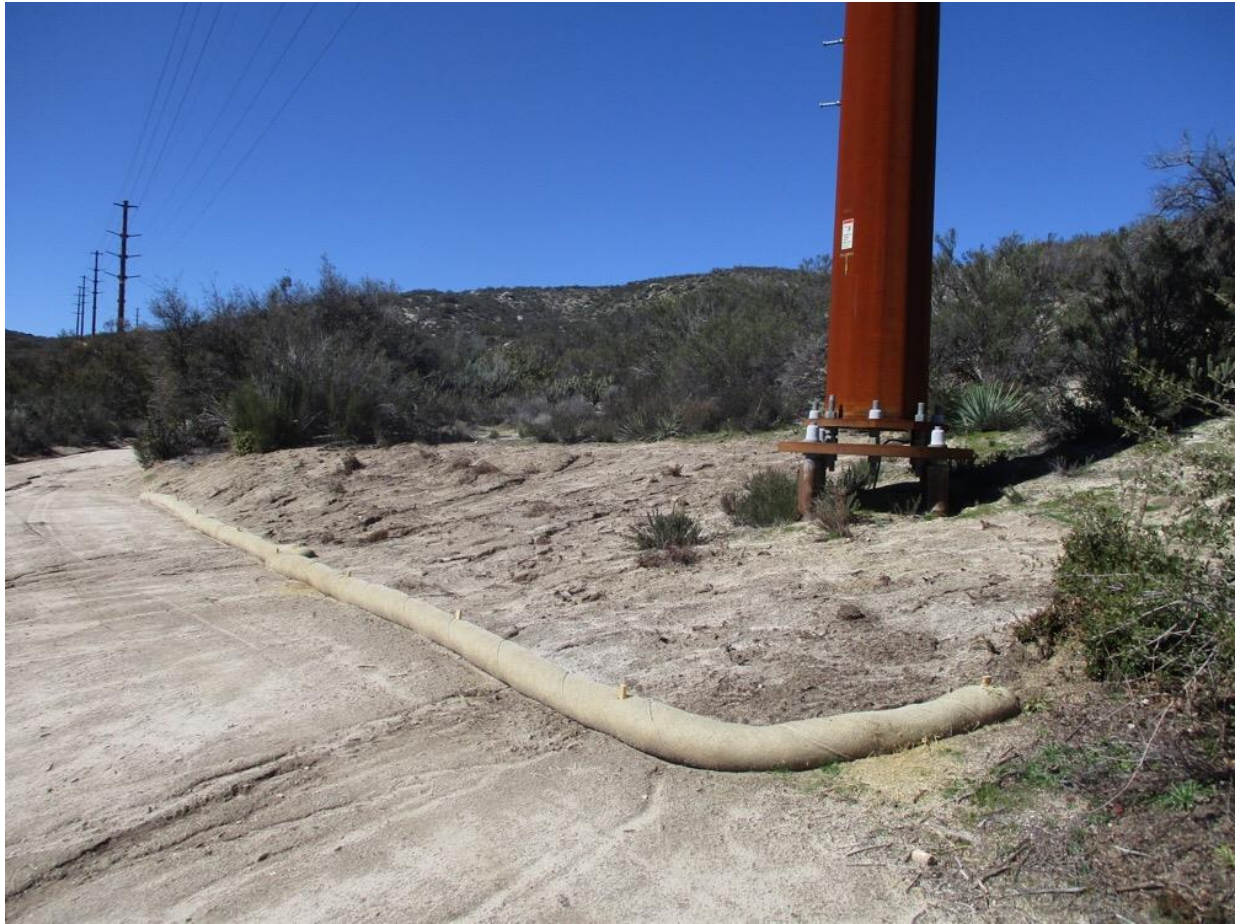
**Photo 4:** CPUC ECMs observed redistributed topsoil and a newly installed fiber roll for erosion and sediment control at the completed worksite at Z44201 (TL 629E).

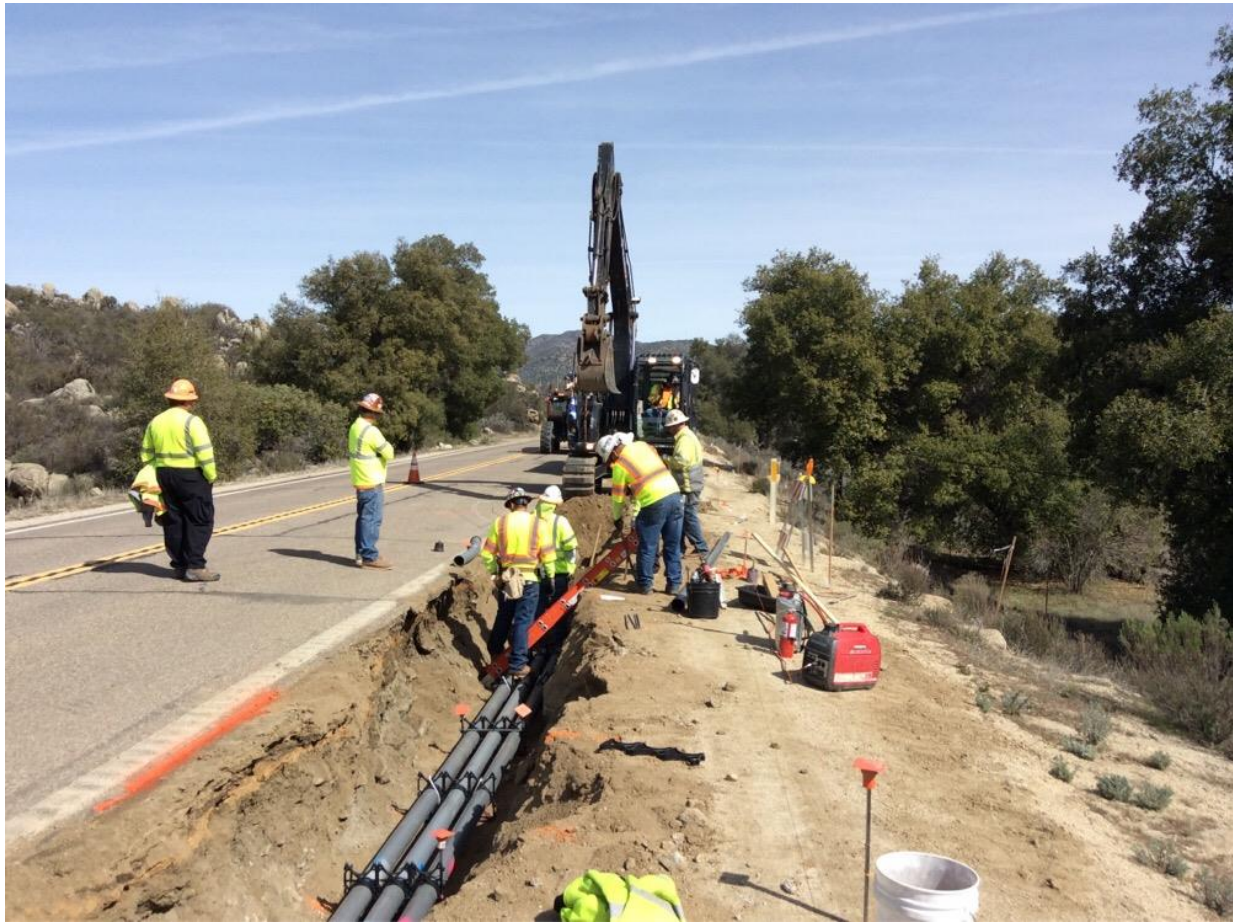
**Photo 5:** Construction crews were observed trenching and installing conduit along Buckman Springs Road (C 449).

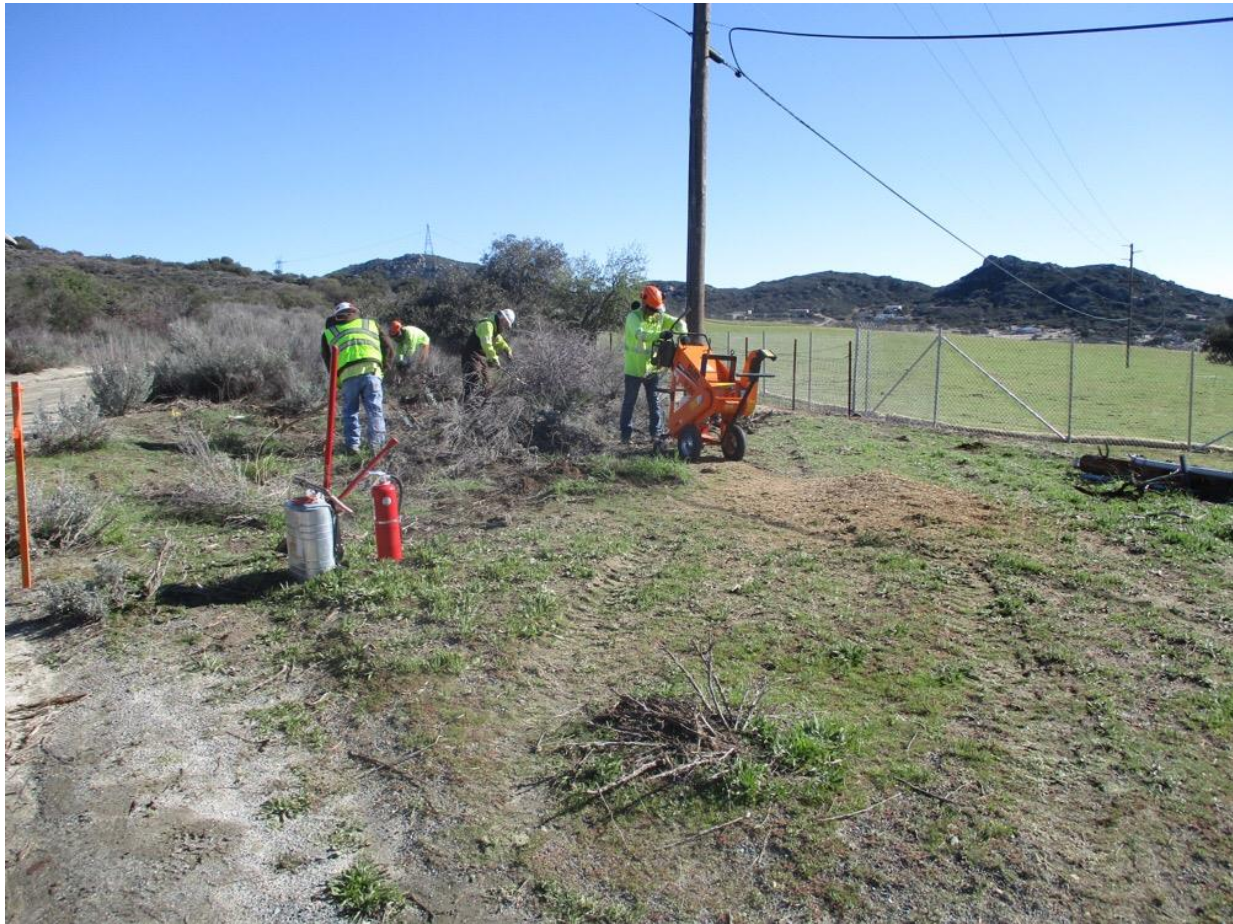
**Photo 6:** A complete set of fire tools was placed within 50 feet of the observed vegetation clearing and chipping activities at the southern entrance/exit to the Bartlett Staging Yard, in accordance with the CFPPP fire prevention matrix. A Biological Monitor was also observed monitoring the activities in accordance with MM BIO-3.
