California Public Utilities Commission <i>Mitigation Monitoring, Compliance, and Reporting Program</i>
	Cleveland National Forest Power Line Replacement Projects Compliance Status Report: 065 March 24, 2019

This compliance status report covers construction activities from March 11, 2019 through March 24, 2019.

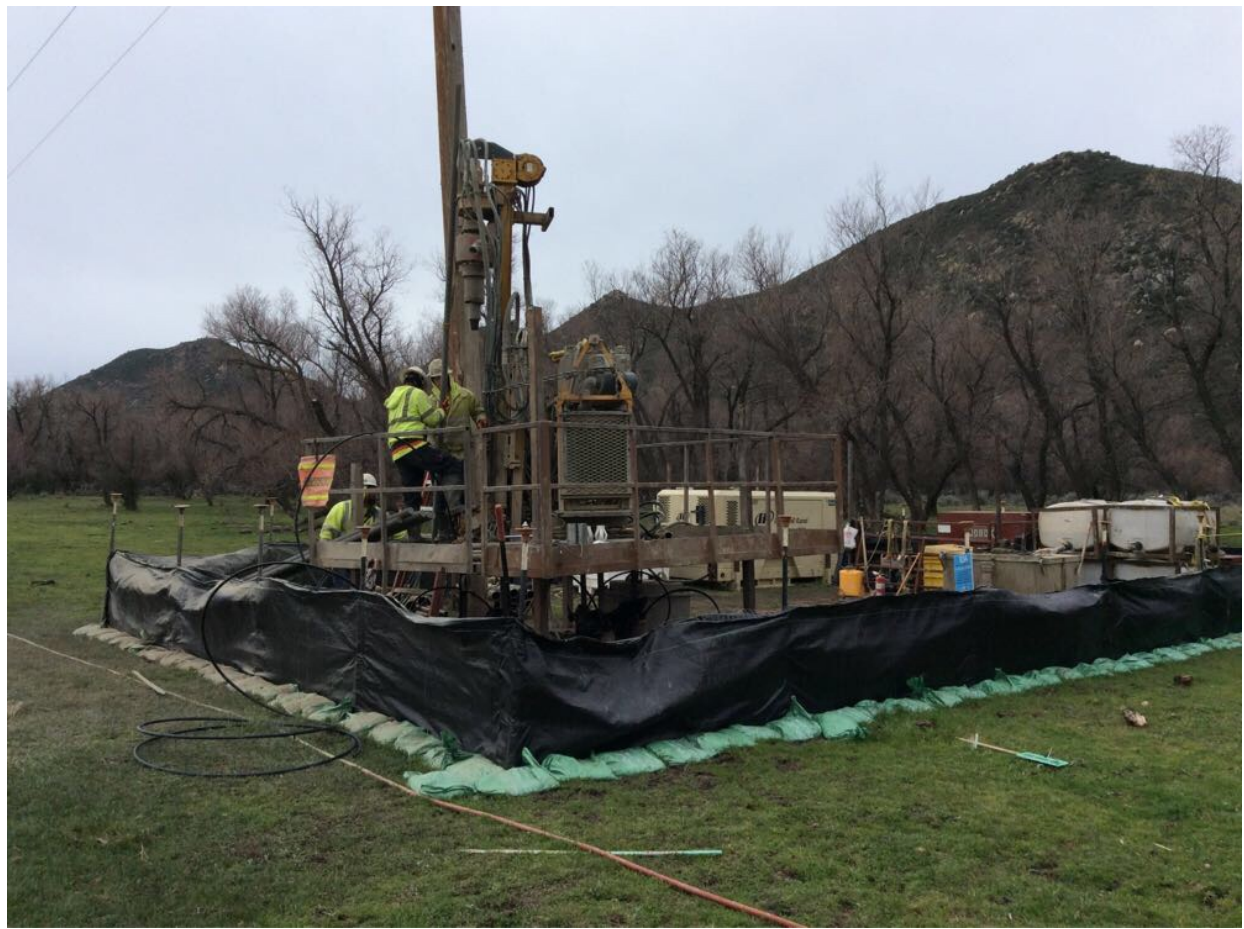
Photo 1: A construction crew was observed setting rebar at Pole Z40980 (TL 6958). The lower portion of the Arroyo toad fencing surrounding the site was observed to stretch outward along the ground and be secured with a continuous line of gravel bags in accordance with the Arroyo Toad Monitoring and Relocation Plan.

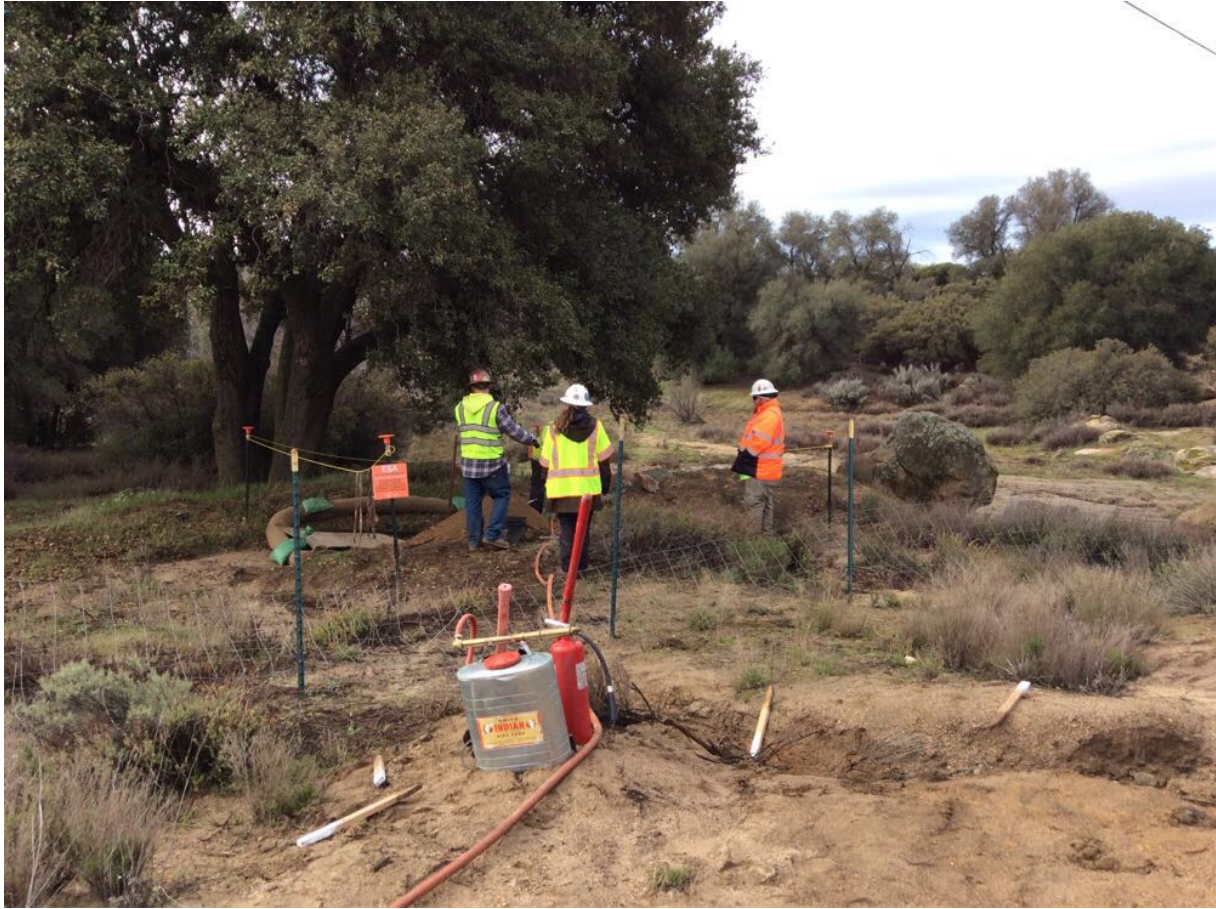
Photo 2: Project personnel were observed avoiding a clearly marked ESA surrounding the anchor at Pole P258862 (C 449) in accordance with the HPMP and APM CUL-03. In addition, Archaeological and Cultural Monitors were present in accordance with APM CUL-04 and MM CUL-1.

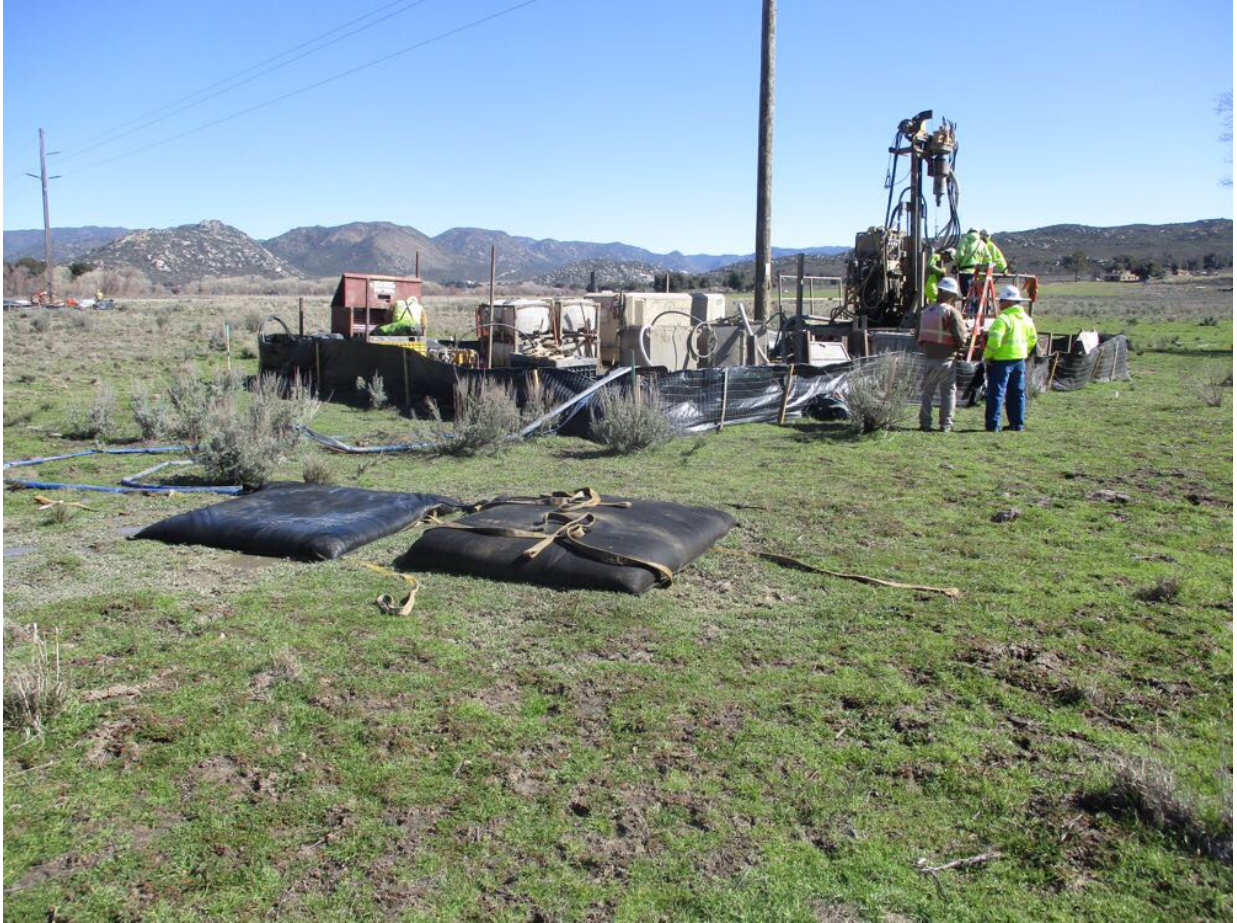
Photo 3: A construction crew observed drilling for a micropile foundation at Pole Z40979 (TL 6958). Ground water encountered while drilling was pumped into tanks and through filter bags before being discharged to land in accordance with APM HYD-08.

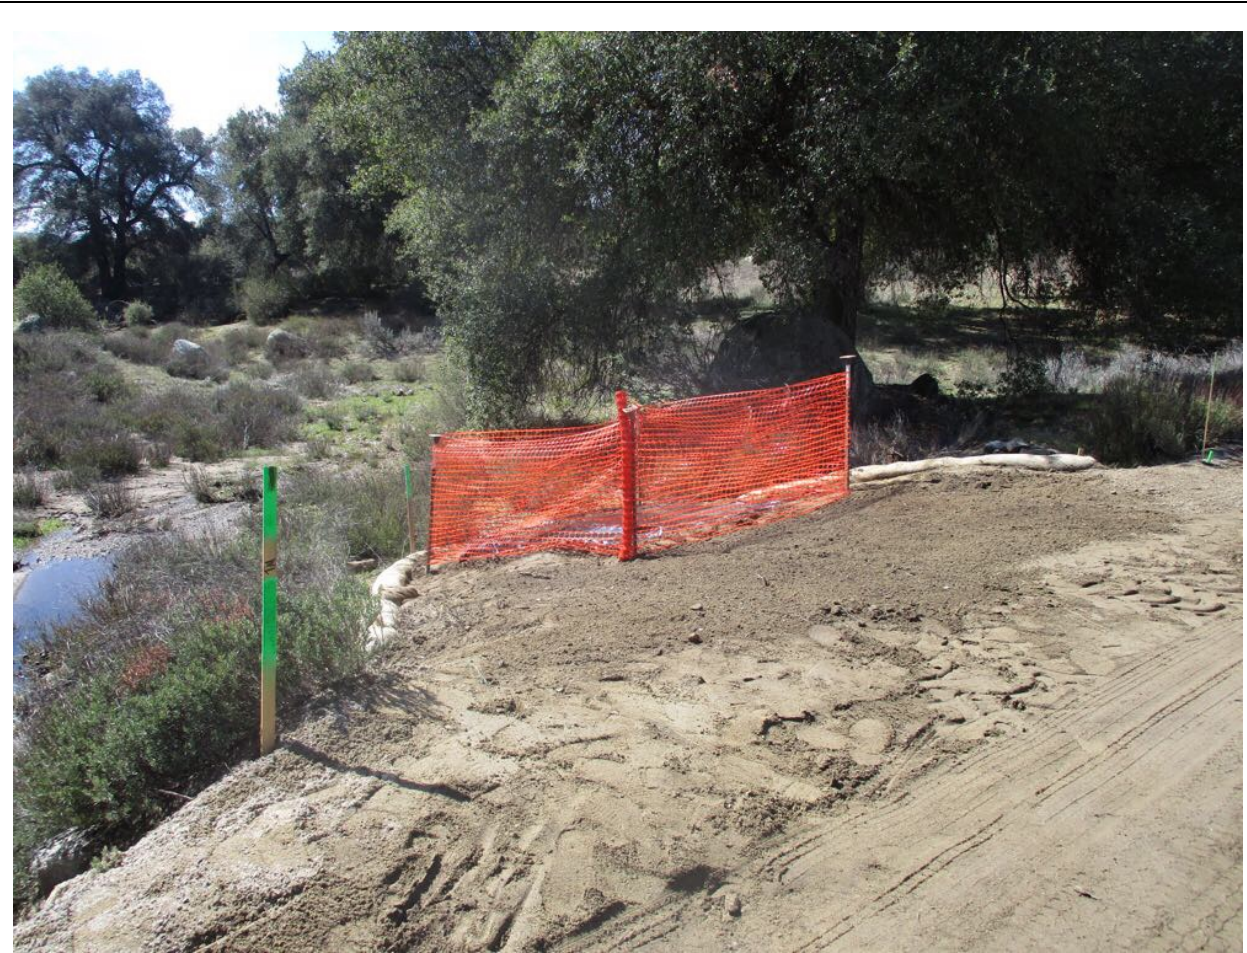
Photo 4: To prevent erosion of dirt spoil (from pole hole drilling) into a nearby jurisdictional drainage adjacent to P258855 (C 449), a construction crew removed the dirt spoil and cleaned-up/raked, and removed sediment buildup on fiber rolls in accordance with the ECP, SWPPP, and SAA. Work limits were clearly delineated in accordance with MM BIO-1.

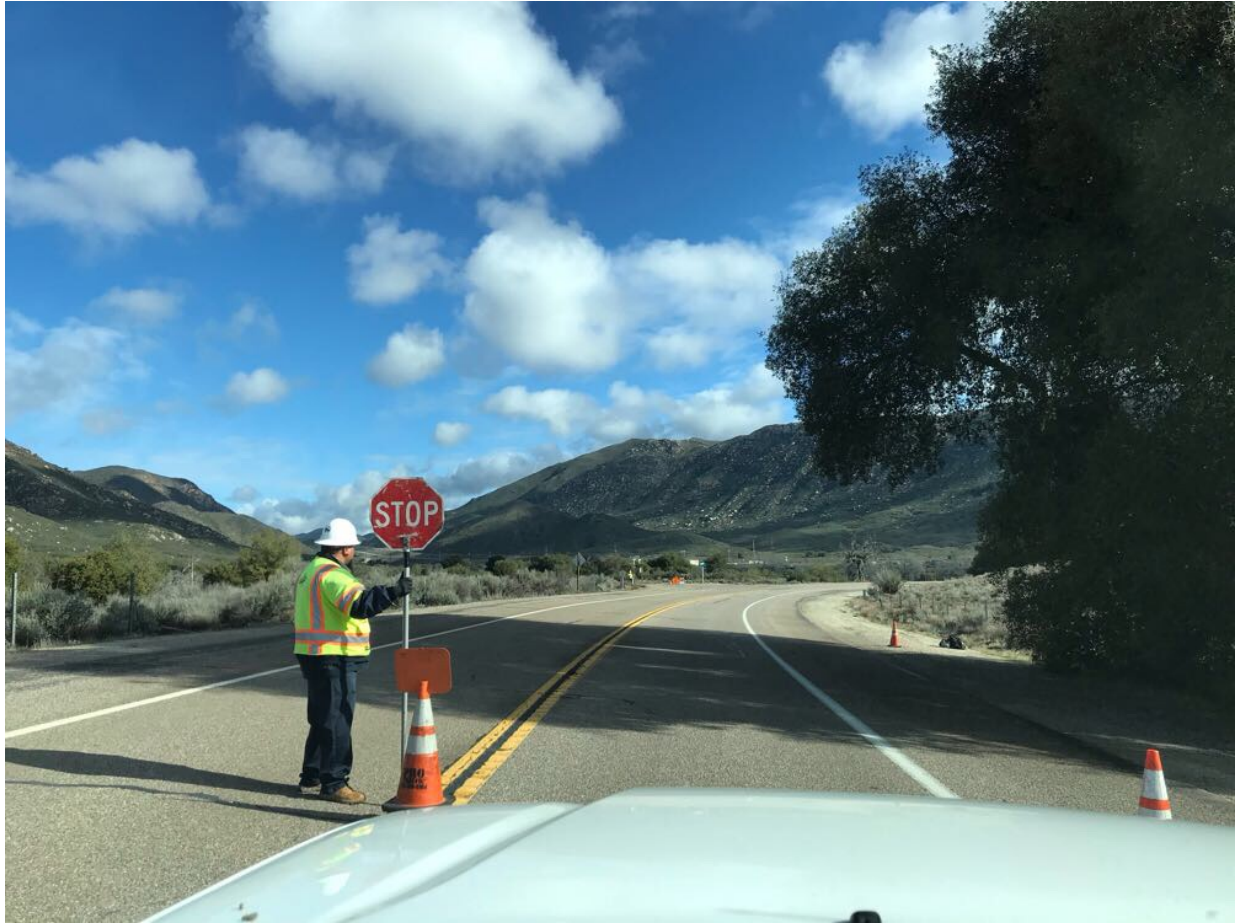
Photo 5: In accordance with APM TRANS-02, traffic was regulated on Buckman Springs Road (TL 629C) while helicopter external load operations were occurring across the road.

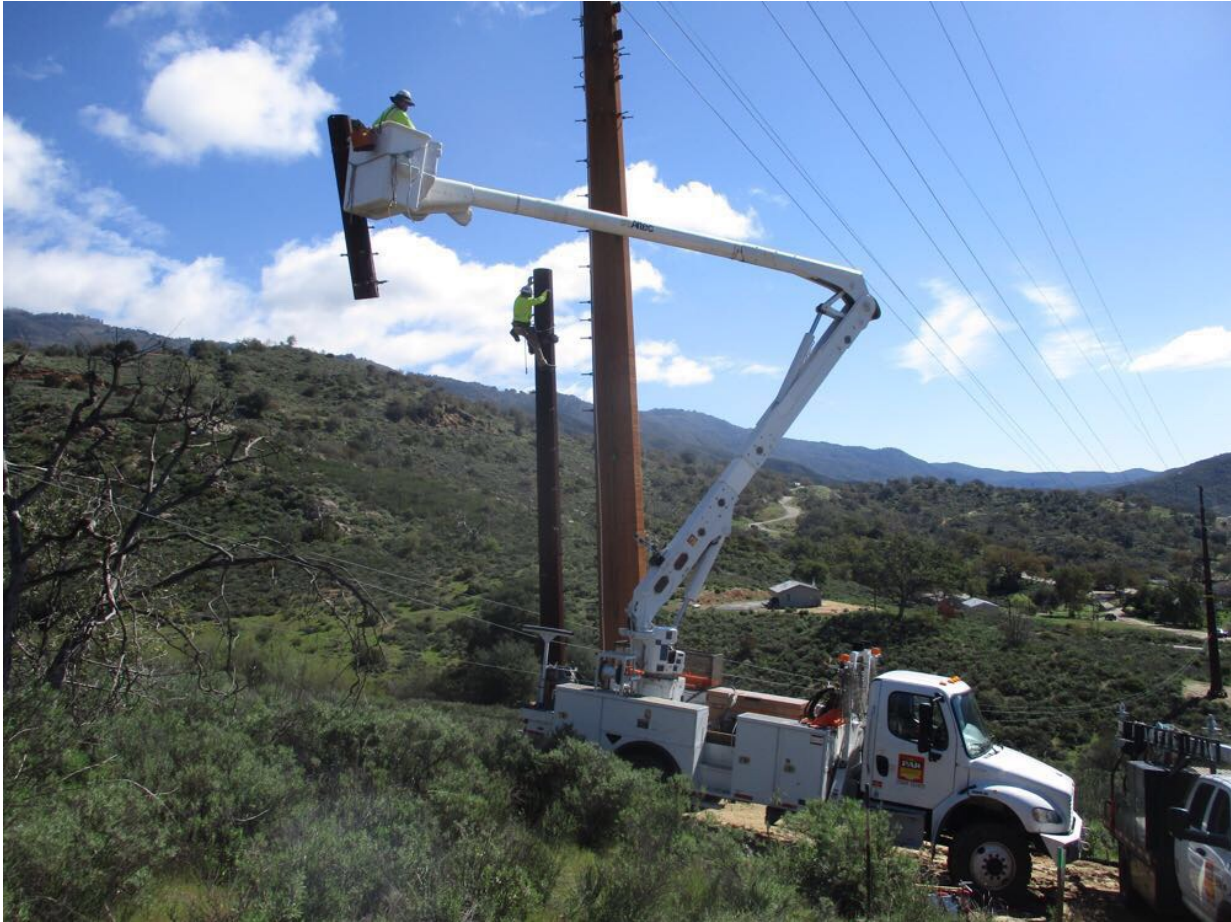
Photo 6: A construction crew observed cutting the old pole at Z118069 (TL 682) and loading pieces onto a truck for off-site hauling. The crew was observed working within the approved work space in accordance with MM BIO-1.
