California Public Utilities Commission <i>Mitigation Monitoring, Compliance, and Reporting</i> <i>Program</i>
	Cleveland National Forest Power Line Replacement Projects Compliance Status Report: 088 February 9, 2020

This compliance status report covers construction activities from January 27 through February 9, 2020.

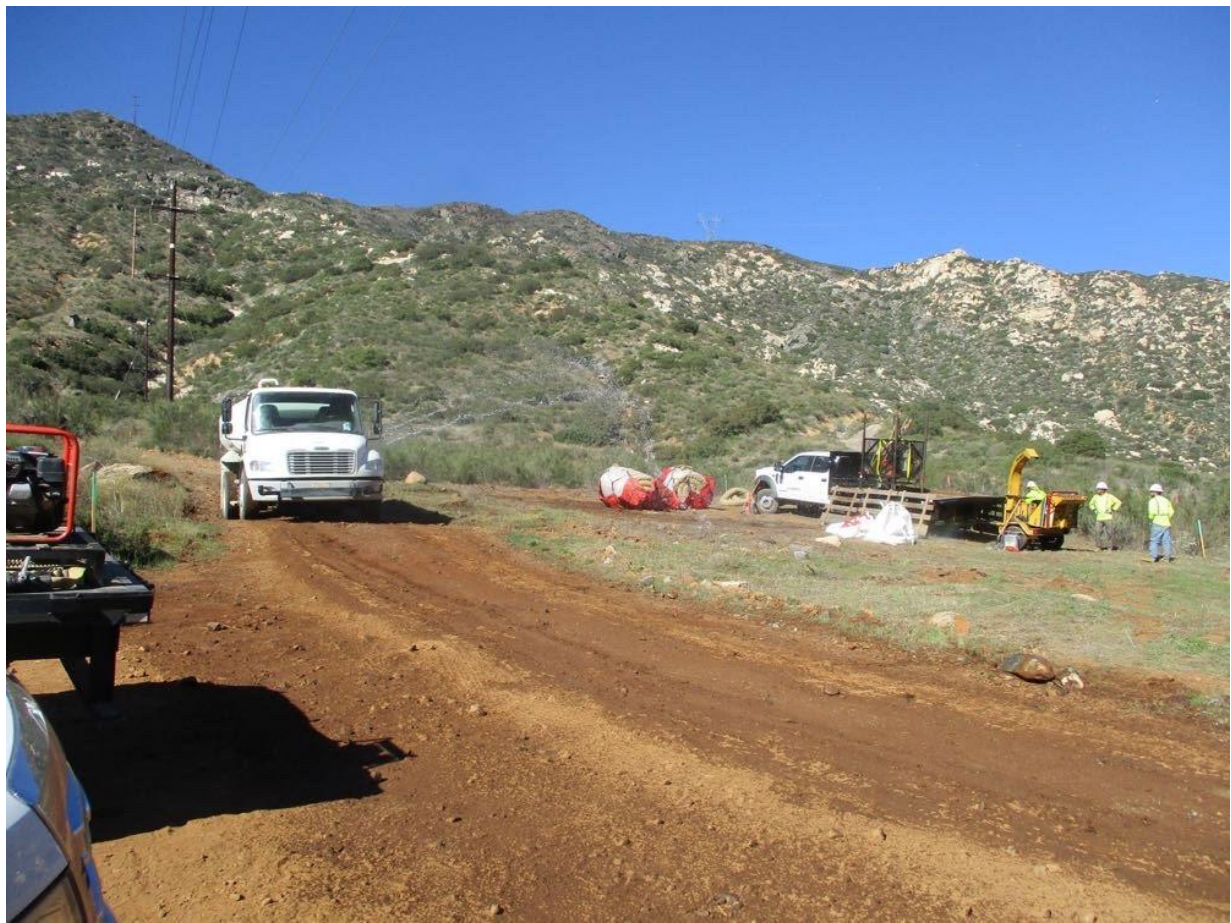
Photo 1: A water truck operator was observed applying water to the work area at SS03 (TL 6923) to prepare for helicopter external load operations (transporting equipment) in accordance with APM AIR-02.

To prevent fugitive dust emissions during project activities, construction crews were observed applying water to prevent fugitive dust at staging and fly yards in preparation for helicopter external load operations, along unpaved access roads, and in work areas in accordance with APM AIR-02 (see Photo 1 – Attachment A). Haul trucks used for dirt export were observed utilizing load covers to prevent dust emissions in accordance with APM AIR-02, and construction personnel were observed maintaining posted speeds of 15 miles per hour on unpaved access roads in accordance with APM AIR-03 and MM BIO-24. Construction crews applied water during perforating and drilling and used cuttings containment boxes to prevent dust emissions in accordance with APM AIR-05.

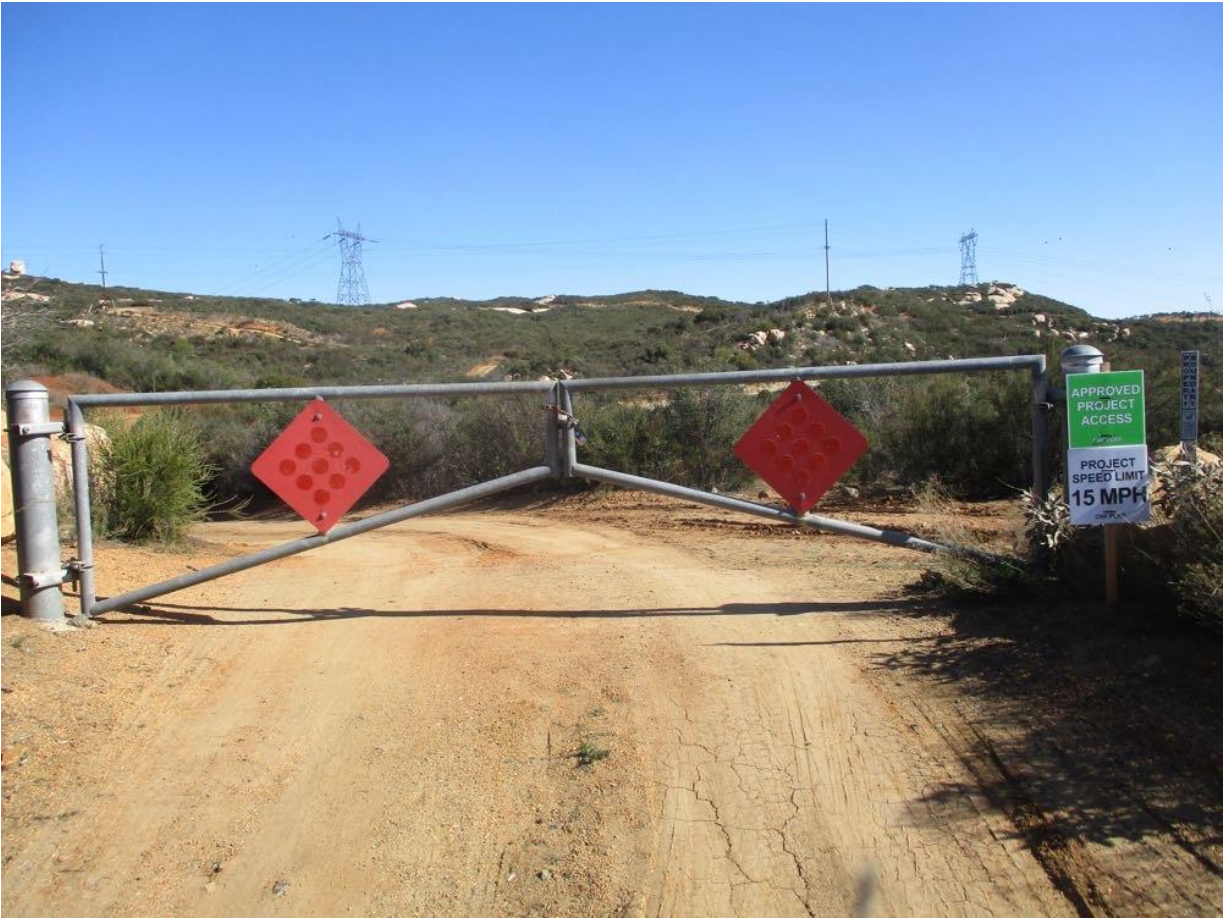
Photo 2: The Forest Service access gate off Manzanita Way was kept closed and locked in accordance with MM REC-2. The approved access road was signed, in accordance with MM BIO-1, and the project speed limit was posted and adhered to by project personnel, in accordance with MM BIO-24.

CPUC ECMs observed that Forest Service access gates were kept locked in accordance with MM-REC-2 (see Photo 2 – Attachment A). Traffic control measures were observed being implemented in accordance with APM TRANS-01–through APM TRANS-05 during this reporting period. CPUC ECMs observed traffic control crews helping to facilitate construction activities by directing one-way traffic along roads associated with TL 629A, TL 625C, and C 440 Phase 1. Motorists were notified of construction activities with signage, and guided around construction activities on or near public roadways with signs, cones, signals, and the use of a pilot car (see Photo 6 – Attachment A). Traffic was observed being temporarily stopped when helicopter external load operations crossed over public roadways, and construction and traffic control crews adhered to specific traffic control restrictions within a half mile of schools.

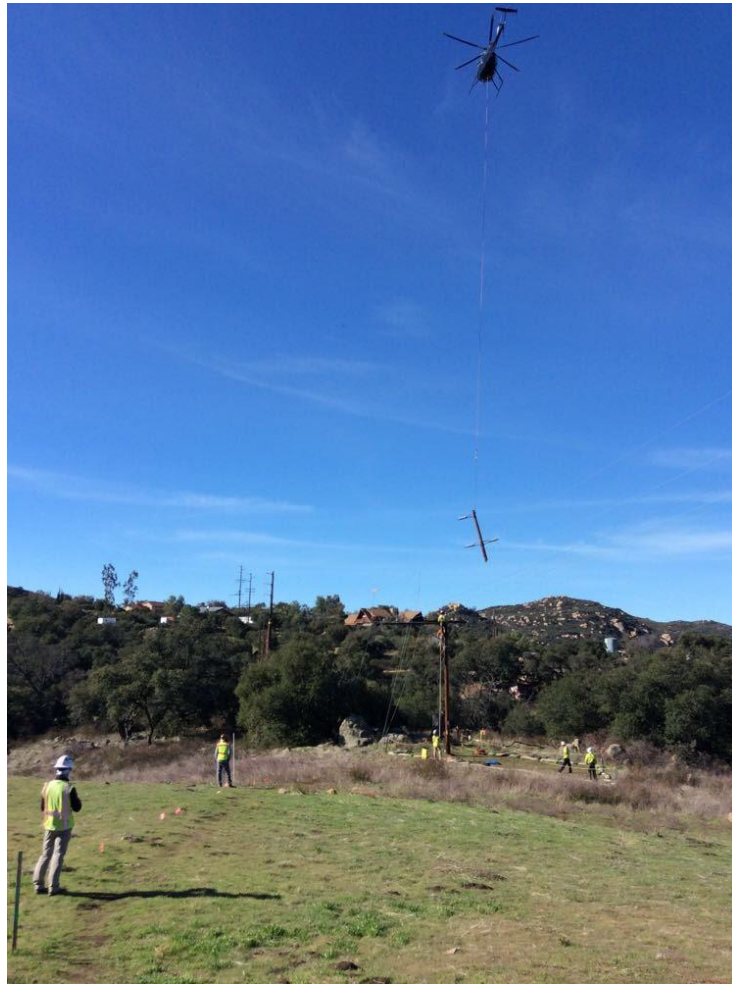
Photo 3: During pole top removal at Pole Z272939 (TL 625C), a Biological Monitor was present to monitor a nearby bird nest and ensure the buffer surrounding the nest was being respected by helicopter pilots in accordance with the APP, NBMP, and MM BIO-28.

Approved workspaces were observed delineated with staking and flagging, and work crews were observed adhering to work space limits and staying on approved access roads in accordance with MM BIO-1. In order to ensure crews were clear on approved access routes, CPUC ECMs observed “no project access” and “approved access” signs at the entrances to access roads (see Photo 2 – Attachment A). Workers were observed having completed the Worker Environmental Awareness Program (WEAP), as shown by project hard hat stickers in accordance with MM BIO-2. Biological monitors were observed conducting full-time monitoring of initial ground-disturbing activities such as vegetation removal in accordance with MM BIO-3, and monitoring all other construction activities to ensure compliance with mitigation measures, applicant proposed measures, and permit conditions in accordance with MM BIO-22. Crews were observed containing trash at work areas in accordance with MM BIO-26. During this reporting period, a CPUC ECM observed partially uncovered bollard excavations along C 440, which was documented as a Level 1 Minor Deviation (see Compliance Status section below). Biological Monitors were present to monitor bird nests during construction activities and ensure helicopter pilots respected helicopter bird nest buffers along TL 625C and TL 6923, in accordance with the Avian Protection Plan/Nesting Bird Management Plan (APP/NBMP) and MM BIO-28 (see Photo 3 – Attachment A).

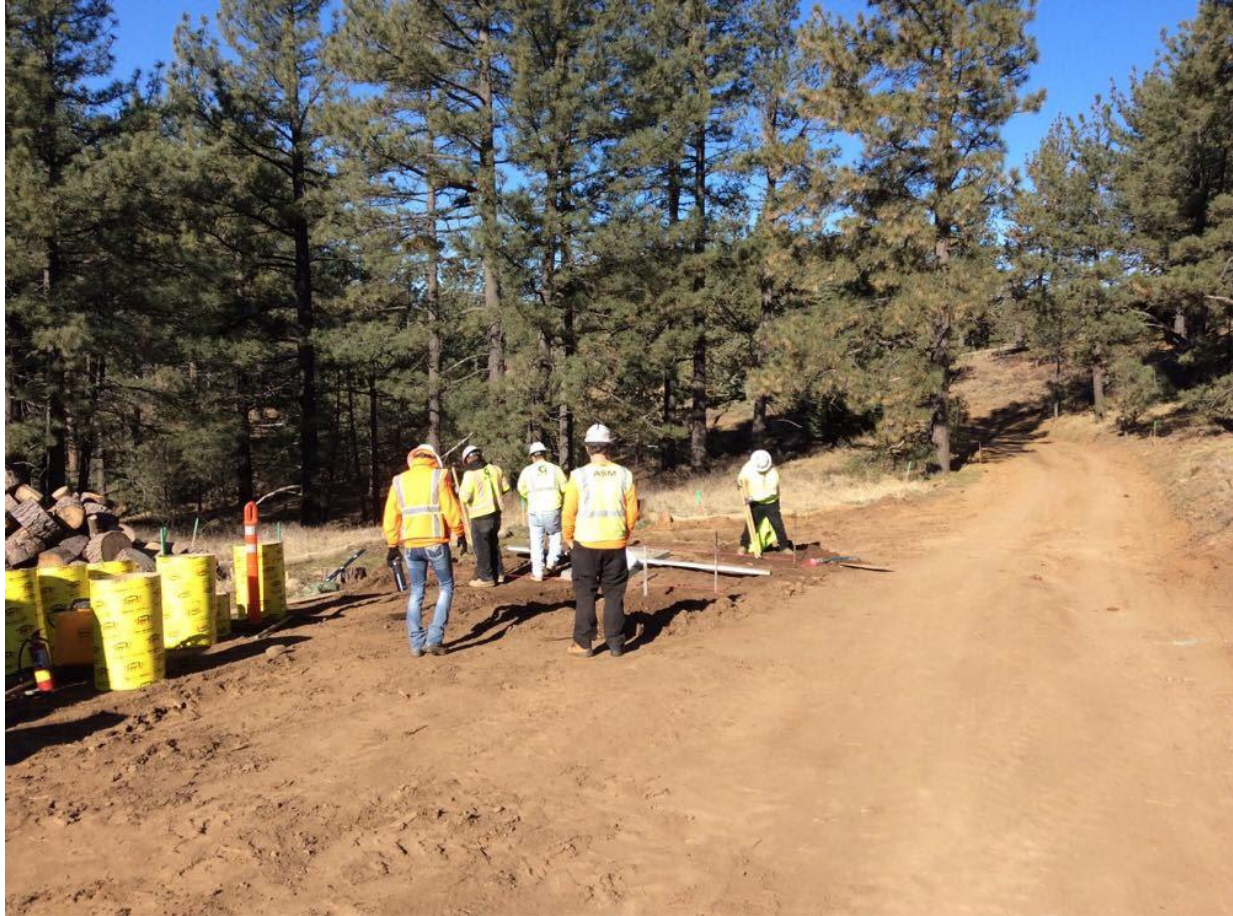
Photo 4: Archaeological and Cultural Monitors were present to monitor bollard excavations at a box location along Alignment C (C 440) in accordance with the HPMP, APM CUL-04, and MM CUL-1.

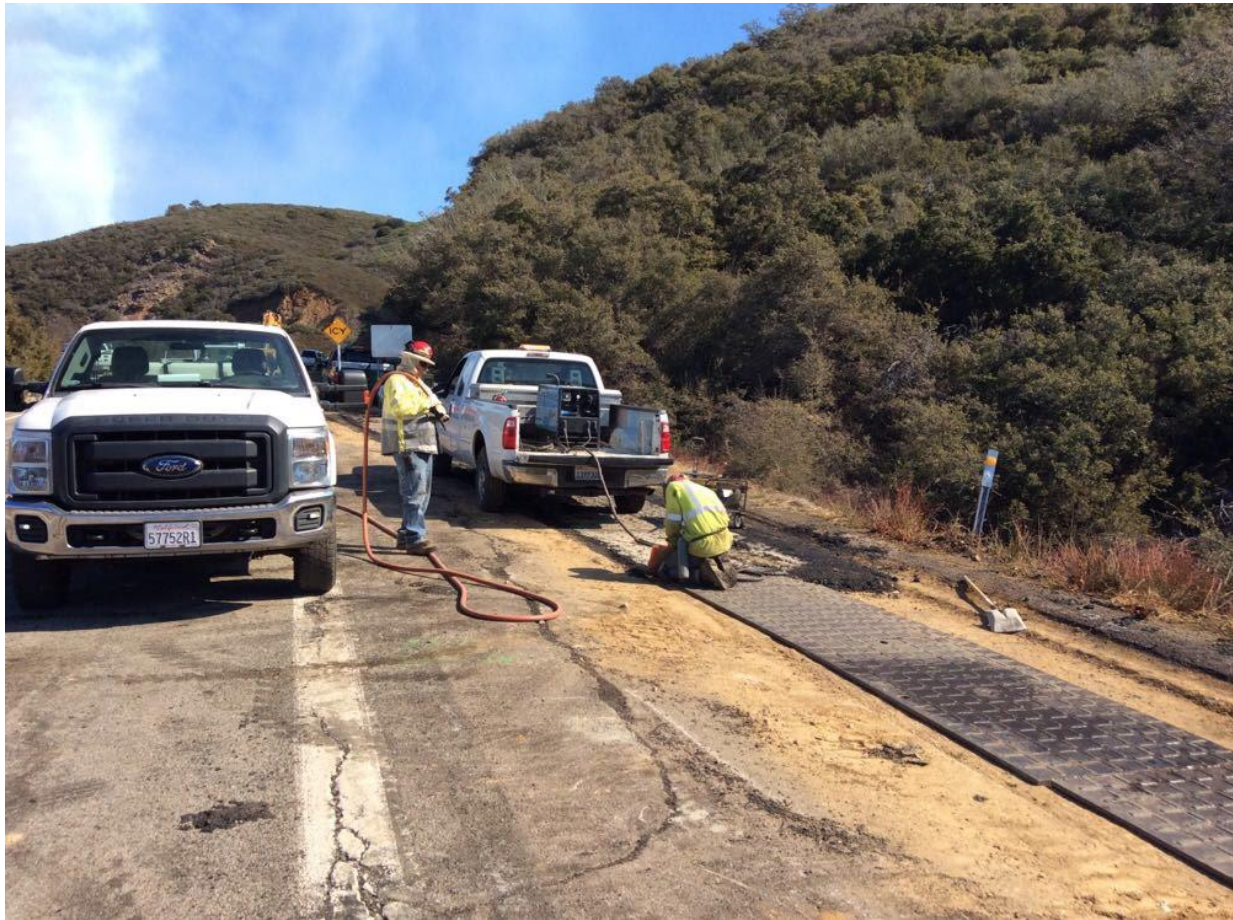
Photo 5: In accordance with the CFPPP, a Dedicated Fire Patrol was present during hot work near station 183+50 (C 440) and remained on site for one hour afterwards. The Fire Patrol was equipped with a full set of fire tools (5-gallon backpack pump, round point shovel, Pulaski, and 2A10BC fire extinguisher) and was also observed wetting down the surrounding area prior to hot work.

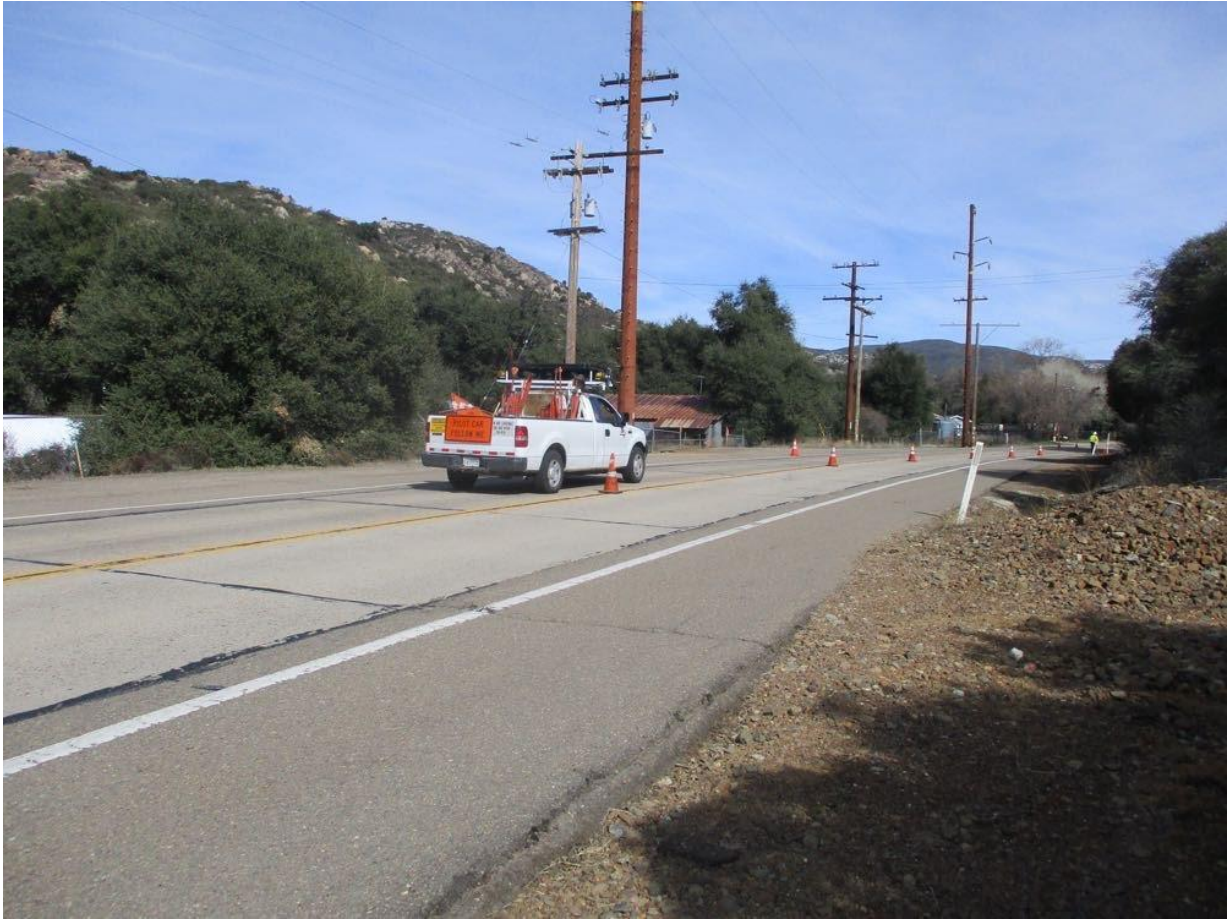
Photo 6: A pilot vehicle was used to lead one-way traffic through a coned off work zone on Old Highway 80 (TL 629A) in accordance with APM TRANS-02 and the TCP.
