| | California Public Utilities Commission <i>Mitigation Monitoring, Compliance, and Reporting</i> <i>Program</i> |
| | Cleveland National Forest Power Line Replacement Projects Compliance Status Report: 093 April 19, 2020 |

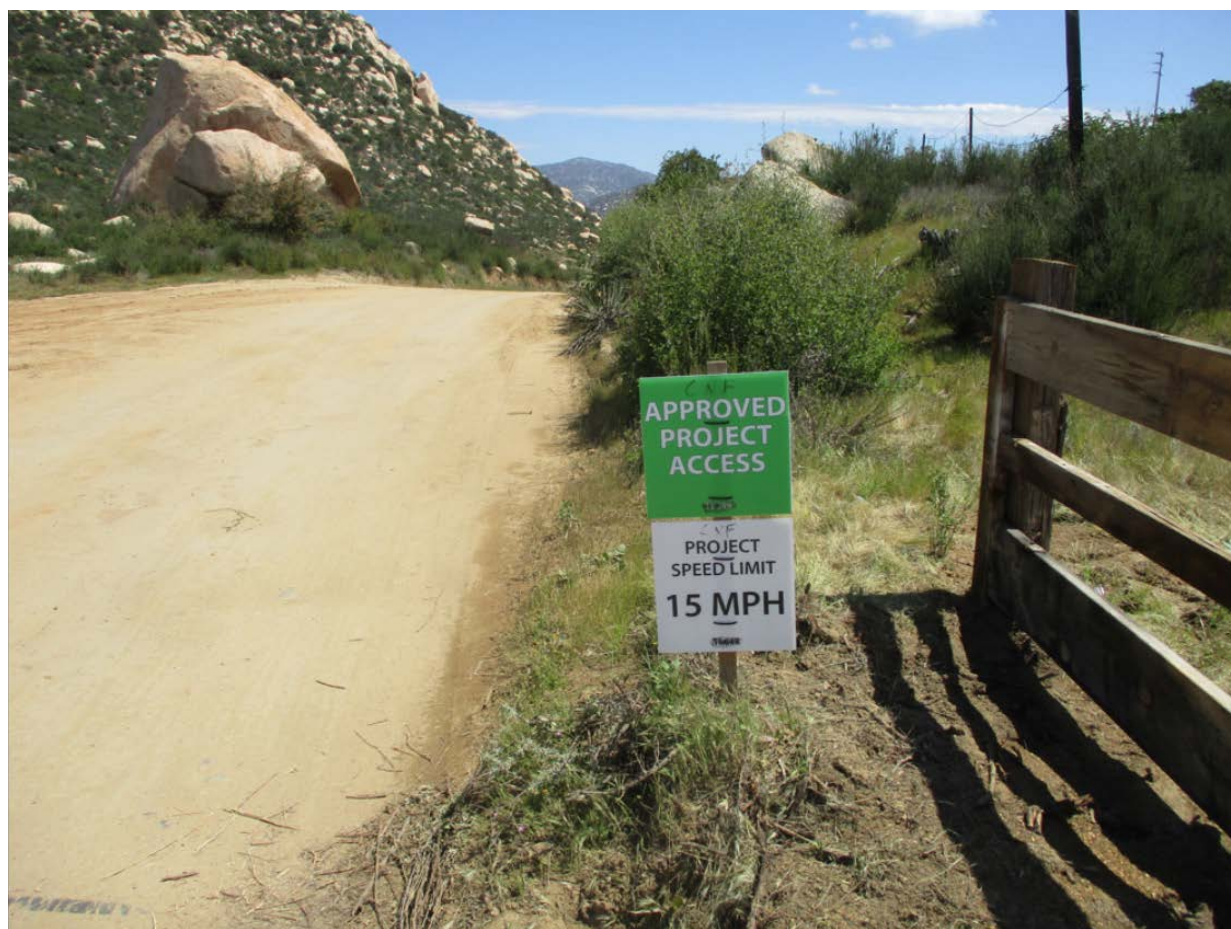
Photo 1: In accordance with APM AIR-03 and MM BIO-24, project personnel were observed abiding by the posted 15 mph speed limit (access road off Round Potrero Road near Z972808 (TL 6923)).

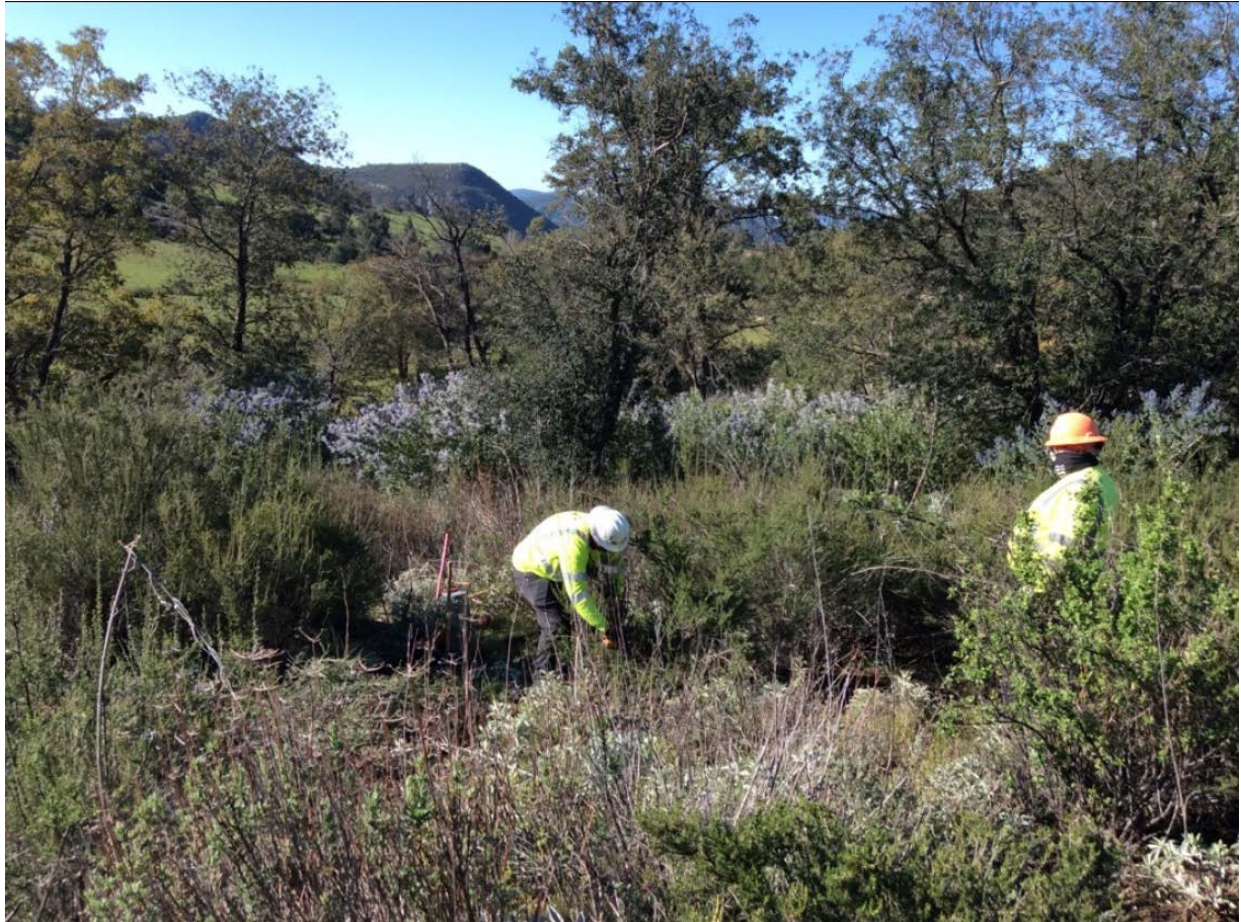
Photo 2: A biological monitor was observed monitoring vegetation removal at P259374 (TL 626 Conversion North (C 222)) in accordance with MM BIO-3 and MM BIO-22.

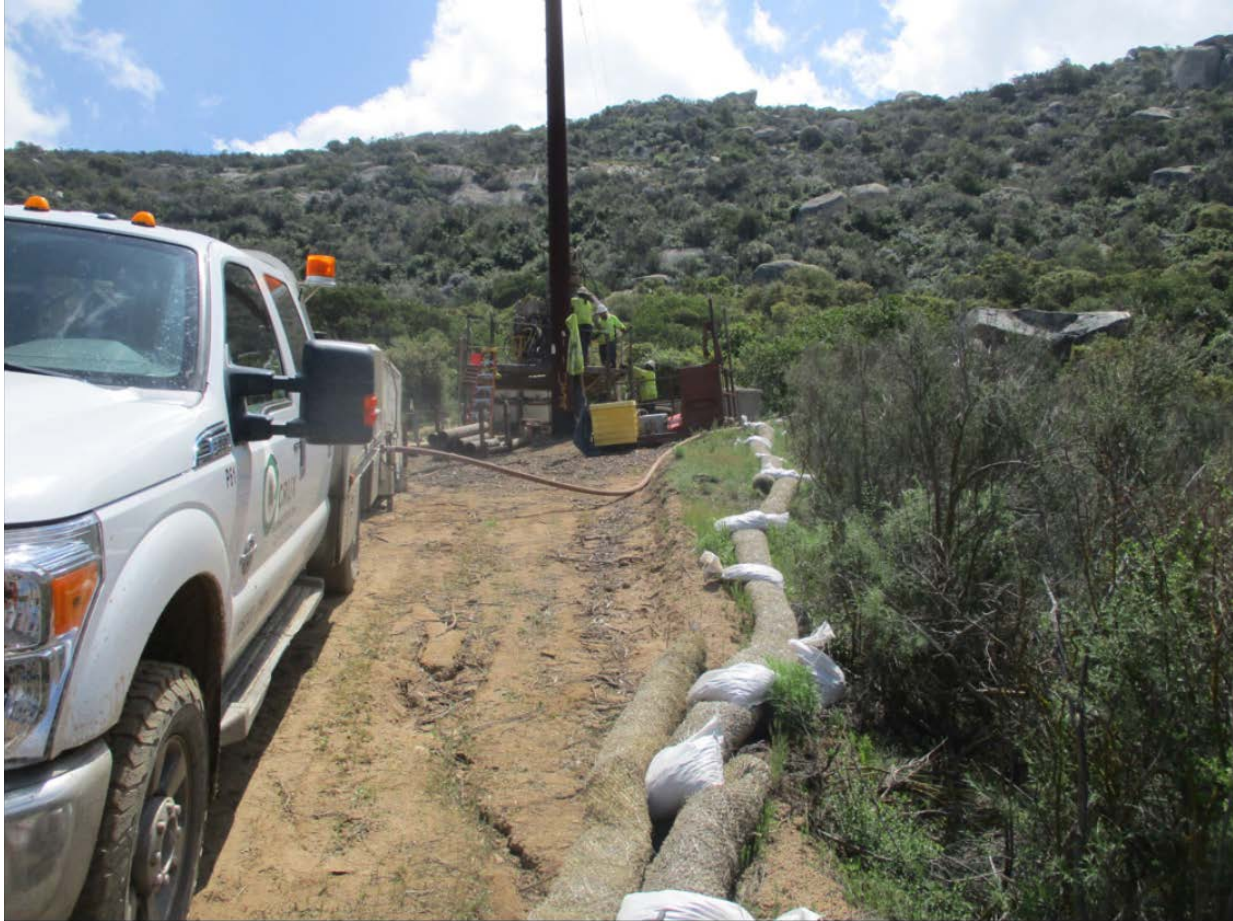
Photo 3: Perimeter fiber rolls at a micropile location along TL 6923 were weighted down with gravel bags instead of being trenched into the ground in order to prevent ground disturbance in an area with a higher potential for cultural resources, in accordance with the HPMP (MM CUL-1) and APM CUL-03.

CPUC ECMs observed cultural resource monitors, including archaeological and Native American monitors, monitoring construction activities that occurred within or adjacent to identified archaeological or cultural resource site boundaries in accordance with the Historic Properties Management Plan (HPMP), MM CUL-1, MM CUL-3, and APM CUL-04. Cultural ESAs were marked to prevent construction access to areas with cultural and/or historical resources in accordance with the HPMP, and work crews were observed respecting cultural ESA boundaries (see Photos 3 and 4 – Attachment A).

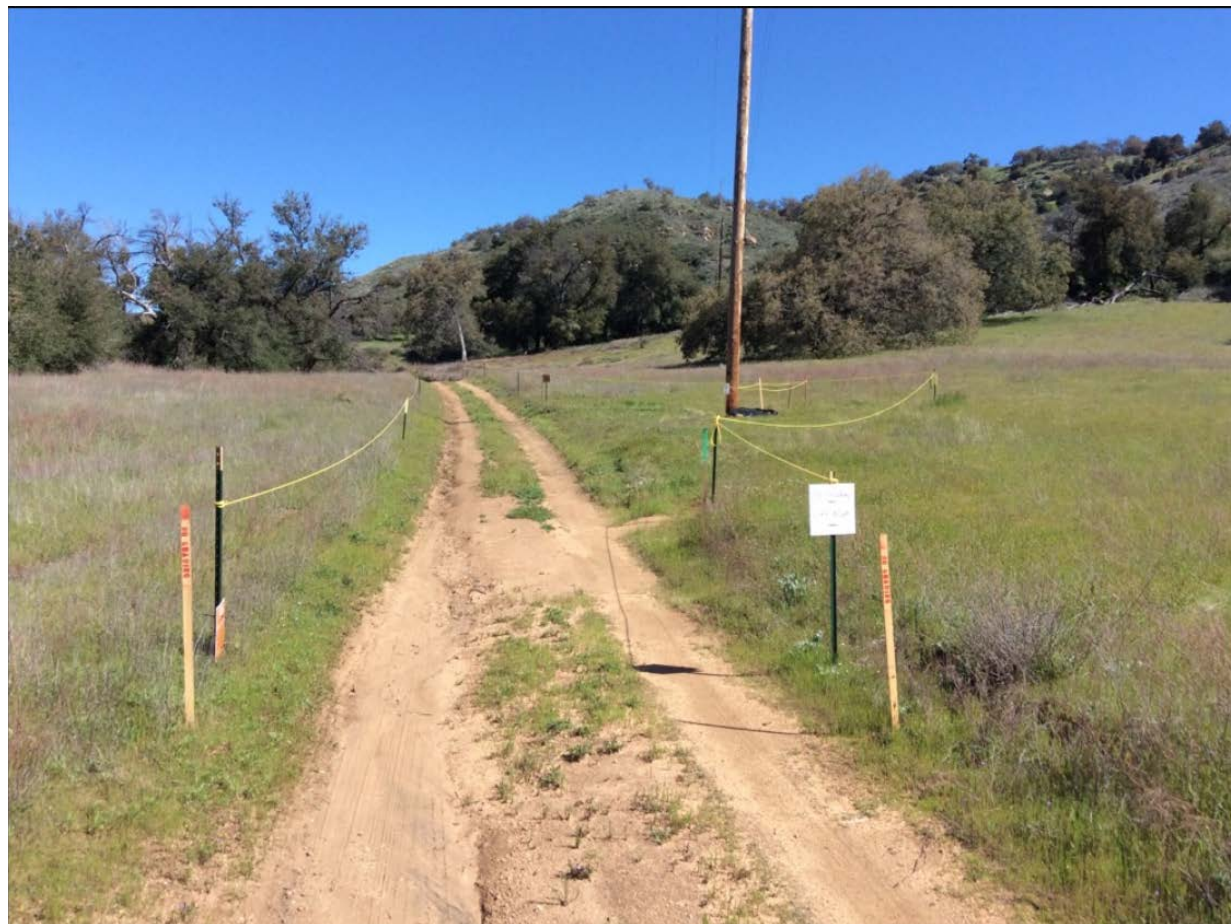
Photo 4: A cultural ESA surrounding a pole and access road along TL 626 Conversion North (C 222) was clearly delineated, and “no grading” signage was present on the road in accordance with the HPMP (MM CUL-1) and APM CUL-03.

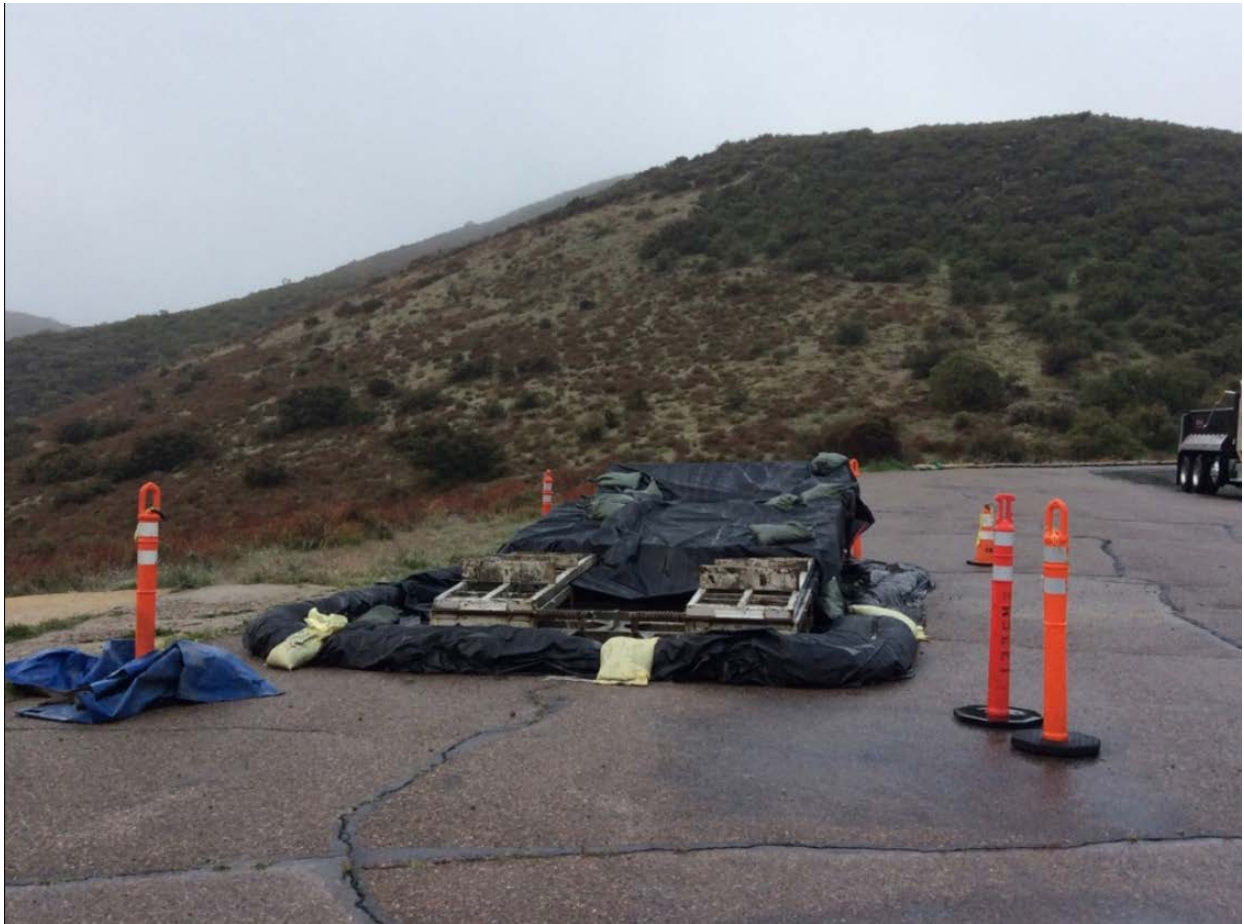
Photo 5: A designated concrete washout station at Staging Area 1 (C 440 Phase I) was observed to be covered in the morning, indicating that it had been covered during recent rain events in accordance with the project's SWPPP (MM HYD-1 and MM BIO-7).

To prevent impacts to hydrology and water quality, site-specific sediment and erosion control BMPs were observed being implemented and maintained along project alignments in accordance with the project Erosion Control Plan (ECP), Stormwater Pollution Prevention Plan (SWPPP; MM HYD-01, MM BIO-7), and APM HYD-09 (see Photo 5 – Attachment A). Hydrological resources were flagged for avoidance, and work activities occurred outside of hydrological resources in accordance with APM HYD-06.

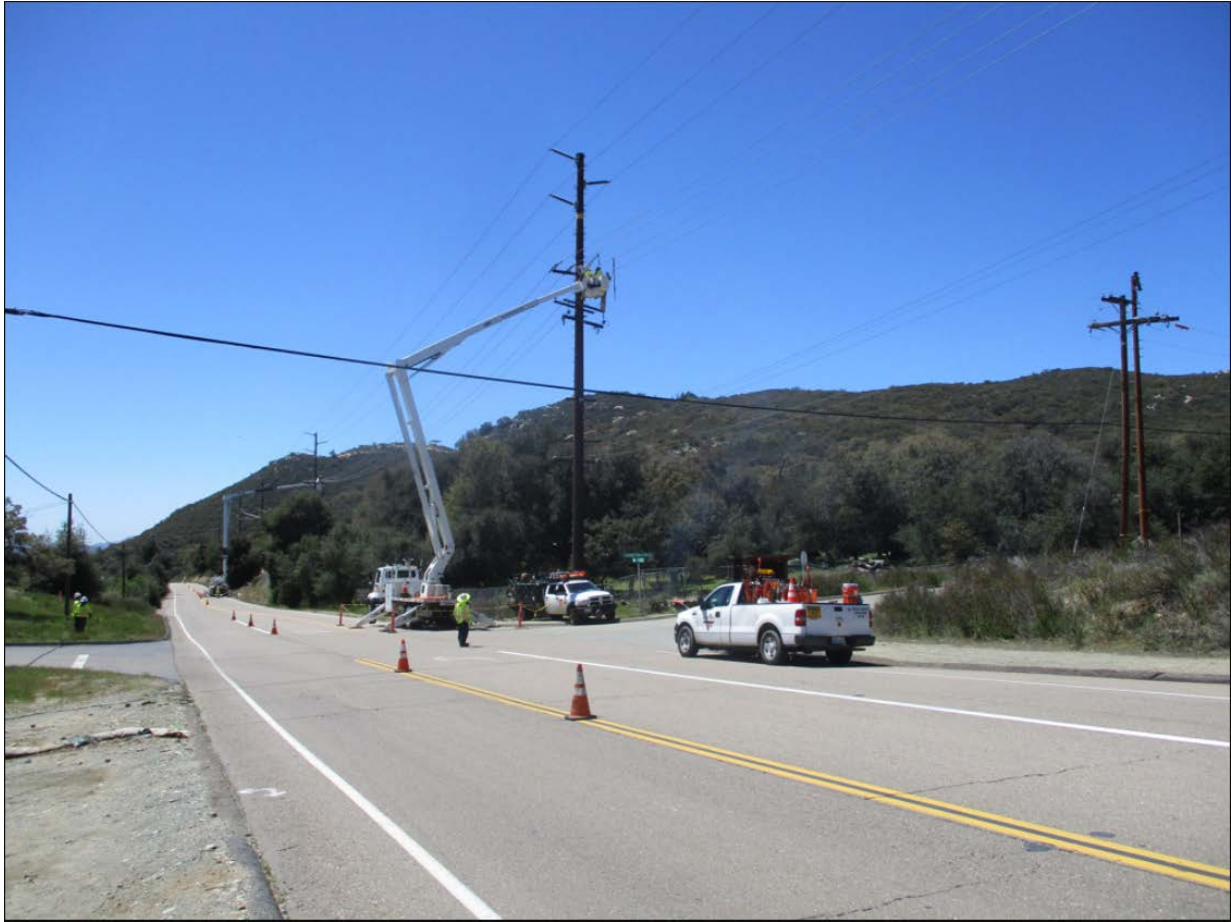
Photo 6: During clipping in of 12-kilovolt wire at Z272989 (TL 625C), personnel directed one-way traffic along Japatul Valley Road in accordance with APM TRANS-02.

Traffic control measures were observed being implemented in accordance with APM TRANS-01 through APM TRANS-05 during this reporting period (see Photo 6 – Attachment A).
