California Public Utilities Commission <i>Mitigation Monitoring, Compliance, and Reporting</i> Program
	Cleveland National Forest Power Line Replacement Projects Compliance Status Report: 096 May 31, 2020

This compliance status report covers construction activities from May 18 through May 31, 2020.

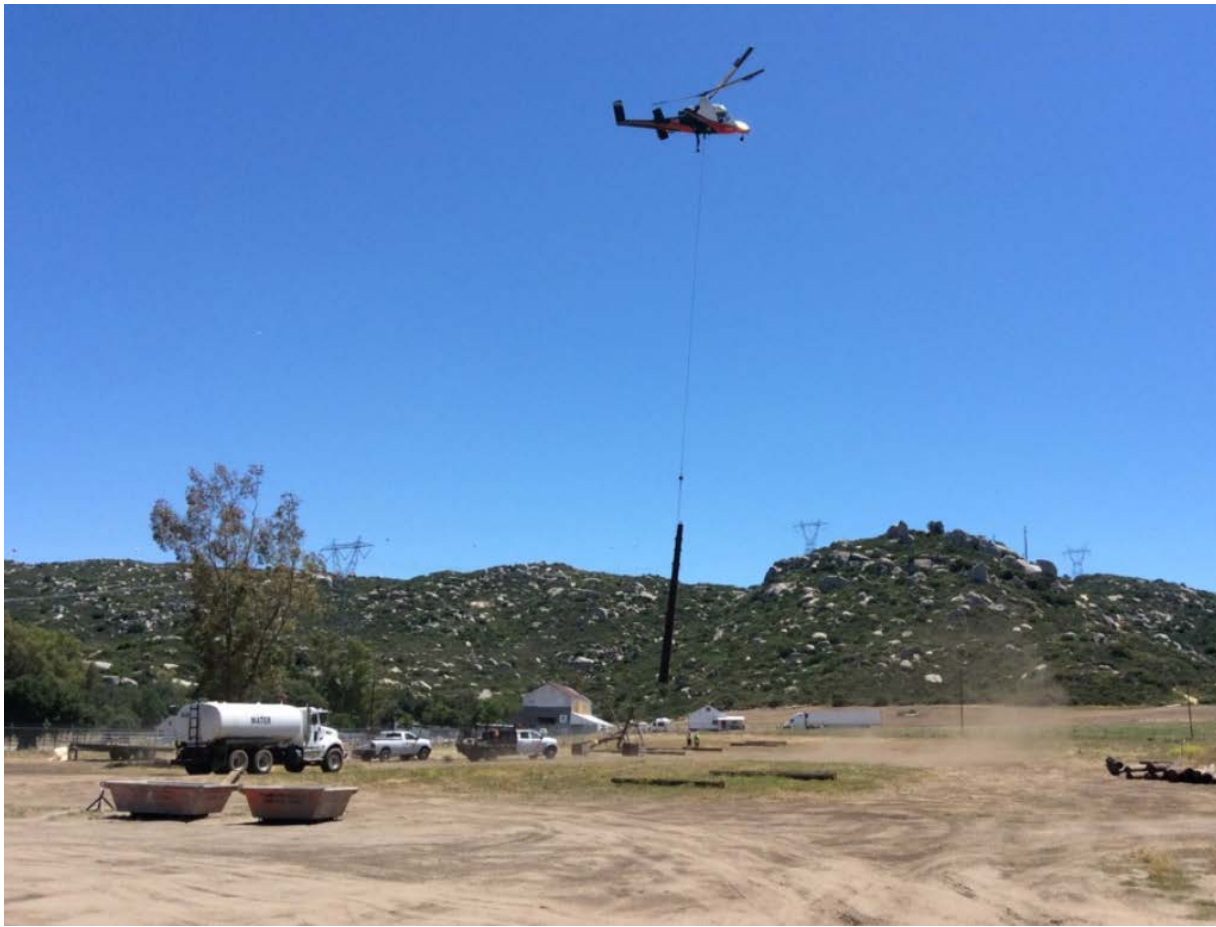
Photo 1: A crew was observed using helicopter external load operations to pick both sections of Z972820 from Sol Valley Staging Yard South (TL 6923). A water tender was observed applying water to the surface surrounding the pole immediately prior to and in between pick up to minimize dust emissions from helicopter rotor wash in accordance with APM AIR-02 and APM AIR-05.

To prevent fugitive dust emissions during project activities, crews were observed applying water to prevent fugitive dust along unpaved access roads and in work areas in accordance with APM AIR-02 and during helicopter operations in accordance with the Aviation Safety Plan (ASP; MM PHS-5) (see Photo 1 – Attachment A). Haul trucks used for dirt export were observed utilizing load covers to prevent dust emissions in accordance with APM AIR-02, and construction personnel were observed maintaining posted speeds of 15 miles per hour on unpaved access roads in accordance with APM AIR-03 and MM BIO-24. Construction crews were observed applying water during drilling and using cuttings containment boxes to prevent dust emissions in accordance with APM AIR-05.

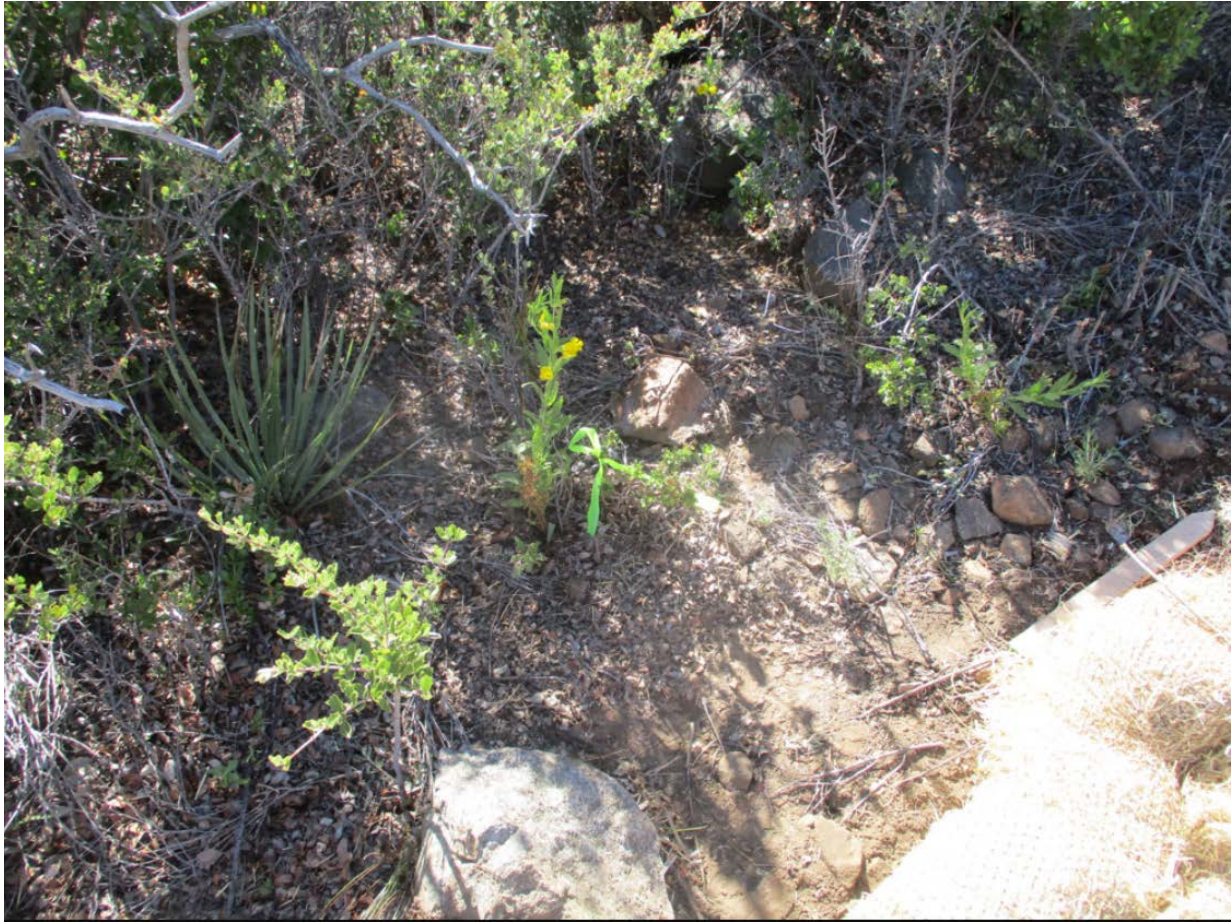
Photo 2: At P259700 (TL 626 Conversion South (C 79B)), sensitive plant species (above, *Mimulus clevelandii*), were observed flagged for avoidance in accordance with MM BIO-13.

Approved workspaces were observed delineated with staking and flagging, and work crews were observed adhering to work space limits and staying on approved access roads in accordance with MM BIO-1 (see Photo 2 – Attachment A). Workers were observed having completed the Worker Environmental Awareness Program (WEAP), as shown by project hard hat stickers in accordance with MM BIO-2. Biological monitors were observed conducting full-time monitoring of initial ground-disturbing activities such as vegetation removal in accordance with MM BIO-3, and monitoring all other construction activities to ensure compliance with mitigation measures, applicant proposed measures, and permit conditions in accordance with MM BIO-22. In accordance with MM BIO-13, MM BIO-14, and MM BIO-16, Environmentally Sensitive Area (ESA) signs and flagging were observed installed around areas with special-status species, and ESAs were observed being avoided by crews (see Photo 2 – Attachment A). Excavations were observed covered to prevent wildlife entrapment in accordance with MM BIO-23, and crews were observed containing trash at work areas in accordance with MM BIO-26 (see Photo 4 – Attachment A). Avian biologists were observed conducting nesting bird surveys and were present to monitor bird nests during construction activities in accordance with the Avian Protection Plan/Nesting Bird Management Plan (APP/NBMP) and MM BIO-28.

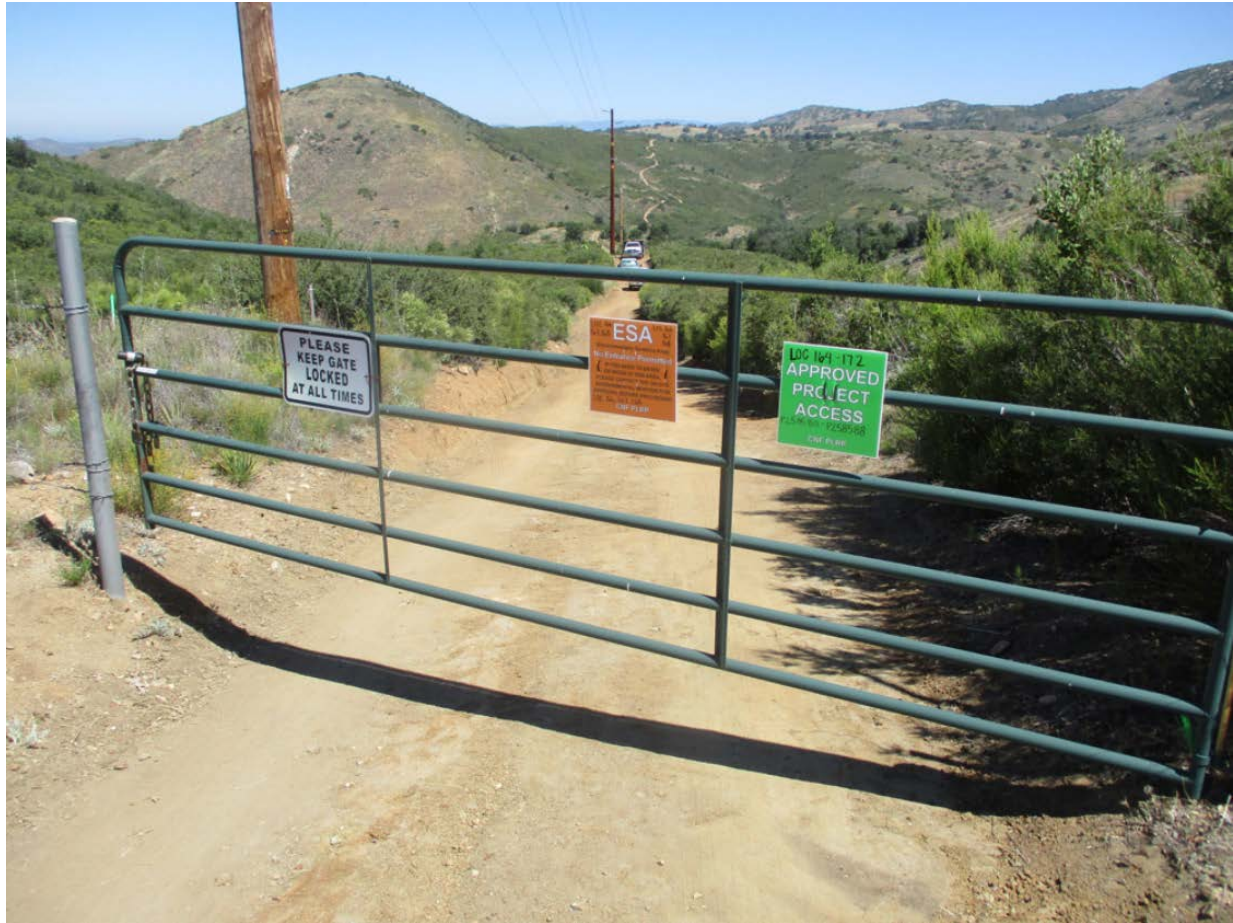
Photo 3: On the gate to access sites from P258579 (TL 626 Conversion South (C 79B)) to the north, an ESA sign listing cultural sites for which monitors are required was posted (APM CUL-04), and an approved access sign was posted in accordance with MM BIO-1.

CPUC ECMs observed cultural resource monitors, including archaeological and Native American monitors, monitoring construction activities that occurred within or adjacent to identified archaeological or cultural resource site boundaries in accordance with the Historic Properties Management Plan (HPMP), MM CUL-1, MM CUL-3, and APM CUL-04. Cultural ESAs were marked to prevent construction access to areas with cultural and/or historical resources in accordance with the HPMP, and work crews were observed respecting cultural ESA boundaries (see Photo 3 – Attachment A).

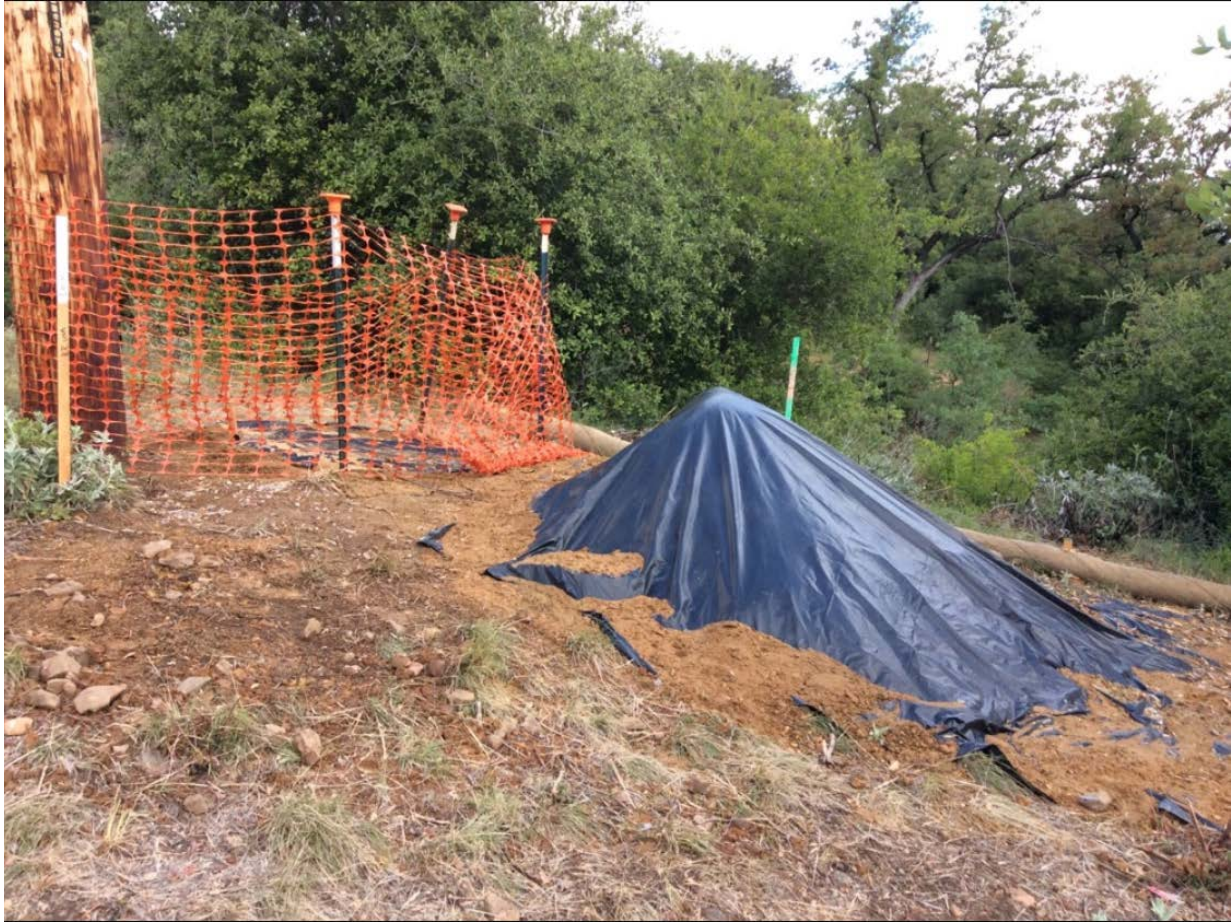
Photo 4: The pole hole and spoils stockpile at P259357 (TL 626 Conversion North (C 222)) were observed to be securely covered in accordance with MM BIO-23, and the ECP/SWPPP (MM HYD-1 and MM BIO-7).

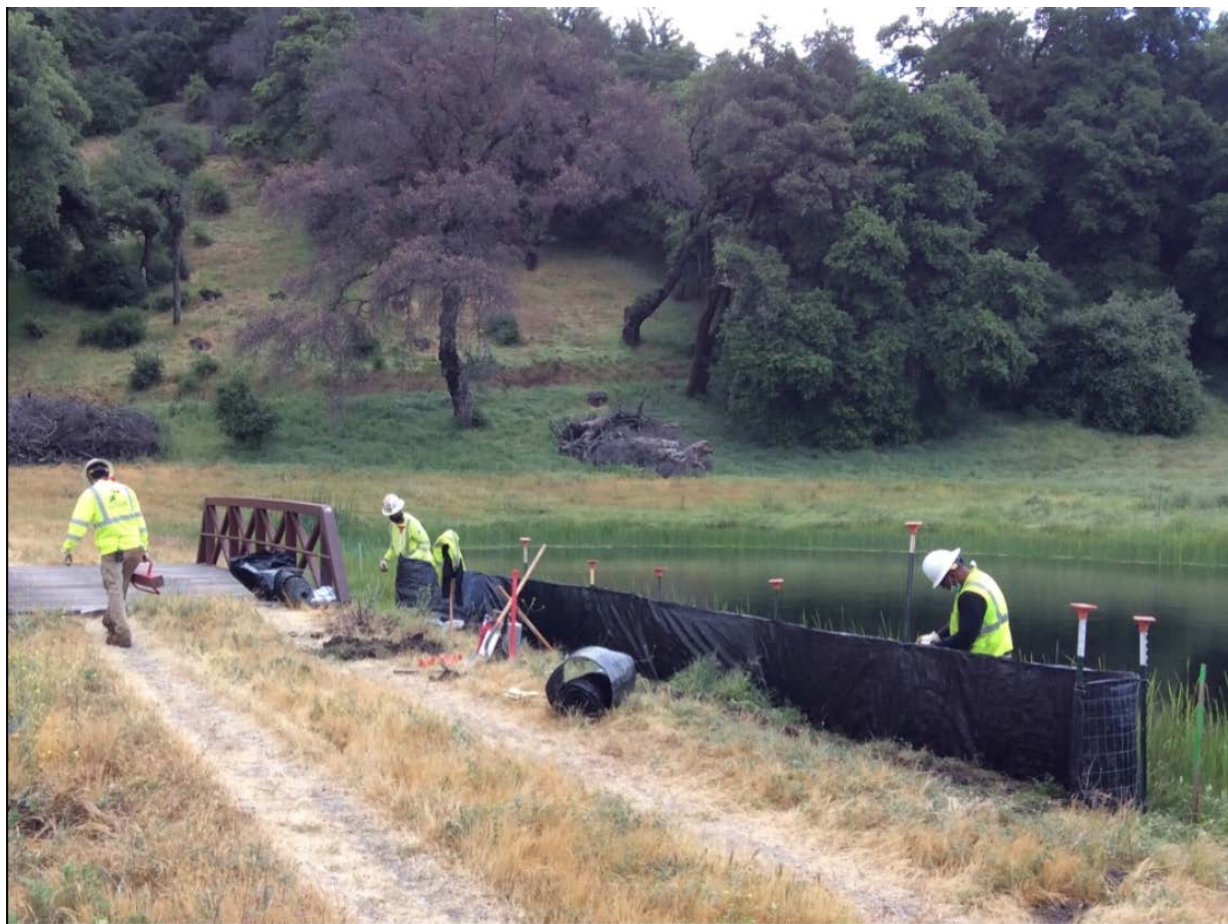
Photo 5: A crew was observed installing silt fence at P259353 (TL 626 Conversion North (C 222)) in accordance with the ECP and SWPPP (MM HYD-1 and MM BIO-7). A full set of fire tools was observed on site in accordance with the CFPPP (MM FF-1).

To prevent impacts to hydrology and water quality, site-specific sediment and erosion control BMPs were observed being implemented and maintained along project alignments in accordance with the project Erosion Control Plan (ECP), Stormwater Pollution Prevent Plan (SWPPP; MM HYD-01 and MM BIO-7), and APM HYD-09 (see Photos 4 and 5 – Attachment A). Other BMPs in the SWPPP, such as hydromulch application, concrete waste containment, and street sweeping, were also observed along the alignments. Hydrological resources were flagged for avoidance, and work activities occurred outside of hydrological resources in accordance with APM HYD-06.

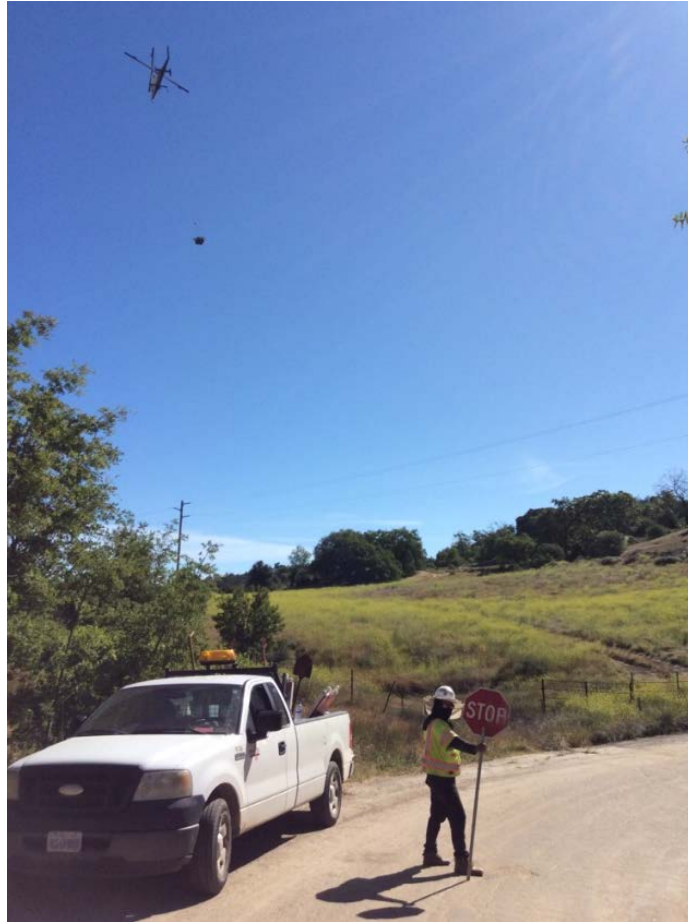
Photo 6: During helicopter external loads crossing Eagle Peak Road (TL 626 Conversion North (C 222)), traffic control measures were observed being implemented in accordance with the Traffic Control Plan (APM TRANS-05) and the ASP (MM PHS-5).

Traffic control measures were observed being implemented in accordance with APM TRANS-01 through APM TRANS-05 during this reporting period (see Photo 6 – Attachment A).
