California Public Utilities Commission <i>Mitigation Monitoring, Compliance, and Reporting</i> <i>Program</i>
	Cleveland National Forest Power Line Replacement Projects Compliance Status Report: 097 June 14, 2020

This compliance status report covers construction activities from June 1 through June 14, 2020.

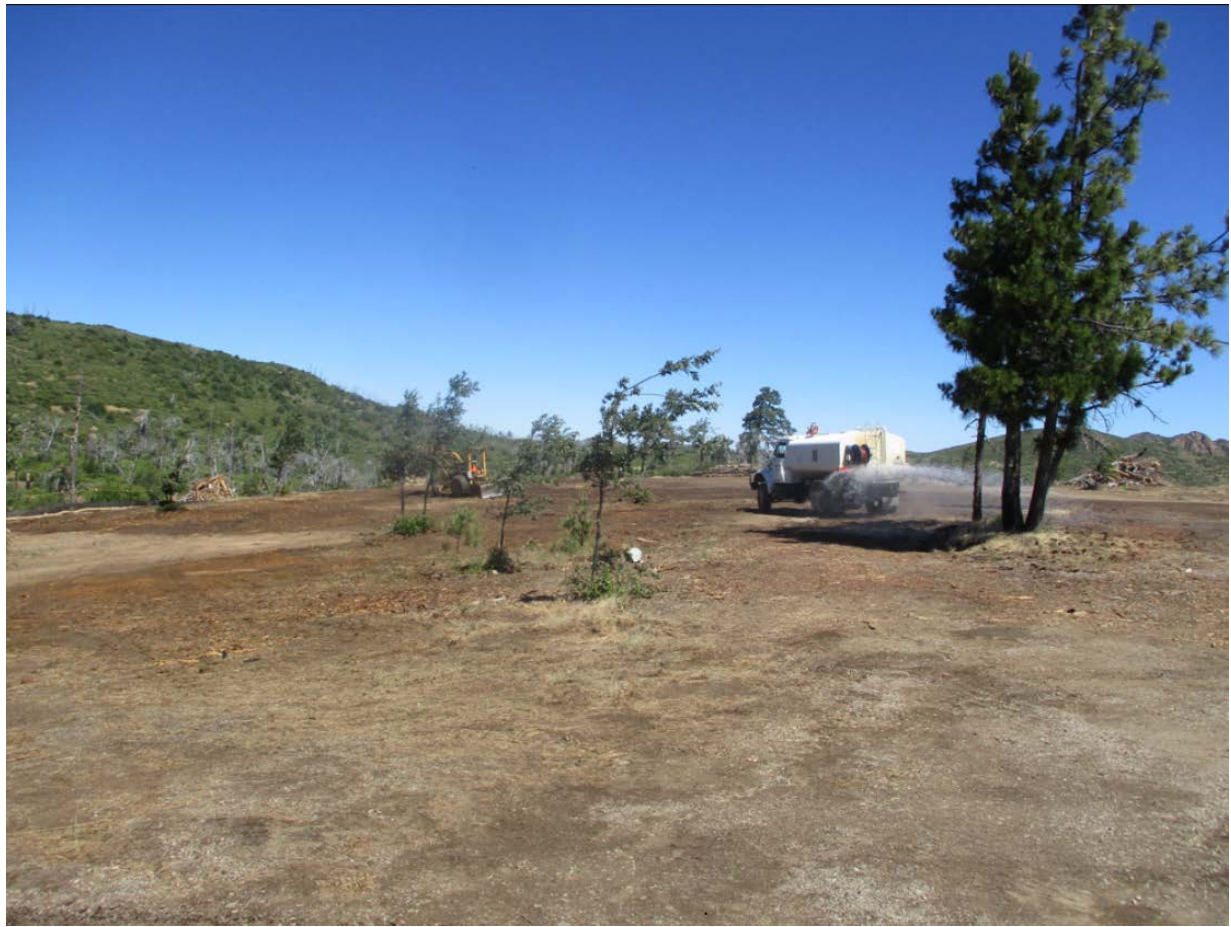
Photo 1: A crew was observed conducting grading work at Shrine Camp Staging Yard. Water was applied to prevent dust emissions in accordance with APM AIR-02 and APM AIR-05.

To prevent fugitive dust emissions during project activities, crews were observed applying water to prevent fugitive dust along unpaved access roads and in work areas in accordance with APM AIR-02 and during helicopter operations in accordance with the Aviation Safety Plan (MM PHS-5) (see Photo 1 – Attachment A). Haul trucks used for dirt export were observed utilizing load covers to prevent dust emissions in accordance with APM AIR-02, and construction personnel were observed maintaining posted speeds of 15 miles per hour on unpaved access roads in accordance with APM AIR-03 and MM BIO-24. Construction crews were observed applying water during drilling and using cuttings containment boxes to prevent dust emissions in accordance with APM AIR-05.

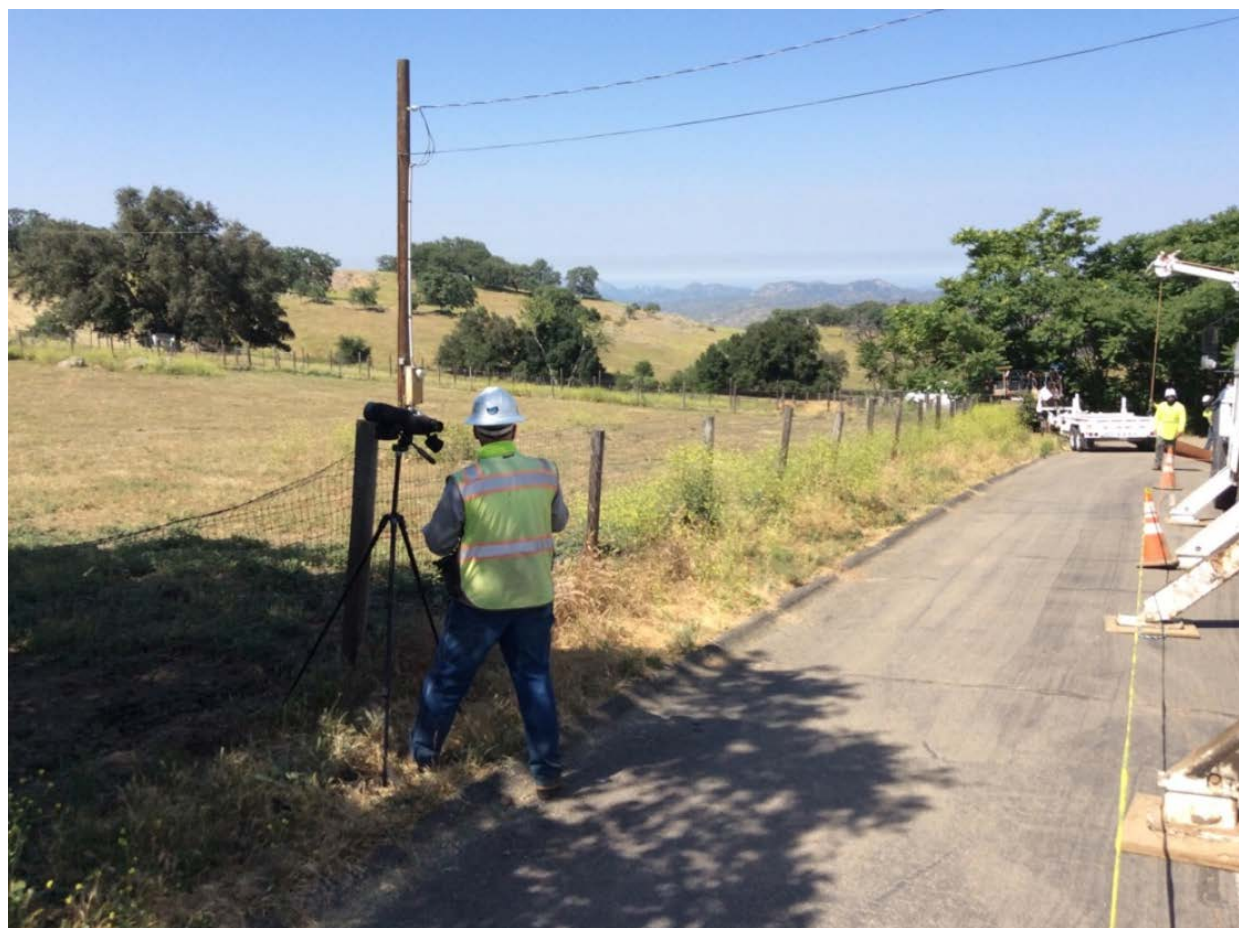
Photo 2: The SDG&E lead environmental inspector was observed monitoring a red-tailed hawk nest between P259288-P259289 to ensure no impacts during construction activities at P100897 and P259286 in accordance with the APP/NBMP (MM BIO-28).

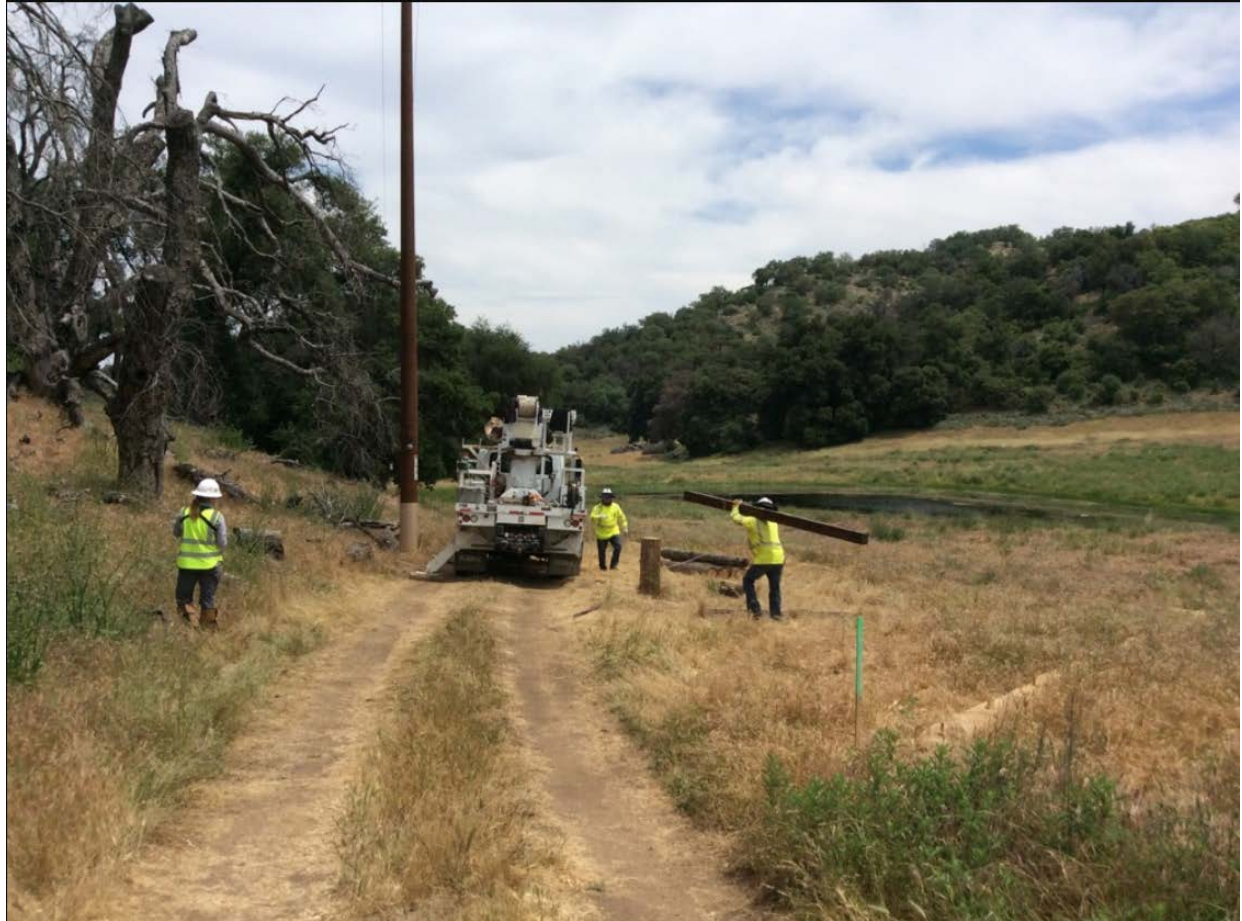
Photo 3: A qualified biological monitor was present to monitor the common bat species roosting near P259355 (TL 626 Conversion North (C 222)) as a general bat protection measure in accordance with MM BIO-30.

Approved workspaces were observed delineated with staking and flagging, and work crews were observed adhering to work space limits and staying on approved access roads in accordance with MM BIO-1. Workers were observed having completed the Worker Environmental Awareness Program (WEAP), as shown by project hard hat stickers in accordance with MM BIO-2. Biological monitors were observed conducting full-time monitoring of initial ground-disturbing activities such as vegetation removal in accordance with MM BIO-3, and monitoring all other construction activities to ensure compliance with mitigation measures, applicant proposed measures, and permit conditions in accordance with MM BIO-22. In accordance with MM BIO-14 and MM BIO-16, Environmentally Sensitive Area (ESA) signs and flagging were observed installed around areas with special-status species, and ESAs were observed being avoided by crews (see Photo 2 – Attachment A). Excavations were observed covered to prevent wildlife entrapment in accordance with MM BIO-23, and crews were observed containing trash at work areas in accordance with MM BIO-26. Avian biologists were observed conducting nesting bird surveys and were present to monitor bird nests during construction activities in accordance with the Avian Protection Plan/Nesting Bird Management Plan (APP/NBMP) and MM BIO-28, and qualified monitors were observed present to protect roosting bat species near pole sites in accordance with MM BIO-30 (see Photo 3 – Attachment A).

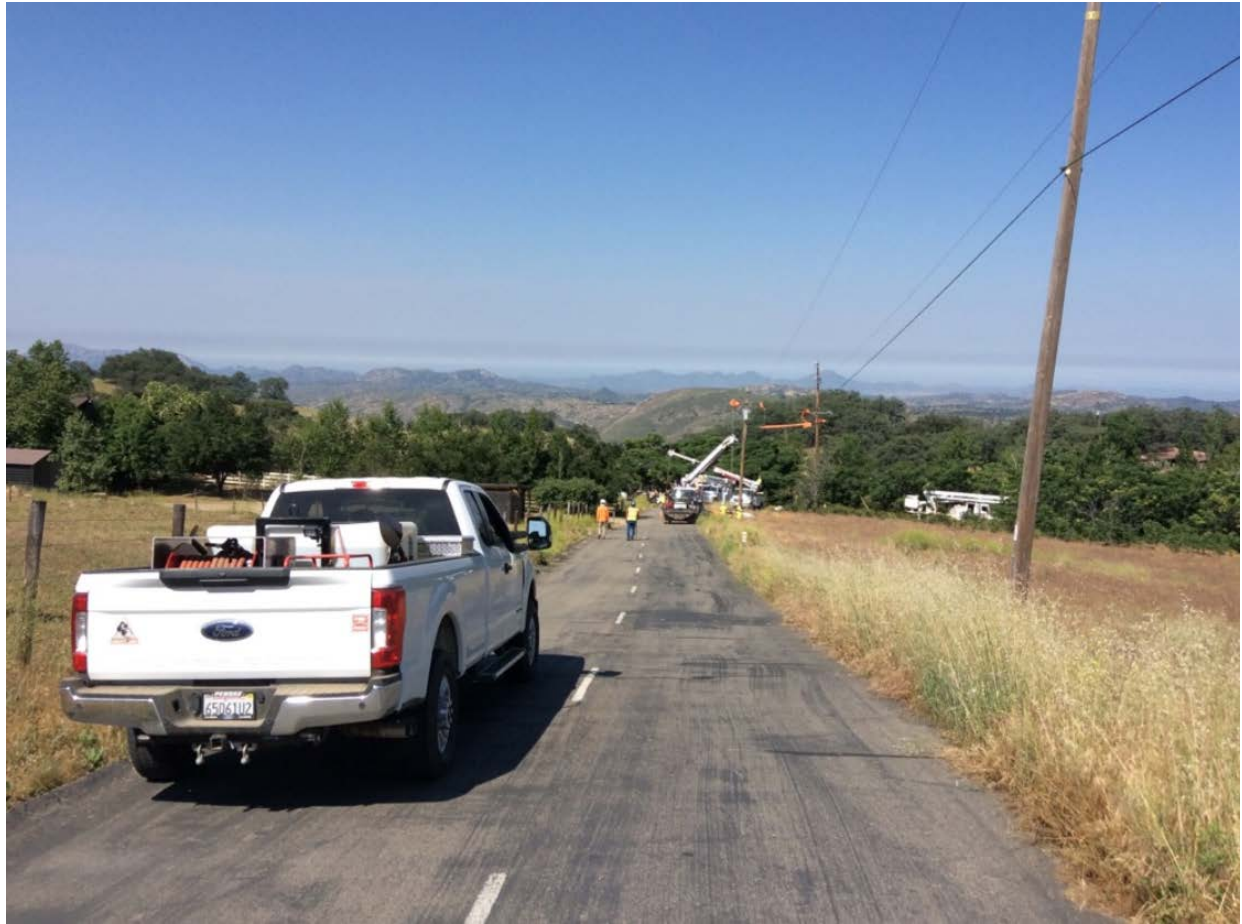
Photo 4: A Dedicated Fire Patrol was present during and 1 hour after pole framing and setting along TL 626 Conversion North (C 222) due to the poles being set between energized lines, in accordance with the CFPPP Fire Prevention Matrix for work with energized lines with a Normal FPI (MM FF-1). In addition, archaeological and cultural monitors were present in accordance with the HPMP (MM CUL-1) and APM CUL-04.

CPUC ECMs observed cultural resource monitors, including archaeological and Native American monitors, monitoring construction activities that occurred within or adjacent to identified archaeological or cultural resource site boundaries in accordance with the Historic Properties Management Plan (HPMP),

MM CUL-1, MM CUL-3, and APM CUL-04 (see Photos 4 and 5 – Attachment A). Cultural ESAs were marked to prevent construction access to areas with cultural and/or historical resources in accordance with the HPMP, and work crews were observed respecting cultural ESA boundaries.

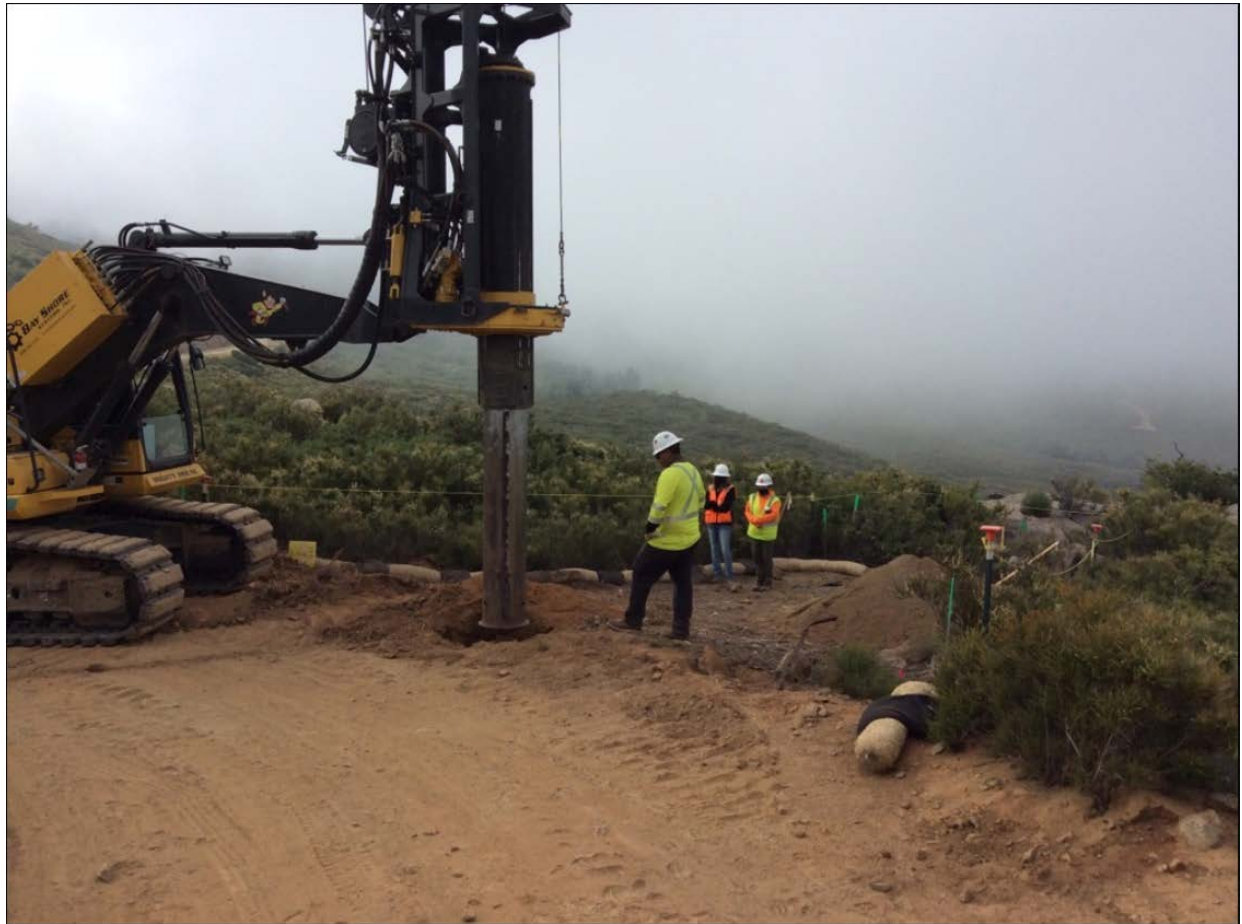
Photo 5: A crew was observed drilling a direct-bury pole hole along TL 626 Conversion South (C 79B). Archaeological and cultural monitors were observed monitoring the activity, and the surrounding ESA was clearly delineated and avoided by the crew in accordance with the HPMP (MM CUL-1), APM CUL-03, and APM CUL-04.

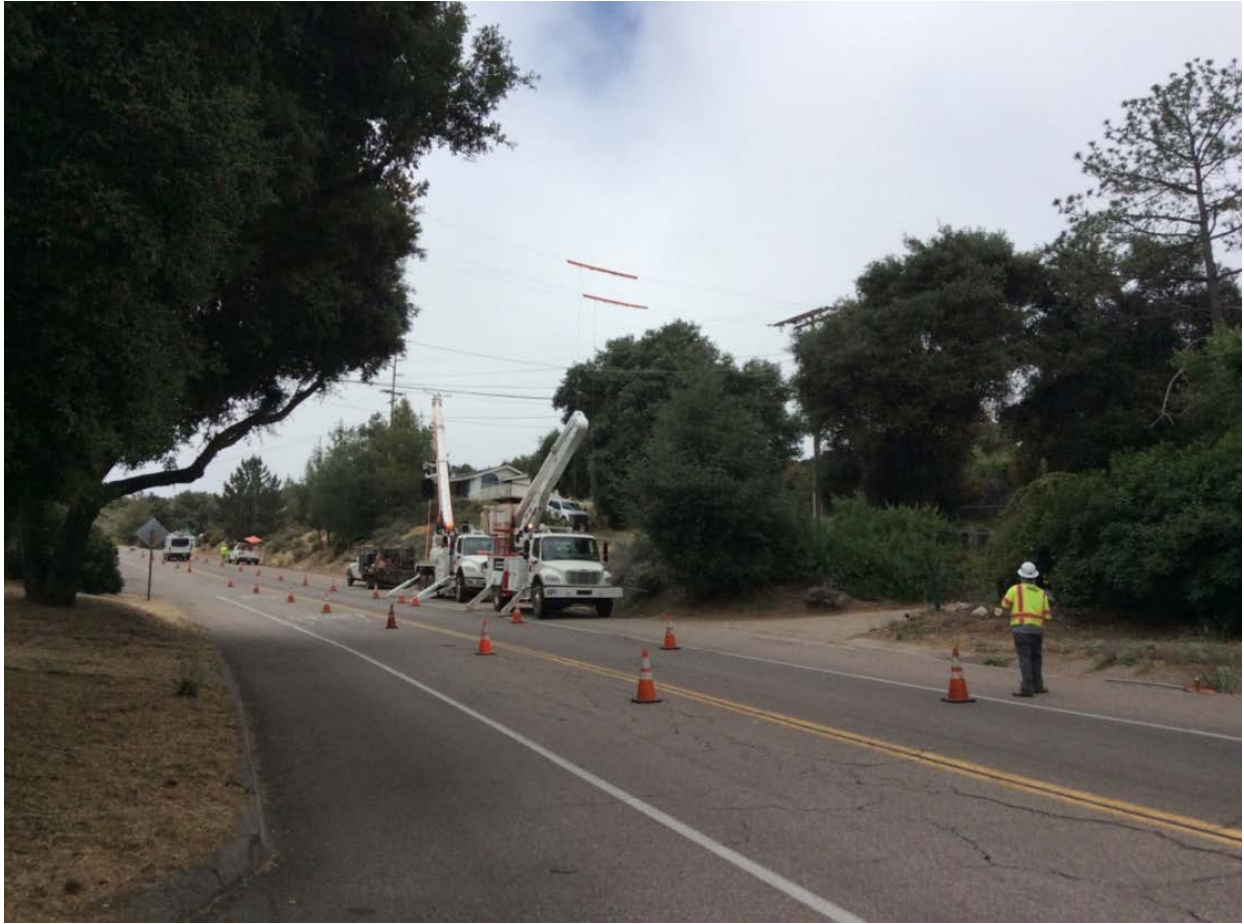
Photo 6: Cones, signage, and flagpersons were used to direct traffic through narrow lanes around the work area for P258402 and P776554 (TL 629A) in accordance with the Traffic Control Plan (APM TRANS-05) and APM TRANS-02.

Traffic control measures were observed being implemented in accordance with APM TRANS-01 through APM TRANS-05 during this reporting period (see Photo 6 – Attachment A).
