<p>California Public Utilities Commission <i>Mitigation Monitoring, Compliance, and Reporting Program</i></p>
	<p>East County (ECO) Substation Project</p> <p>Compliance Status Report: 017</p> <p>November 24, 2013</p>

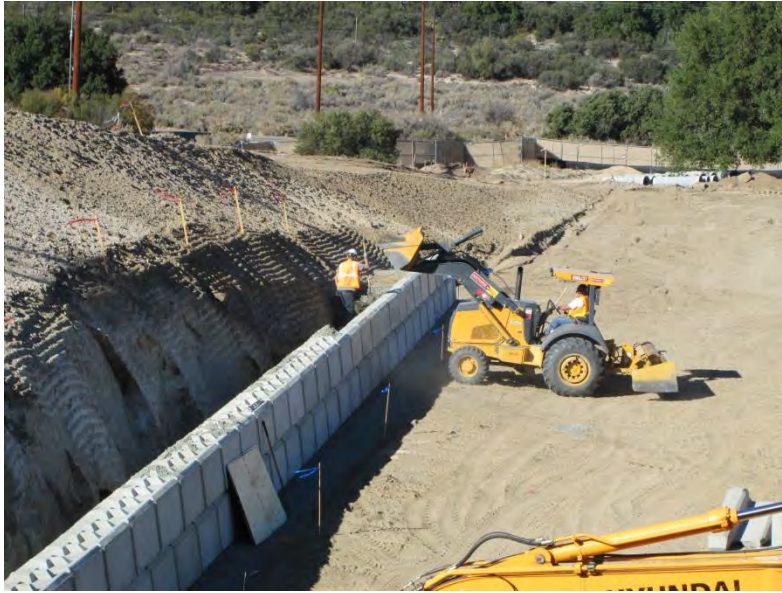
Photo 1: Construction activities associated with building a retaining wall along the western limits of the Boulevard Substation were initiated during this reporting period.

Construction activities at the Boulevard Substation Rebuild Site consisted of finish grading and compaction of the substation pad. In addition, construction crews were observed installing a concrete retaining wall at the western end of the site (see photo 1 – Attachment A).

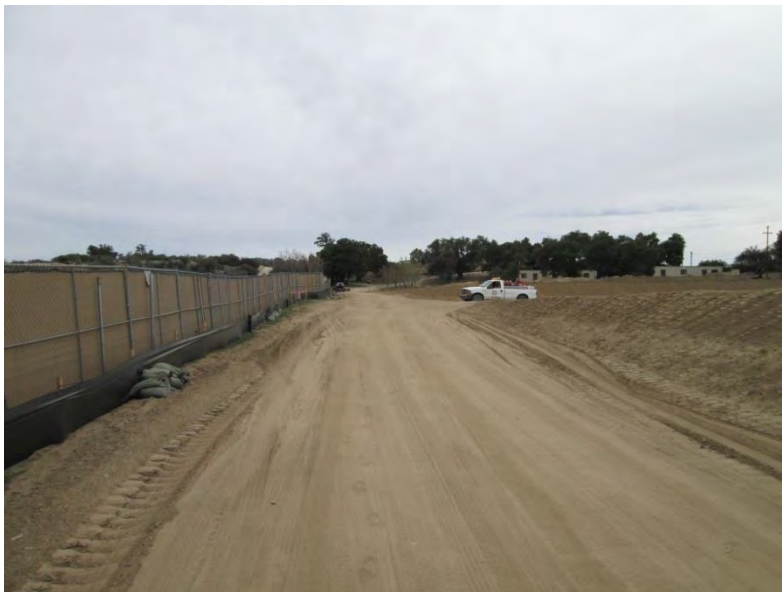
Photo 2: In accordance with the Construction Fire Prevention Plan (Mitigation Measure FF-1), a fire watch is present at the Boulevard Substation during construction.

Fire patrols were on-site during construction activities to ensure construction equipment and vehicles had the required fire safety equipment and provided ongoing fire patrols in accordance with Mitigation Measure FF-1 (see photo 2 – Attachment A).

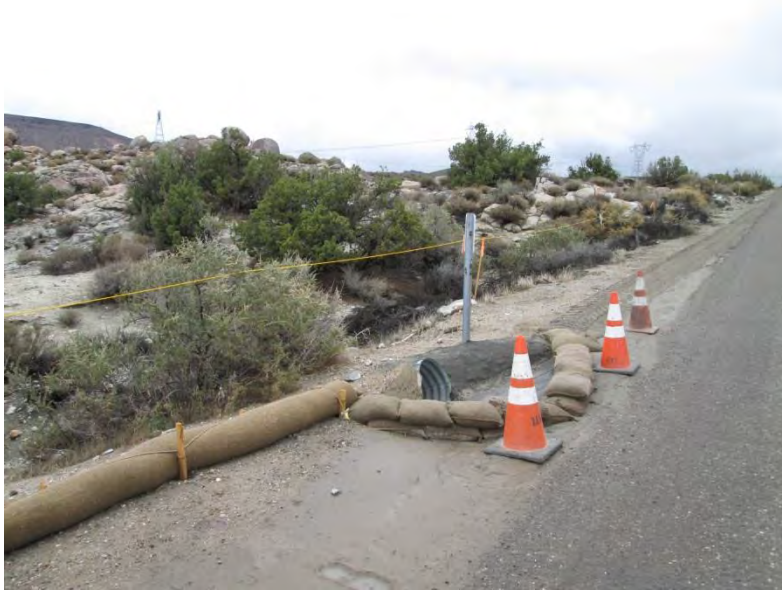
Photo 3: BMP's were observed in place prior to construction activities associated with the 138 kV underground being initiated along Old Highway 80. Gravel bags and straw wattles can be seen in this photo to minimize the potential for pollutants and sediment to enter into a storm drain located along Old Highway 80.

Erosion control features consisting of silt fencing, straw wattles, and gravel bags have been placed along the 138 kV underground component along Old Highway 80 to minimize the potential for pollutants and sediment to enter into storm drains (see photo 3 – Attachment A). The erosion control features have been installed and observed to be maintained in accordance with the Storm Water Pollution Prevention Plan (SWPPP) and Mitigation Measure HYD-1.

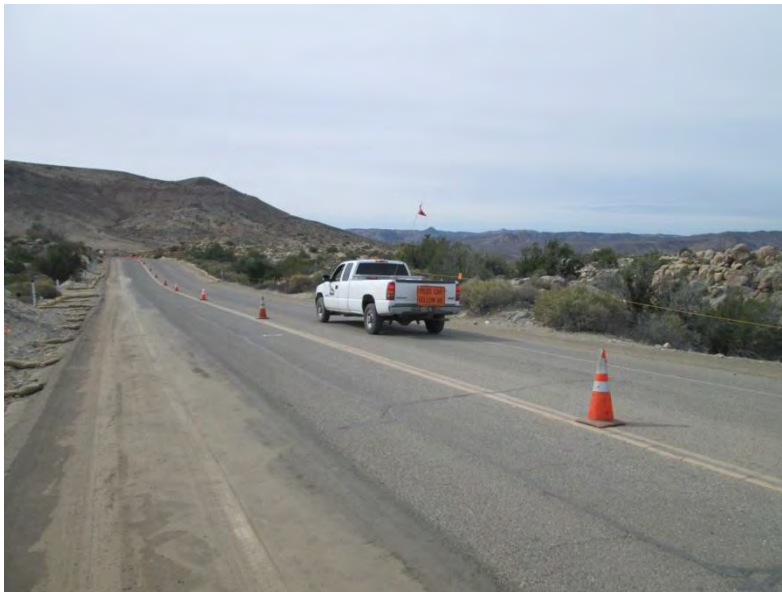
Photo 4: Construction activities required traffic to be reduced to one lane resulting in the need for an escort car to be utilized for both eastbound and westbound traffic along Old Highway 80. Traffic control measures were observed being implemented as required in the Traffic Control Plan and MM-TRA-1.

Construction activities along Old Highway 80 required traffic to be reduced to one lane. In accordance with Mitigation Measure TRA-1, traffic control measures consisting of flaggers, signage, and an escort vehicle were observed escorting motorists travelling along Old Highway 80 (see photo 4 – Attachment A).

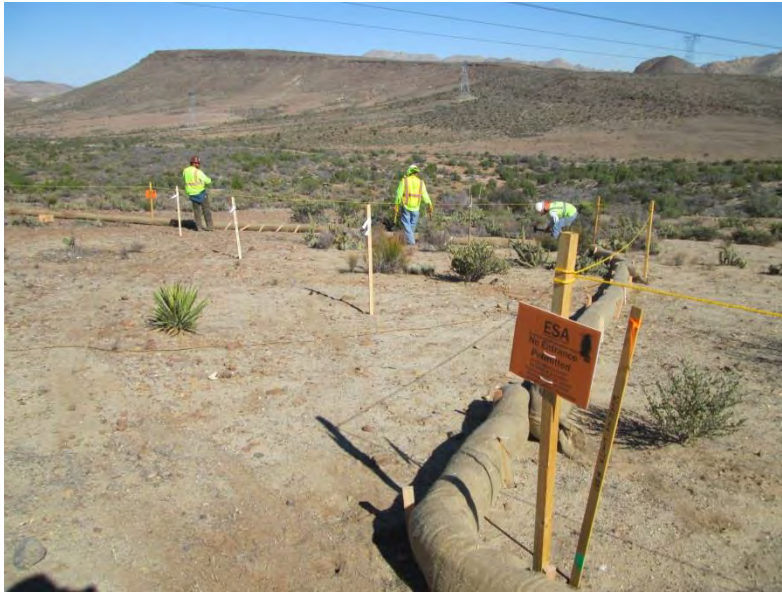
Photo 5: Construction crews were observed placing BMP's at overhead transmission line pad sites in accordance with MM-HYD-1 and the SWPPP. Signage was also observed being placed adjacent to Environmentally Sensitive Areas along the right-of-way as required in MM-CUL-1a.

During this reporting period construction crews continued to stake the work limits and install environmentally sensitive area (ESA) markings and fencing in accordance with Mitigation Measures CUL-1a and CUL-1d (see photo 5 – Attachment A). In addition, construction crews began to remove vegetation and conduct drilling activities at transmission pole locations.

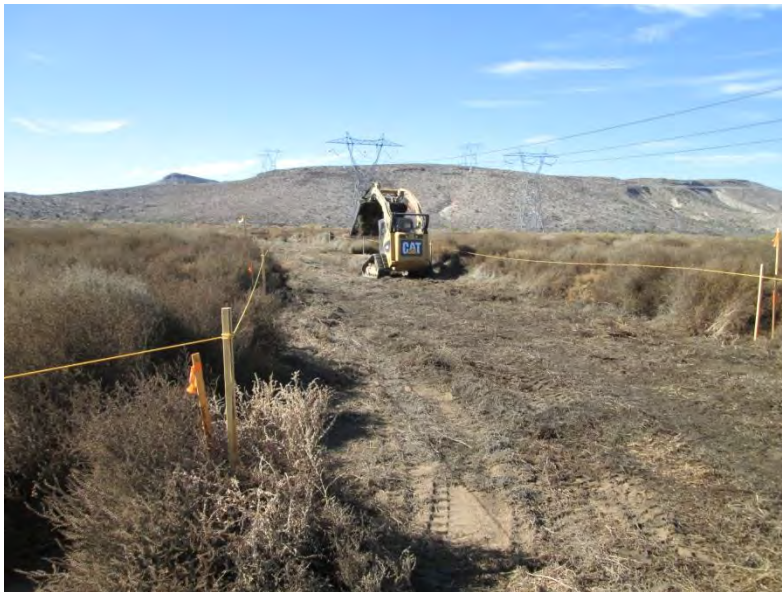
Photo 6: In accordance with MM-BIO-1a work activities associated with establishing access roads and pad sites for the 138 kV overhead construction component were observed being completed within the approved work limits. Staking and yellow rope is utilized to delineate the approved work limits.

In accordance with Mitigation Measure BIO-1a, an environmental monitor was on-site to ensure all work was completed within the approved work limits. Staking and yellow rope to delineate the approved work limits was observed to be properly maintained during this reporting period (see photo 6 – Attachment A).

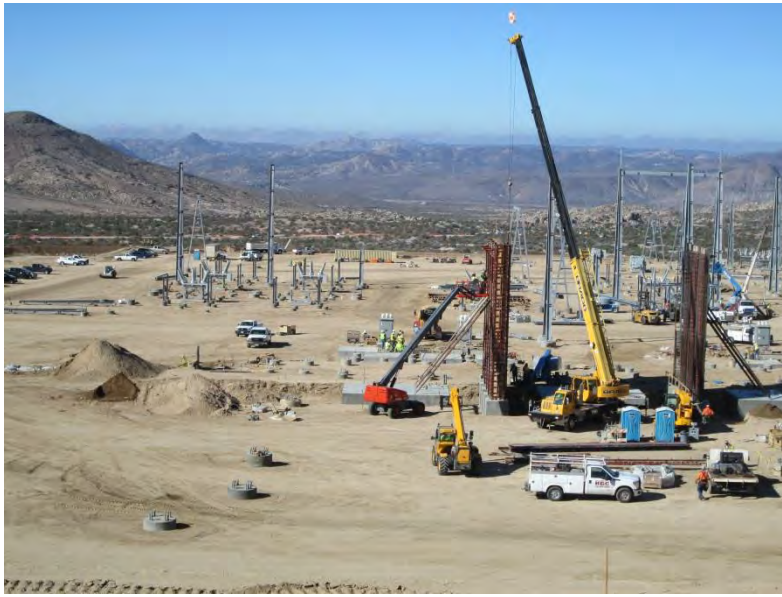
Photo 7: An overview of the ECO substation construction looking west towards the 138/230 kV pad. A crew can be seen in the forefront of the photo utilizing a crane to construct fire walls that will be located on either side of a transformer.

Construction crews at 230/138 kV substation pad site were observed drilling foundations, constructing fire walls on each side of a transformer pad (see photo 7 – Attachment A), and began building the form for the concrete steps between the 500 kV and 230/138 kV substation pad sites.

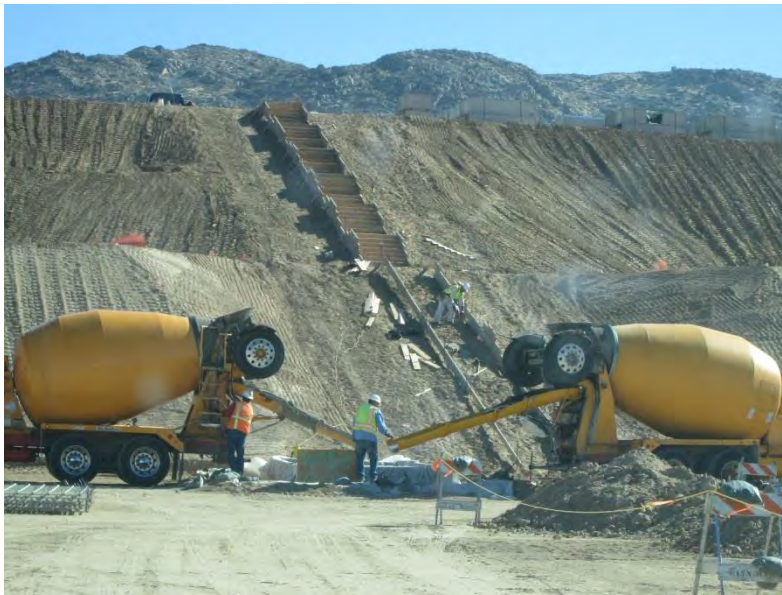
Photo 8: A concrete washout is utilized by cement truck operators to wash equipment prior to leaving the right-of-way in accordance with the SWPPP and MM-HYD-1.

Concrete washout stations were observed to be used during foundation pours at the 138/230 kV substation pad site in accordance with the SWPPP and Mitigation Measure HYD-1 (see photo 8 – Attachment A). In addition, secondary containment was observed to be properly installed under staged equipment, hazardous materials, and portable sanitary facilities.
