<p>California Public Utilities Commission <i>Mitigation Monitoring, Compliance, and Reporting Program</i></p>
	<p>Mira Sorrento Distribution Substation Project</p> <p>Compliance Status Report: 016</p> <p>October 27, 2013</p>

SUMMARY

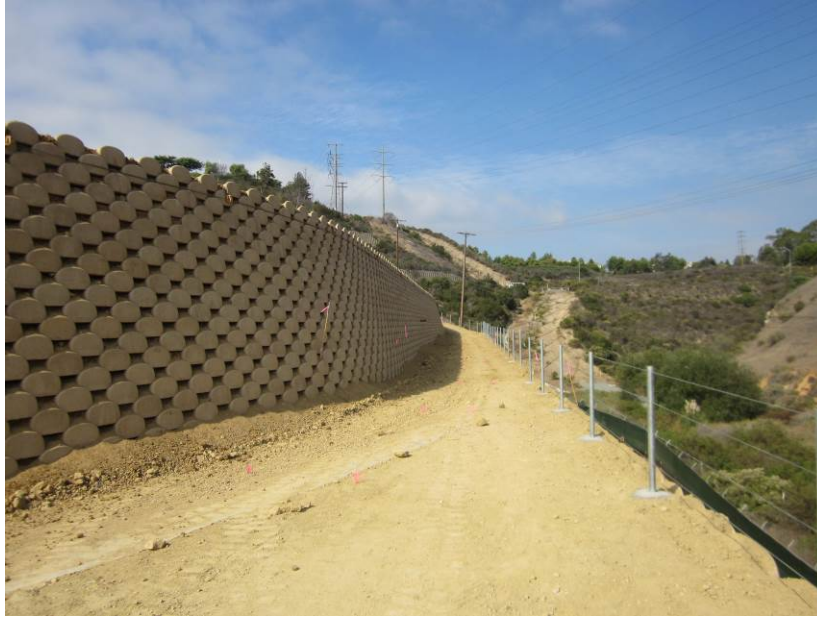
Construction activities observed during this reporting period consisted of crews erecting the upper and lower retaining walls along the eastern, southern and western limits of the substation pad. The lower retaining wall has been completed and a safety barrier consisting of posts with wire between the posts has been installed along the perimeter of the retaining wall. An access road has also been established between the upper and lower retaining walls that will provide access to the retention basin located in the southwest portion of the project site (see Photo 1 – Attachment A).

Photo 1: An access road has been constructed between the lower and upper retaining walls in order to provide access to a retention basin located in the southwest portion of the project site. A safety fence has also been constructed along the perimeter of the lower retaining wall.

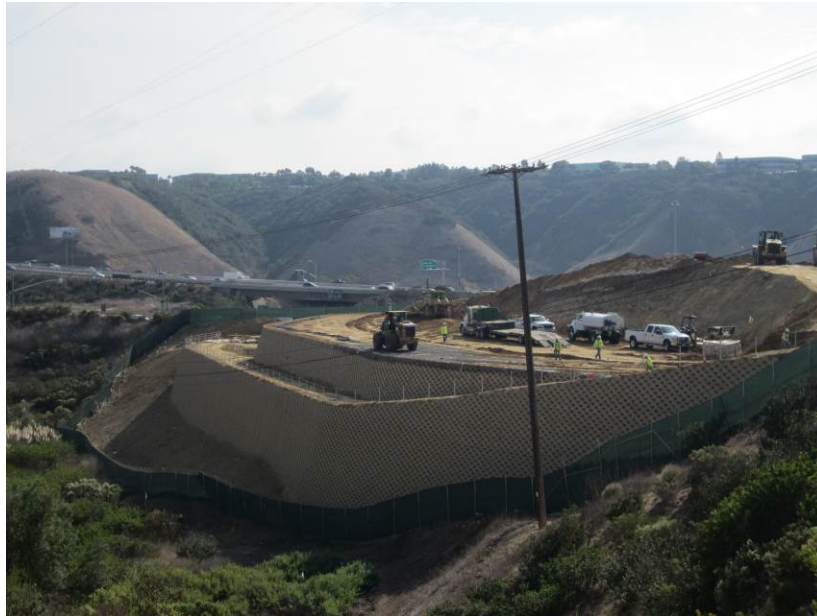
A construction crew was observed erecting the upper retaining wall that extends along the eastern, southern and western portion of the project site (see Photo 2 – Attachment A). Haul trucks were utilized to import fill material that was being mixed with onsite soils for backfill along the retaining wall. Following completion of the retaining walls and establishing final grade of the substation pad site, a screening wall will be constructed along the perimeter of the substation.

Photo 2: Construction activities associated with erecting the upper retaining wall to obtain final grade of the substation pad site continued during this reporting period.

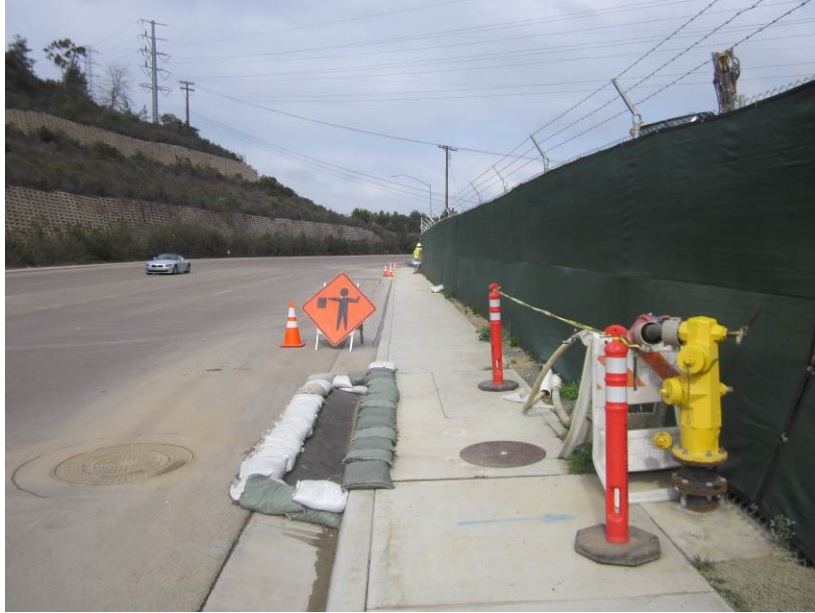
Traffic control measures consisting of signage placed along nearby roadways notifying motorists of construction activities was observed in place in accordance with MM-TT-1 (see Photo 3 – Attachment A). A flagger was also observed being utilized to direct dirt haulers and temporarily stop passing motorists to ensure dirt haulers could safely access and exit the project site.

Photo 3: Traffic signage has been placed along Mira Sorrento Place notifying motorists of construction activities in accordance with MM-TT-1.

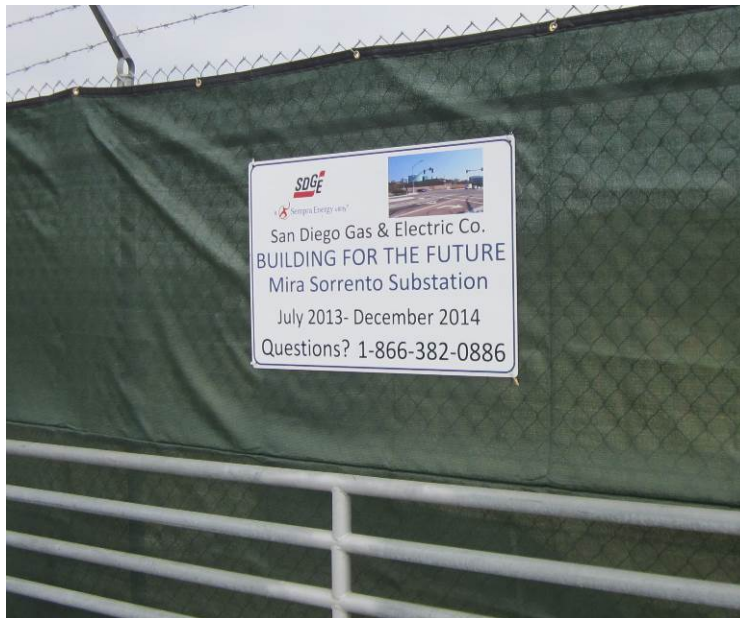
Signage has been placed along the project perimeter fence, notifying members of the public of construction activities (see Photo 4 – Attachment A). The signage includes a phone number to contact SDG&E in accordance with MM-NOI-2.

Photo 4: Signage has been placed at the intersection of Mira Sorrento Place and Vista Sorrento Parkway notifying the public of the construction activities. A toll-free number has been established by SDG&E for responding to any questions or complaints in accordance with MM-NOI-2.
