| | California Public Utilities Commission <i>Mitigation Monitoring, Compliance, and Reporting Program</i> |
| | East County (ECO) Substation Project Compliance Status Report: 012 September 15, 2013 |

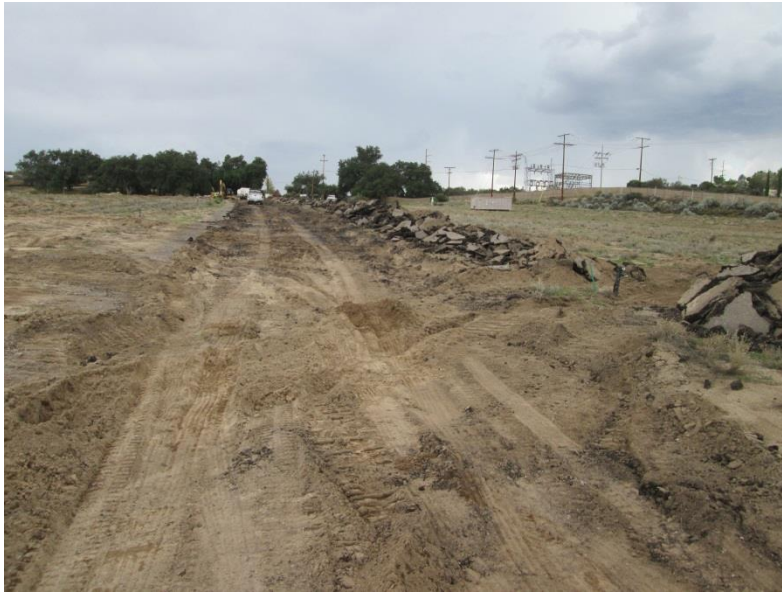
Photo 1: Construction crews removed the existing asphalt access road to the Boulevard Substation Rebuild site. All work at Boulevard Substation Rebuild site was completed within the approved work limits.

Notice to Proceed (NTP) No. 001. Construction crews were also observed removing an existing asphalt roadway, vegetation and trees in accordance with the Tree Replacement Plan (MM-VIS-3M) (see photo 1 – Attachment A).

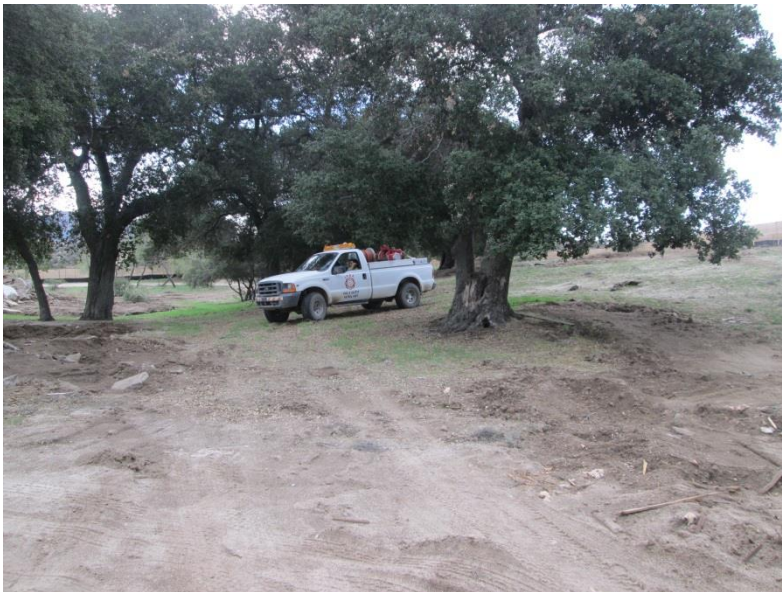
Photo 2: In accordance with Mitigation Measure FF-1, fire patrols are onsite during construction and for 1 hour following construction activities.

Fire patrols were observed onsite during construction activities at the Boulevard Rebuild Site to ensure construction equipment and vehicles had the required fire safety equipment and provided ongoing fire patrols in accordance with MM-FF-1 (see photo 2 – Attachment A).

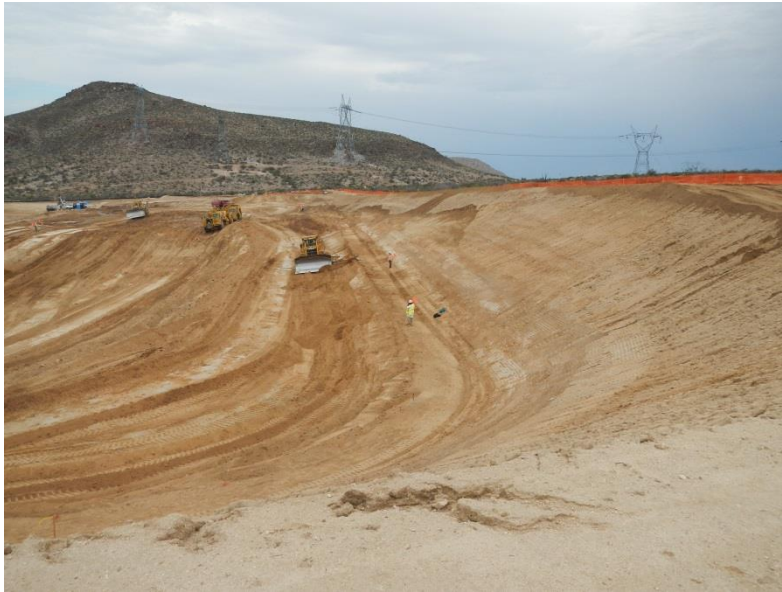
Photo 3: Construction activities associated with rough grading of the 500 kV substation pad at the ECO substation site continued during the week of September 2.

Construction activities at the ECO Substation site during the week of September 2nd consisted of rough grading at the 500 kV substation pad and minor grading and fill around the perimeter of the temporary office trailers (see photo 3 – Attachment A). In addition, construction crews began excavations for foundations, creating foundation forms, drilling, and pouring concrete for the 138/230 kV substation pad. In an effort to prevent spills and concrete debris, a concrete washout station has been established at the 138/230 kV substation pad in accordance with the SWPPP and MM-HYD-1 (see photo 4 – Attachment A).

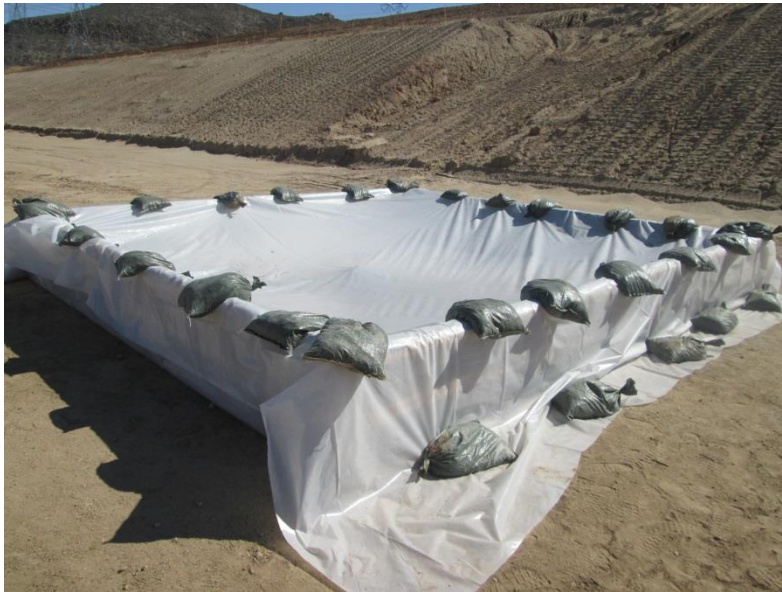
Photo 4: A concrete washout basin is established in preparation of pouring concrete foundations at the 138/230 kV pad site in accordance with the SWPPP and MM-HYD-1.

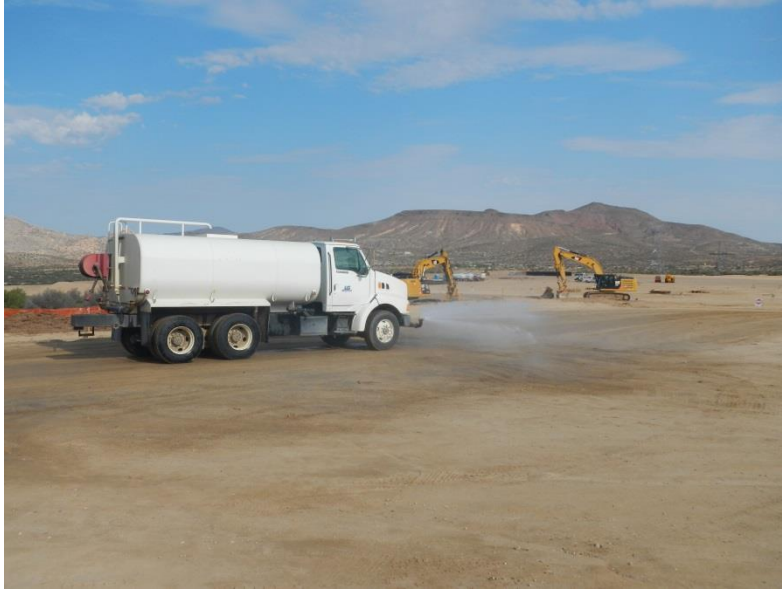
Photo 5: Water trucks are utilized on a regular basis to minimize fugitive dust emissions in accordance with MM-BIO-4A and the Dust Control Plan.

Water trucks were observed alongside graders and scrapers to prevent fugitive dust in accordance with Mitigation Measure BIO-4A and the Dust Control Plan (see photo 5 –Attachment A). Trac-out measures consisting of a rattle plate and rock apron are being maintained at the point of ingress/egress to the ECO Substation along Old Highway 80. In addition, a street sweeper was observed being utilized along Old Highway 80 to remove trac-out.

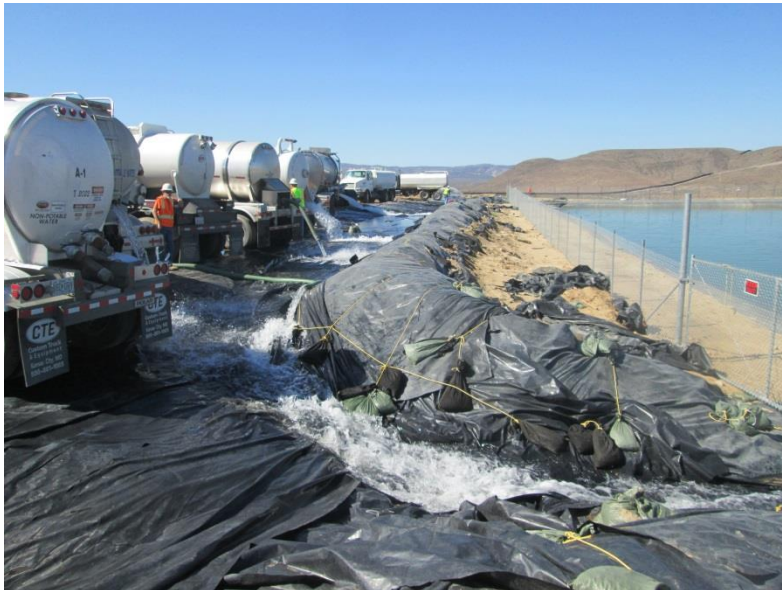
Photo 6: Water trucks deliver water from offsite resources including the City of San Diego, Campo Indian Reservation and Jacumba Community Services District in accordance with MM-HYD-3 and the Amended Construction Water Supply Plan.

Water utilized for construction activities is being trucked onsite from the City of San Diego, Jacumba Community Services District and from the Campo Indian Reservation in accordance with MM-HYD-3 and the associated Amended Construction Water Supply Plan (July 2013). Water trucked onsite is stored in a temporary retention basin where it is then transferred into water trucks being utilized for onsite distribution for both dust control and soil compaction purposes (see photo 6 – Attachment A).
