## CHAPTER 4 – ENVIRONMENTAL IMPACT ASSESSMENT

### 4.4 BIOLOGICAL RESOURCES

South Bay Substation Relocation Project

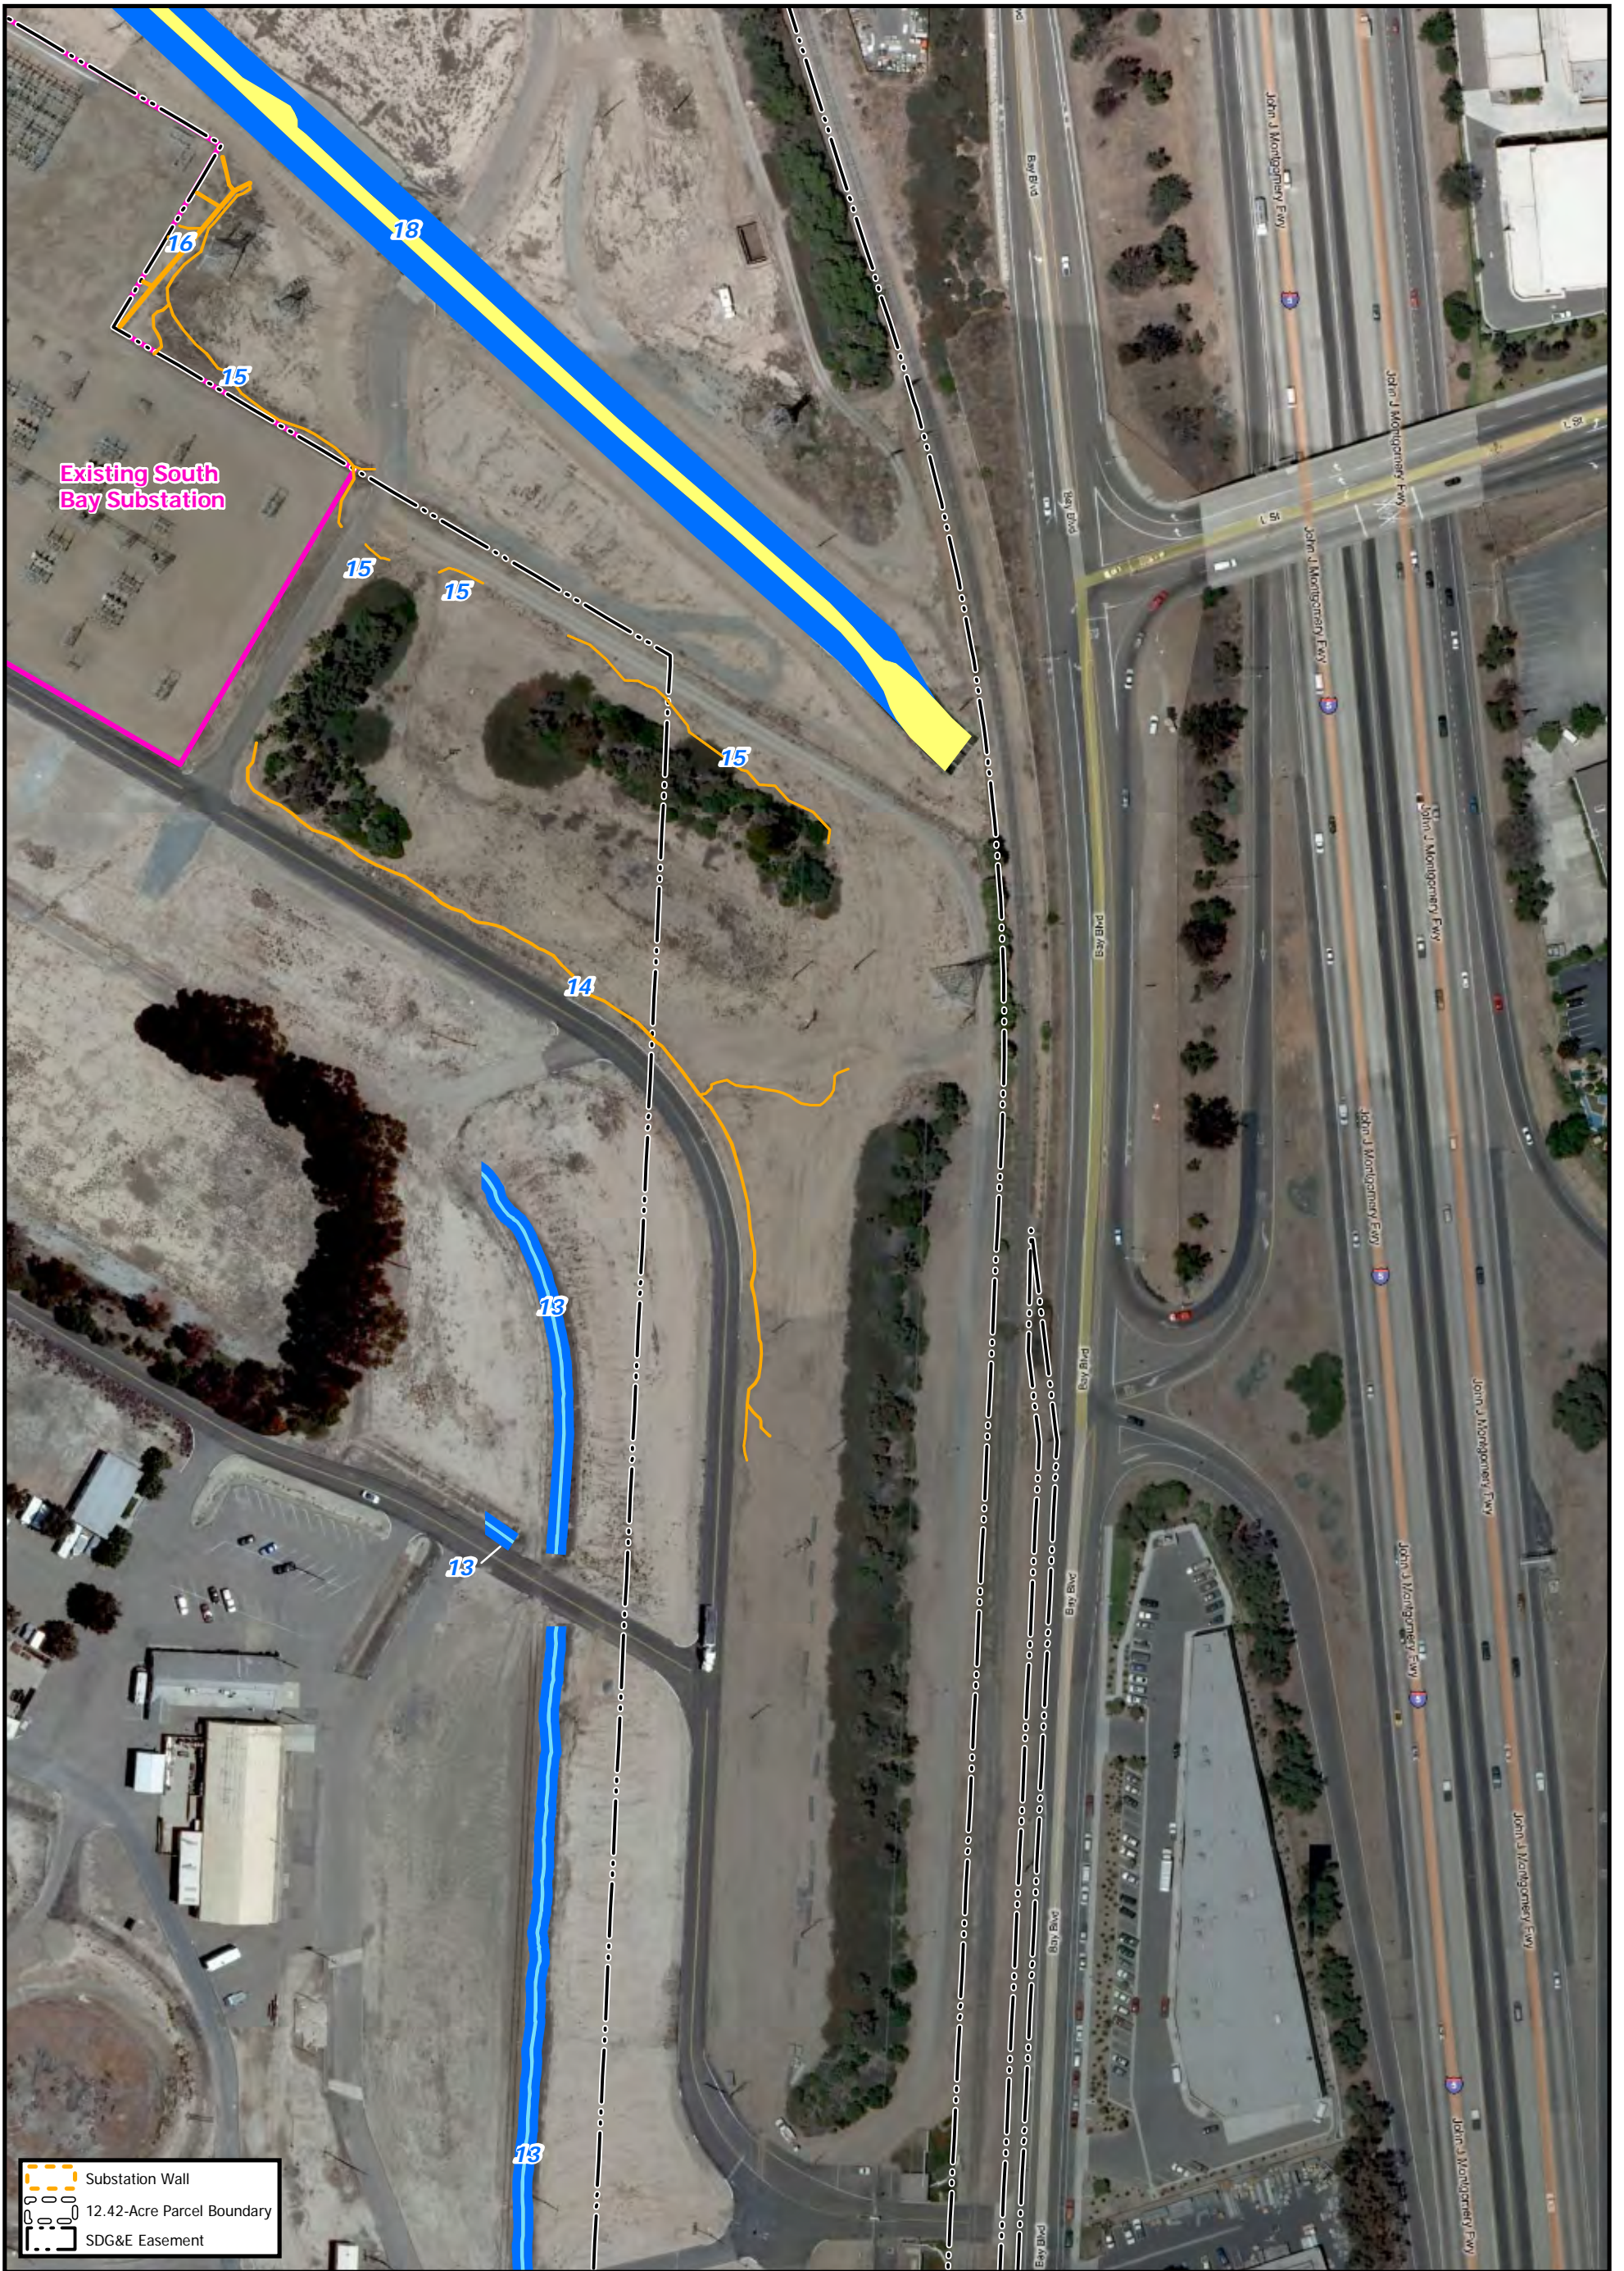
**Figure 4.4-3: Hydrological Features Map 2 of 3 South Bay Substation Relocation Project**

<b>Potential Jurisdictional Resources</b>		
City of Chula Vista	RWQCB and City of Chula Vista	USACE, RWQCB, and CDFG
CDFG	RWQCB	USACE, RWQCB, CDFG and City of Chula Vista
CDFG and City of Chula Vista	RWQCB and CDFG	Exempt from All Wetland Regulation

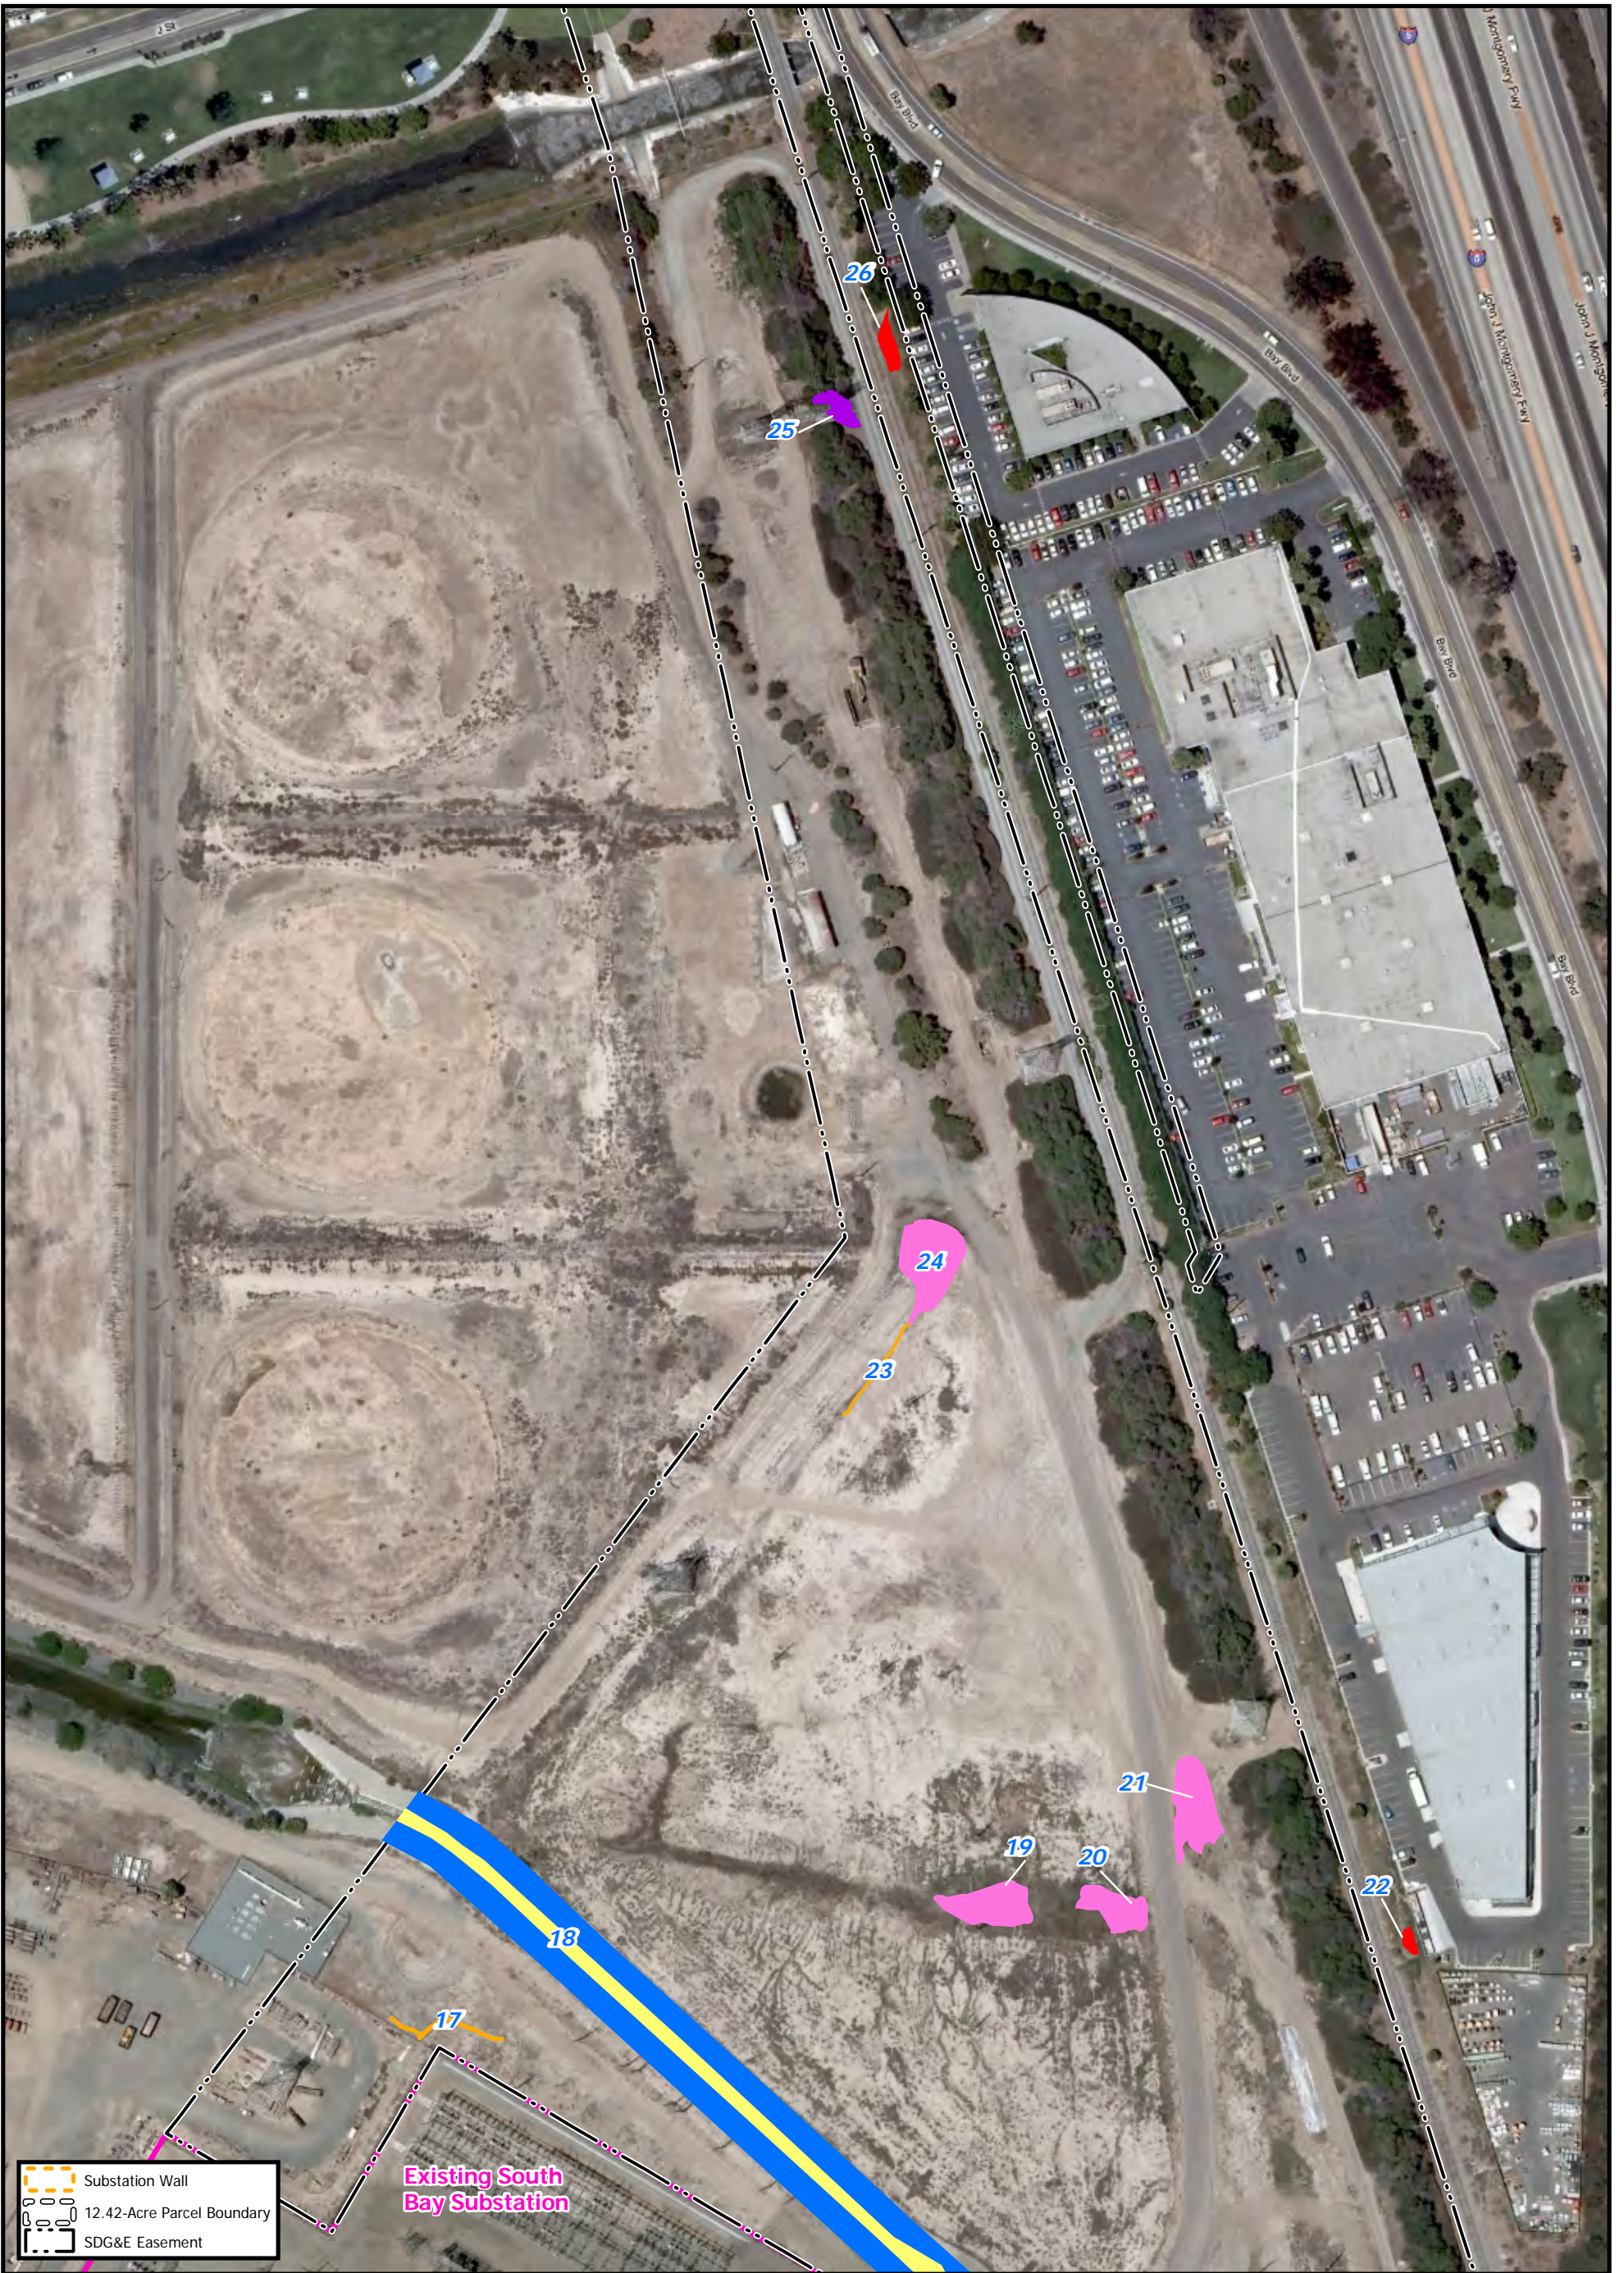
**Figure 4.4-3: Hydrological Features Map 3 of 3 South Bay Substation Relocation Project**

<b>Potential Jurisdictional Resources</b>		
City of Chula Vista	RWQCB and City of Chula Vista	USACE, RWQCB, and CDFG
CDFG	RWQCB	USACE, RWQCB, CDFG and City of Chula Vista
CDFG and City of Chula Vista	RWQCB and CDFG	Exempt from All Wetland Regulation

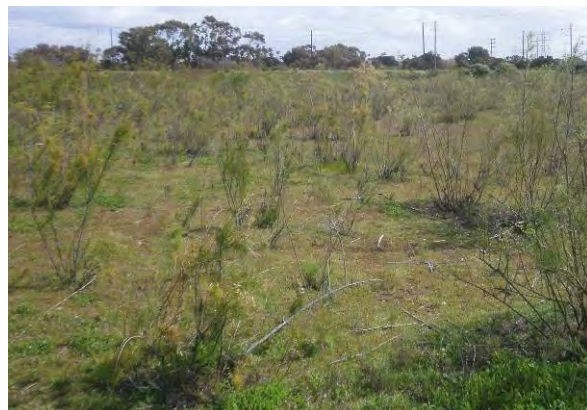
*Disturbed Wetland Scrub dominated by Tamarisk and other weedy wetland species.*

Disturbed Scrub vegetation occurs within the southern half of the study area's industrial stormwater and spill containment basin. Seasonal storm events result in drainage within the stormwater and spill containment basin to a low point where ponding of water occurs on the clay-lined floor of the basin. By design, the basin has no outlet and water must be removed by pumping from this low point. Seasonal pooling promotes the growth of shallow rooted and adventitious water-rooted hydrophytic vegetation. Shrubs including tamarisk (*Tamarix parviflora*), mule fat (*Baccharis salicifolia*), and coyote brush (*Baccharis pilularis*) are scattered throughout the basin. Tamarisk is FAC species and mule fat is a FACW species. The herbaceous understory includes a variety of hydrophytic plants including FAC species such as sourclover (*Melilotus indicas*), and FACW species such as brass-buttons (*Cotula coronopifolia*), and pineapple weed (*Amblyopappus pusillus*). Mapping the extent of

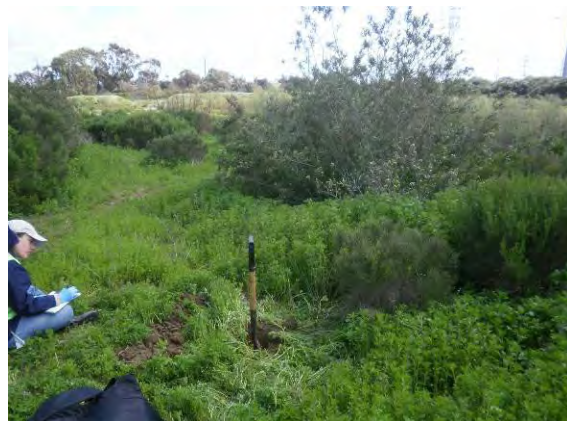
*Scattered mule fat define this sparse habitat that is likely kept in an immature state by intermittent flooding and poor soil development due to the clay liner of the basin floor.*

Patches of mule fat (FACW) occur within the stormwater and spill containment basin along the toe of the southern and western berms. The understory includes FAC forbs such as sourclover and Douglas' nightshade (*Solanum douglasii*). The matrix of the sandy clay soils showed evidence of depletion and small, scattered redox concentrations. Soil was saturated within the upper 12 inches of the matrix, which indicated wetland hydrology.

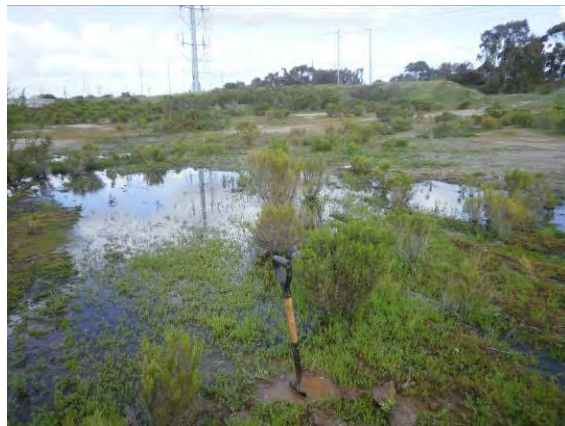
Seasonal ponds fully charged during the early spring months when grass-poly dominates the flora (March 9, 2010).

Surface run-off and direct precipitation are trapped in these clay-lined shallow depressions. No groundwater recharge occurs as the clay soils are too tight to allow for either percolation or infiltration. Water evaporates slowly and provides a mostly brackish environment that

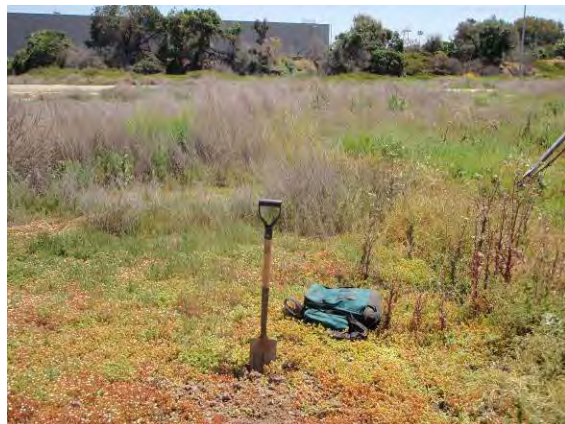
Seasonal pond dried out during the late spring months (May 5, 2010).

accommodates a dominant growth of the non-native forb, grass poly. Since these features are constricted, they trap and retain inorganic sediments and/or chemical substances transported by sheet flow over the site. However, the capacity of these areas for sediment/toxicant retention and nutrient transformation is limited given their relatively small size and shallow depth. Wildlife use is expected to be limited to those species that use disturbed grassland fields that surround these depressions.

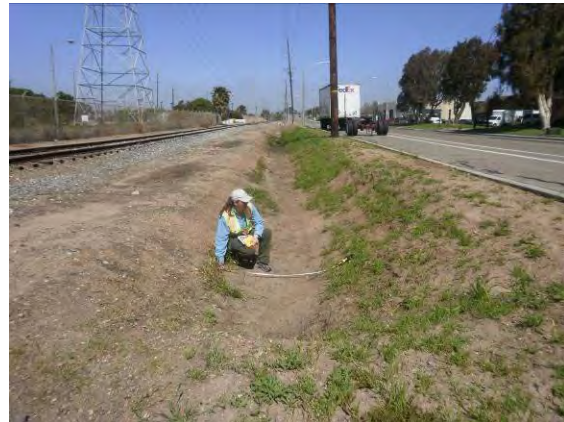
*Emergent wetland in early spring (March 11, 2010)*

A man-made drainage ditch that parallels Bay Boulevard along the eastern property boundary is dominated by non-native hydrophytic forbs. Included here are FAC species such as dallis grass (*Paspalum dilatatum*) and Bermuda grass (*Cynodon dactylon*), as well as FACW species such as curly dock (*Rumex crispus*). Some patches of the native Dombey's spike-rush (*Eleocharis montevidensis*), a FACW species are also found in this drainage. Near the southern end of the drainage ditch, a small stand of soft-flag cattail (*Typha latifolia*) occurs in a low point of the drainage. Totalling approximately 200 square feet, this stand of vegetation is too small to warrant treatment as a separate community features.

Soils consisted of sandy loam in the upper 8 inches of the soil and clay from 8 to 12 inches. The depleted matrix exhibited a low chroma and scattered redox concentrations below a depth of 2 inches. The presence of surface water indicated wetland hydrology.

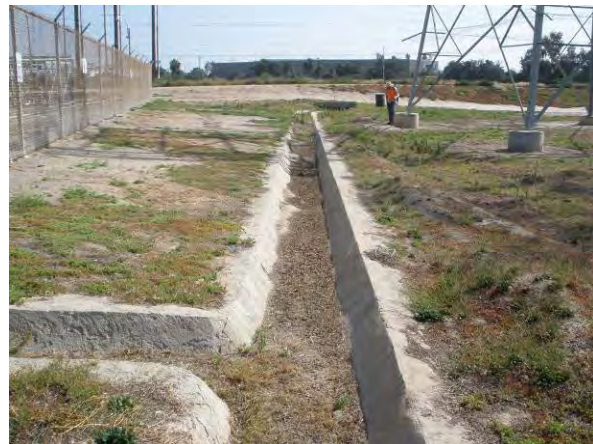
*Concrete-lined ditches draining stormwater from substation yard.*

In the northern portion of the study area, a small collector system of concrete-lined drainage ditches has been developed to convey water flows from the exiting substation yard. This system of ditches meets up with a similarly small ephemeral swale prior to draining through a grated culvert to the concrete channel of Telegraph Creek. This stormwater system has been constructed on the pads to collect and efficiently convey rainfall runoff off of the substation site. Approximately 2 to 3 inches of sediment occur in this ditch system, which allows for the growth of non-native upland species such as garland (*Chrysanthemum coronarium*), tocalote (*Centaurea melitensis*), and crystalline iceplant (*Mesembryanthemum crystallinum*). Shrubs that overhang this feature include upland species such as tree tobacco (*Nicotiana glauca*) and coyote brush. No wetlands occur in this area; however, wetland hydrology was indicated by surface water and sediment deposits.

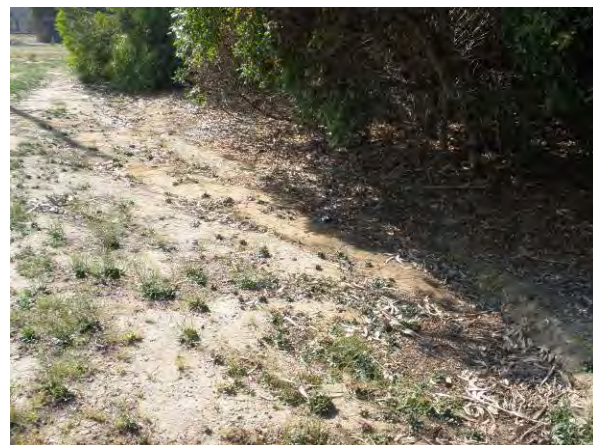
*Ephemeral swale approximately 9-18 inch in width of sorted sand where sheet flow is concentrated in storm runoff.*

Ephemeral drainages and swales are located throughout the study area. These features occur in low-lying areas of previously graded pads and collect surface runoff water during periods of heavy precipitation. The swales drain only the local watershed of the upland pads surrounding the features. The swales typically lack vegetation and hydric soils; however, evidence of flow is present intermittently, within the unconsolidated sandy surface soils. These features vary in width from as little as 4 inches to approximately 2.5 feet and are very shallow. The OHWM and top of bank are of approximately equal in width as there is no defined bank to the features. All of these features eventually drain into Telegraph Creek via culverts, although evidence of flow along

the drainage may be intermittent and broken. The features are best characterized as areas within which sheet flow from the pad concentrates enough energy to result in a minor, but detectible surface sediment mobility.

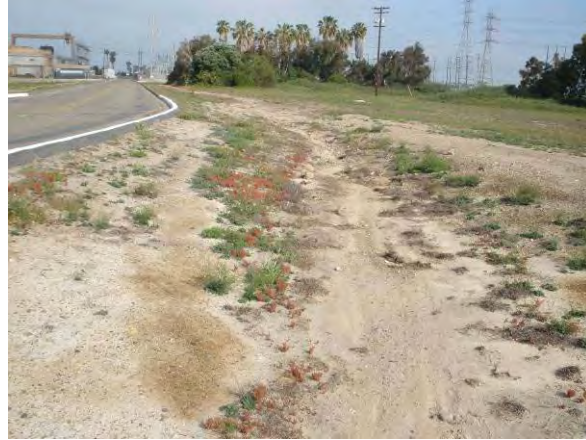
Roadside drainage depicting higher flow evidence within a swale lacking defined channel banks.

A slightly larger drainage swale occurs near the central portion of the site (Figure 4a-b). This drainage is a collector for one of the small ephemeral swales, but is better characterized as a roadside drainage due to its receipt of water flows from impervious pavement and the generally higher frequency of flows. The drainage enters the stormwater system of the SBPP and ultimately discharges to the intake channel of the power plant cooling water system. As with the ephemeral swales discussed above, the drainage is not highly incised and generally lacks definition or any banks. The drainage is dominated by non-native upland species such as red brome (*Bromus madritensis* ssp. *rubens*) and garland. Shrub growth included mostly coyote brush (UPL) with occasional mule fat (FACW). Soils consisted of a loam with a relatively high chroma matrix color. No hydric soil characters were observed. Wetland hydrology was indicated by drift deposits, drainage patterns, and surface water in portions of the drainage.

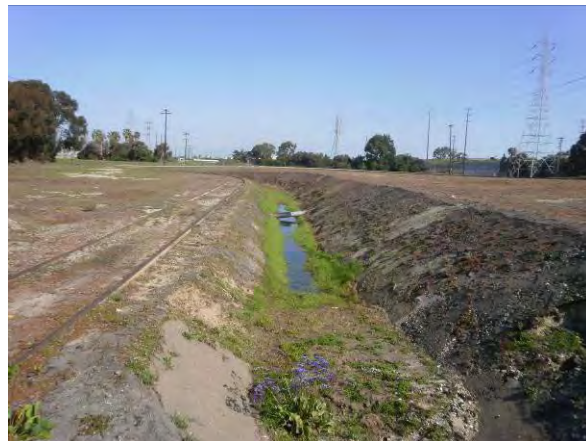
Ephemeral channel through central portion of study area.

Three ephemeral drainages occur on the subject site. These are distinguished from the previously discussed features, principally by their scale, frequency of flows, and high degree of connectivity to San Diego Bay via either a storm drain pipe or a separate drain. On the westernmost portion of the site (Figure 4b), a small concrete-lined drainage discharges locally collected rainfall run-off and conveys water via a continuous drainage ditch around the north side of the offsite South Bay Saltworks crystallizer pond to tidal waters within the Palomar Drain within the cooling water discharge channel of the SBPP. While the watershed of this drainage feature is small, the high degree of past development around the feature enhances runoff and thus it is believed that this drainage flows more regularly during moderate to heavy storms than do most of the smaller features described above. A larger ephemeral drainage runs through the south-central portion of the site. This is a conduit for both stormwater collected within the study area and that entering the study area from developed portions of the SBPP outside of the study area. The swale drains to the underground stormwater system of the SBPP and ultimately discharges to San Diego Bay within the cooling water channel system. Finally, a long swale supporting principally emergent wetlands runs along the Bay

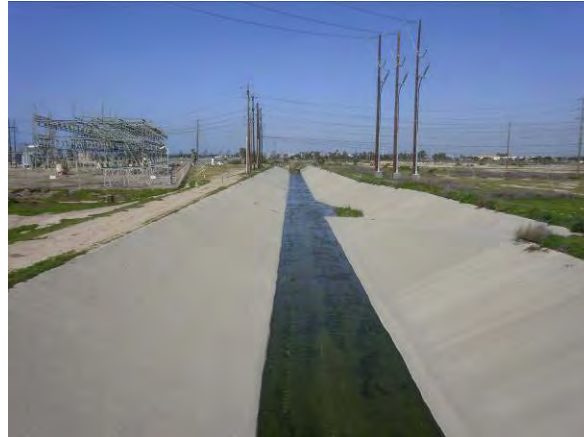
*Telegraph Creek looking toward the west from near upstream edge of study area.*

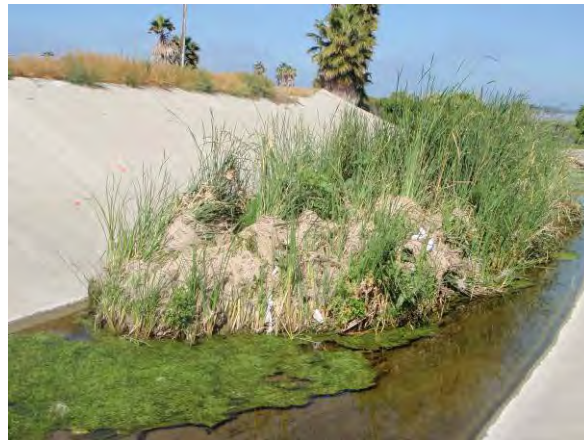
*Telegraph Creek depicting vegetation blockage on accumulated.*

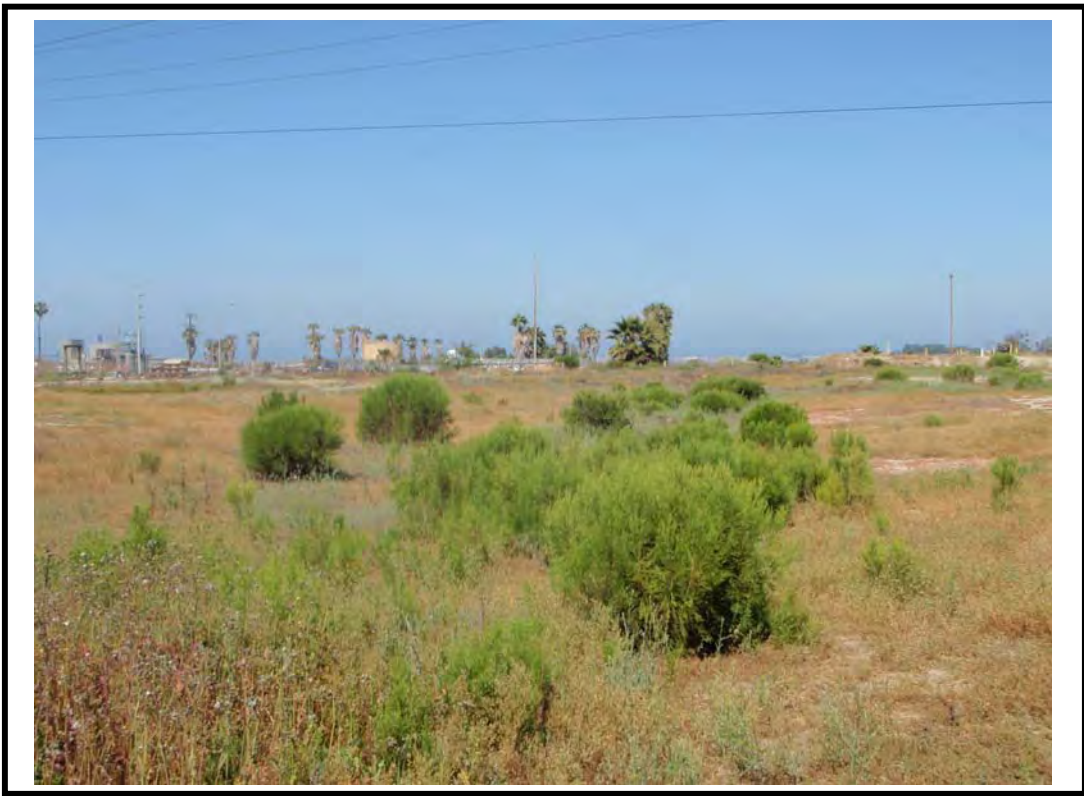
**Photo Point 47.** Telegraph Creek facing east.
