# California Public Utilities Commission Mitigation Monitoring, Compliance, and Reporting Program

**South Bay Substation Relocation Project**

**Compliance Status Report: 022**

**April 30, 2016**

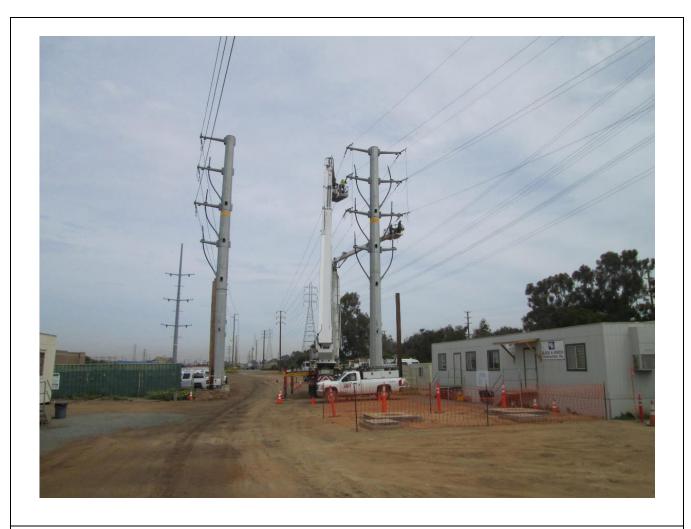
**Photo 1**: Crews were observed sagging 69kV wire along a transmission line within the right-of-way.

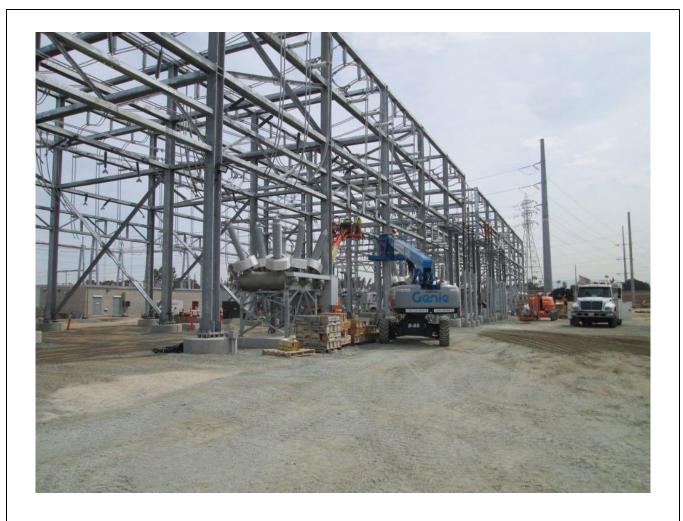
**Photo 2:** Crews were observed conducting wire termination work at the 69kV rack at the Bay Boulevard Substation. Installation of bird deterrents/ribbons were reported to be installed within the racks by SDG&E on April 22, 2016.

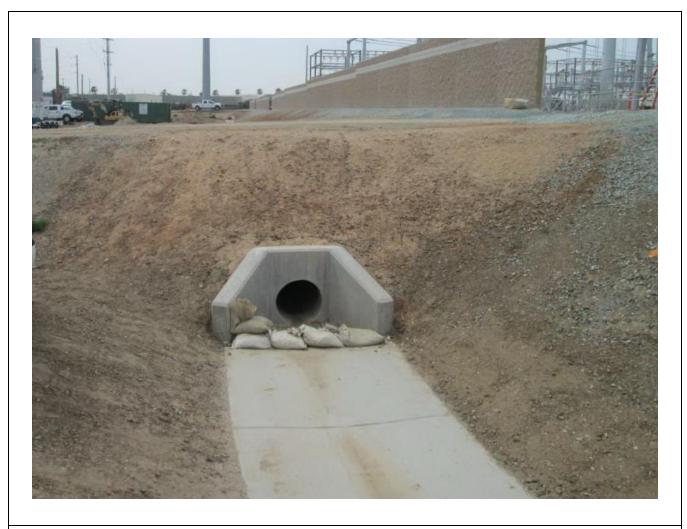
SWPPP BMPs installed at the Bay Boulevard Substation site and along the transmission alignment, including silt fencing and gravel bags along the temporary perimeter fence and around stockpiles, and gravel bag berms within the drainage channels were observed in good working condition (See Photo 3—Attachment A). Equipment was observed stored on absorbent fabric and generators stored within containment units to prevent soil contamination in accordance with the project SWPPP (MM-HYDRO-01) BMPs (See Photo 4—Attachment A).

**Photo 3:** Gravel bag berms were observed placed along drainage channel inlets in accordance with the project SWPPP BMPs (MM HYDRO-1).

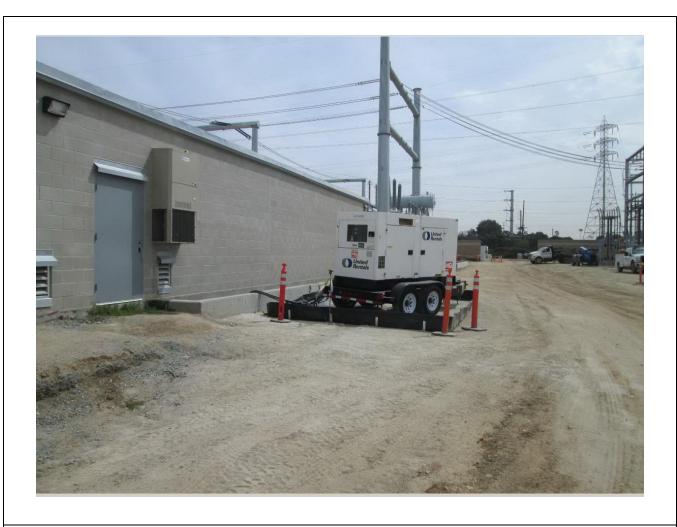
**Photo 4:** Generators were stored within catchment areas to prevent potential contamination of soil in accordance with project SWPPP BMPs (MM HYDRO-1).
