<p>California Public Utilities Commission <i>Mitigation Monitoring, Compliance, and Reporting Program</i></p>
	<p>CalPeco 625 and 650 Electrical Line Upgrade Project</p> <p>Compliance Status Report: 002</p> <p>September 15, 2015</p>

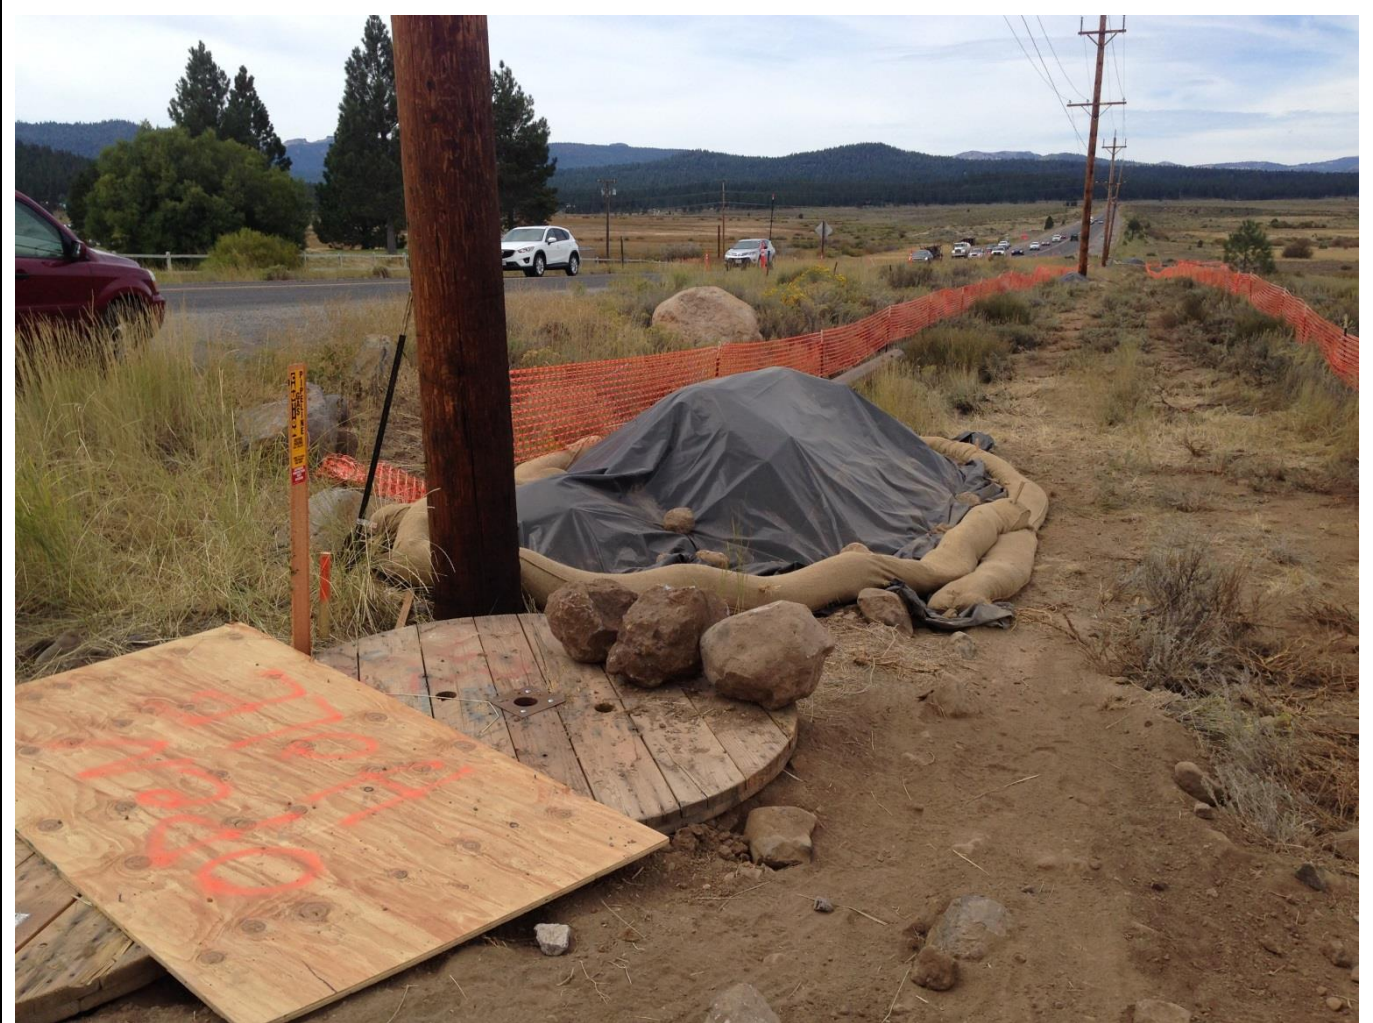
Photo 1: Topsoil salvage piles covered with BMPs installed (straw wattles), consistent with APM-BIO-23. Excavated pole holes covered to prevent wildlife from entering holes.

- Topsoil salvage piles: During a compliance monitoring visit on August 28, 2015, Dudek monitors confirmed that topsoil salvage piles has been covered. This corrective action was identified by Liberty Utilities to address conditions inconsistent with the measures outlined in APM-BIO-23.

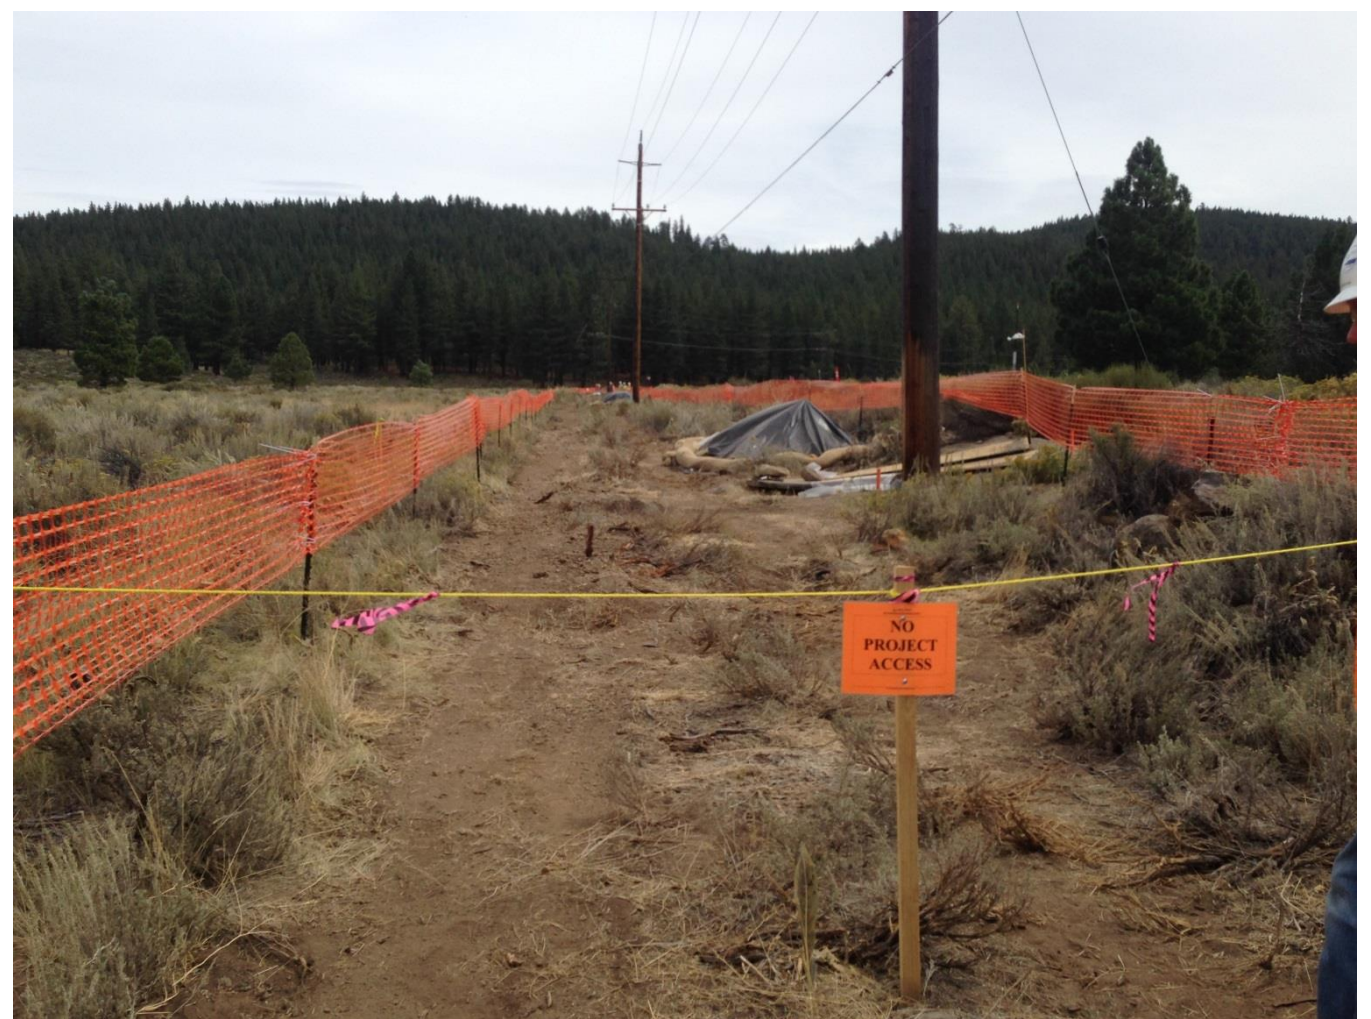
Photo 2: Signage noting that cultural site CA-PLA-006 was closed to construction activity resulting from rock movement conducted without the presence of an archeological monitor, as required by APM-CUL-1. Protocols were followed as outlined in the project's Cultural Resources Protection, Monitoring and Unanticipated Discovery Plan and the area was later re-opened to construction activity following an assessment conducted in coordination with the United States Forest Service (USFS) archaeologist representative.

In addition to the aforementioned non-compliance issues, Liberty Utilities notified the CPUC and Dudek of a non-compliant action that occurred on the project site on August 25, 2015. The CPUC and Dudek were notified on August 27, 2015 that construction crews moved approximately 25 boulders out of the 20-foot-wide limited work area between Poles #291073 and #291081. This area is mapped as a cultural site (CA-PLA-006) and no archeological monitor was present during the activity, inconsistent with APM-CUL-1. Upon notification of the ground-disturbing activity, the project's archeological monitor halted construction activity in the area, consistent with the protocols outlined in the project's Cultural Resources Protection, Monitoring and Unanticipated Discovery Plan, and closed the area so that an assessment could be conducted in coordination with the United States Forest Service (USFS) archaeologist representative. The assessment protocol was prepared by the project's archeological monitor and provided to the CPUC on August 27, 2015 and outlined the approach for mapping, documenting, and testing/sampling the site to determine whether archaeological resources were present. The assessment occurred on August 28, 2015, in coordination with the USFS's archaeologist representative. The CPUC was notified on September 1, 2015 that the USFS had concluded that the area could be re-opened to construction activity and that all construction activity in this area will require that an archeological monitor is present. This will be verified during subsequent monitoring visits.

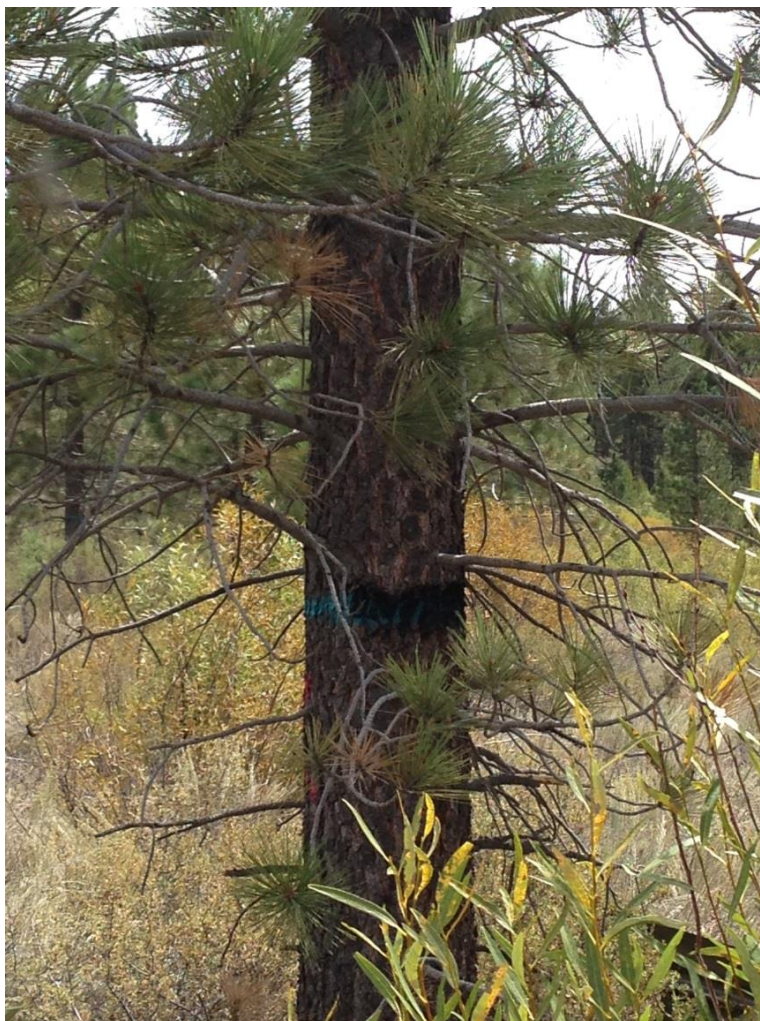
Photo 3: Cut tree marks painted over with black paint on the SR 267 side of trees. This corrective measure was implemented by CalPeco following notification by the CPUC that road-side cut tree marks were inconsistent with the requirements of APM-SCE-1.

- Cut tree marking paint: During a compliance monitoring visit on August 28, 2015, Dudek monitors confirmed that road-side tree marking paint had been covered with black paint. This

corrective action was identified by Liberty Utilities to address conditions inconsistent with the measures outlined in APM-SCE-1.

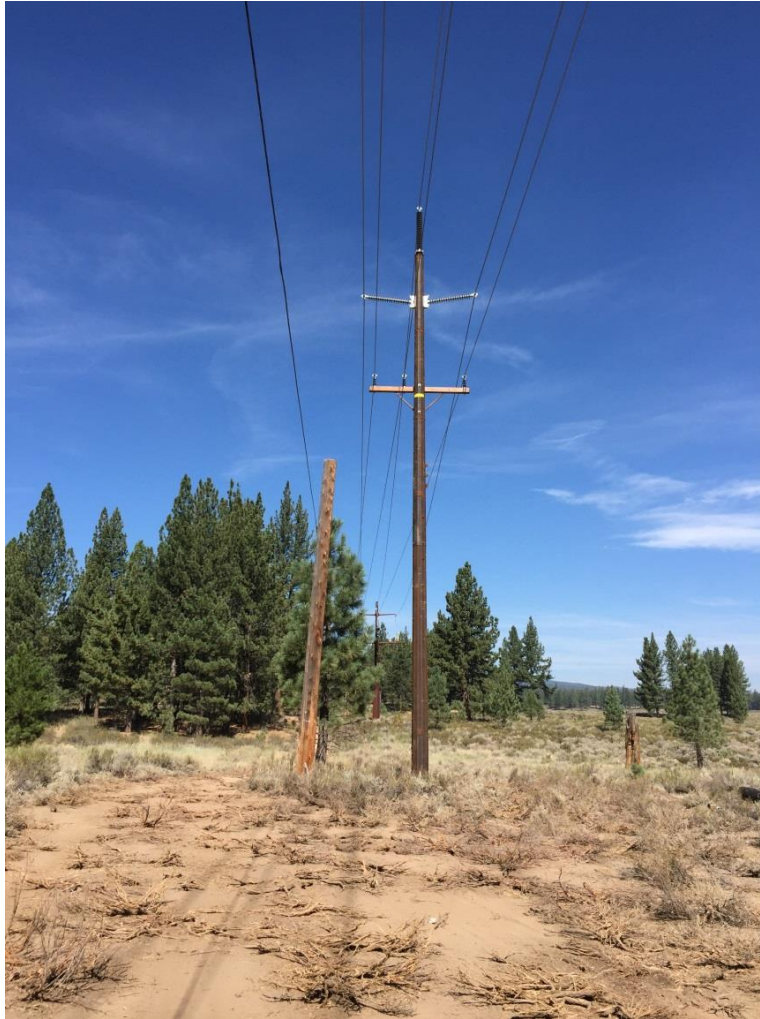
Photo 4: New weathered-steel pole installed at the northwest end Line segment 650-4. Old pole top has been and is laying in the ROW prior to removal from the project site.

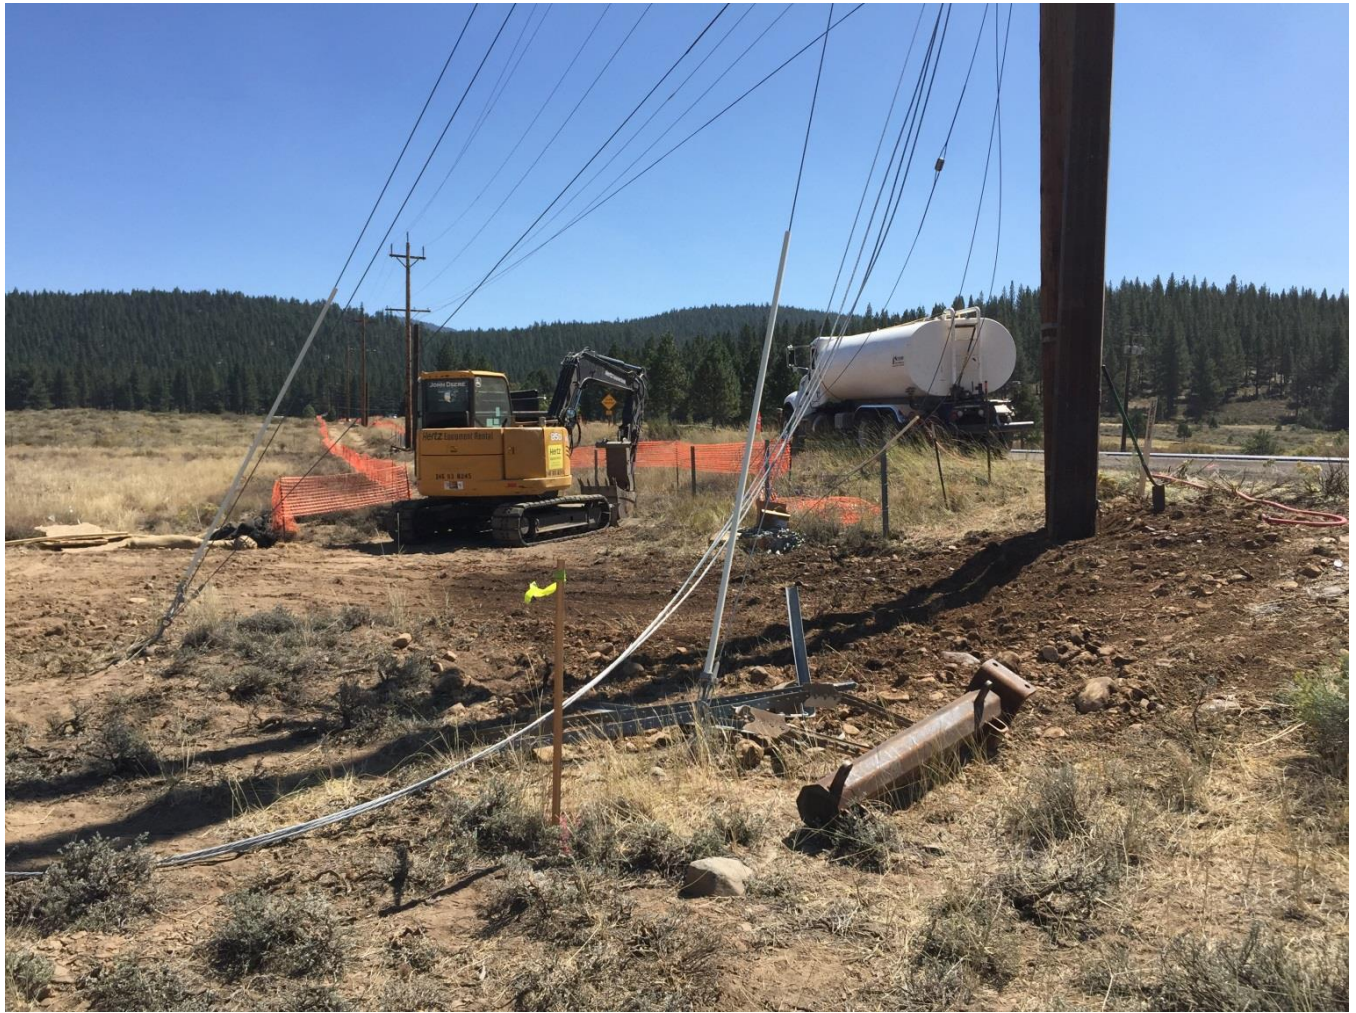
Photo 5: Construction crews setting anchors at corner Pole #291068, across SR 267 from Martis Valley. Cultural and environmental monitors present. Water truck nearby for dust control, consistent with APM-AQ-2.

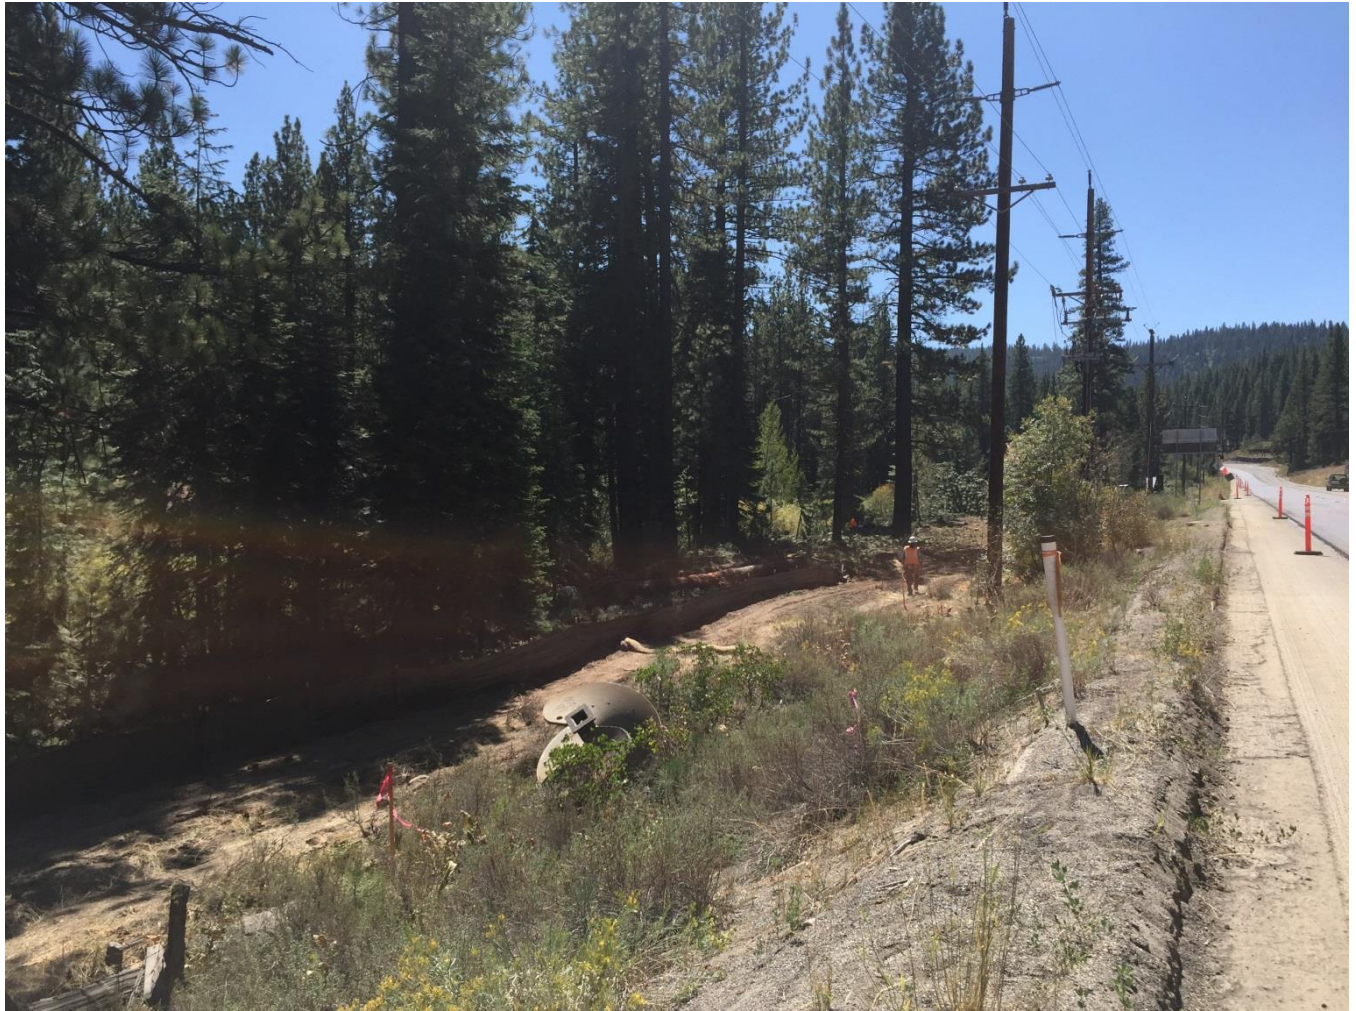
Photo 6: Tree removal activities underway between Poles #291101 and #291105. Silt fence installed along the lower edge of the ROW.
