<p>California Public Utilities Commission <i>Mitigation Monitoring, Compliance, and Reporting Program</i></p>
	<p>CalPeco 625 and 650 Electrical Line Upgrade Project</p> <p>Compliance Status Report: 012</p> <p>August 10, 2016</p>

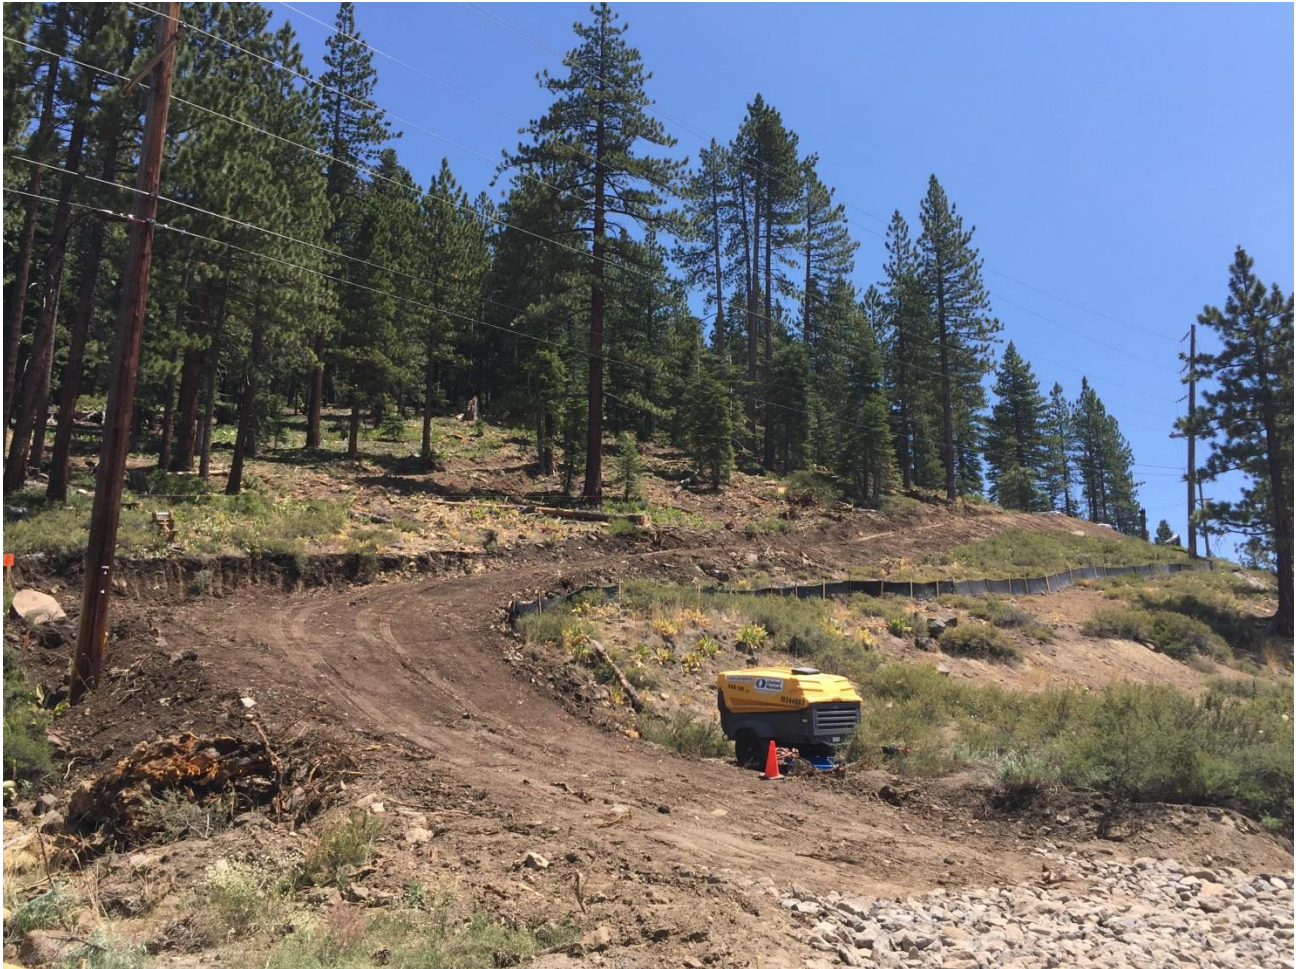
Photo 1: Right-of-way entrance with stabilized rock entrance, weed cleaning station, and silt fence installed below access road.

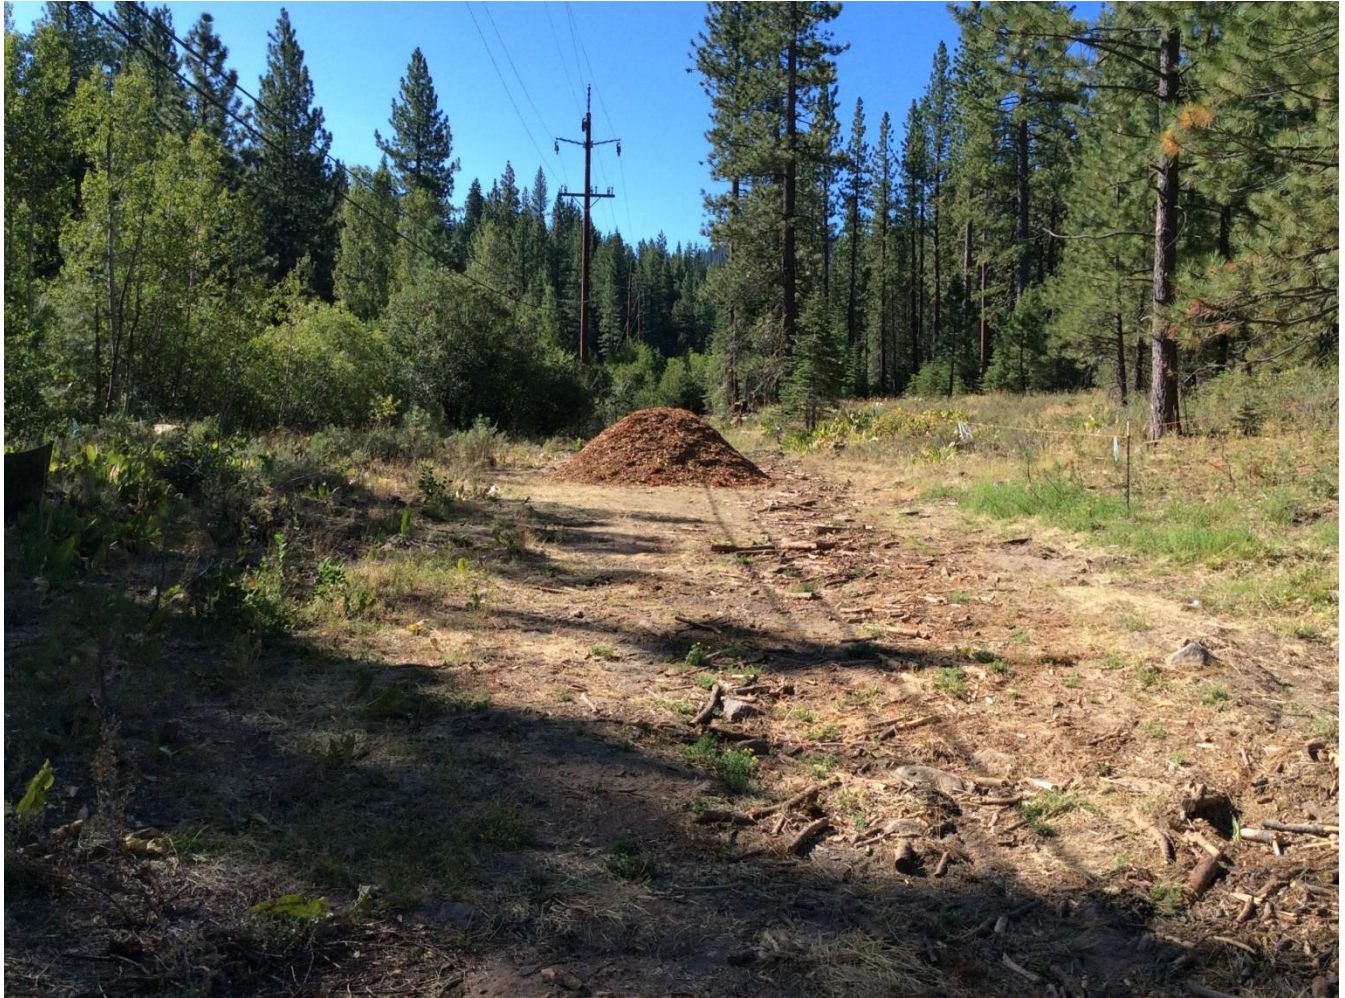
Photo 2: Right-of-way near Pole 291110 following pole installation. Mulch staged for future distribution for erosion control purposes.

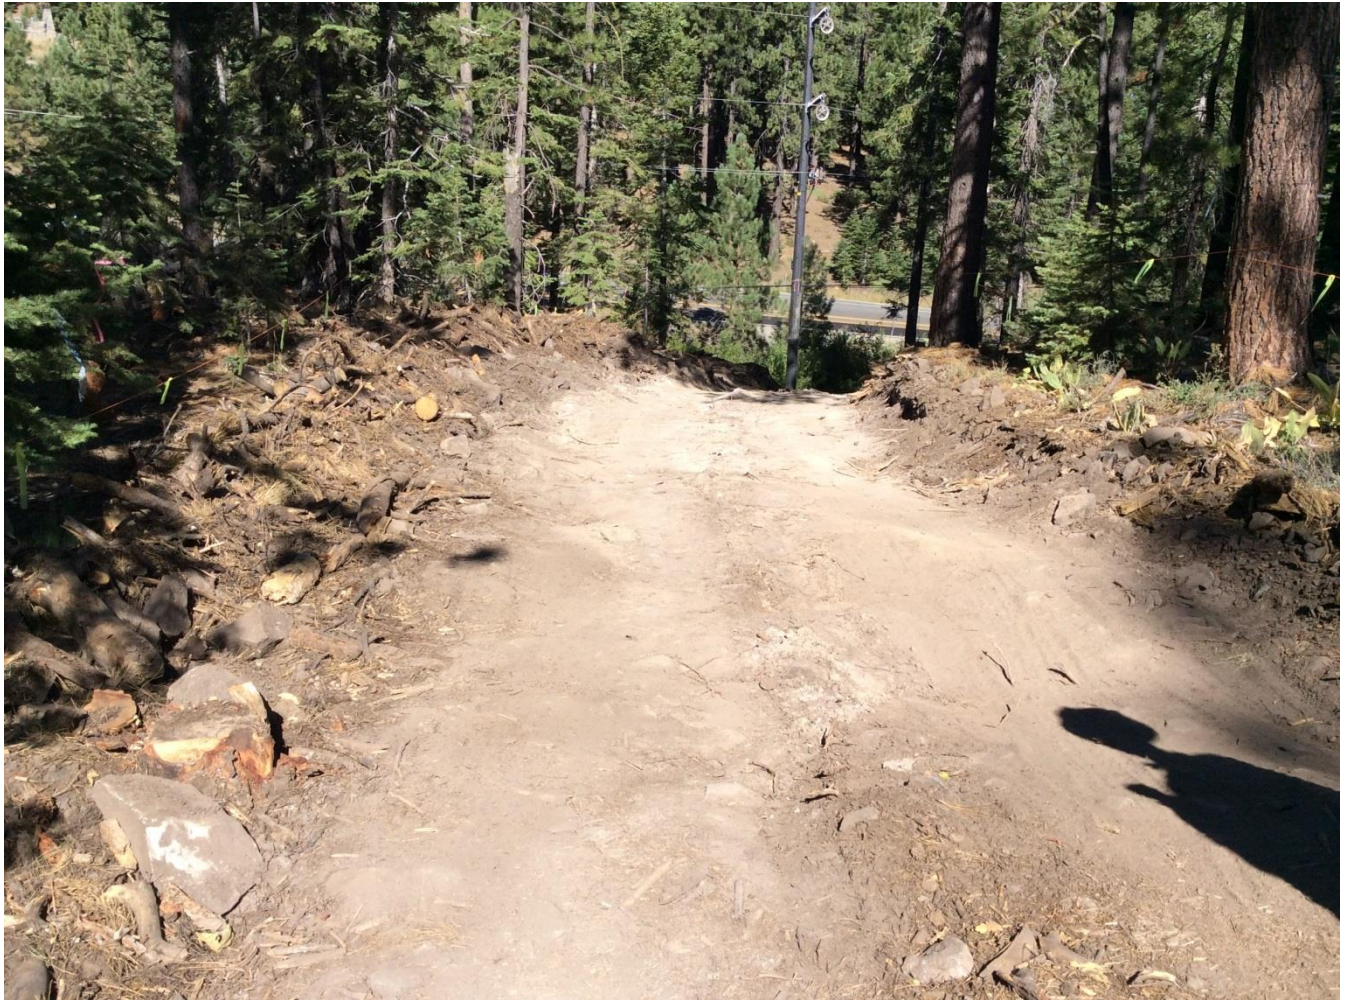
Photo 3: Temporary access road to Pole 291108, approved with Minor Project Refinement #2. Work area boundaries delineated.

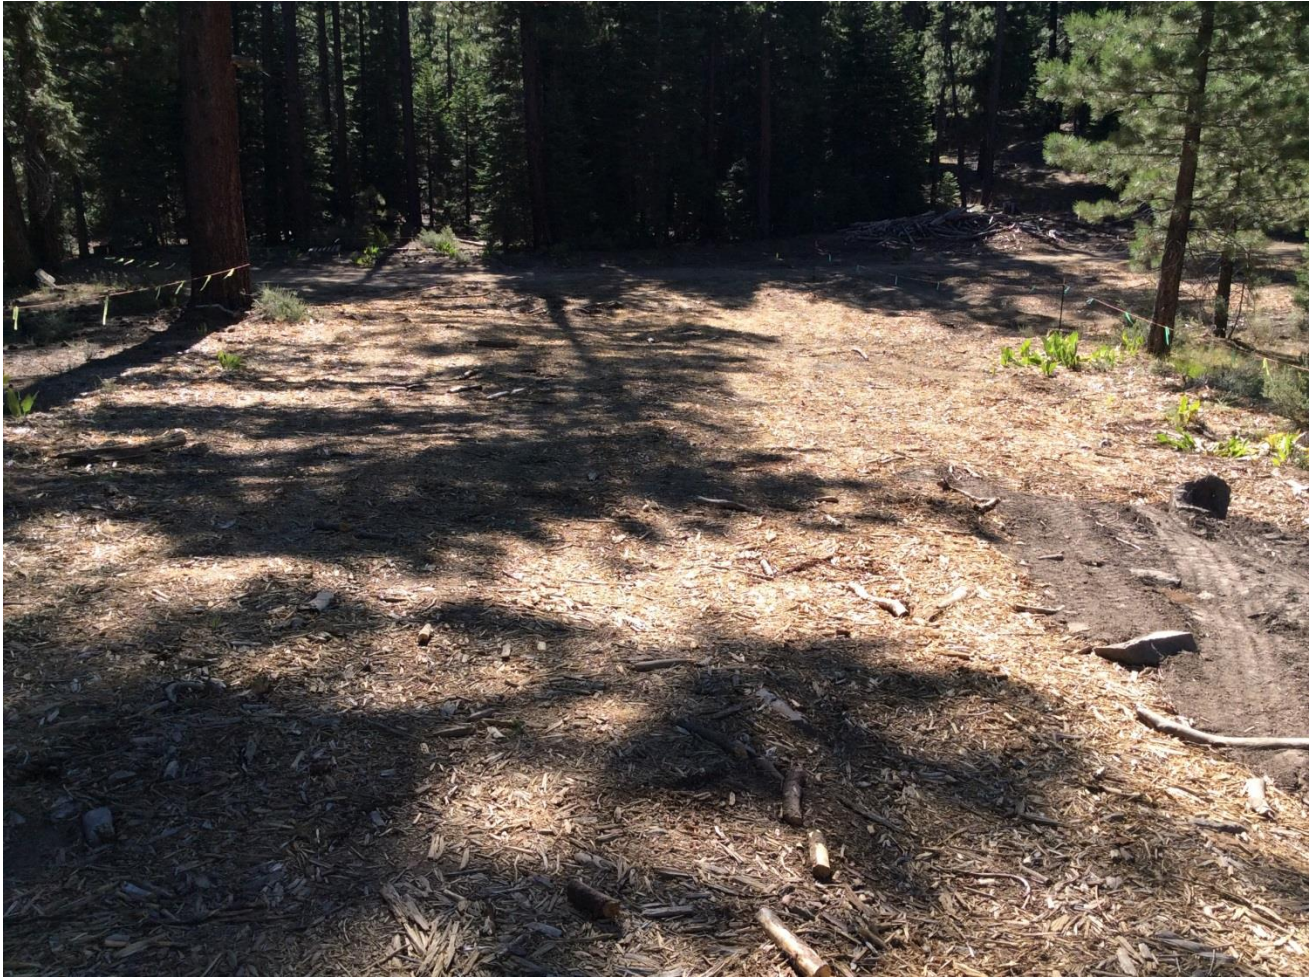
Photo 4: Staging area approved under Minor Project Refinement #2 following construction activity, with work area boundaries delineated.

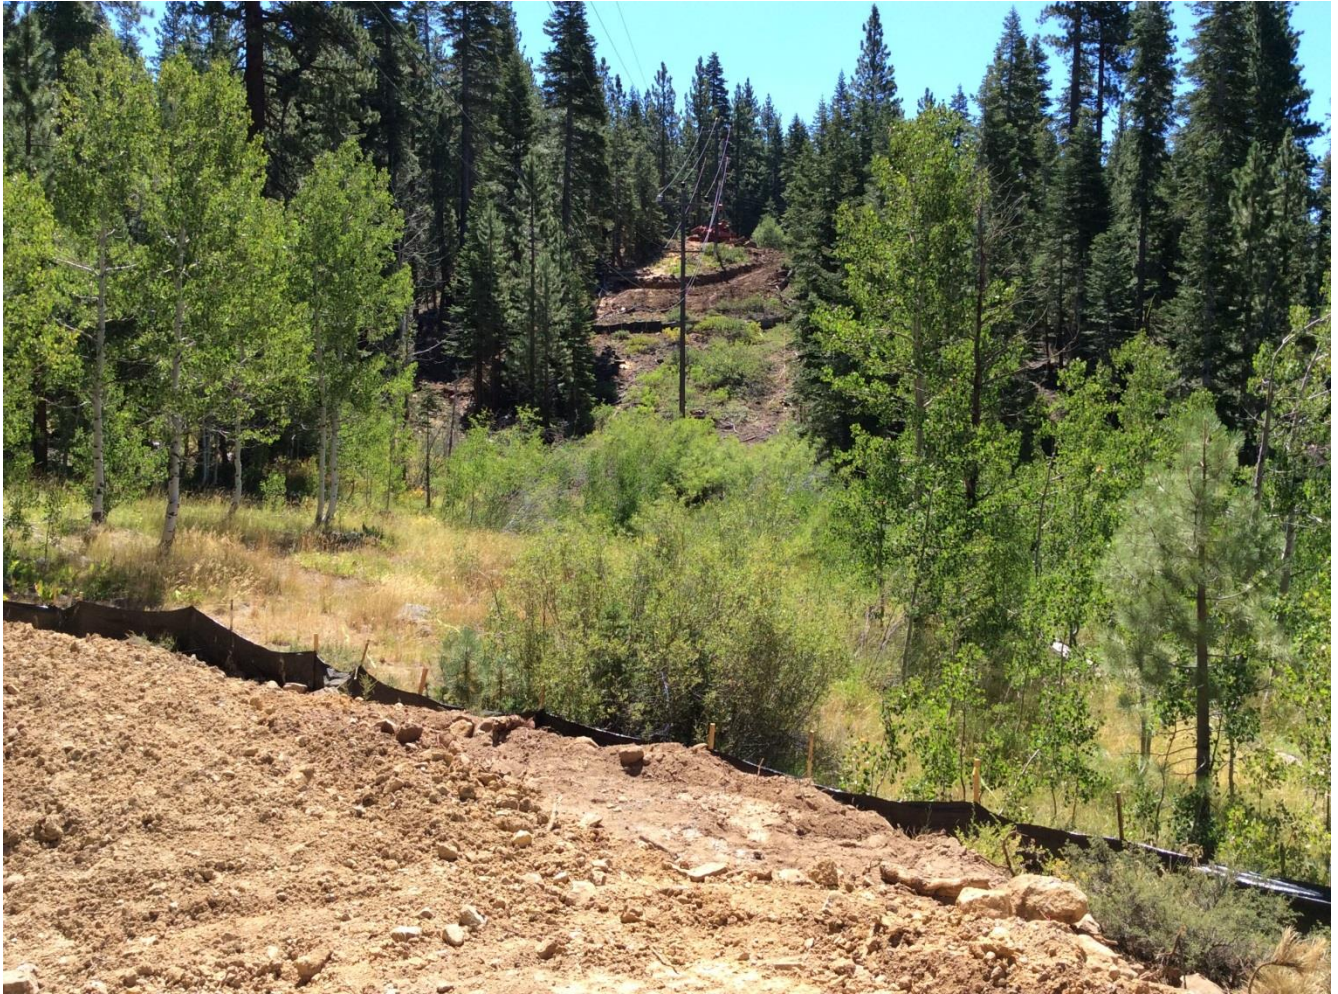
Photo 5: Right-of-way with Pole 291161 in the background. Based on engineering design, the foreground pole(nearest pole) will be removed and not replaced.

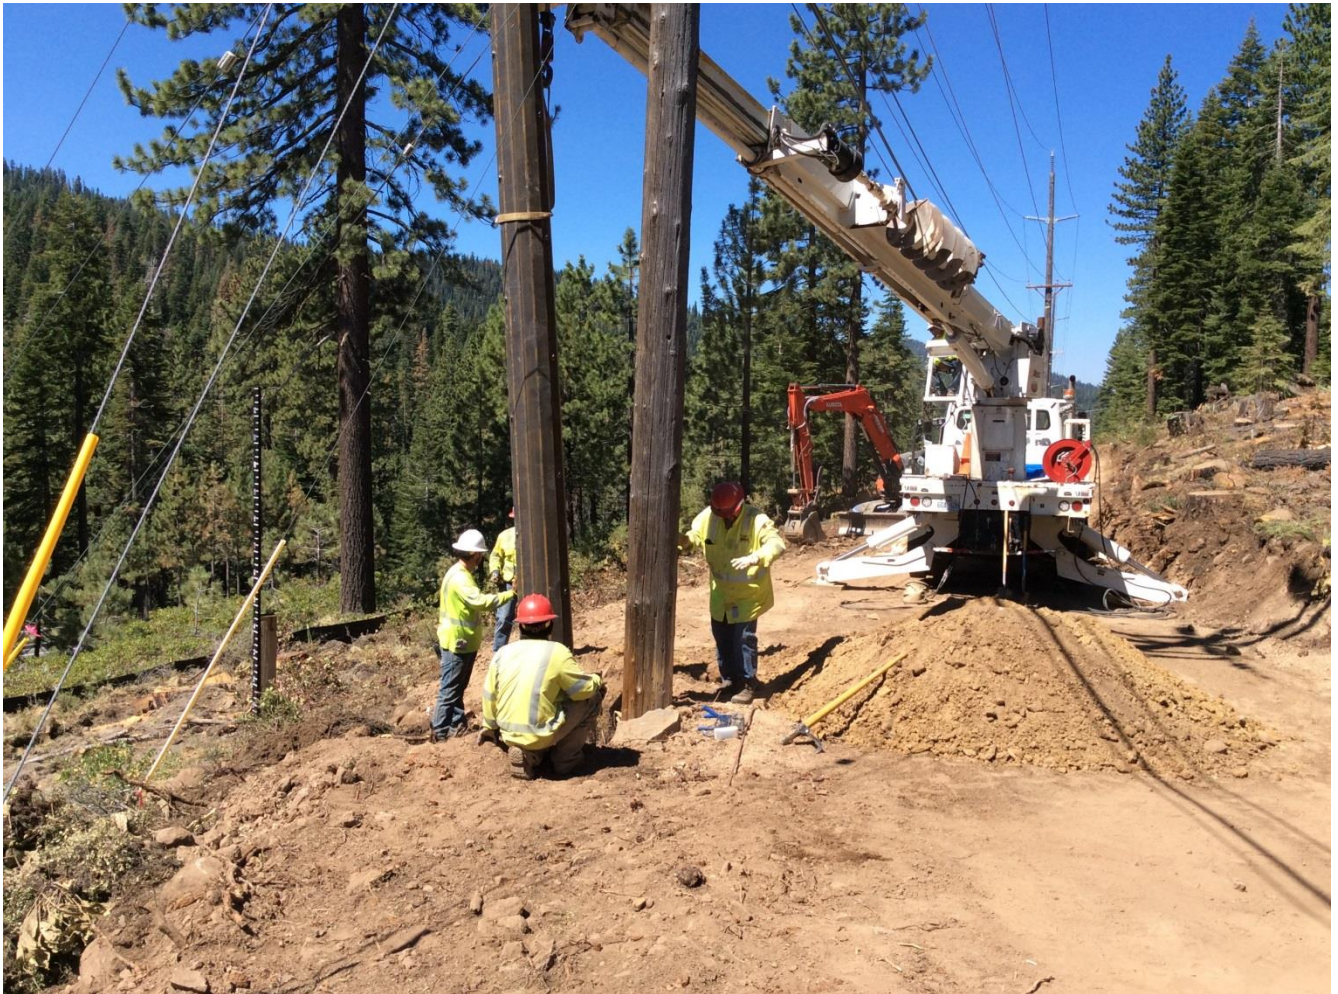
Photo 6: Crews installing angle Pole 291158.
