PUBLIC UTILITIES COMMISSION

Incident Date:	7/13/2018-ongoing (for MM HAZ-3), 12/11/2019-1/28/2019 (for MM HYD-1)	Report No.:	NCR-004
Date Submitted:	1/29/2019	Location:	Standpipe in the detention basin
Level:	Level 2	Relevant Plan/Measure:	MM HAZ-3 (including SPCC Plan) and MM HYD-1 (including SWPPP)
Current Land Use:	Mesa substation expansion area	Sensitive Resources:	Public storm drain system

NCR-004 Incident Photographs

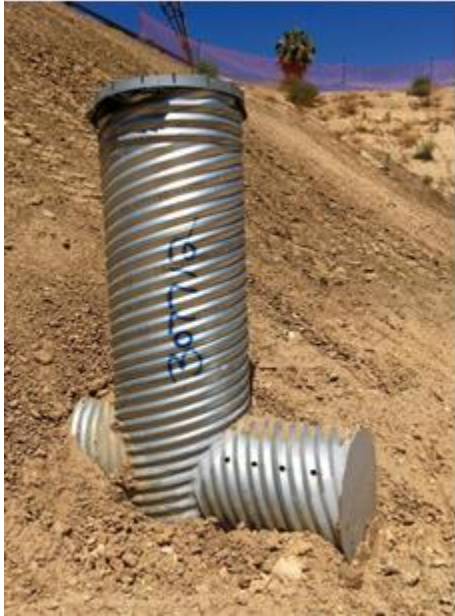
Photo 1: Standpipe in the bottom of the detention basin. Note the perforations along the bottom of the pipe. Photo taken 7/13/2018.

In late June 2018, SCE installed a standpipe with perforations on the bottom near the western edge of the large detention basin located on the western side of the substation expansion area (Photos 1-2). Prior to installation of the standpipe, the basin detained water for extended periods of time, meeting the SPCC Plan requirement that the basin function as adequate secondary containment during the construction phase. To maintain compliance with this requirement, in September 2019 SCE wrapped the standpipe in plastic sheeting (Visqueen) and installed gravel and sandbags around the base of the standpipe to ensure that water would not drain from the basin through the perforations in the standpipe (Photo 3). In addition to meeting SPCC Plan requirements, the basin and standpipe designs for the construction phase must meet SWPPP requirements. By sealing the standpipe perforations with plastic sheeting, the basin should detain water until water levels exceed the height of the standpipe (approximately 6 feet), at which point the water would flow into the opening on top of the standpipe; this system would allow sediments in the water column to settle to the bottom of the basin (and not flow off-site).

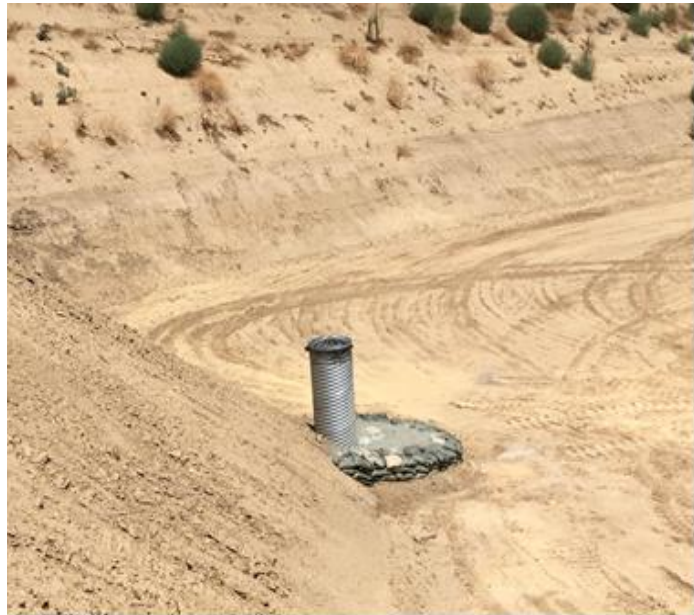
Photo 2: Detention basin standpipe with added gravel and gravel bags at base. Photo taken 8/28/2018.

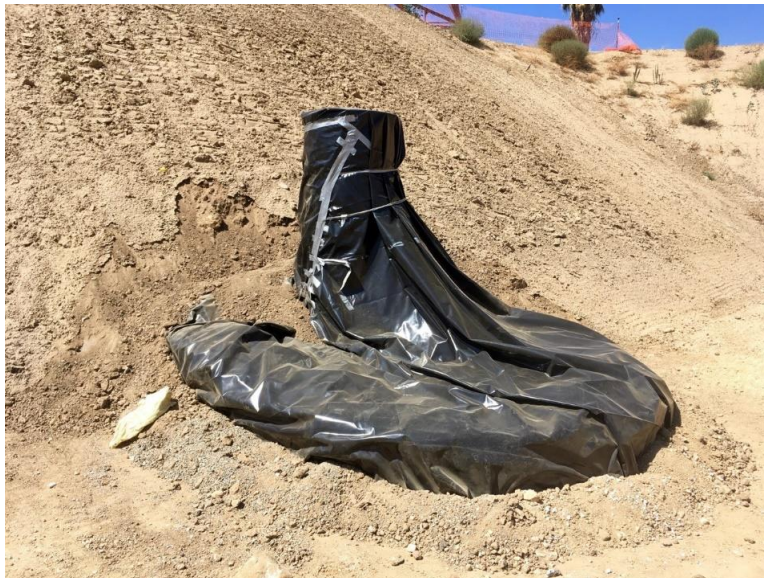
Photo 3: Detention basin standpipe. SCE installed plastic Visqueen sheeting over the standpipe, including the perforations along the base. Photo taken 9/19/2019.

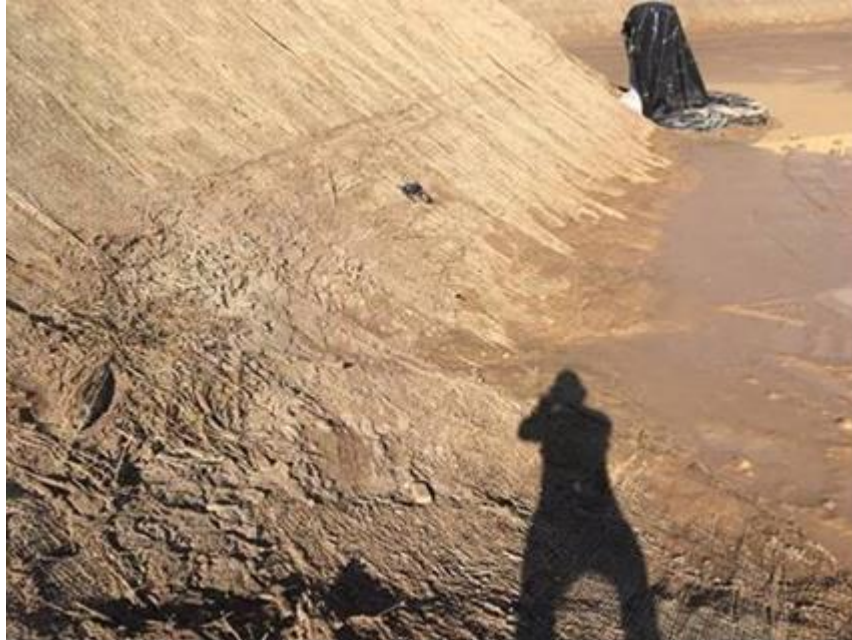
Photo 4: Water line from recent major rain event visible along the banks of the detention basin (water line extends approximately 4-5 feet above the floor of basin). Basin has minimal standing water remaining despite recent high water levels. Photo taken 12/11/18.

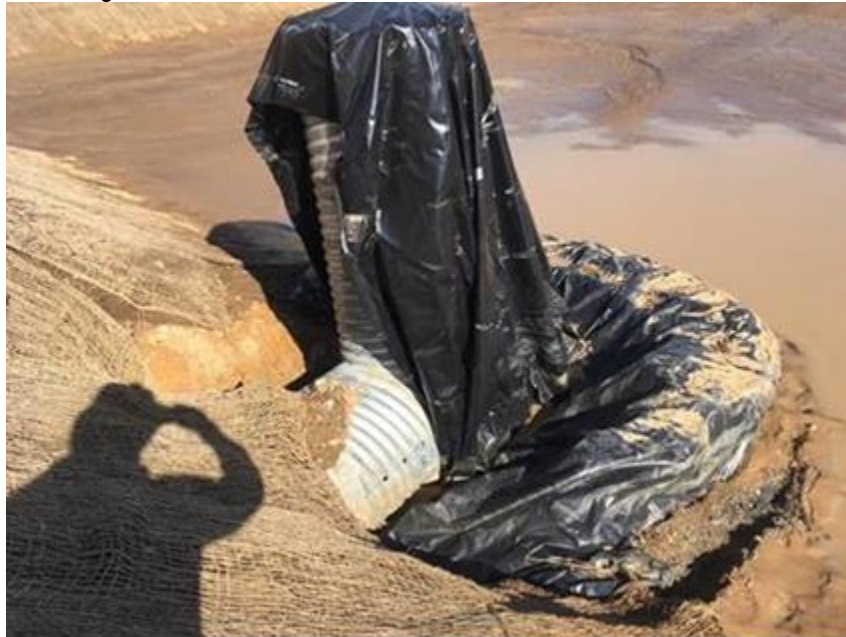
Photo 5: Failed plastic Visqueen sheeting and sandbags surrounding the basin. Perforations visible at base of standpipe. Photo taken 12/11/18.

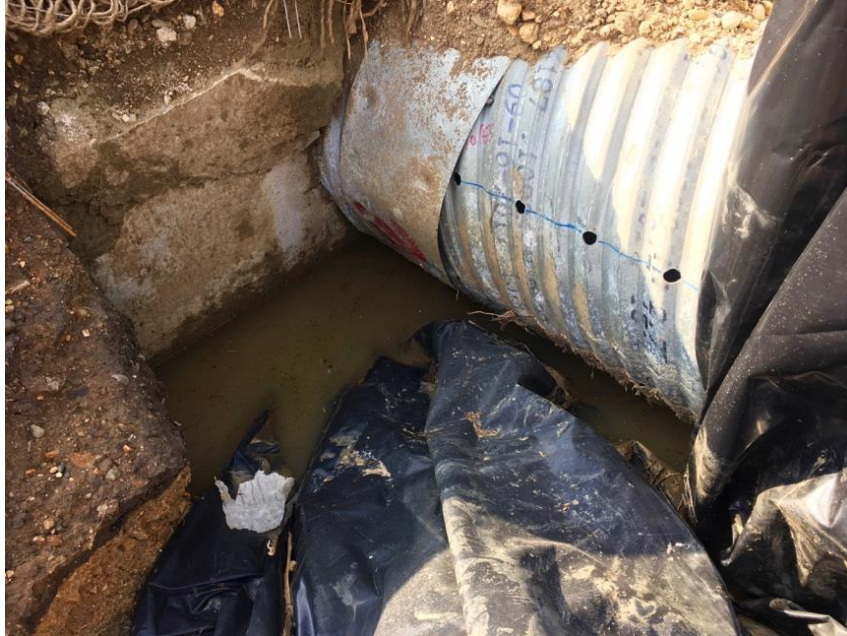
Photo 6: Close-up of the standpipe in the detention basin, with perforated holes allowing sediment-polluted water to quickly run offsite. Photo taken 12/11/2018.

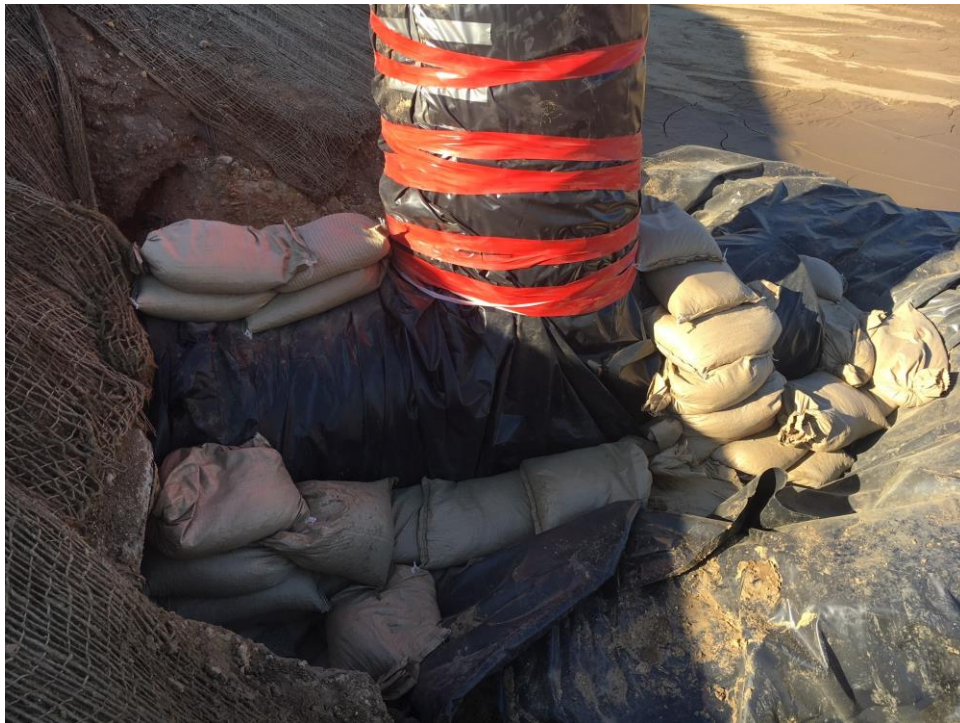
Photo 7: SCE repaired BMPs around the standpipe; plastic sheeting, tape, and additional sandbags reinstalled along the base. Photo taken 1/4/2019, by SCE.

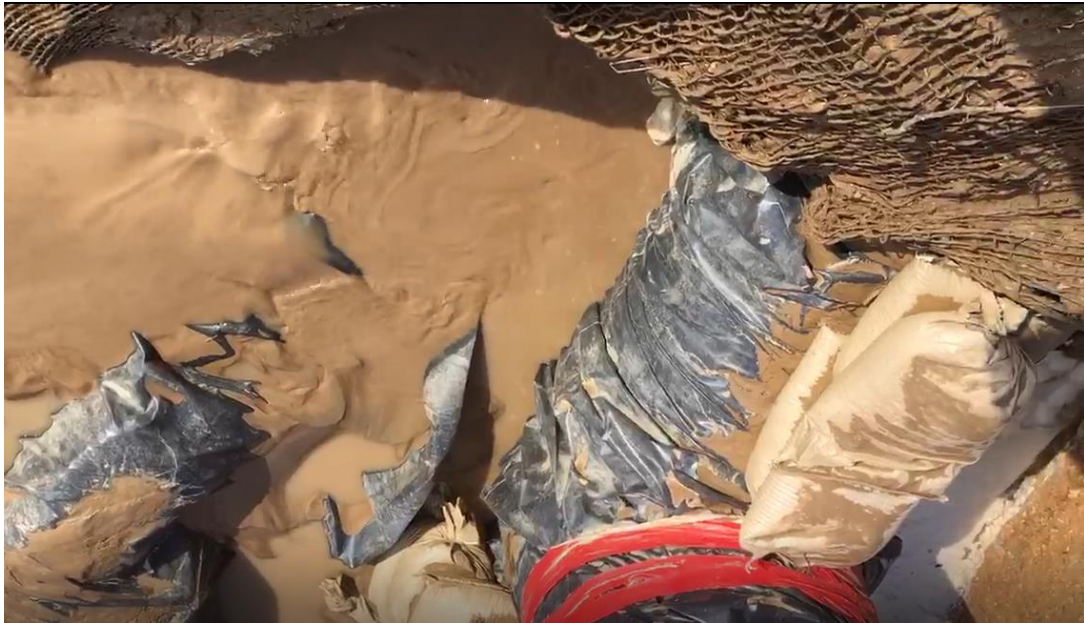
On January 18, 2019 the CPUC Compliance Monitor again observed sediment-polluted water rapidly flowing underneath failed plastic sheeting and BMPs, and exiting the detention basin via the perforations at the bottom of the standpipe (Photo 8). Although the severity of the storm prevented SCE staff from conducting stormwater pH and turbidity monitoring in the detention basin during this storm, SCE reported that stormwater monitored at Potrero Grande Drive indicated NAL exceedances for turbidity during rain events; similar or further elevated turbidity levels can be anticipated at other locations throughout the project site, including at the detention basin. In addition, the stormwater flowing from the basin was visibly heavily sediment-laden.

Photo 8: Water rapidly exiting the detention basin from area near the bottom of the standpipe following a large rain event. Water flowing under the plastic sheeting. Photo taken 1/18/2019.

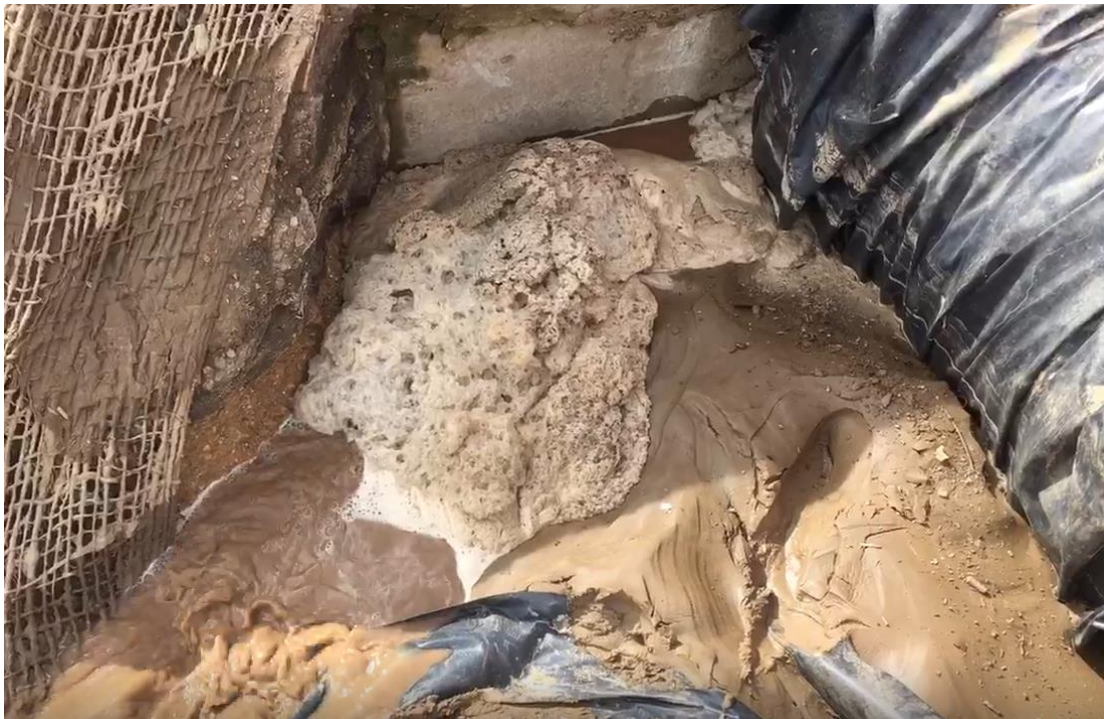
On January 28, 2019 the CPUC Compliance Monitor observed water being pumped from one of the conduit vaults into the detention basin. Because the BMPs at the standpipe had not been corrected since the January 18, 2019 observations, the basin did not detain the water, which was flowing off-site through the standpipe almost immediately (Photo 9).

Photo 9: Water rapidly exiting the detention basin from area near the bottom of the standpipe following dewatering of a conduit vault. Water flowing under the plastic sheeting. Photo taken 1/28/2019.

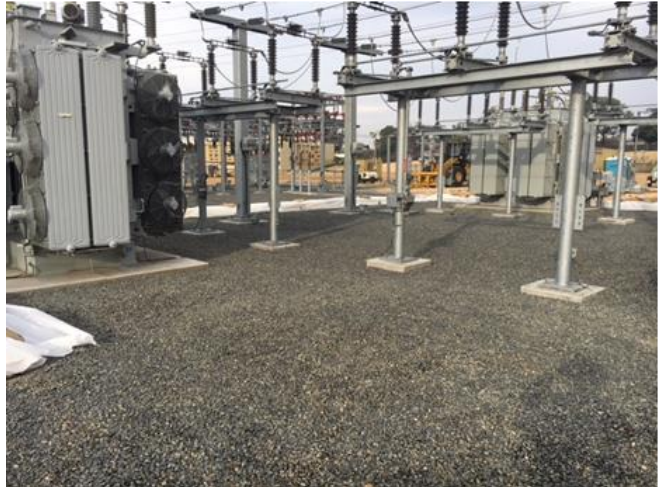
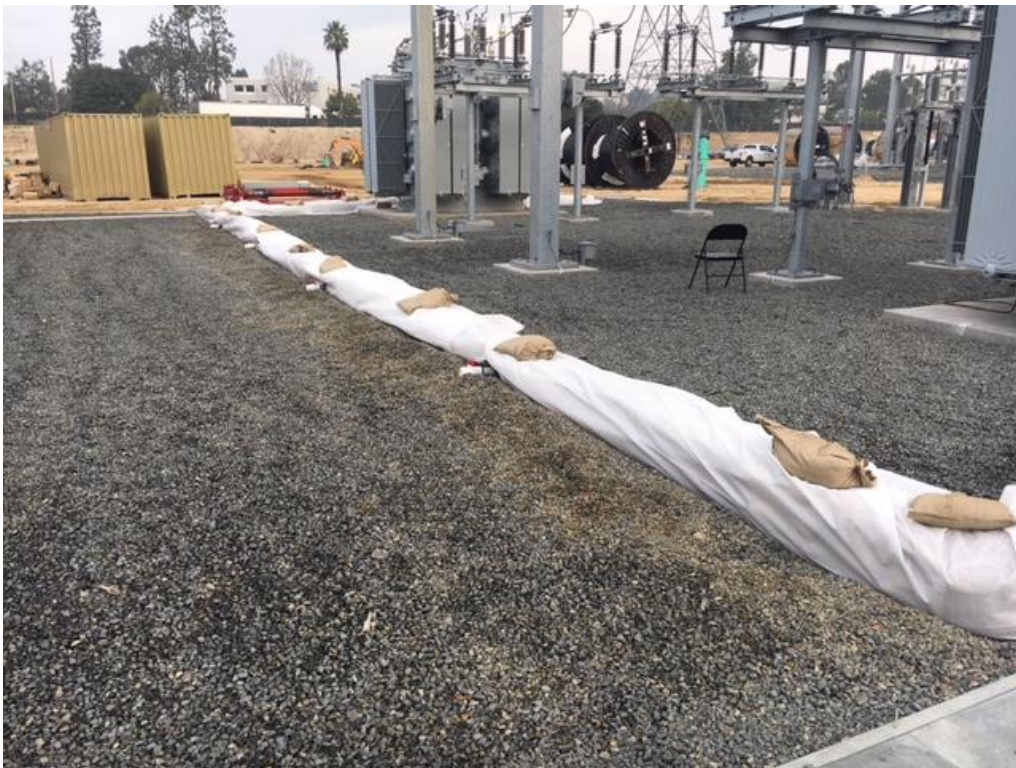
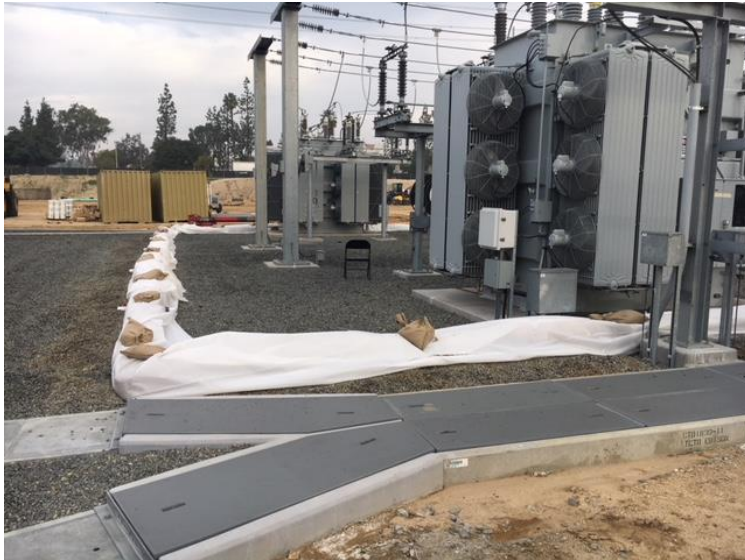
Photo 6 Temporary Containment Berms

Photo 7 Temporary Containment Berms

- Photos 5-7 show the temporary berm around the “B” banks. The temporary berm is buried to the soil beneath the rock; plastic lined the trenched rock and gravel bags were installed 4 bags high; the plastic was then wrapped around the gravel bags to create an impermeable barrier. Drainage valves were installed as identified on the permanent SPCC berm drawings.

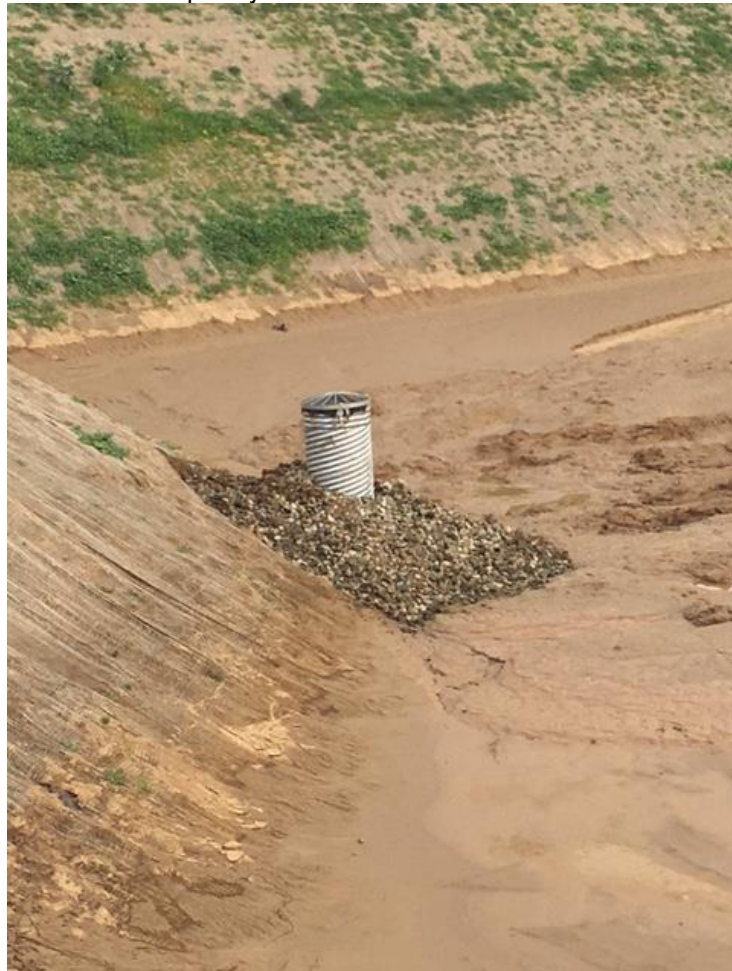
Photo 8 Gravel installed over sediment filter fabric at basin standpipe

BMPs (sediment filter fabric and gravel) at the basin standpipe. See attachment 2 for details. CPUC has reviewed SCE's submittal and determined that the implemented corrective actions are appropriate and are consistent with the requirements of the SPCC Plan and SWPPP.

To allow the basin to continue to function as designed and installed, and since the basin will no longer be utilized for containment, the standpipe should not be sealed. However, this week we implemented additional BMPs to the standpipe within the basin. These adjustments, completed Tuesday, January 29 will allow the basin to continue to effectively function as designed, which is not to retain water, but to allow accumulated water to draw down, allowing flows to be temporarily detained for pollutant settlement. All previous BMPs were excavated from around the pipe and the pipe was lined with filter fabric. The pipe was then buried with 3" minus rock to a depth of 6 feet. This will provide additional filtration of sediment from the water as it flows through the rock and filter fabric. See photo 8. However, the sediment basin is functioning as designed and we have seen no evidence of sedimentation in the storm drain junction downstream of the sediment basin, as shown in the attached photo. See photo 9.
