## Santa Barbara County Reliability Project Construction Non-Compliance Report

<b>Incident Date:</b>	9/20/2017 to 11/21/2017	<b>Report No.:</b>	NCR-01
<b>Date Submitted:</b>	1/8/18	<b>Location:</b>	Multiple
<b>Level:</b>	Level 2	<b>Relevant Plan/ Measure:</b>	APM BIO-2, MM BIO-1, MM BIO-2, MM BIO-4, MM BIO-8
<b>Current Land Use:</b>	Disturbed; native oak; protected oak woodland; Rincon Creek environmentally sensitive area	<b>Sensitive Resources:</b>	Coast live oaks; California red-legged frog; Plummer's baccharis; Fish's milkwort

### Description of Incidents:

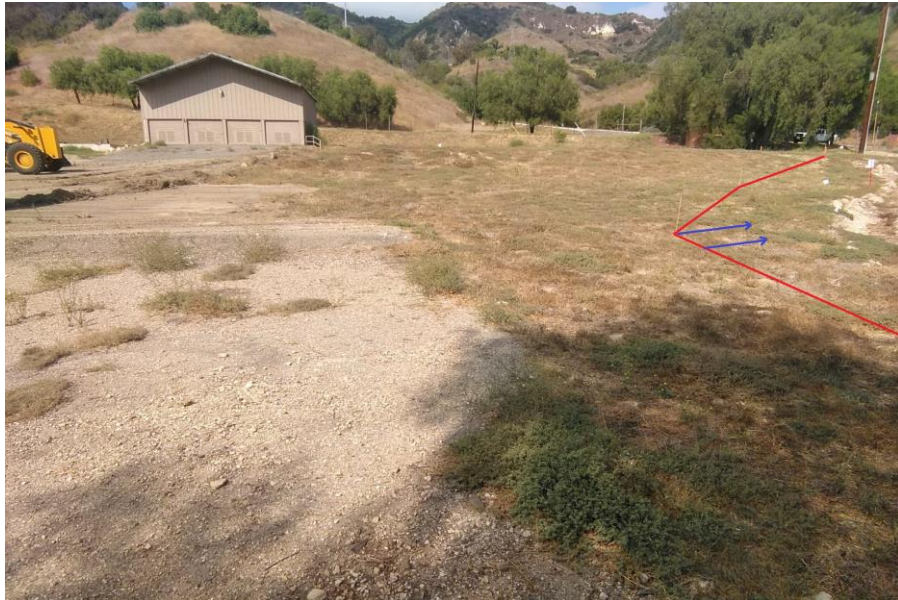
On September 20, 2017, despite approved work areas being clearly flagged, a Henkels & McCoy (H&M) backhoe reversed outside disturbance limits at the Teen Challenge Yard in Segment 1. Approximately 6 square feet of ruderal vegetation was disturbed. No listed species habitat was present. The backhoe operator moved back into the approved work area immediately upon being told he was outside the approved disturbance area.

Photo 1: Area where an H&M backhoe went outside of disturbance limits at the Teen Challenge Yard. The area is staked indicating the disturbance limits. September 20, 2017 (Photo by SCE)

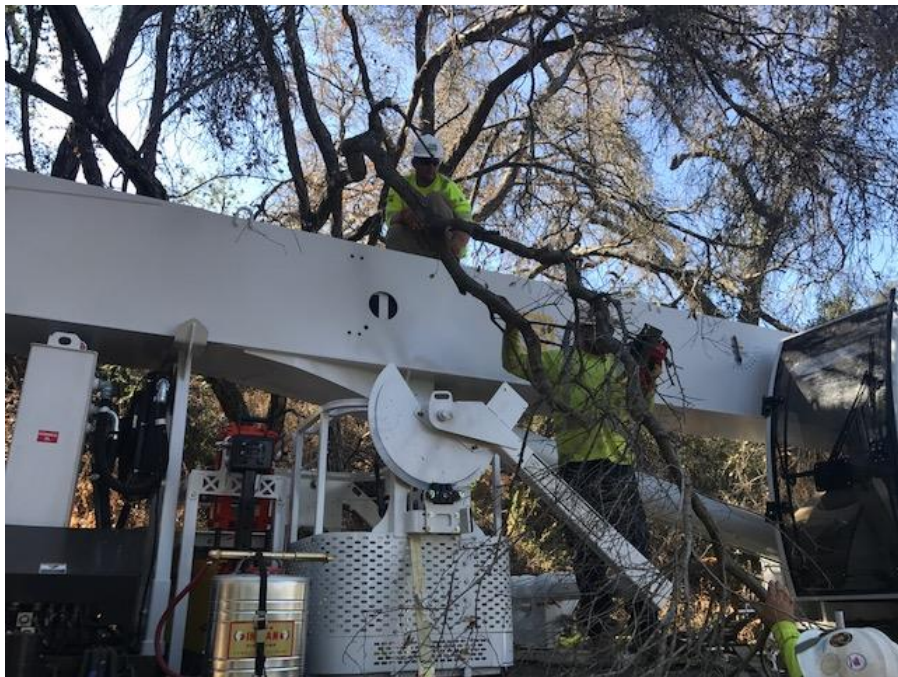
On October 18, 2017, a biological monitor observed an H&M crew trimming a dead coast live oak tree without an arborist present. The incident occurred in Segment 2 within disturbance limits. A convoy of H&M vehicles were travelling on the access road, including a crane that was too tall to pass under the oak tree. The access road was too narrow to turn around and reversing down the road would have been unsafe. The crew decided to trim the tree without an arborist present because the biologist confirmed the tree was dead.

An arborist is required to be present for the trimming of oak trees and is required to be consulted in order to reduce impacts on root systems. By trimming oak trees in the coastal zone without an arborist and by bulldozing in protected oak woodland and impacting roots, SCE violated MM BIO-4 on October 18 and November 21, 2017.

Photo 2: An H&M crew trimming a coast live oak tree along Segment 2 without an arborist present. October 18, 2017 (Photo by SCE)

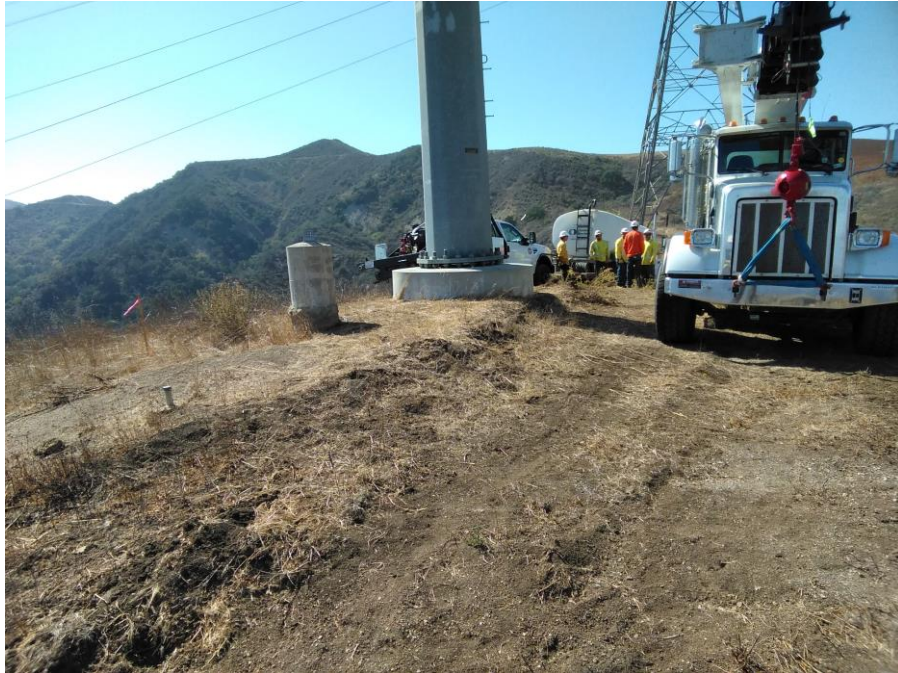
On October 18, 2017, at Construct 4453643E along Segment 2, an H&M crew welded brackets onto a tubular steel pole (TSP) in an area where a clearance sweep had not yet been performed. The area had been previously surveyed, the work was performed within approved disturbance limits and outside listed species habitat, and no resources were impacted by the incident. To resolve the incident, the foreman was informed that work must be preceded by a clearance sweep.

Photo 3: An H&M crew began welding brackets onto TSPs along Segment 3A before a pre-construction clearance sweep was conducted. October 18, 2017 (Photo by SCE)

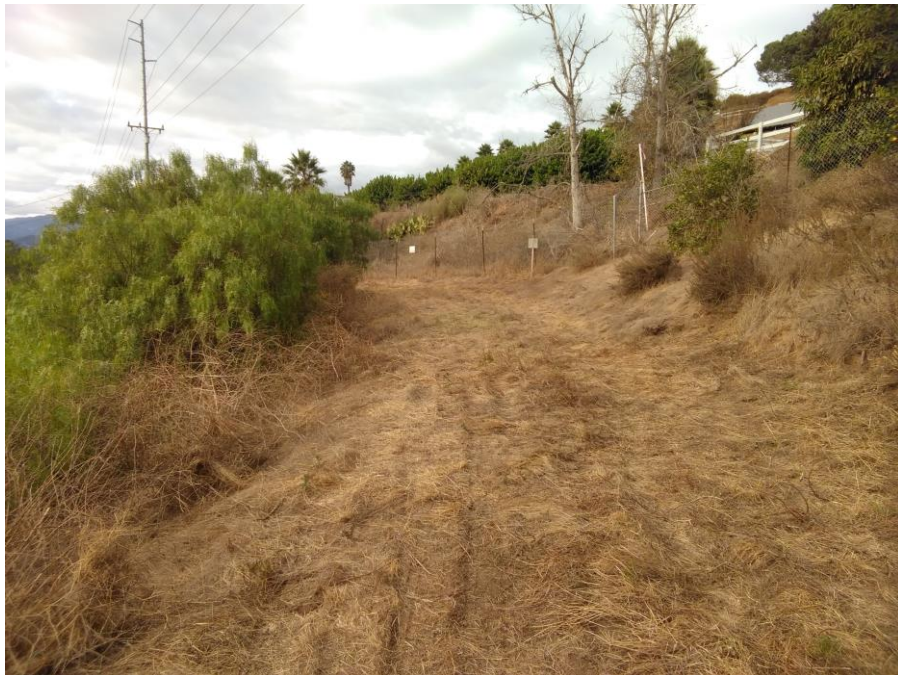
On November 2, 2017, an H&M crew trimmed vegetation along an access road to Construct 4435049E along Segment 3A before a clearance sweep had been performed. The area had been previously surveyed, the work was performed within approved disturbance limits and outside listed species habitat, and no resources were impacted by the incident. The incident was in the coastal zone. The incident report did not indicate the resolution.

Photo 4: Areas where an H&M crew trimmed and cleared vegetation along Segment 3A prior to a pre-construction clearance sweep. November 2, 2017 (Photo by SCE)

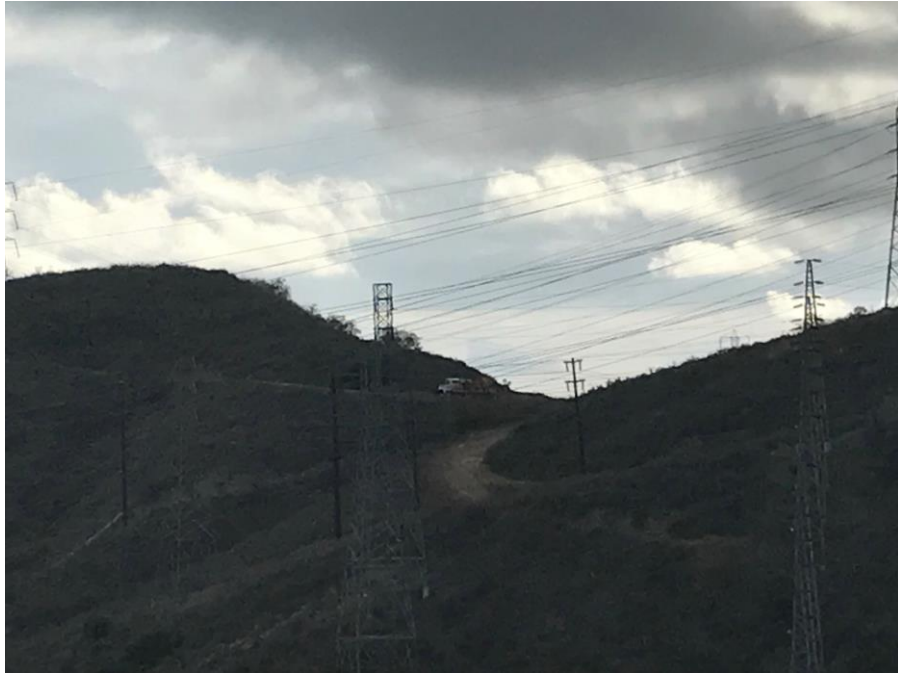
On November 3, 2017, near Construct M0-T1 along Segment 1, an H&M crew mobilized and staged a wire spool truck and conducted helicopter work in an area where a clearance sweep had not yet been performed. This incident occurred within approved disturbance limits in coastal sage scrub habitat. Environmentally Sensitive Area (ESA) signs were present and installed correctly. The foreman was reminded that crews must wait for clearance sweeps to be conducted before entering a new work area.

Photo 5: An H&M crew mobilized and staged equipment along Segment 3A prior to a pre-construction clearance sweep. November 3, 2017 (Photo by SCE)

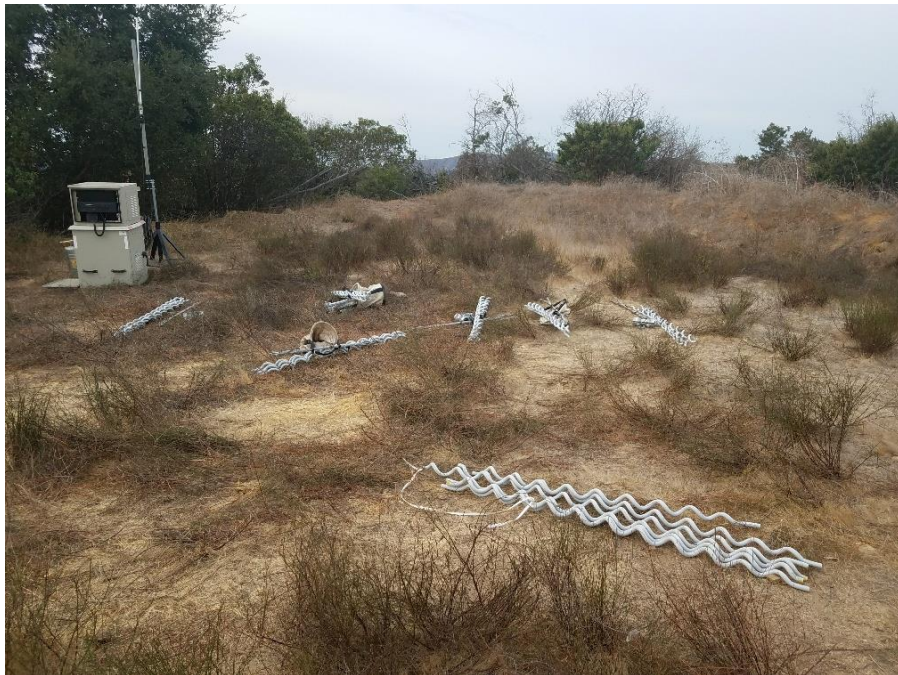
On November 12, 2017, materials were staged outside the approved work area along Segment 1 near Construct 4453231E. The materials crushed approximately 700 square feet of native vegetation. The materials were placed back inside approved disturbance limits on November 17, 2017.

Photo 6: Materials were staged outside of disturbance limits along Segment 1. November 12, 2017 (Photo by SCE)

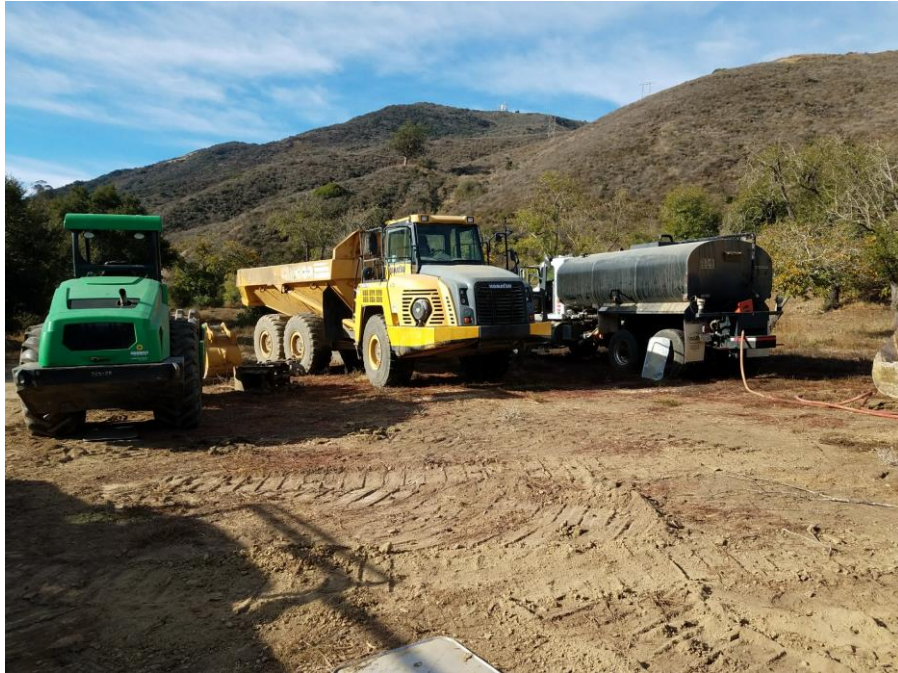
On November 20, 2017, H&M staged equipment outside approved disturbance limits west of Carver Summit Road on Segment 3B between Highway 150 and Construct 61. The equipment had been staged in this location over the weekend. This was the second incident of this kind for this crew, who had been told previously that they could not stage equipment in that location. The crew moved the equipment back inside the approved disturbance limits.

Photo 7: H&M staged equipment outside of project disturbance limits along Segment 3B. November 20, 2017 (Photo by SCE)

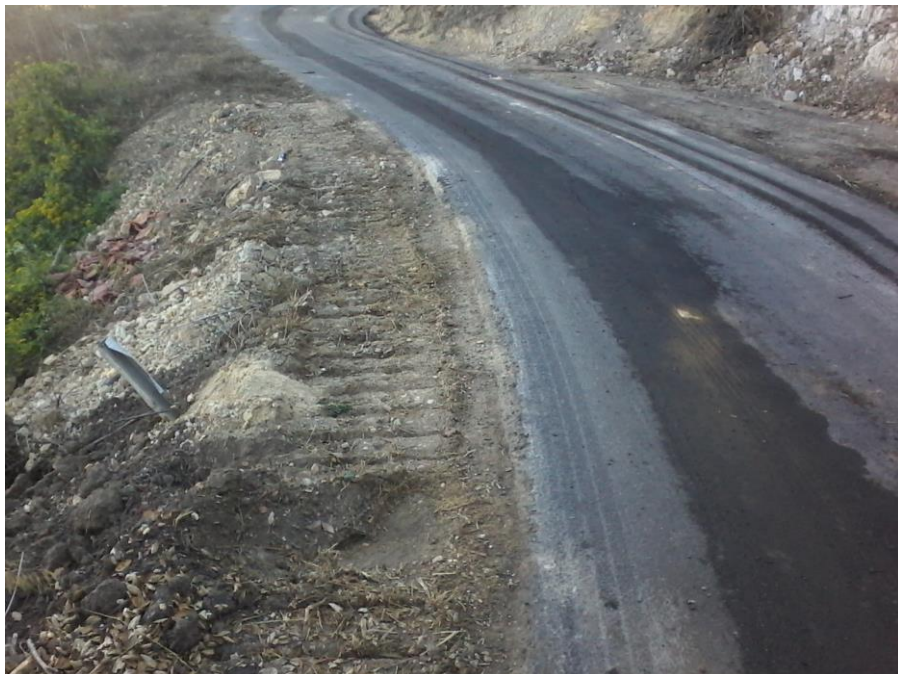
On November 21, 2017, an H&M bulldozer left tracks and was staged overnight within the Rincon Creek ESA along Segment 3B near Construct 70. The area was completely outside approved disturbance limits within potential habitat for California red-legged frog and adjacent to ESAs for Plummer's baccharis and Fish's milkwort. A landowner knocked over two ESA flags and, therefore, the crew parking the equipment was unaware of the ESA (Attachment 1). The equipment was moved back inside the approved disturbance limits the following day.

Riparian habitat and hydrological features are required to have a 50-foot exclusionary buffer or SCE is required to employ measures to reduce impacts to these areas. By parking equipment overnight in an exclusionary buffer around riparian habitat, SCE violated MM BIO-8 on November 21, 2017.

Photo 8: Bulldozer tracks outside of disturbance limits within the Rincon Creek ESA along Segment 3B. November 21, 2017 (Photo by SCE)

The monitor supporting the 11/22 work in the area spoke with the crew about parking in the area and the presence of the ESA. Additionally, the downed ESAs were re-established, clearly marking the boundary of the approved road and the start of the waterway.

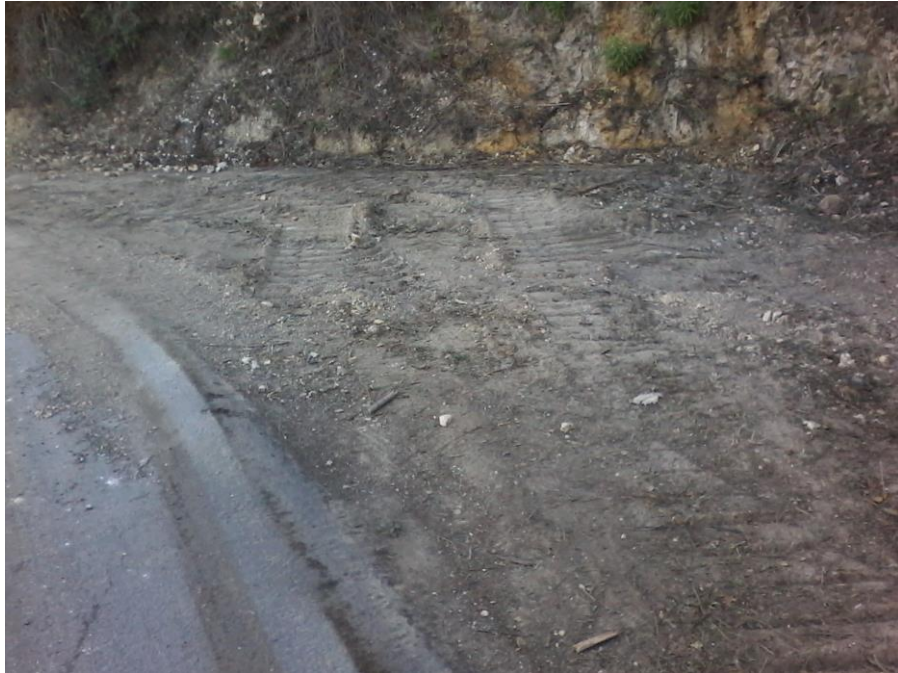
Photo 9: Bulldozer tracks within the Rincon Creek ESA buffer along Segment 38. November 21, 2017 (Photo by SCE)

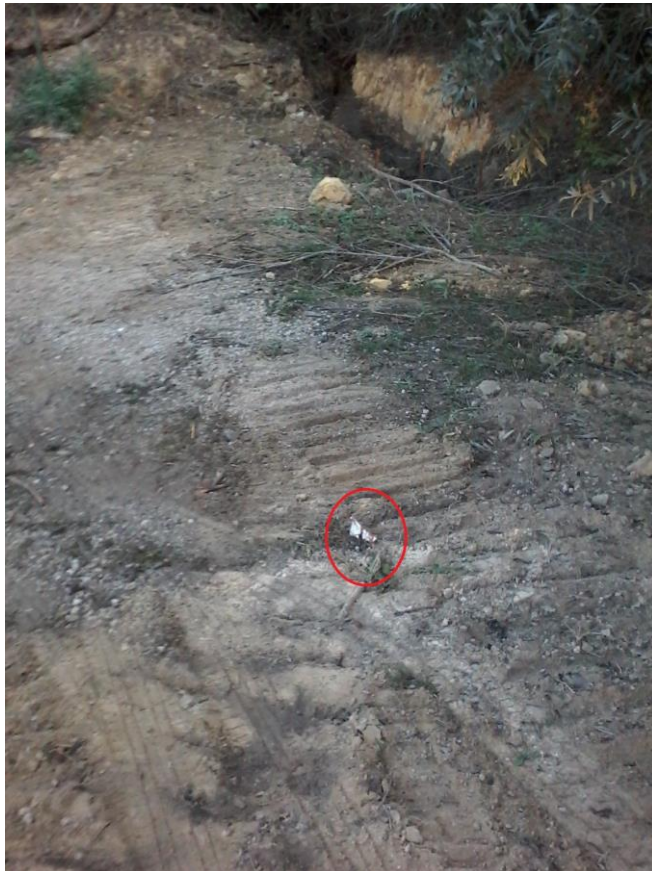
Upon further investigation, it was determined that the property owner had been blading the road and vegetation. During the landowner activities, the ESAs were damaged and downed.

Photo 10: ESA flagging and a stake knocked over and underneath bulldozer tracks within the Rincon Creek ESA buffer along Segment 3B. November 21, 2017 (Photo by SCE)

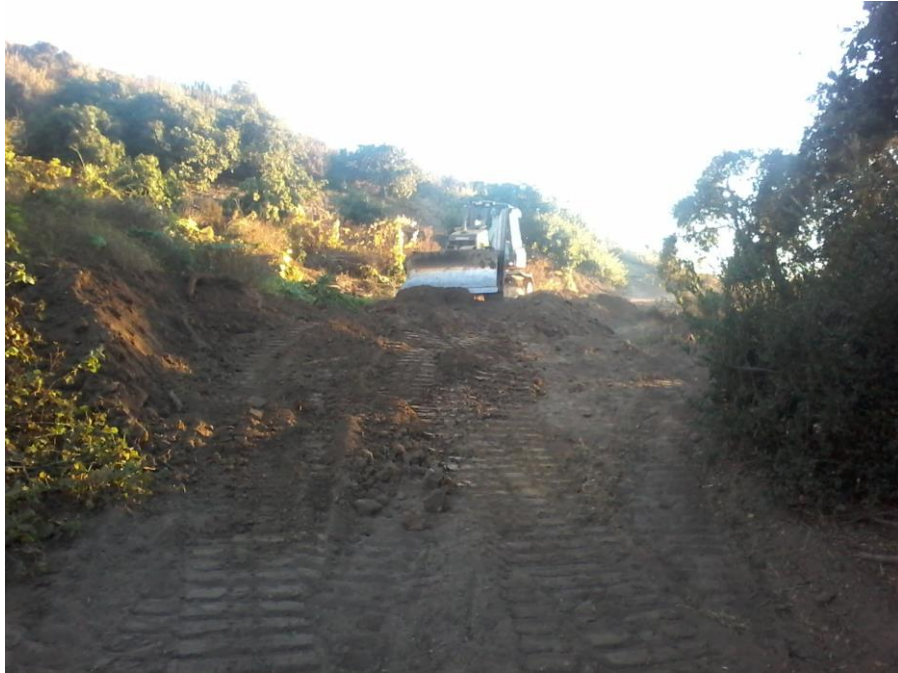
On November 21, 2017, at the request of the landowner, an H&M bulldozer graded a private road that had become overgrown for the purpose of depositing dirt from Construct 70 onto the landowner's property along Segment 3B. The road was not part of the project and was completely outside approved disturbance limits. The bulldozed area was about 450 feet long and impacted protected oak tree roots. The environmental monitor issued a stop work notice to the crew until a resolution could be reached. The California Public Utilities Commission (CPUC) was made aware of the incident by an automatic notification from SCE's online database. The CPUC was not notified that a stop work order had been issued until November 30, 2017. SCE informed H&M that landowner requests for soil or additional work are not part of the project permit and will not be permitted (Attachment 1).

Photo 11: An H&M crew bulldozing road outside of the approved project area near Construct 70 on Segment 3B. November 21, 2017 (Photo by SCE)

*The Contractor project manager, Paul Viggiano, addressed all crew members at the morning tailboard briefing reinforcing the compliance requirements and potential for further action in the event that the noncompliance trend continues. He indicated these actions, while well intentioned for landowner acceptability, were simply not in compliance with the project's permit. H&M's crews were instructed to follow the permit requirements and that landowner requests for soils or additional work cannot be a part of our project. All excavated soils shall be removed from the project in accordance with the project's requirements.*

*Additionally, the Environmental Manager, Felicia Nancarrow, contacted the foremen and requested they contact her or the project manager immediately if the land owners requested modifications to construction or additional work by the crews prior to any work taking place. The Environmental Manager also reminded the environmental leads that they have the authority to stop work and the protocols that need to be followed in the event a stop work has been issued and should escalate the issue to the Environmental Manager and the Project Manager.*

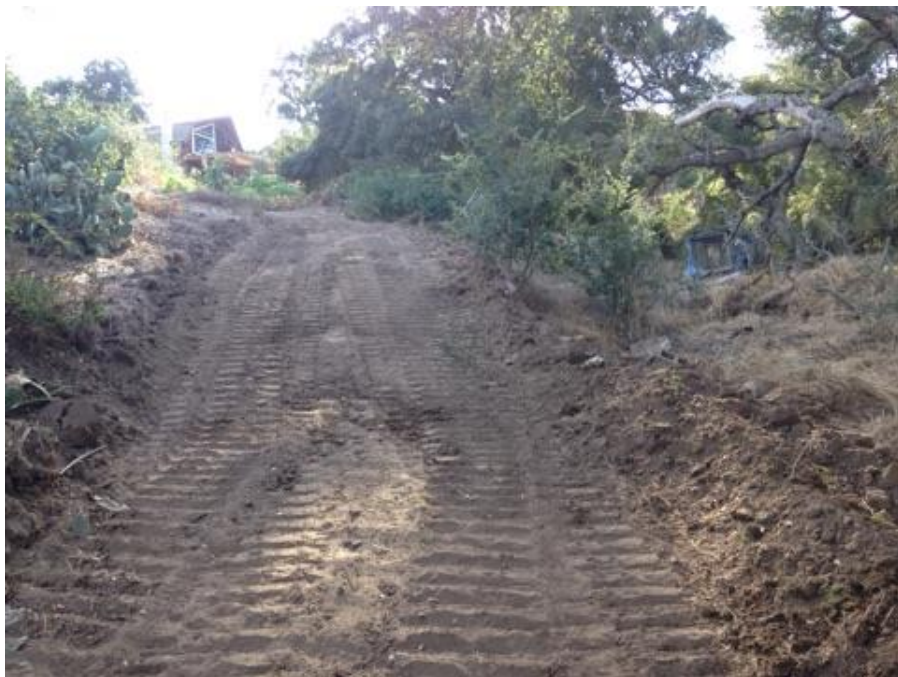
Photo 12: New road bulldozed outside the approved project area near Construct 70 on Segment 3B. November 21, 2017 (Photo by SCE)

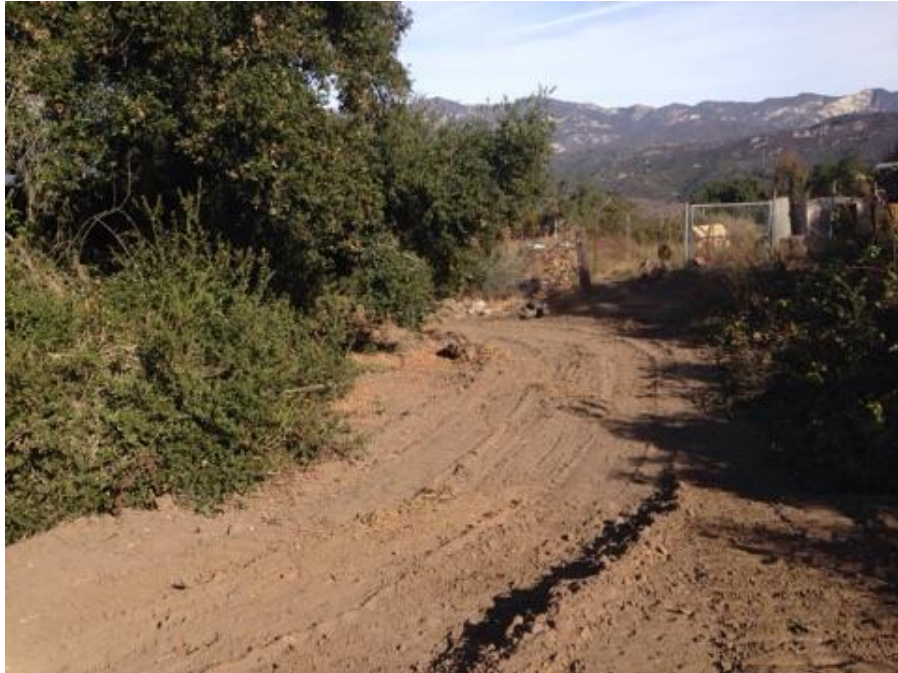
Photo 13: Oak woodland impacted by the new road incident near Construct 70 on Segment 3B. November 21, 2017 (Photo by SCE)

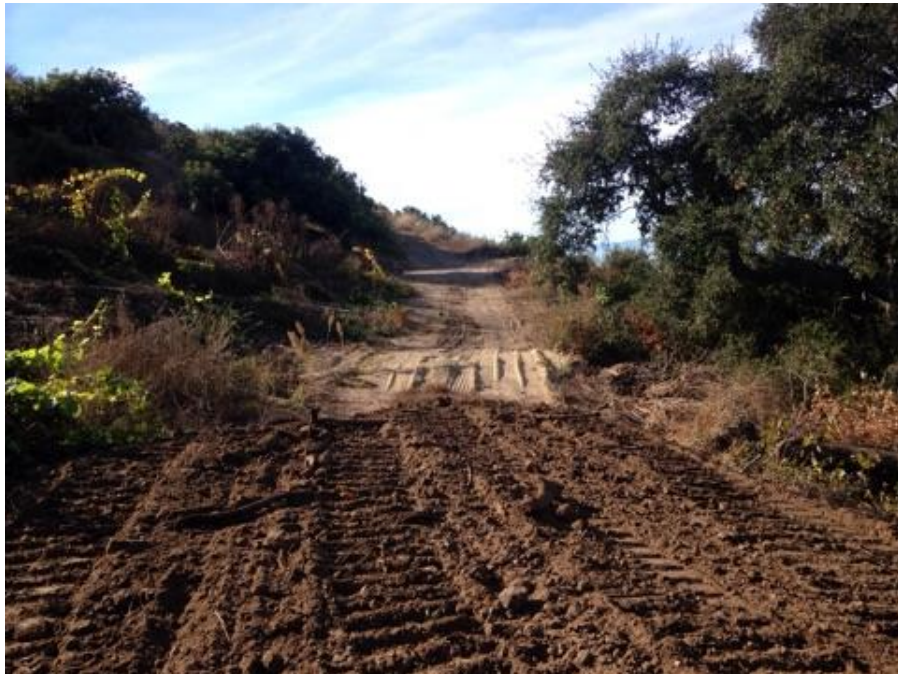
Photo 14: End of new road bulldozed outside of disturbance limits near Construct 70 on Segment 3B. November 21, 2017 (Photo by SCE)
