**GEOTECHNICAL INVESTIGATION REPORT
PACIFIC GAS AND ELECTRIC COMPANY
FULTON-FITCH TSP REPLACEMENT PROJECT
SONOMA COUNTY, CALIFORNIA**

PROJECT NO. 20190527.001A

**SEPTEMBER 6, 2018
Revised September 24, 2018**

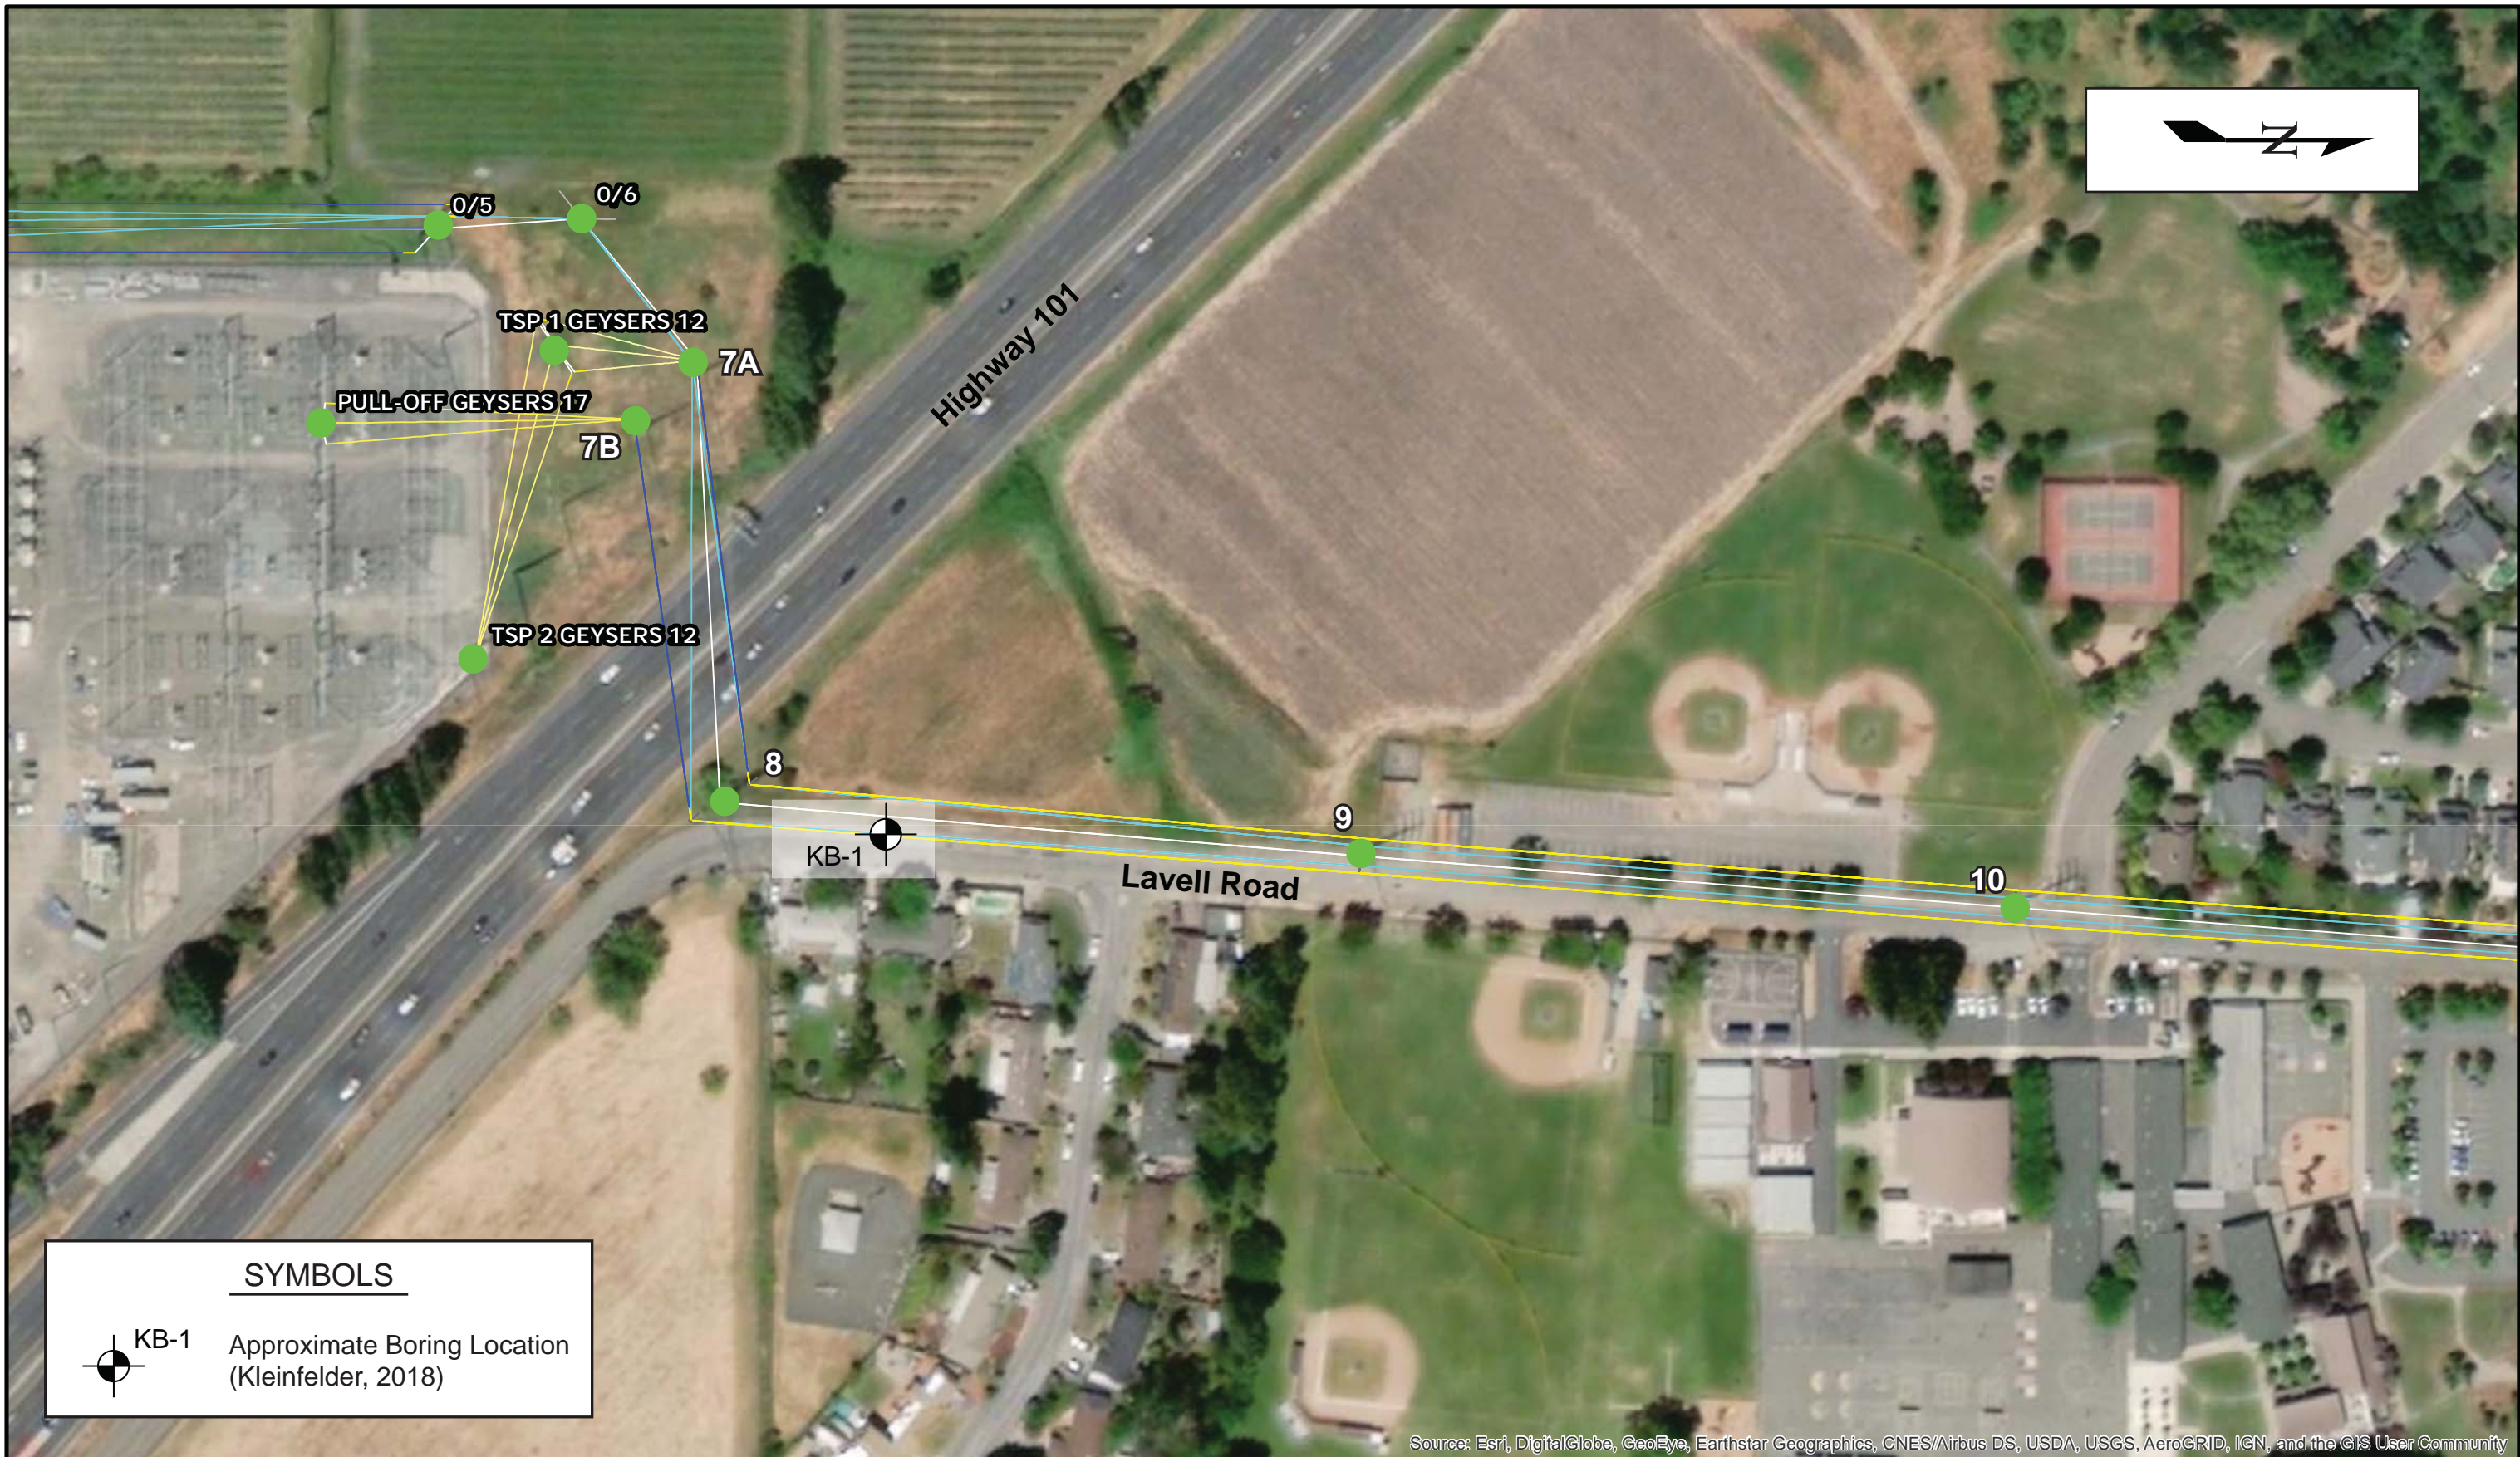
FIGURE
2a

SITE PLAN	
PG&E FULTON FITCH TSP REPLACEMENT GEOTECHNICAL INVESTIGATION SANTA ROSA, CALIFORNIA

This report presents the results of the geotechnical investigation conducted for the proposed tubular steel pole (TSP) replacements in a line segment starting near Fulton substation and continuing north to Faught Road near Shiloh Ranch Regional Park. A site location map and site plan showing the exploration locations are shown on Figures 1 and 2, respectively. Larger scale site plans showing the proposed TSP replacement locations are provided on Figures 3 through 6.

Our understanding of the project is based on correspondence with PG&E, a conference call on April 5, 2018 with PG&E, and a review of CPUC records. We understand that 21 TSPs will be replaced along an approximately 9,000-foot long segment of the southern “Fulton Shiloh Segment”, which includes the line segment between the Fulton Substation and Faught Road near Shiloh Ranch Regional Park. The poles slated for replacement are Poles 7_A/B through Pole 23, as shown on Figures 3 through 6.

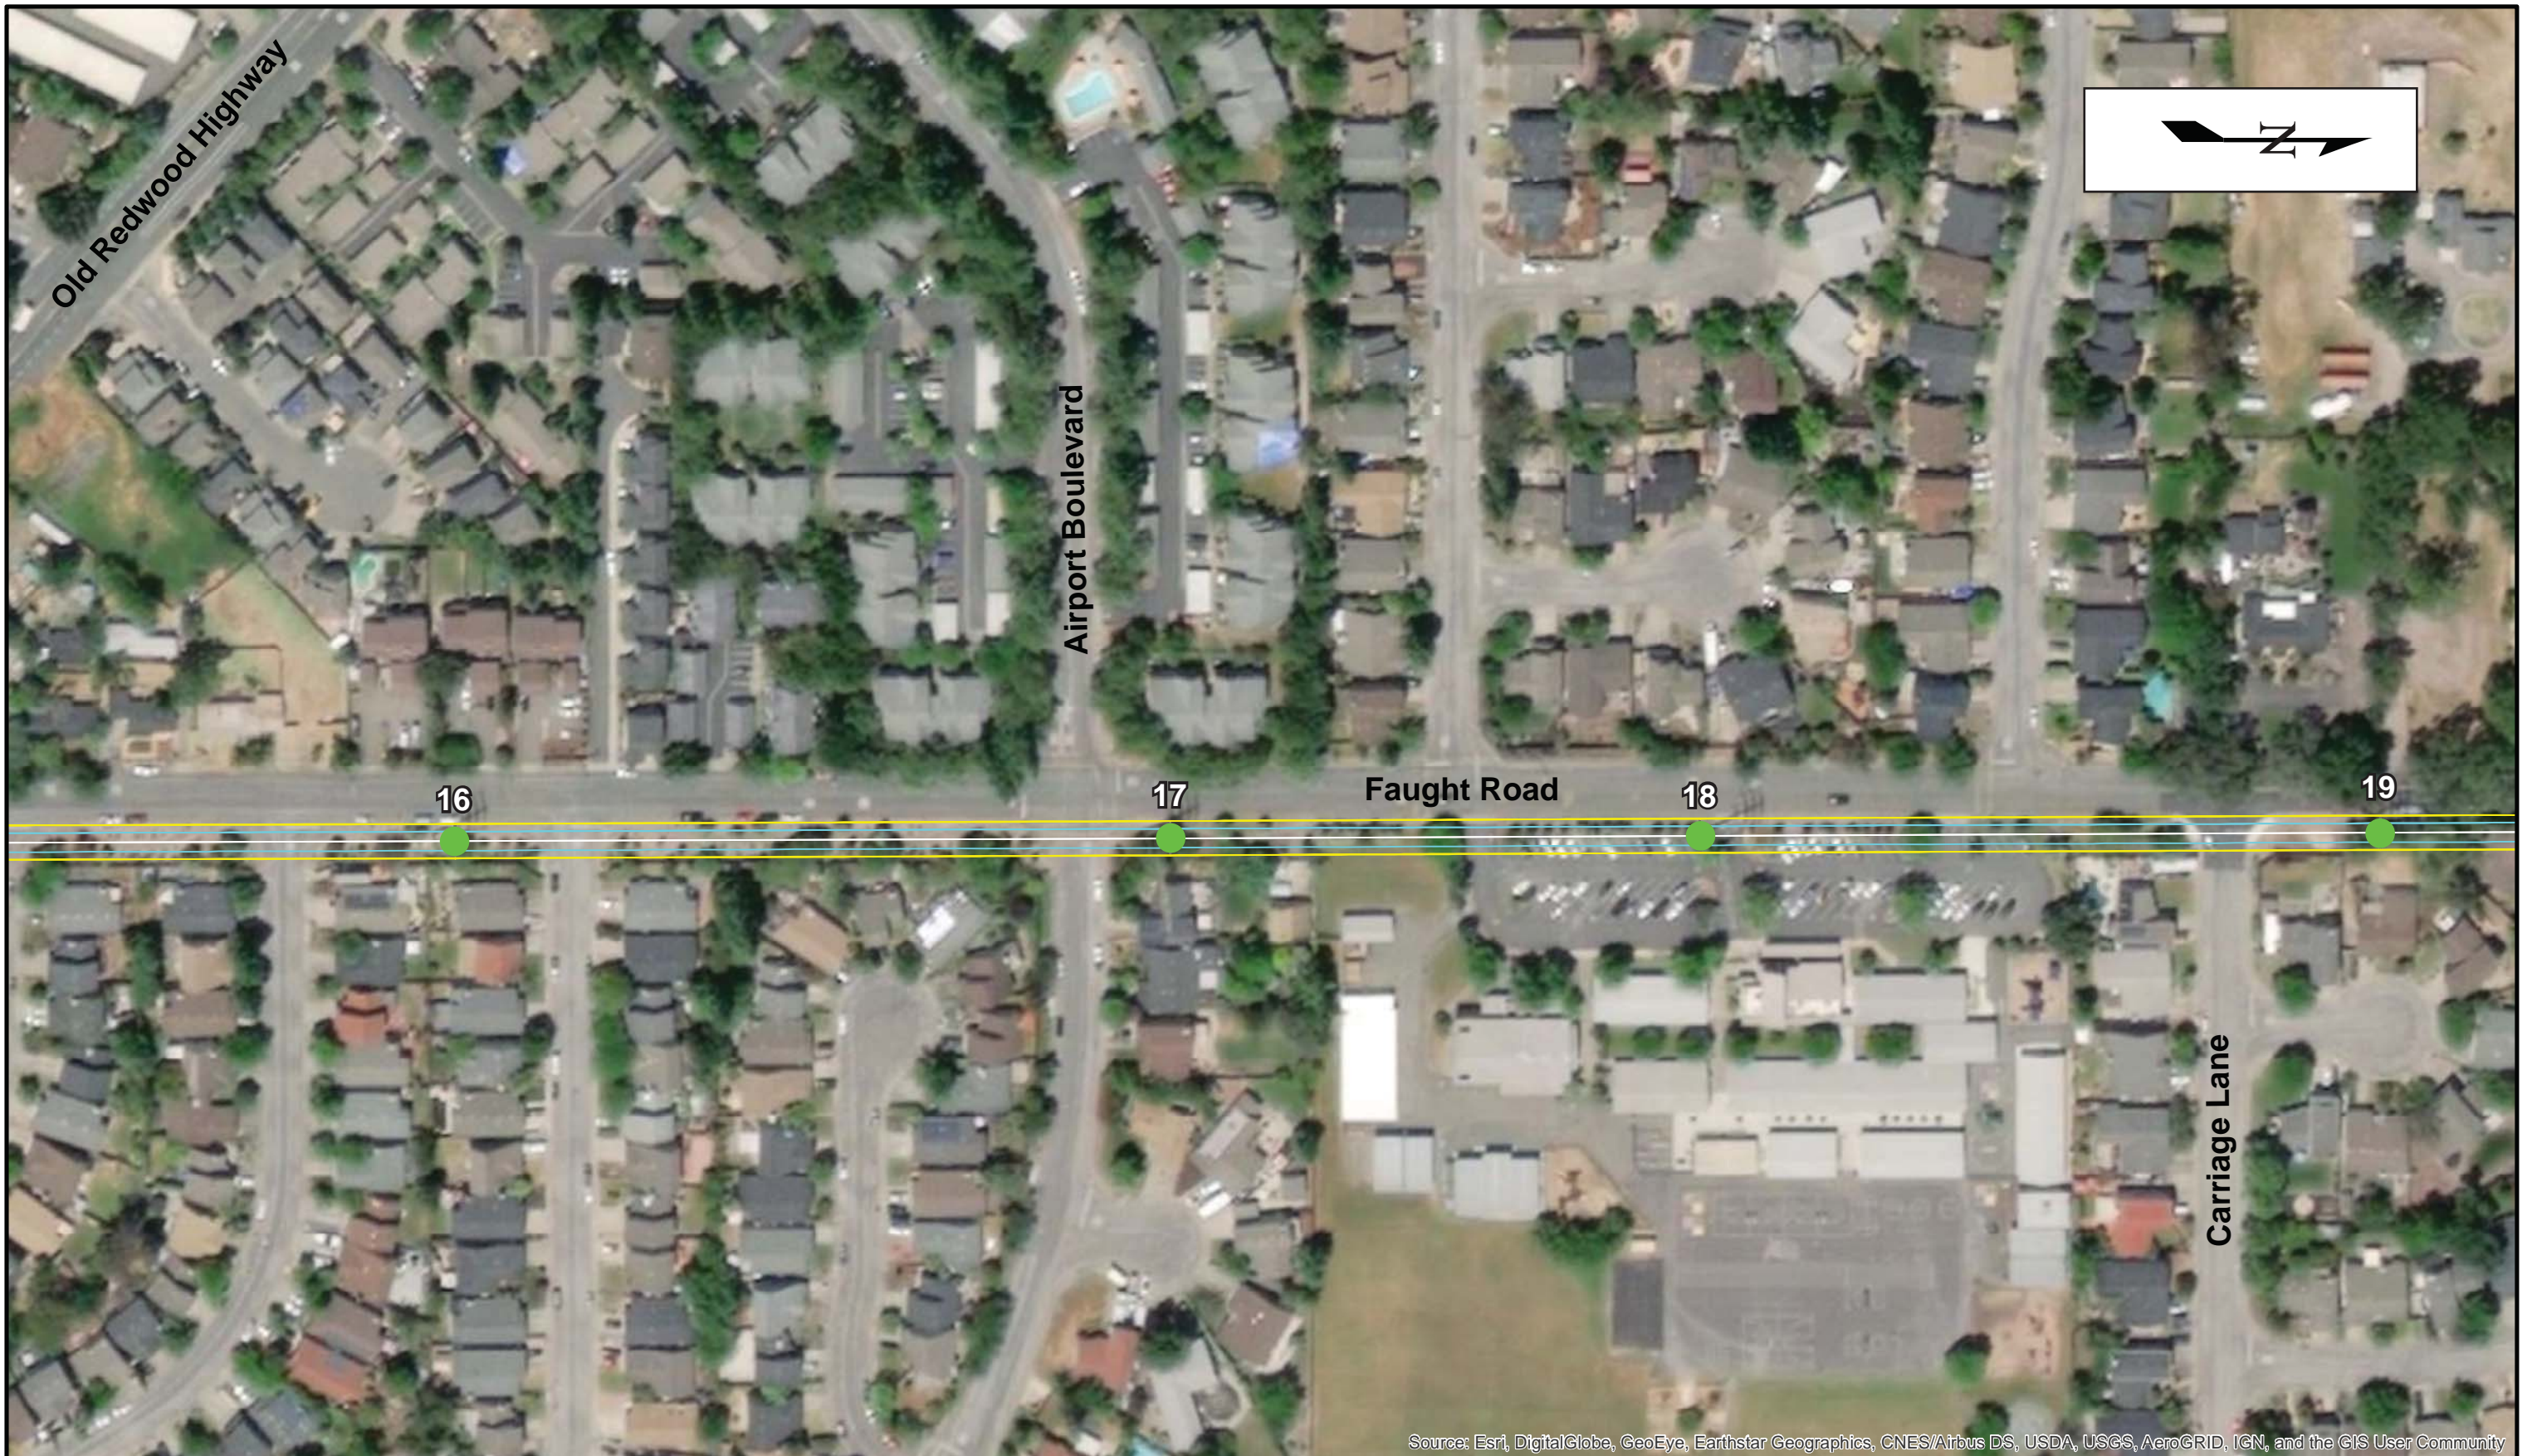
FIGURE
2c

SITE PLAN
PG&E FULTON FITCH TSP REPLACEMENT GEOTECHNICAL INVESTIGATION SANTA ROSA, CALIFORNIA

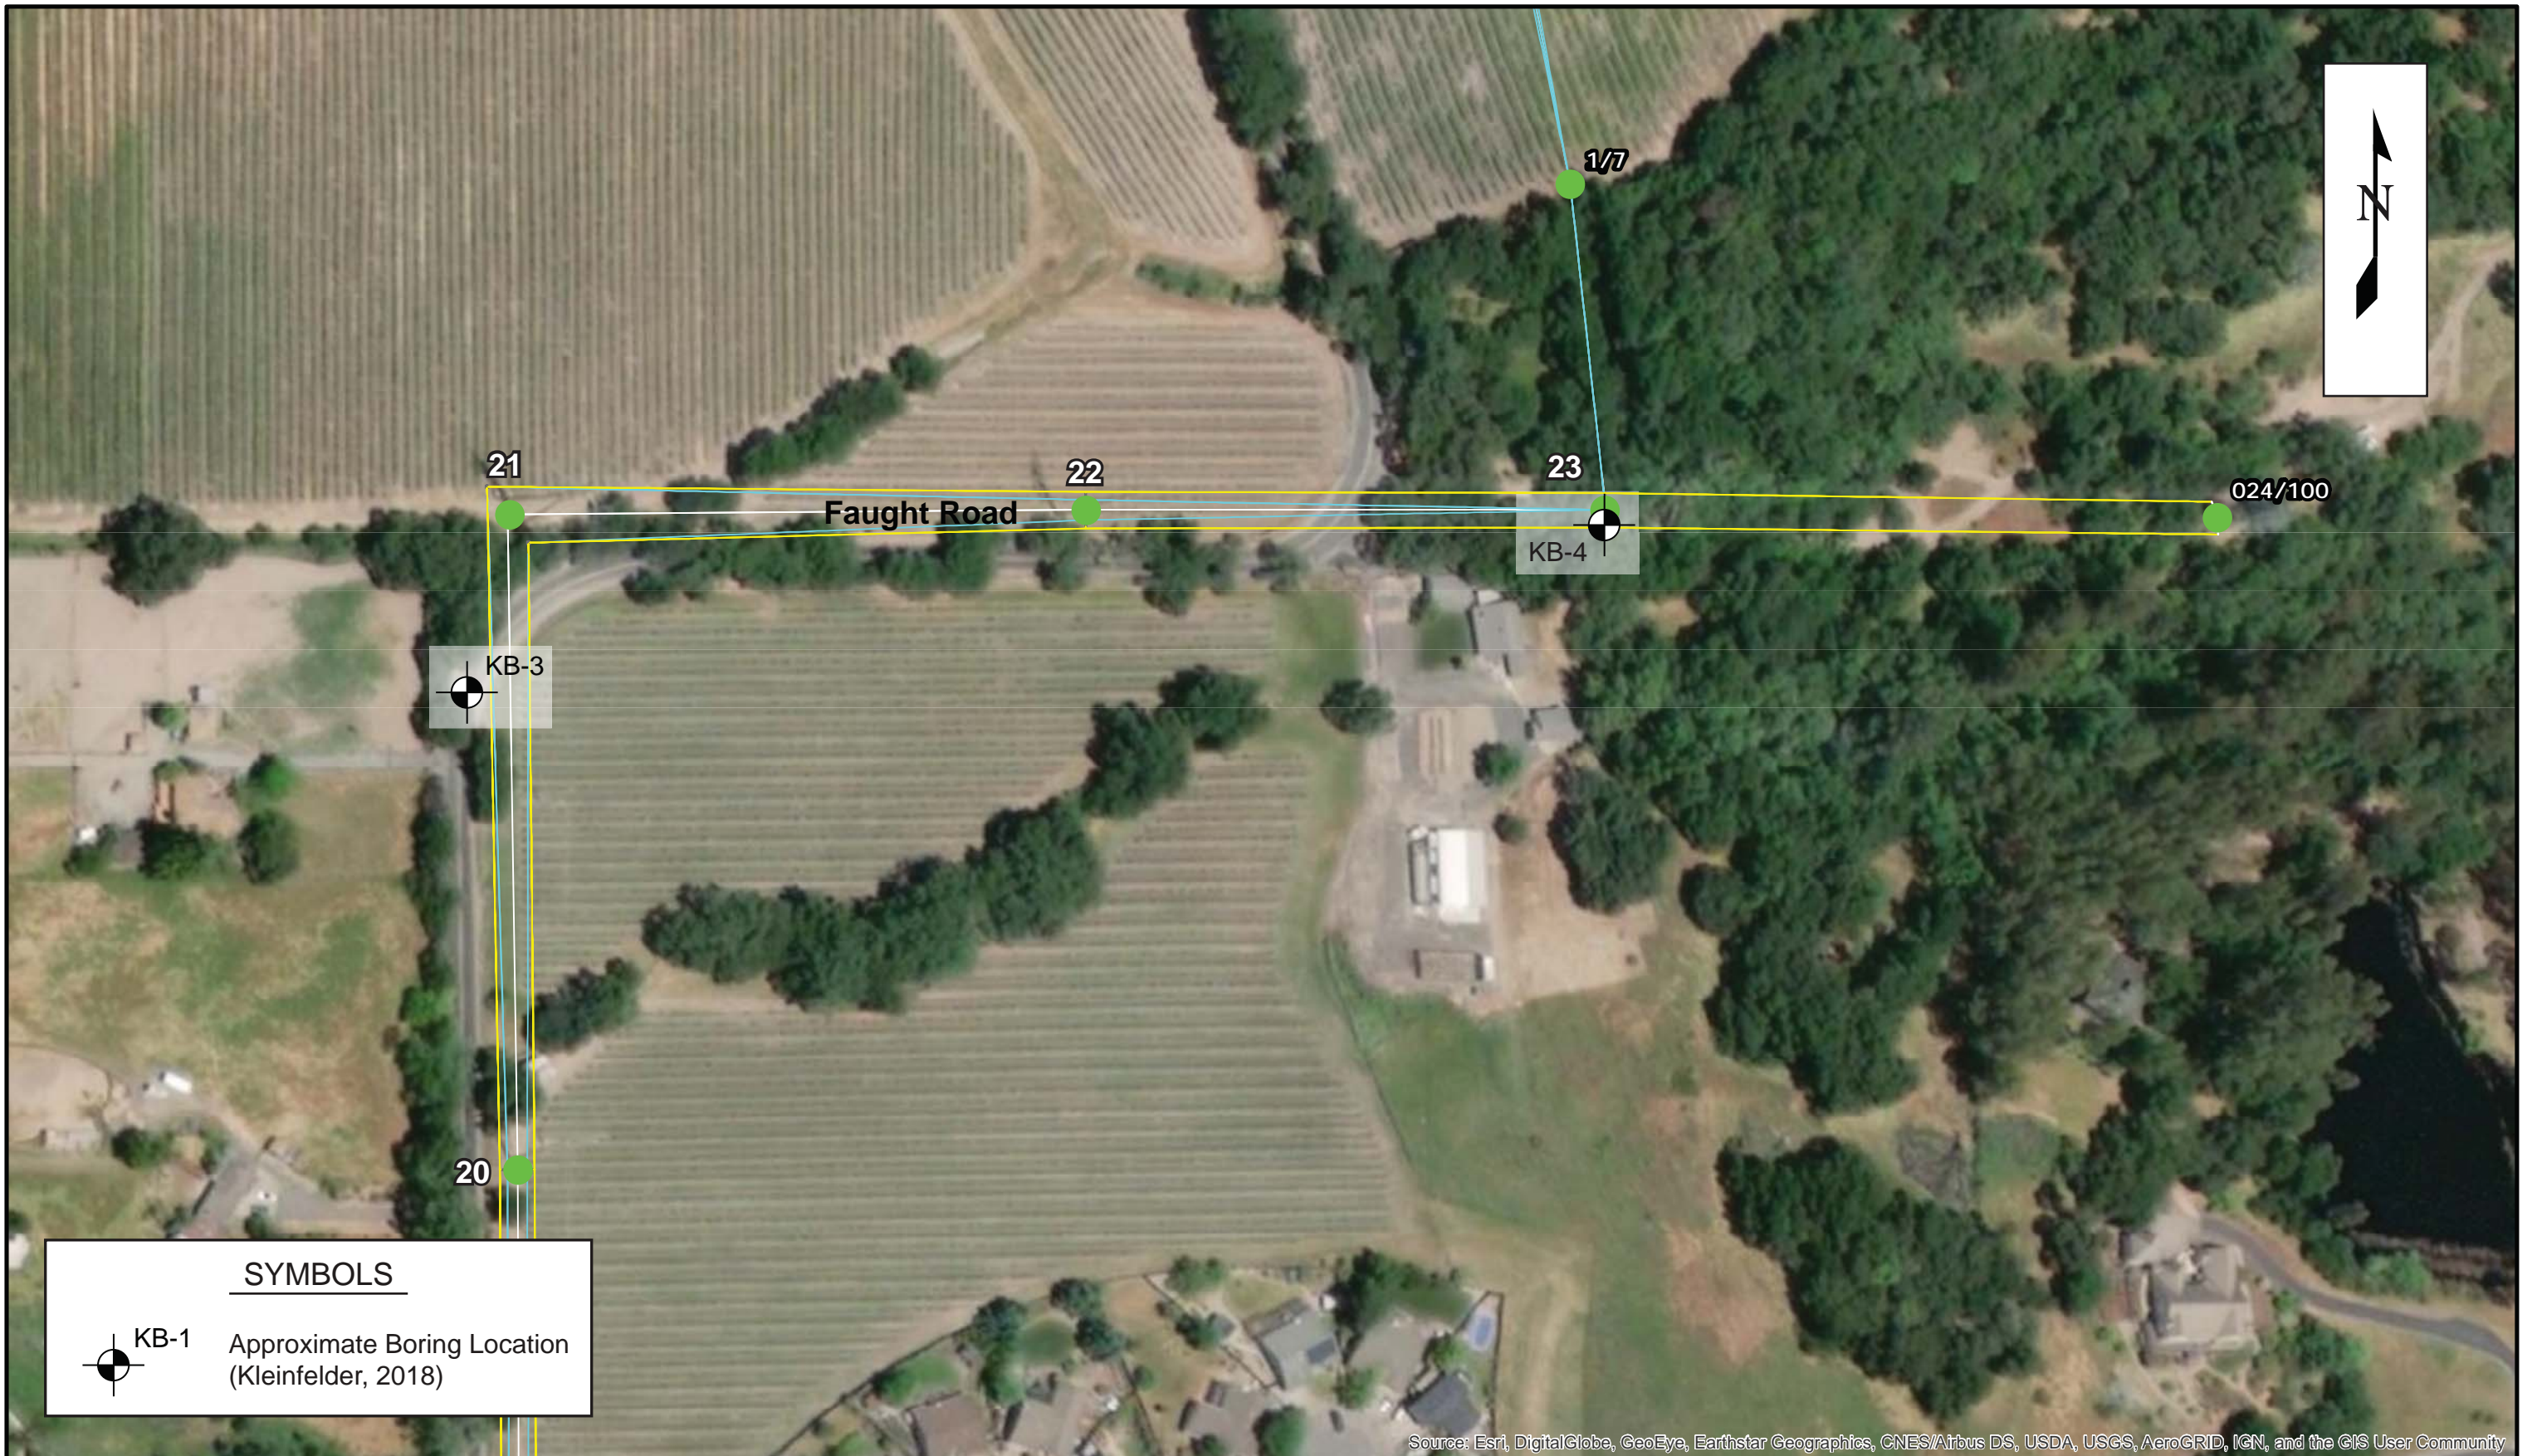
FIGURE
2d

SITE PLAN
PG&E FULTON FITCH TSP REPLACEMENT GEOTECHNICAL INVESTIGATION SANTA ROSA, CALIFORNIA

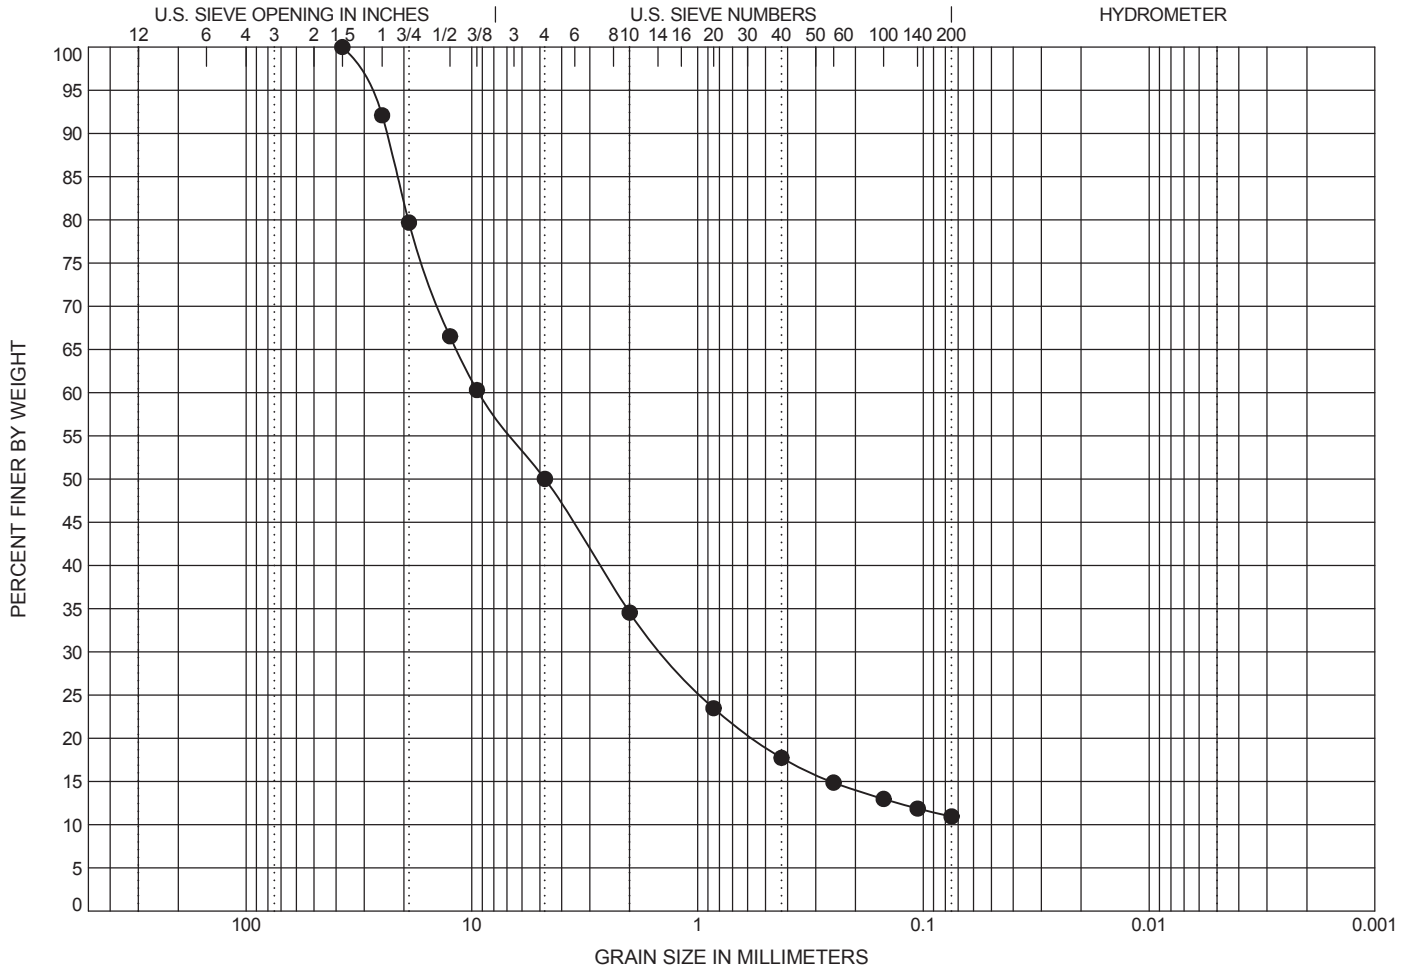
SIEVE ANALYSIS
 PG&E Fulton-Fitch TSP Replacements
 Santa Rosa, California

Exploration ID	Depth (ft.)	Sample Description	LL	PL	PI
● KB-2	25	POORLY GRADED GRAVEL WITH SILT AND SAND (GP-GM)	NM	NM	NM

Exploration ID	Depth (ft.)	D ₁₀₀	D ₆₀	D ₃₀	D ₁₀	C _c	C _u	Passing #4	Passing #200	%Silt	%Clay
● KB-2	25	37.5	9.309	1.407	NM	4.07	178.13	80	11	NM	NM

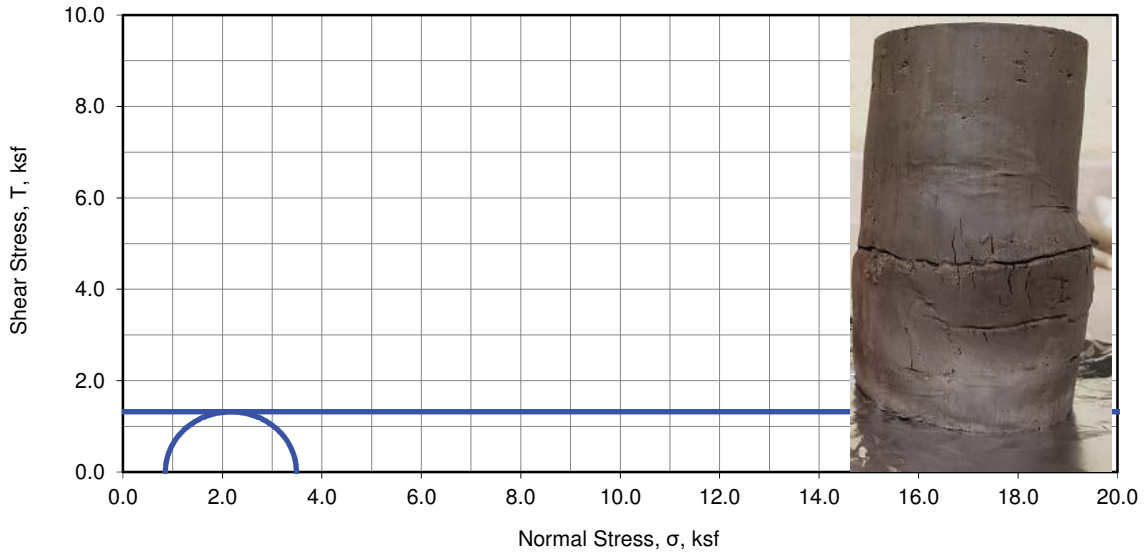
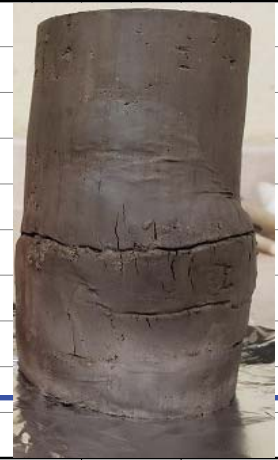
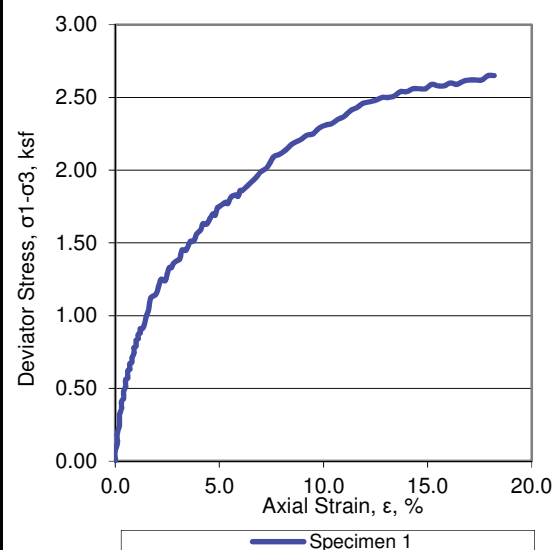
Specimen No.		1
Initial	Diameter, in	D ₀ 2.40
	Height, in	H ₀ 4.37
	Water Content, %	w ₀ 29.6
	Dry Density, lbs/ft ³	γ _{d0} 107.6
	Saturation, %	S ₀ 146
Void Ratio		e ₀ 0.537
Minor Principal Stress, ksf		σ ₃ 0.85
Maximum Deviator Stress, ksf		(σ ₁ -σ ₃) _{max} 2.65
Time to (σ ₁ -σ ₃) _{max} , min		t _f 14.83
Deviator Stress @ 15% Axial Strain, ksf		(σ ₁ -σ ₃) _{15%} 2.56
Ultimate Deviator Stress, ksf		(σ ₁ -σ ₃) _{ult} na
Rate of strain, %/min		'ε 1.00
Axial Strain at Failure, %		ε _f 14.83

Description of Specimen: Dark Yellowish Brown Lean Clay (CL)			
Amount of Material Finer than the No. 200, %: nm			
LL: nm	PL: nm	PI: nm	G _s : 2.65 Assumed
Specimen Type: Undisturbed		Test Method: ASTM D2850

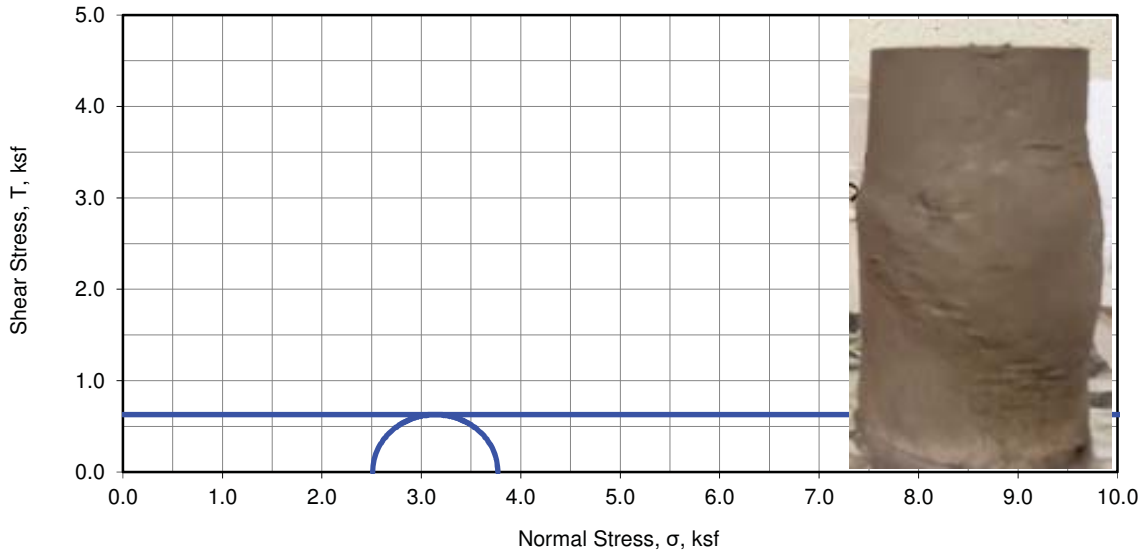
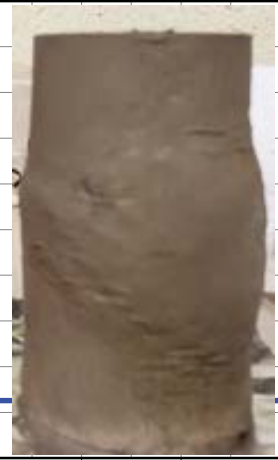
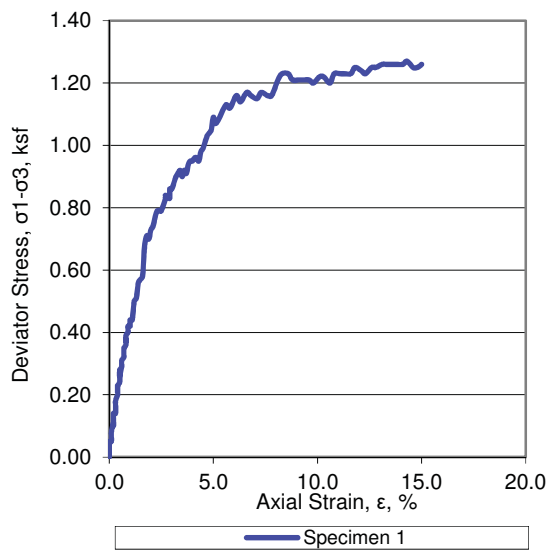
Specimen No.		1
Initial	Diameter, in	D ₀ 2.39
	Height, in	H ₀ 5.36
	Water Content, %	w ₀ 44.7
	Dry Density, lbs/ft ³	γ _{d0} 76.0
	Saturation, %	S ₀ 101
Void Ratio		e ₀ 1.176
Minor Principal Stress, ksf		σ ₃ 2.51
Maximum Deviator Stress, ksf		(σ ₁ -σ ₃) _{max} 1.27
Time to (σ ₁ -σ ₃) _{max} , min		t _f 14.33
Deviator Stress @ 15% Axial Strain, ksf		(σ ₁ -σ ₃) _{15%} 1.26
Ultimate Deviator Stress, ksf		(σ ₁ -σ ₃) _{ult} na
Rate of strain, %/min		'ε 1.00
Axial Strain at Failure, %		ε _f 14.33

Description of Specimen: Dark Grayish Brown Sandy Fat Clay (CH)

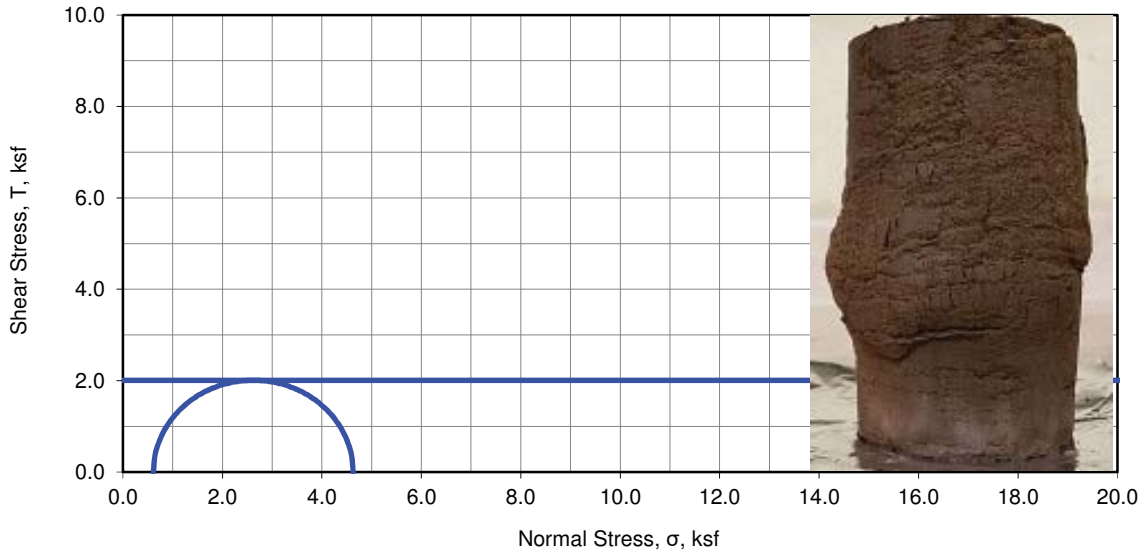
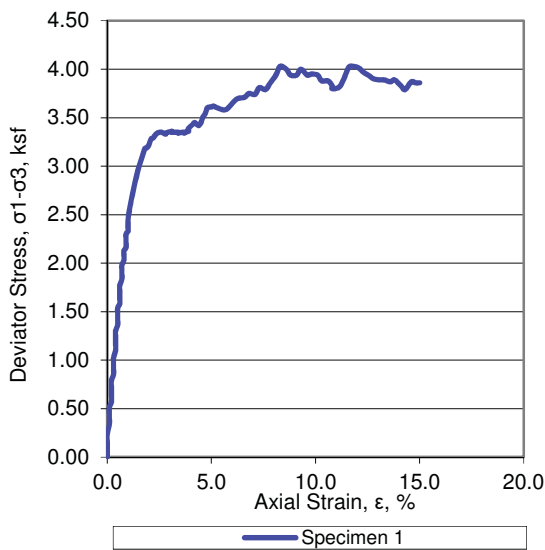
Specimen No.		1
Initial	Diameter, in	D ₀ 2.39
	Height, in	H ₀ 5.67
	Water Content, %	ω ₀ 19.2
	Dry Density, lbs/ft ³	γ _{d0} 86.7
	Saturation, %	S ₀ 56
Void Ratio		e ₀ 0.907
Minor Principal Stress, ksf		σ ₃ 0.60
Maximum Deviator Stress, ksf		(σ ₁ -σ ₃) _{max} 4.03
Time to (σ ₁ -σ ₃) _{max} , min		t _f 8.33
Deviator Stress @ 15% Axial Strain, ksf		(σ ₁ -σ ₃) _{15%} 3.86
Ultimate Deviator Stress, ksf		(σ ₁ -σ ₃) _{ult} na
Rate of strain, %/min		'ε 1.00
Axial Strain at Failure, %		ε _f 8.33

Description of Specimen: Dark Yellowish Brown Sandy Lean Clay (CL)

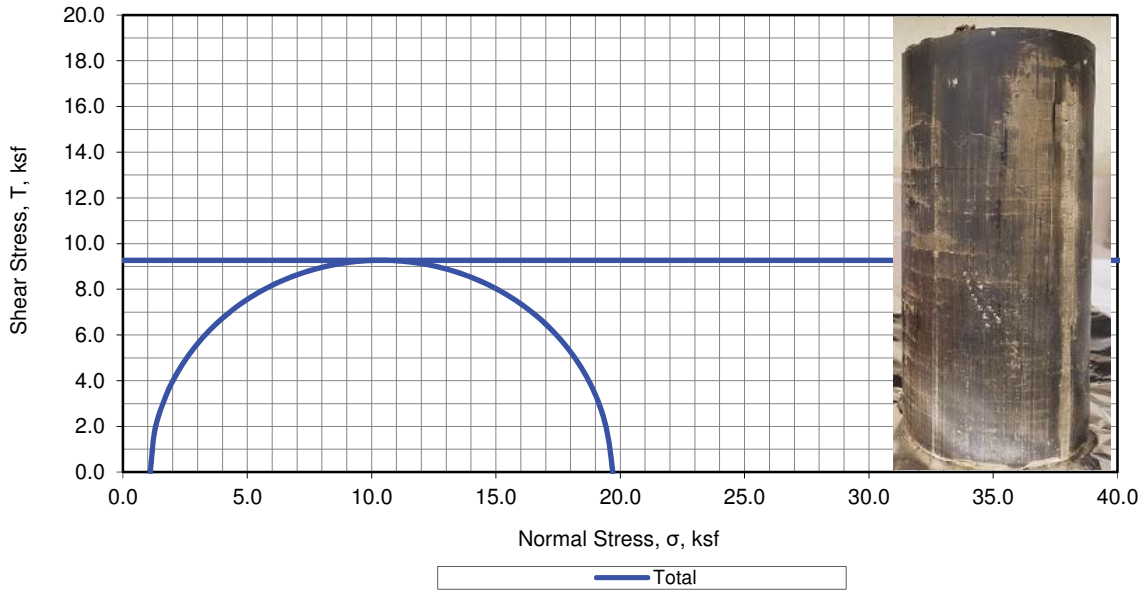
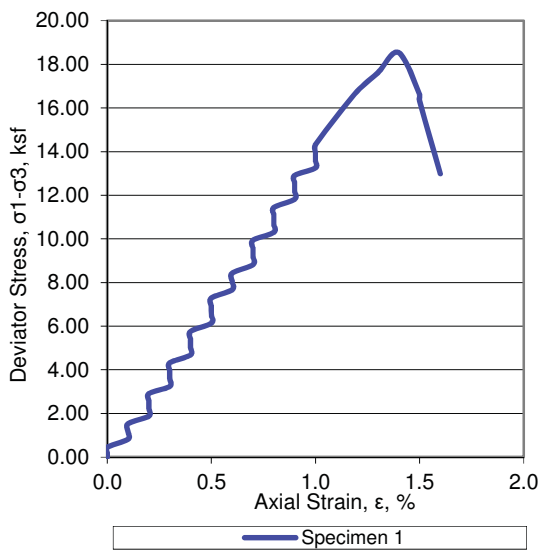
Specimen No.		1
Initial	Diameter, in	D ₀ 2.40
	Height, in	H ₀ 5.30
	Water Content, %	w ₀ 21.1
	Dry Density, lbs/ft ³	γ _{d0} 84.6
	Saturation, %	S ₀ 59
Void Ratio		e ₀ 0.955
Minor Principal Stress, ksf		σ ₃ 1.09
Maximum Deviator Stress, ksf		(σ ₁ -σ ₃) _{max} 18.54
Time to (σ ₁ -σ ₃) _{max} , min		t _f 1.45
Deviator Stress @ 15% Axial Strain, ksf		(σ ₁ -σ ₃) _{15%} 12.99
Ultimate Deviator Stress, ksf		(σ ₁ -σ ₃) _{ult} na
Rate of strain, %/min		'ε 1.00
Axial Strain at Failure, %		ε _f 1.45

Description of Specimen: Olive Brown Lean Clay (CL)

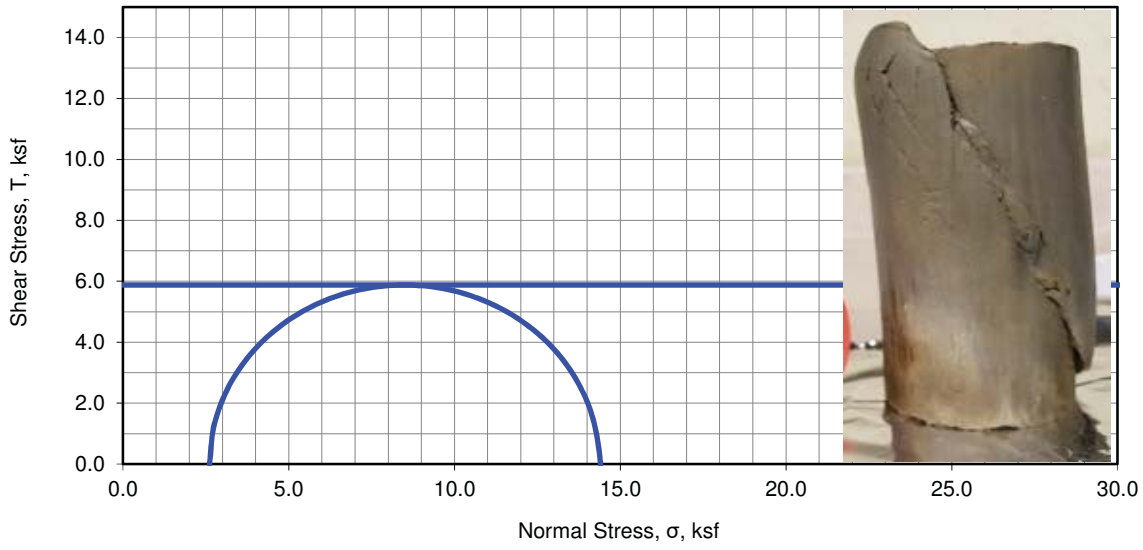
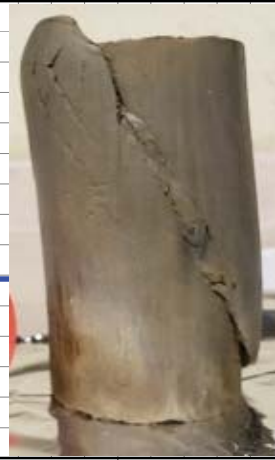
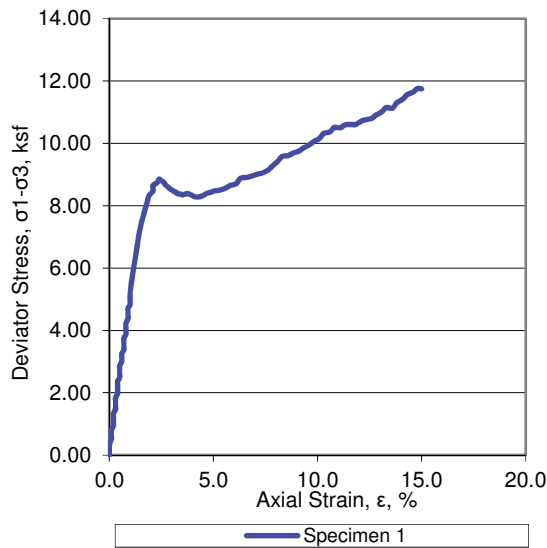
Specimen No.		1
Initial	Diameter, in	D ₀ 2.40
	Height, in	H ₀ 5.47
	Water Content, %	ω ₀ 28.6
	Dry Density, lbs/ft ³	γ _{d0} 89.3
	Saturation, %	S ₀ 89
	Void Ratio	e ₀ 0.852
Minor Principal Stress, ksf		σ ₃ 2.61
Maximum Deviator Stress, ksf		(σ ₁ -σ ₃) _{max} 11.76
Time to (σ ₁ -σ ₃) _{max} , min		t _f 14.82
Deviator Stress @ 15% Axial Strain, ksf		(σ ₁ -σ ₃) _{15%} 11.75
Ultimate Deviator Stress, ksf		(σ ₁ -σ ₃) _{ult} na
Rate of strain, %/min		'ε 1.00
Axial Strain at Failure, %		ε _f 14.82

Description of Specimen: Olive Brown Sandy Fat Clay (CH)

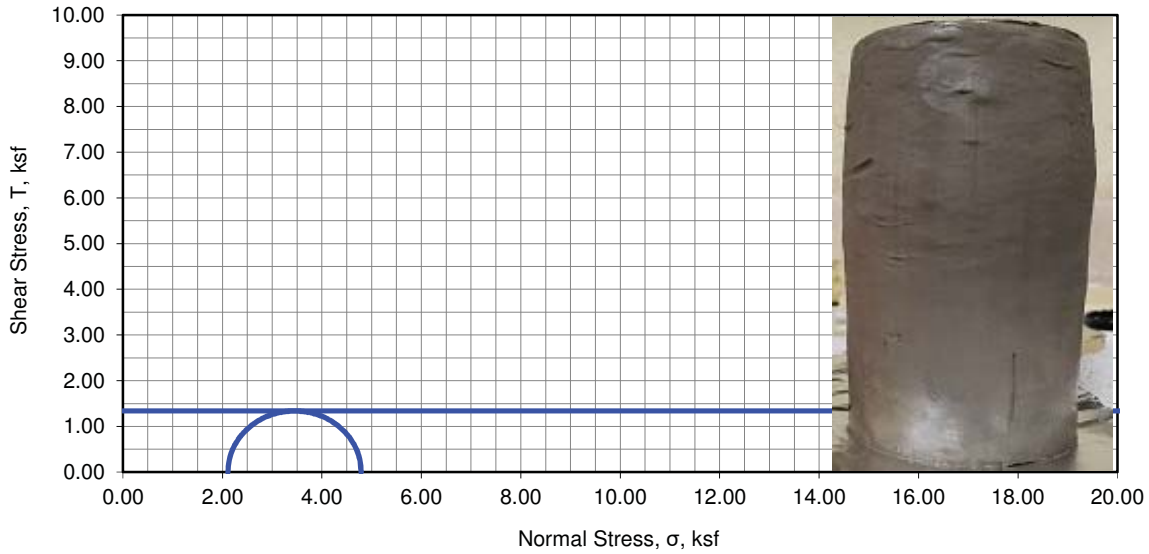
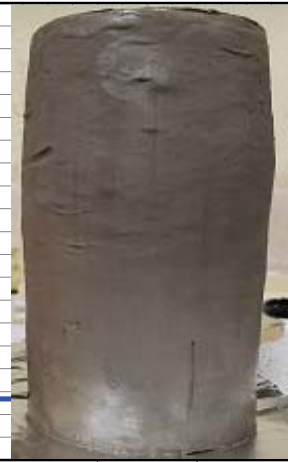
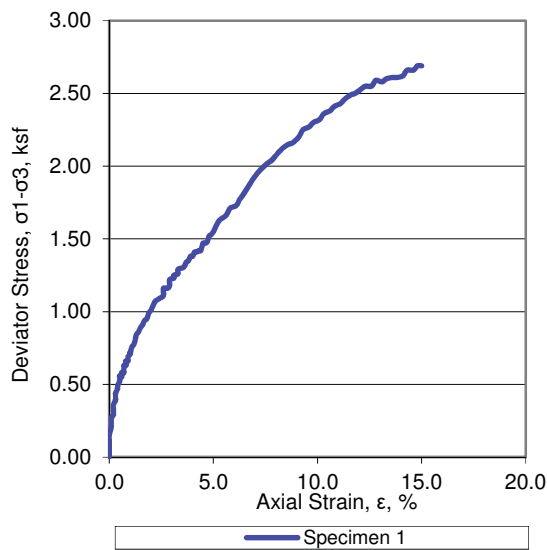
Specimen No.		1
Initial	Diameter, in	D ₀ 2.39
	Height, in	H ₀ 5.35
	Water Content, %	w ₀ 19.6
	Dry Density, lbs/ft ³	γ _{d0} 104.7
	Saturation, %	S ₀ 90
Void Ratio		e ₀ 0.579
Minor Principal Stress, ksf		σ ₃ 2.10
Maximum Deviator Stress, ksf		(σ ₁ -σ ₃) _{max} 2.69
Time to (σ ₁ -σ ₃) _{max} , min		t _f 14.83
Deviator Stress @ 15% Axial Strain, ksf		(σ ₁ -σ ₃) _{15%} 2.69
Ultimate Deviator Stress, ksf		(σ ₁ -σ ₃) _{ult} na
Rate of strain, %/min		'ε 1.00
Axial Strain at Failure, %		ε _f 14.83

Description of Specimen: Sandy Fat Clay (CH)

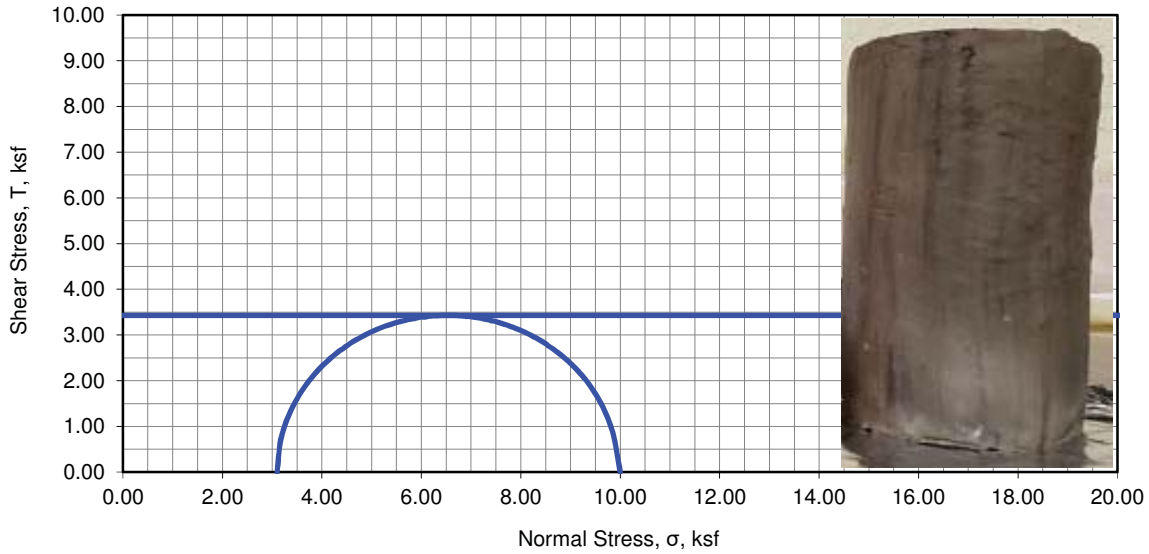
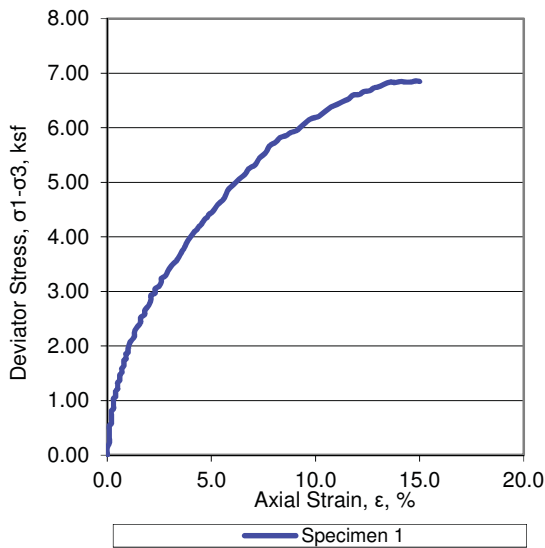
Specimen No.		1
Initial	Diameter, in	D ₀ 2.40
	Height, in	H ₀ 5.05
	Water Content, %	w ₀ 14.2
	Dry Density, lbs/ft ³	γ _{d0} 115.8
	Saturation, %	S ₀ 88
	Void Ratio	e ₀ 0.428
	Minor Principal Stress, ksf	σ ₃ 3.10
	Maximum Deviator Stress, ksf	(σ ₁ -σ ₃) _{max} 6.86
	Time to (σ ₁ -σ ₃) _{max} , min	t _f 14.82
	Deviator Stress @ 15% Axial Strain, ksf	(σ ₁ -σ ₃) _{15%} 6.85
	Ultimate Deviator Stress, ksf	(σ ₁ -σ ₃) _{ult} na
	Rate of strain, %/min	'ε 1.00
	Axial Strain at Failure, %	ε _f 14.82

Description of Specimen: Sandy Lean Clay (CL)
