**GEOTECHNICAL INVESTIGATION REPORT  
PACIFIC GAS AND ELECTRIC COMPANY  
FULTON-FITCH TSP REPLACEMENT PROJECT  
SONOMA COUNTY, CALIFORNIA**

**PROJECT NO. 20190527.001A**

**SEPTEMBER 6, 2018  
Revised February 6, 2019**

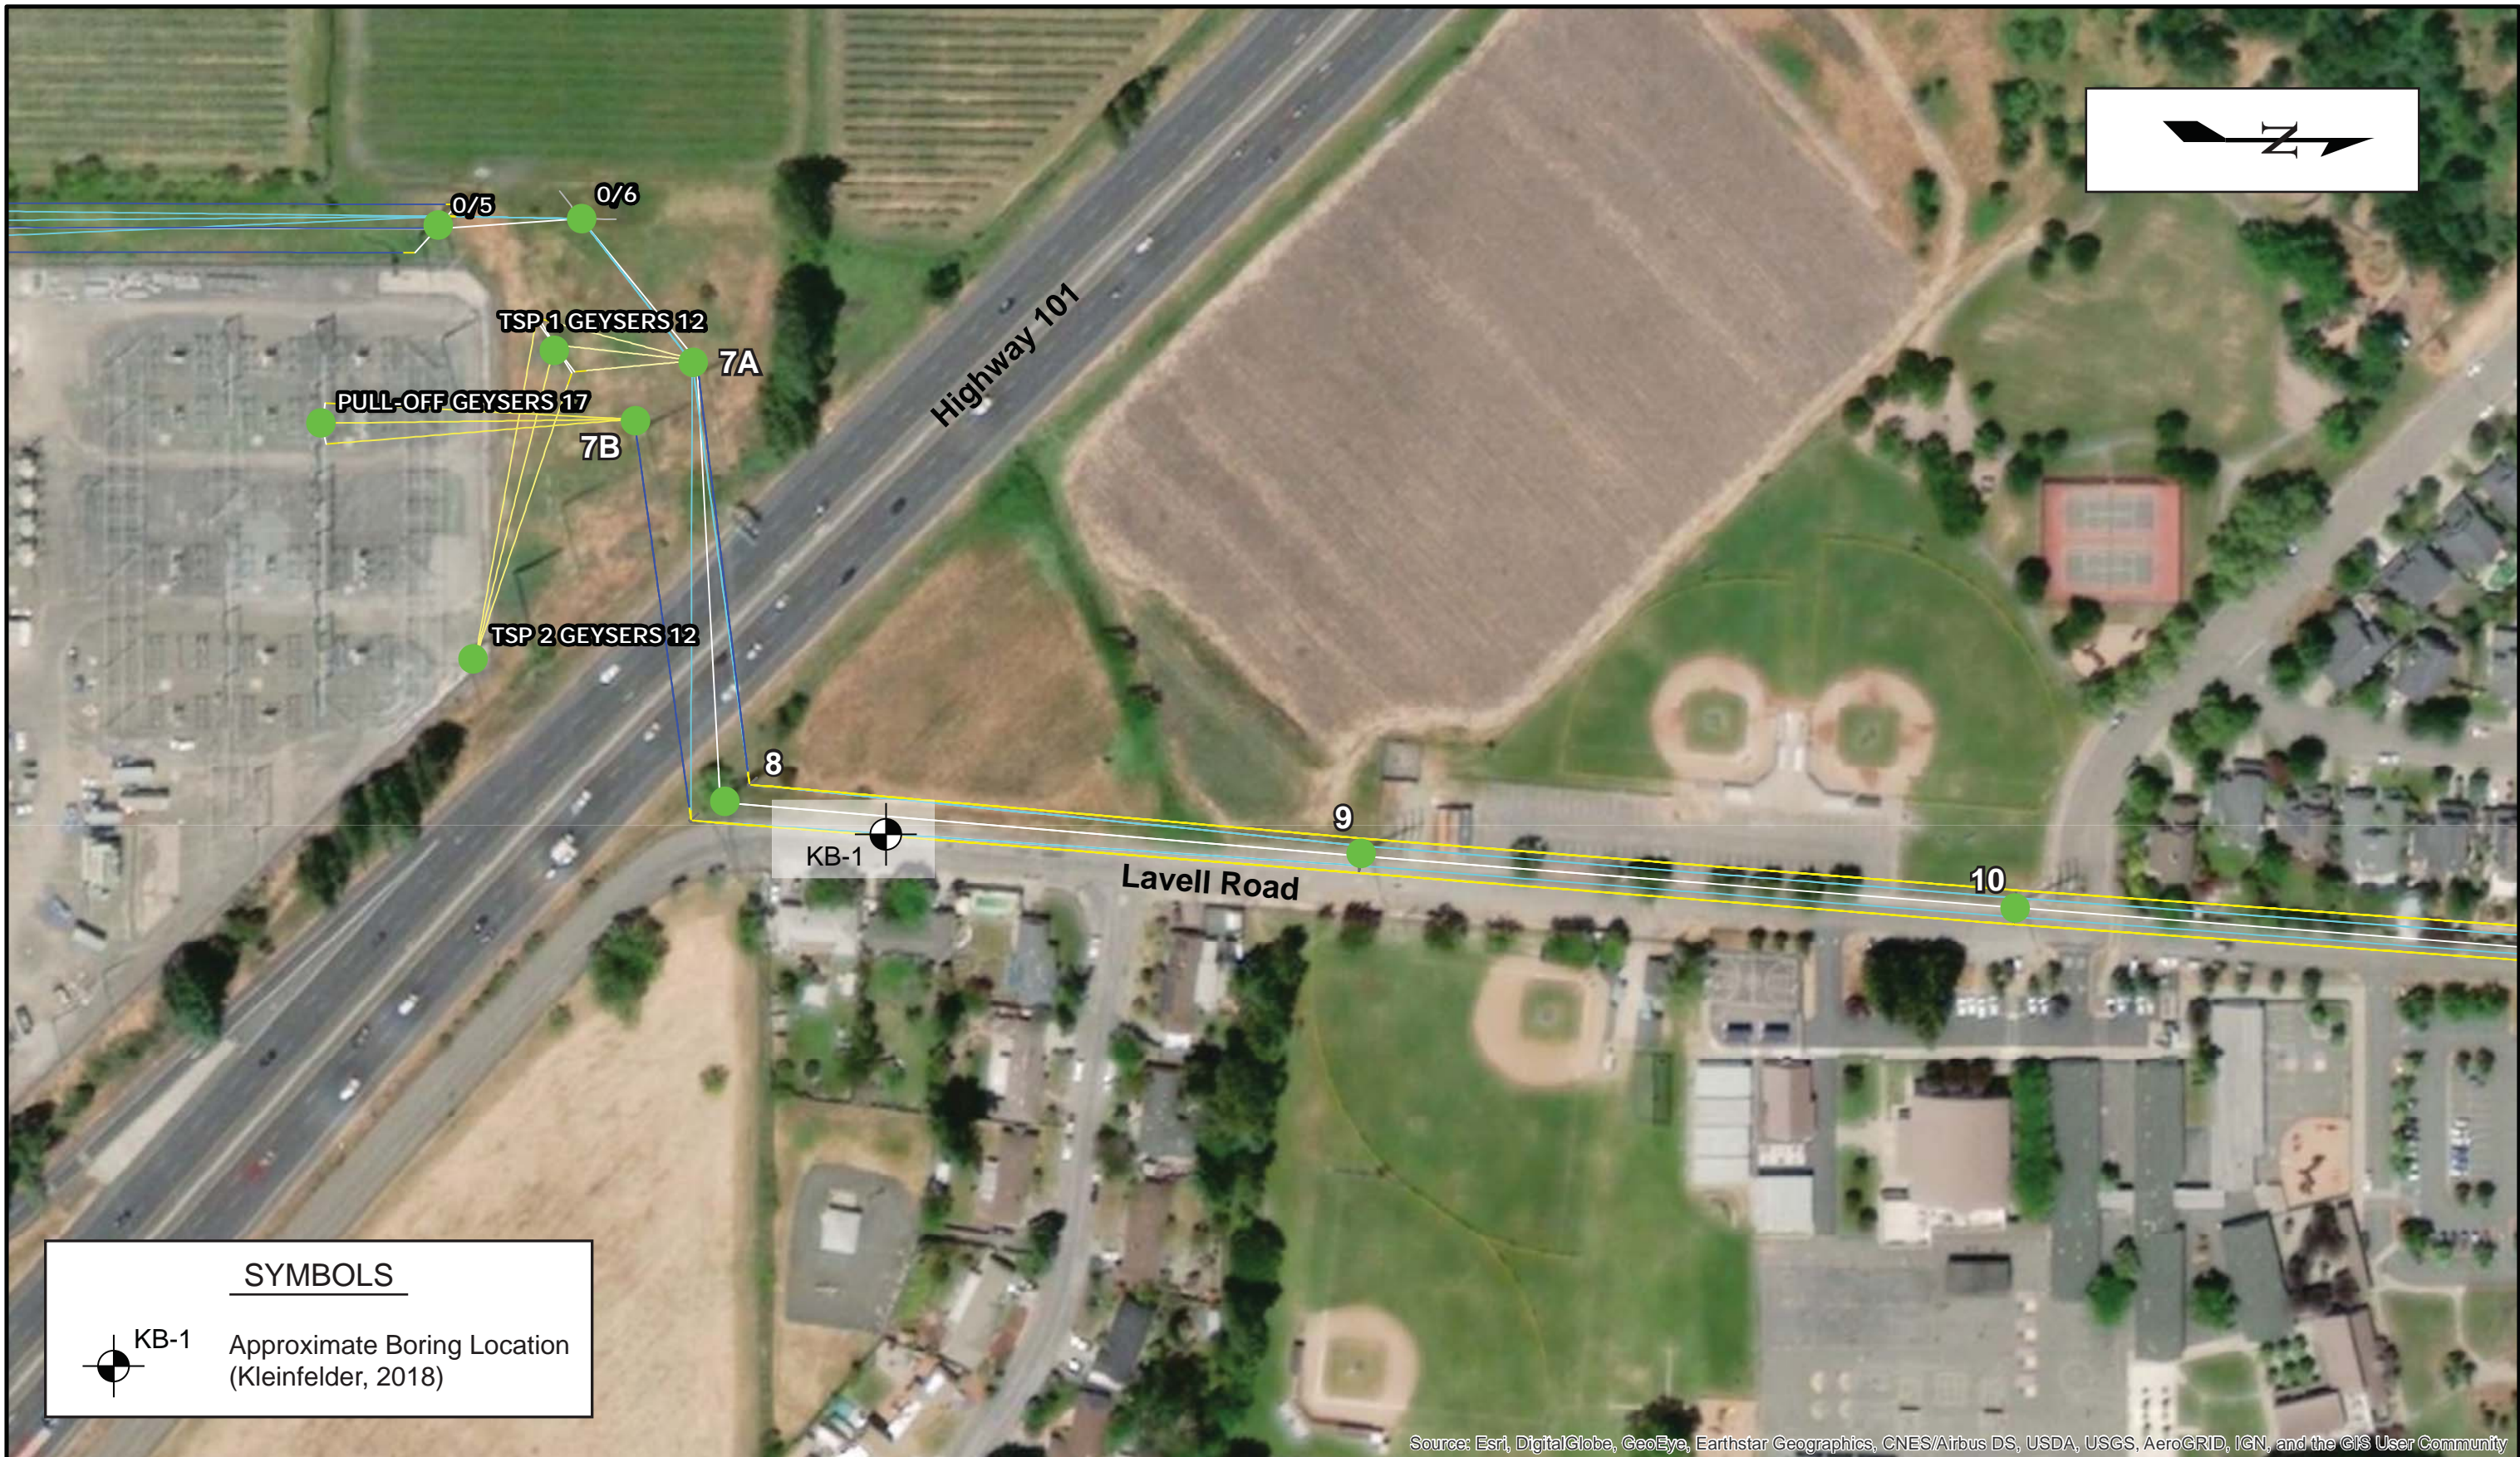
Bright People. Right Solutions. www.kleinfelder.com	PROJECT NO. 20190527	FIGURE  <b>3</b>
	DRAWN: AUG 2018	
	DRAWN BY: SDC	
	CHECKED BY: MJP	
FILE NAME: Figure 2 Site Plan.ai	SITE PLAN  PG&E FULTON FITCH TSP REPLACEMENT GEOTECHNICAL INVESTIGATION SANTA ROSA, CALIFORNIA

This report presents the results of the geotechnical investigation conducted for the proposed tubular steel pole (TSP) replacements in a line segment starting near Fulton substation and continuing north to Faught Road near Shiloh Ranch Regional Park. A site location map and site plan showing the exploration locations are shown on Figures 1 and 2, respectively. Larger scale site plans showing the proposed TSP replacement locations are provided on Figures 3 through 6.

Our understanding of the project is based on correspondence with PG&E, a conference call on April 5, 2018 with PG&E, and a review of CPUC records. We understand that 21 TSPs will be replaced along an approximately 9,000-foot long segment of the southern “Fulton Shiloh Segment”, which includes the line segment between the Fulton Substation and Faught Road near Shiloh Ranch Regional Park. The poles slated for replacement are Poles 7\_A/B through Pole 23, as shown on Figures 3 through 6.

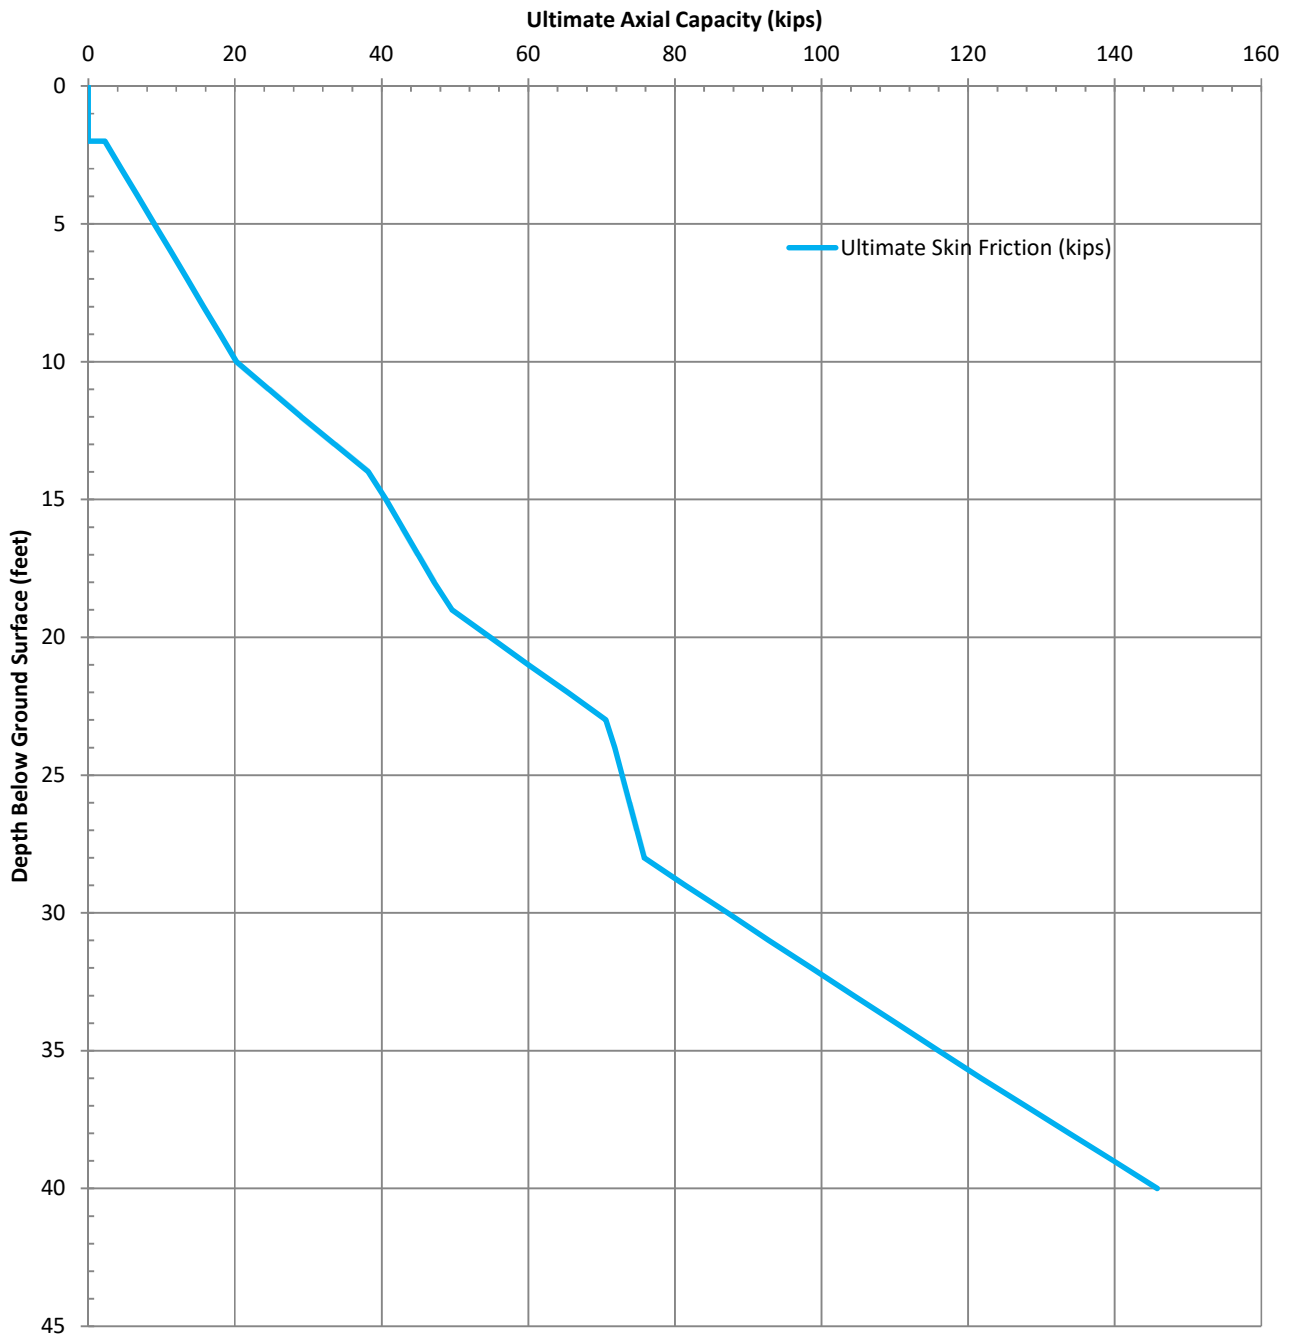
FIGURE

1. Axial capacities of drilled piers with diameters other than one foot may be obtained by multiplying the unit capacity by the diameter of the pile (in feet).
2. Ultimate tensile capacity may be obtained by multiplying the ultimate compressive capacity by a factor of 0.8.
3. The curve represents ultimate axial capacity of a straight-sided drilled pier. See text discussion for factor of safety and group effects.

SOUTH REACH  
 POLE 7\_A/B THROUGH POLE 13  
 ULTIMATE AXIAL CAPACITY PLOT UNIT DIAMETER  
 (1-FOOT) DRILLED PIER  
 FULTON FITCH TSP REPLACEMENT  
 GEOTECHNICAL INVESTIGATION  
 SANTA ROSA, CALIFORNIA

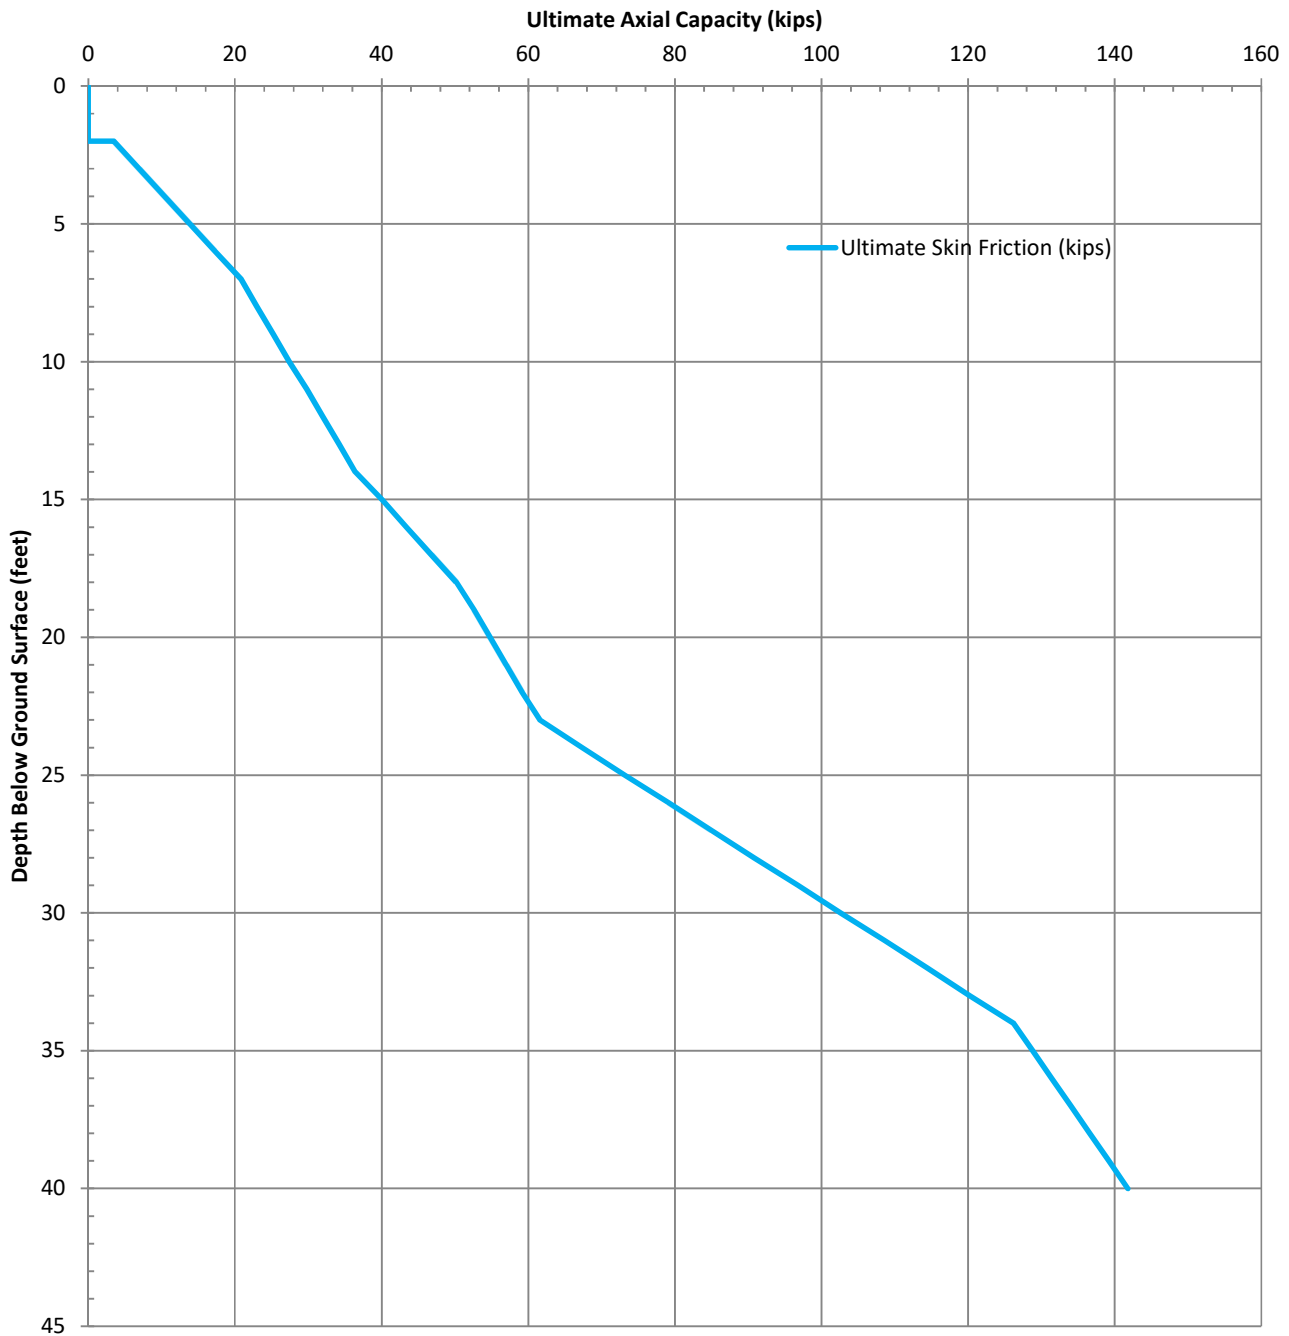
8

1. Axial capacities of drilled piers with diameters other than one foot may be obtained by multiplying the unit capacity by the diameter of the pile (in feet).
2. Ultimate tensile capacity may be obtained by multiplying the ultimate compressive capacity by a factor of 0.8.
3. The curve represents ultimate axial capacity of a straight-sided drilled pier. See text discussion for factor of safety and group effects.

CENTRAL AND NORTH REACH  
 POLE 14 THROUGH POLE 23  
 ULTIMATE AXIAL CAPACITY PLOT UNIT DIAMETER  
 (1-FOOT) DRILLED PIER  
 FULTON FITCH TSP REPLACEMENT  
 GEOTECHNICAL INVESTIGATION  
 SANTA ROSA, CALIFORNIA

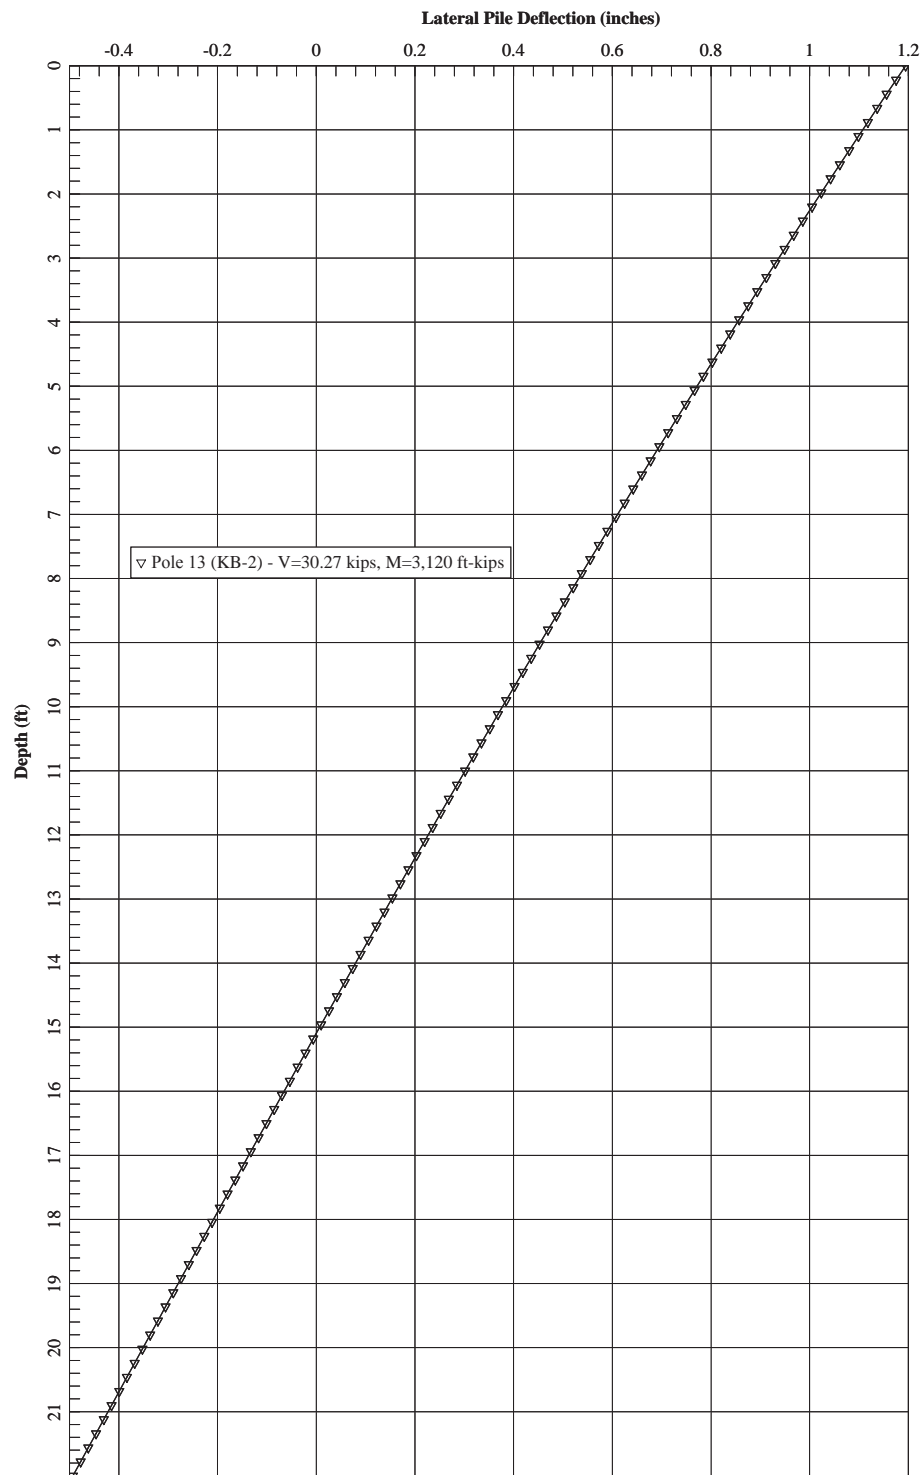
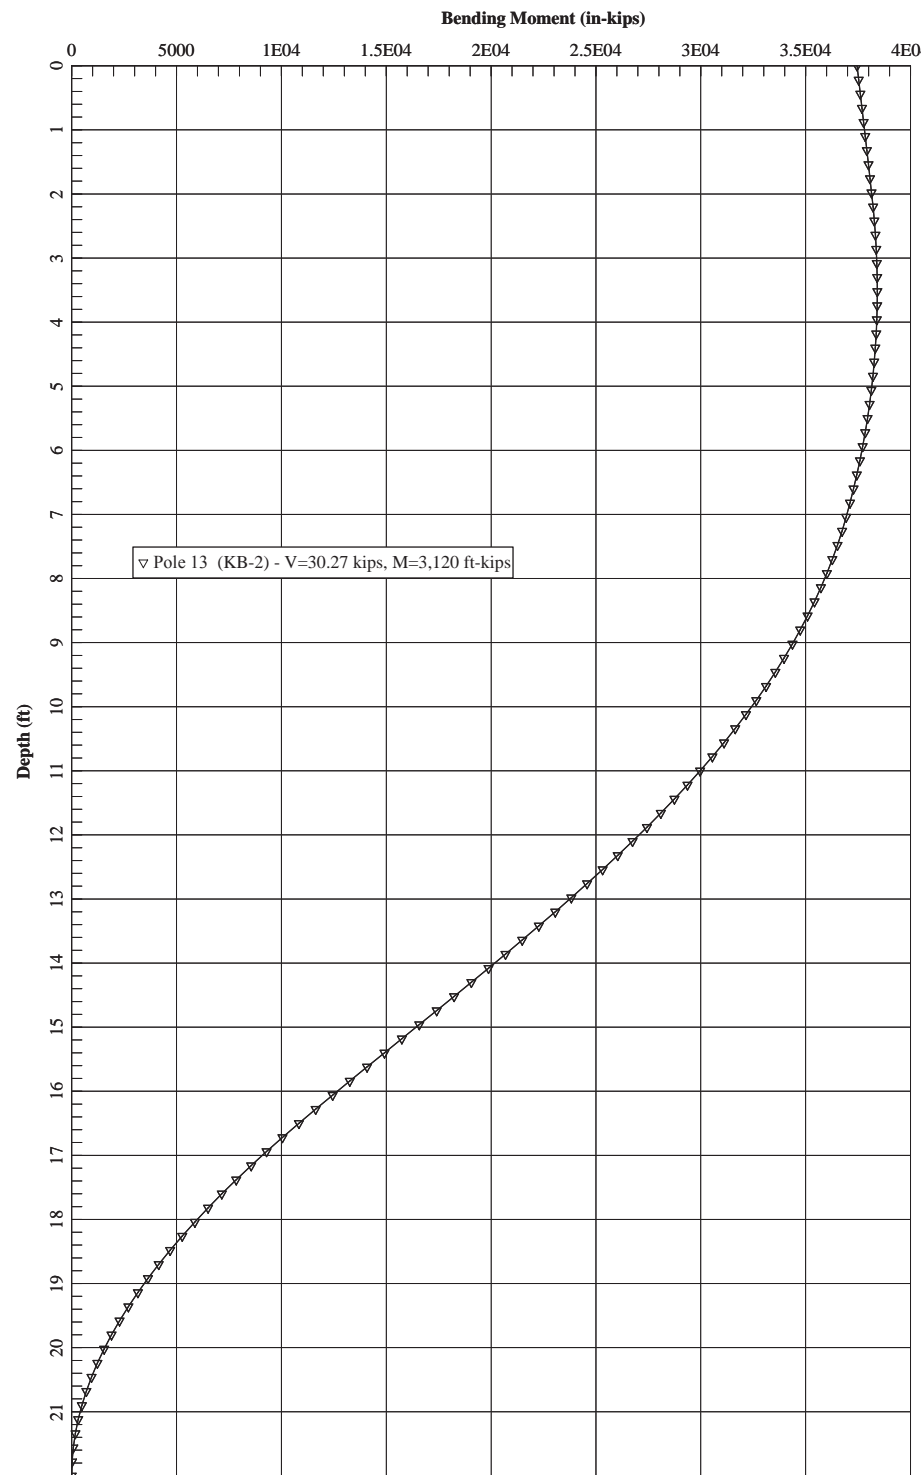
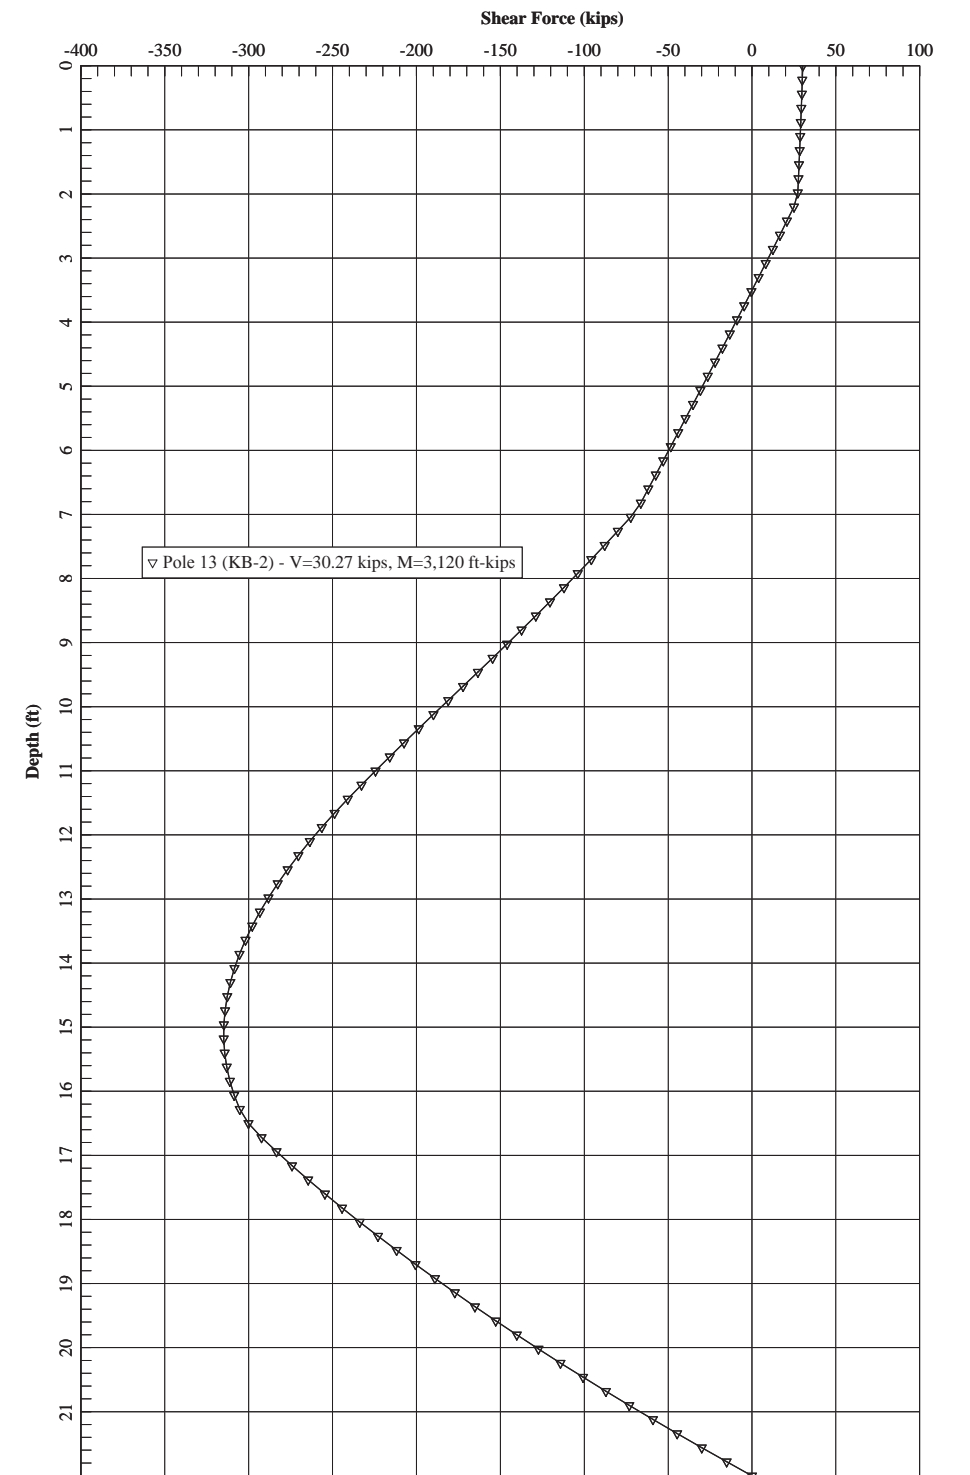
POLE 13  
 LATERAL PILE RESPONSE  
 72-INCH DIAMETER DRILLED PIER  
 PG&E FULTON FITCH TSP REPLACEMENT  
 GEOTECHNICAL INVESTIGATION  
 SANTA ROSA, CALIFORNIA

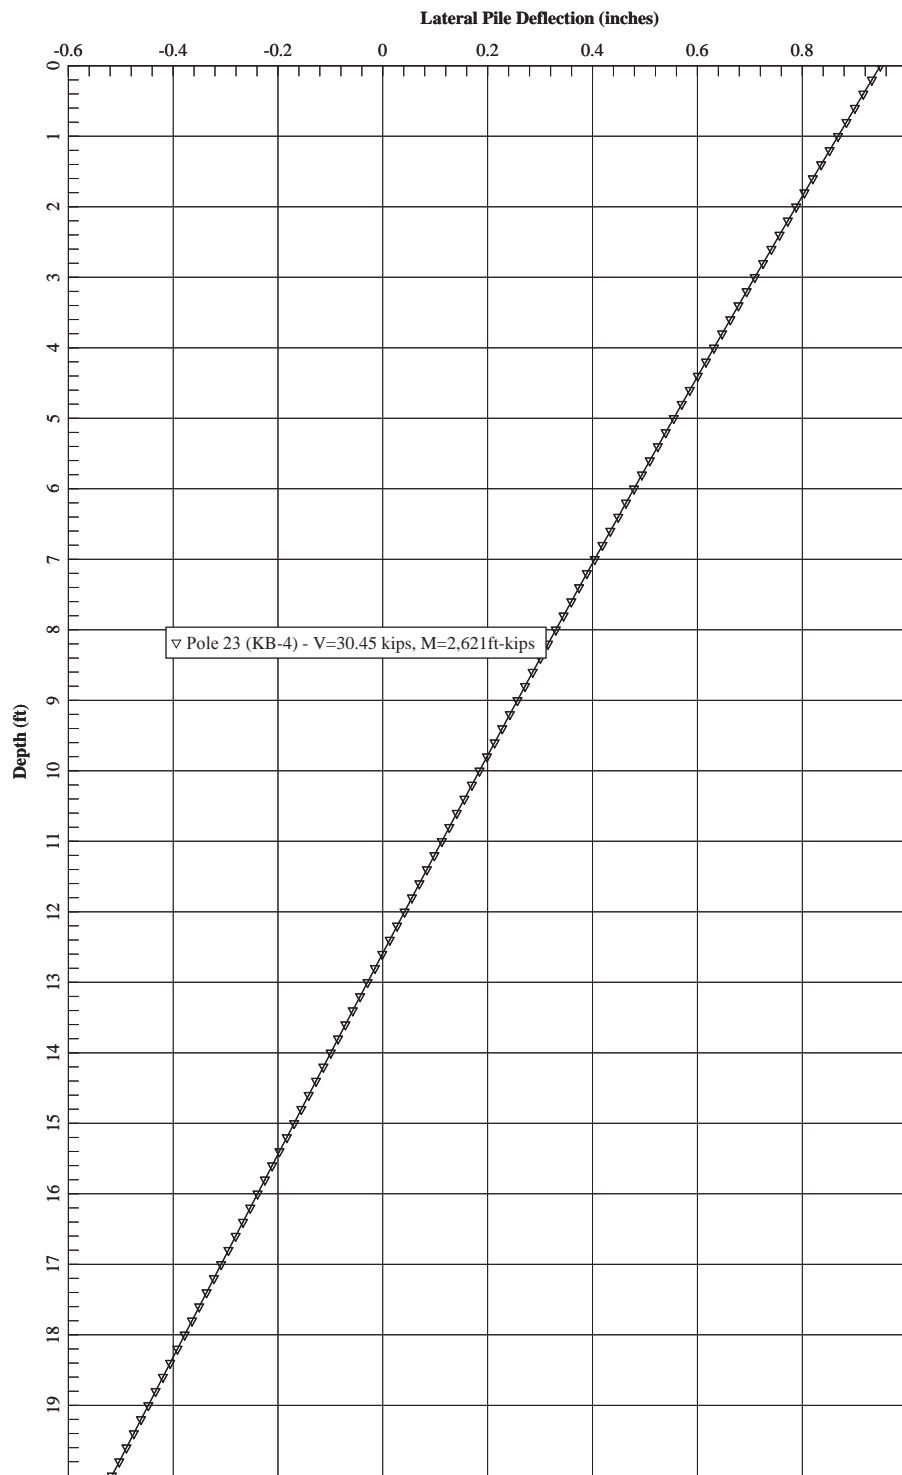
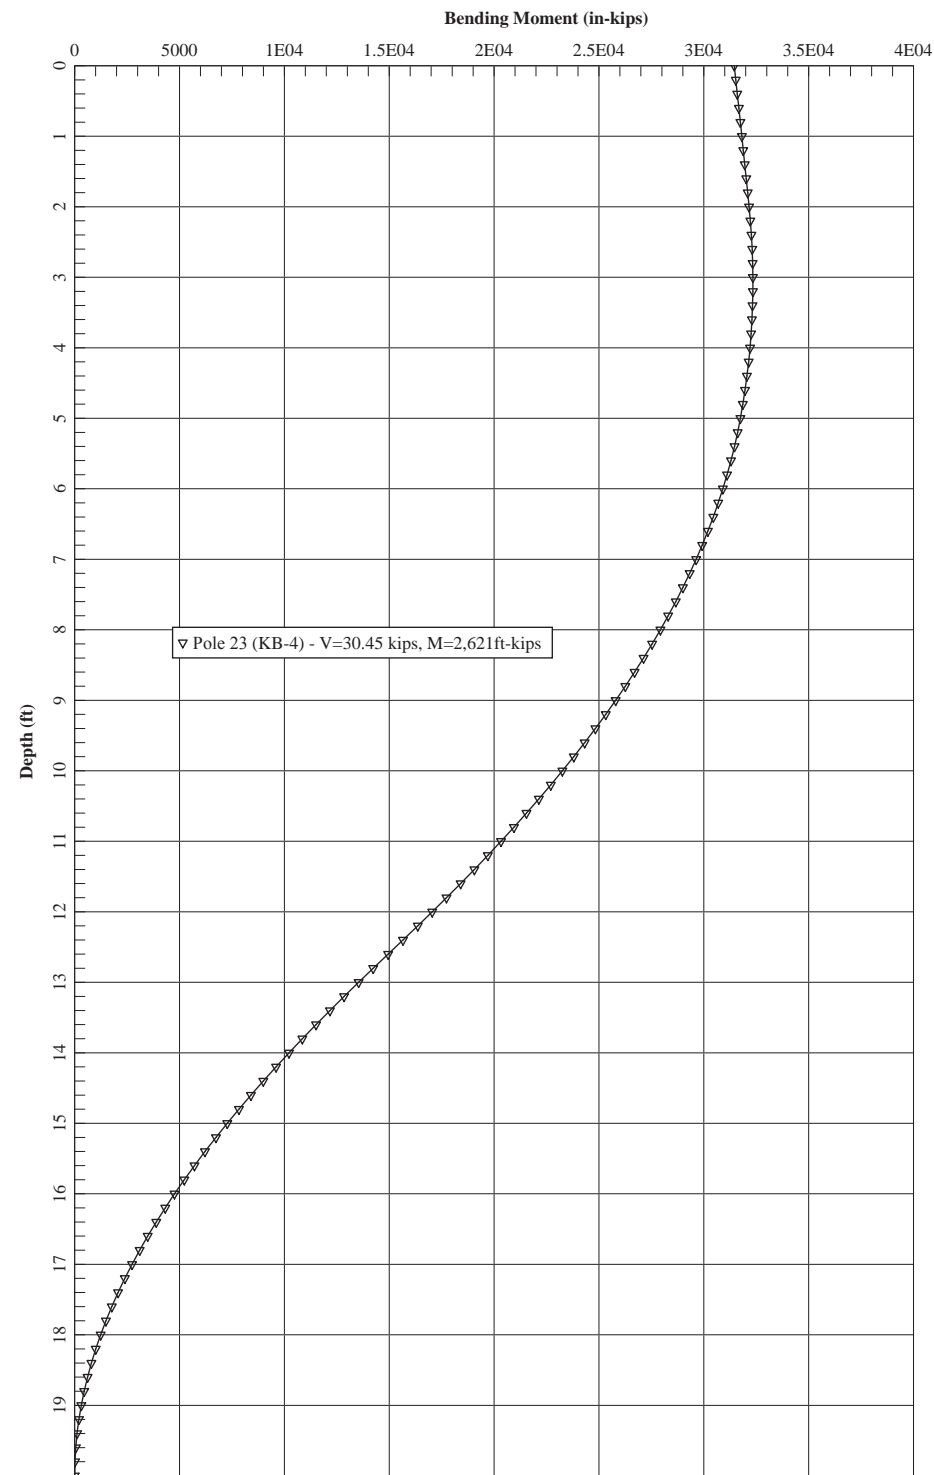
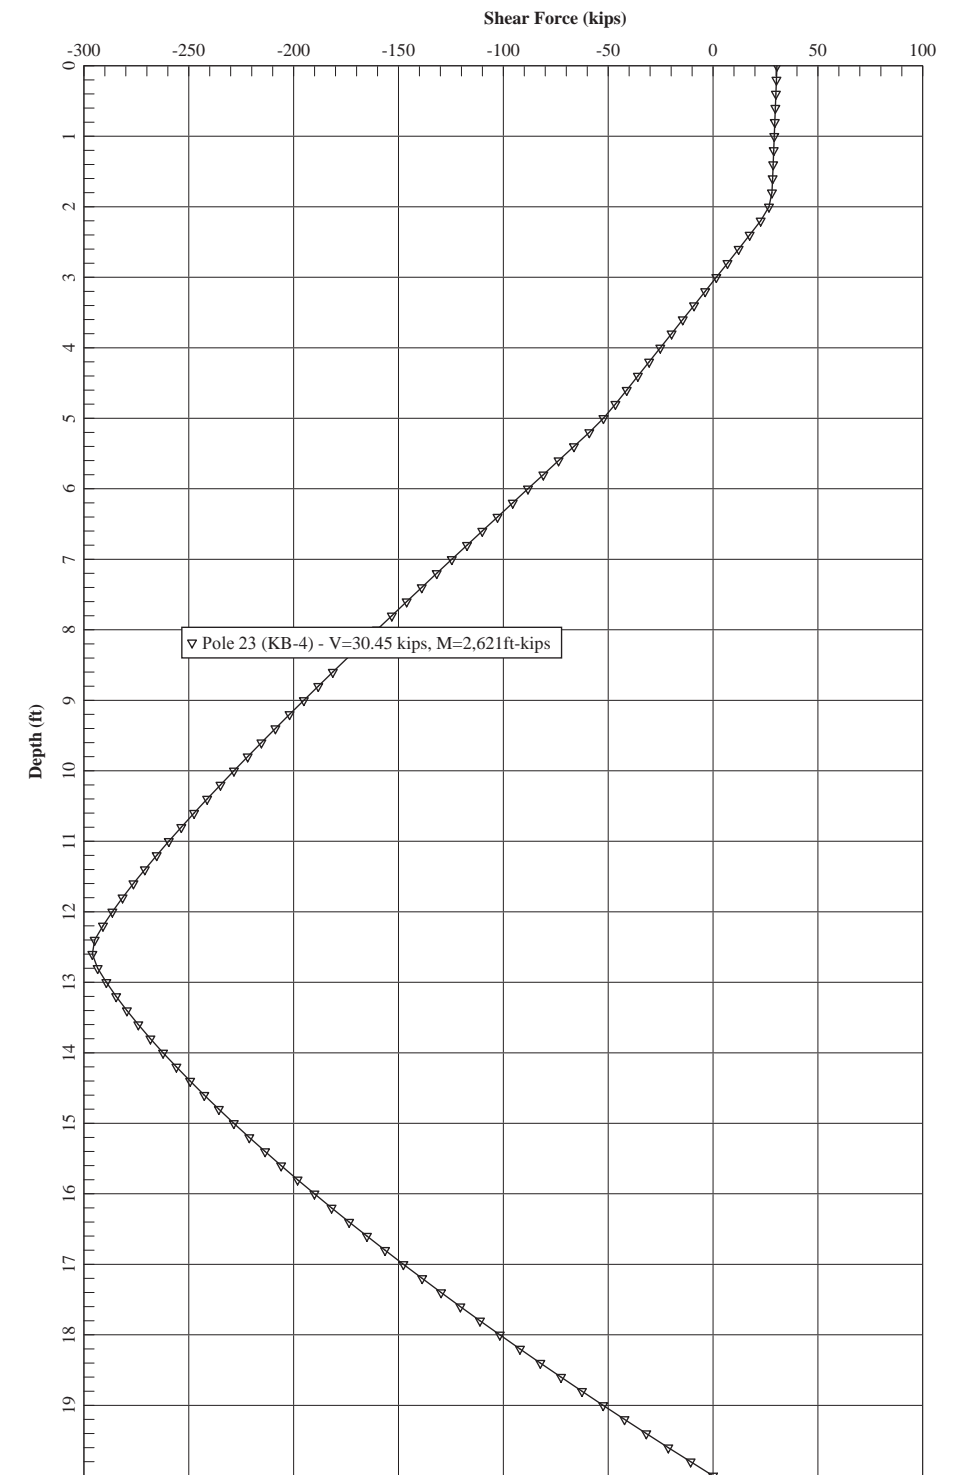
POLE 23  
LATERAL PILE RESPONSE  
72-INCH DIAMETER DRILLED PIER

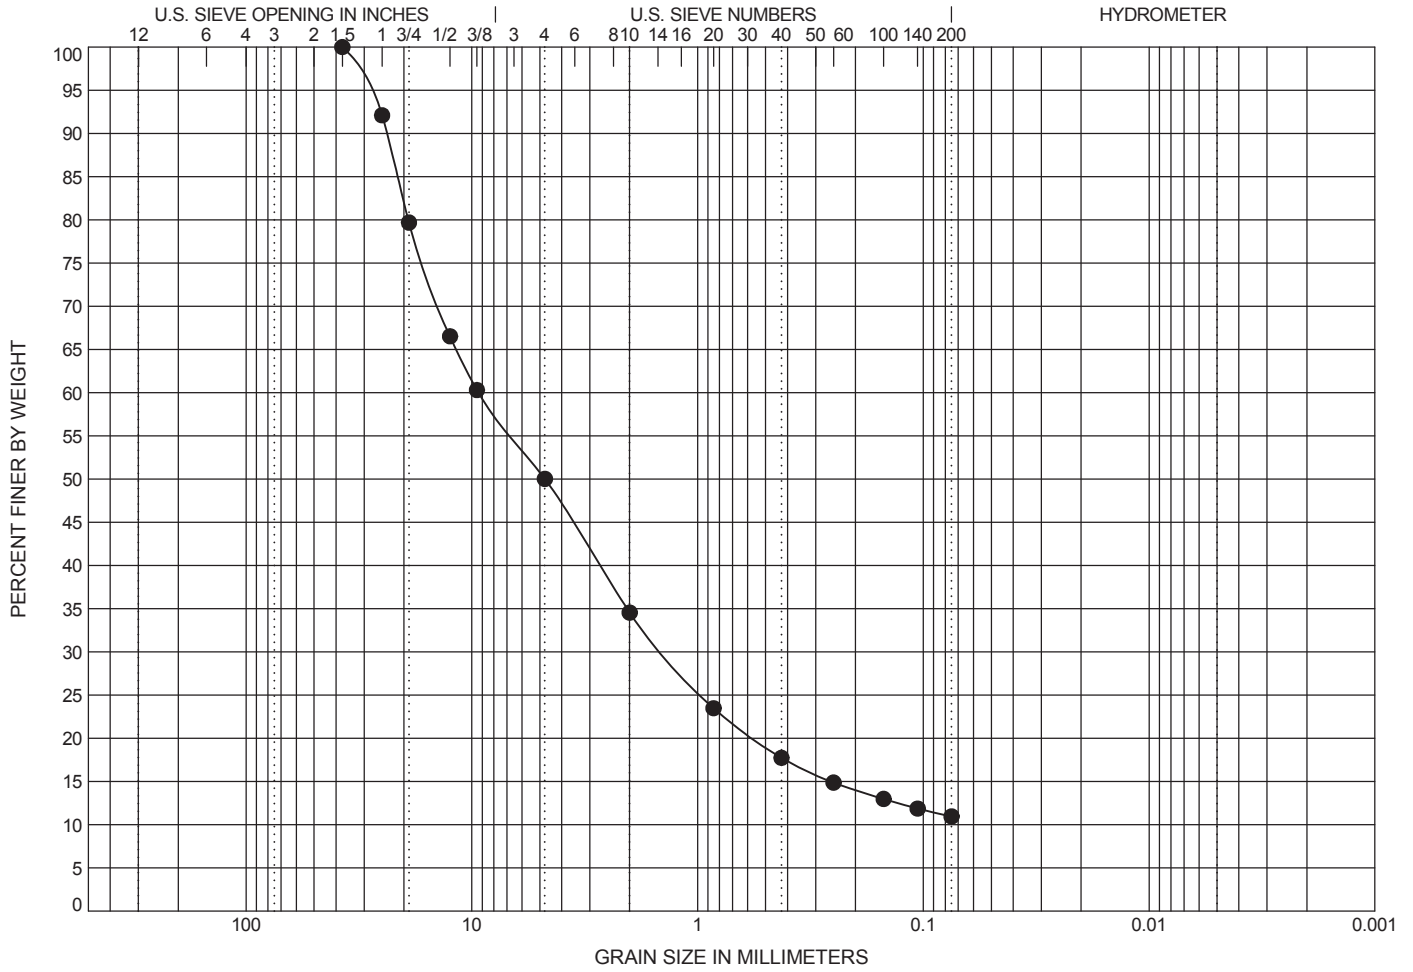
Exploration ID	Depth (ft.)	Sample Description	LL	PL	PI
● KB-2	25	POORLY GRADED GRAVEL WITH SILT AND SAND (GP-GM)	NM	NM	NM

PROJECT NO.: 20190527	<b>SIEVE ANALYSIS</b>  PG&E Fulton-Fitch TSP Replacements Santa Rosa, California	<b>FIGURE</b>  <b>B-2</b>
	DRAWN BY: SDC CHECKED BY: MJP DATE: REVISED: -

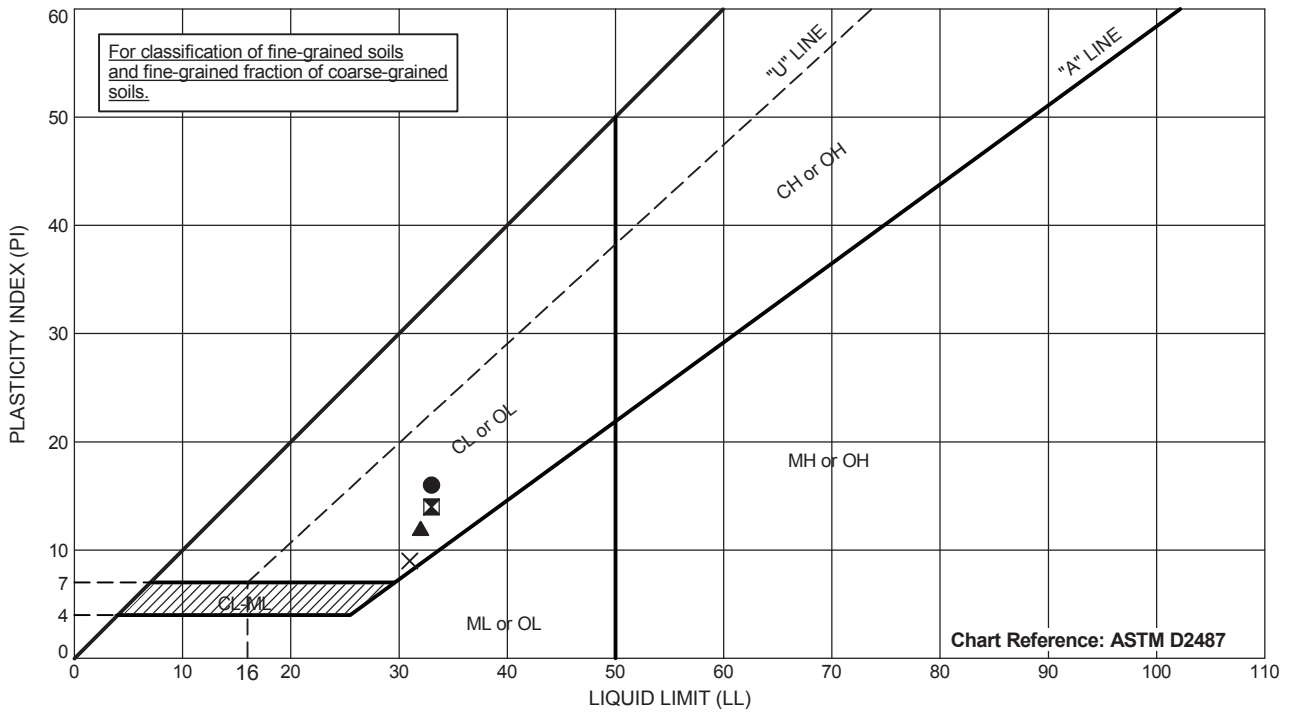
Exploration ID	Depth (ft.)	Sample Description	Passing #200	LL	PL	PI
● KB-1	11	CLAYEY SAND (SC)	40	33	17	16
▣ KB-1	21	CLAYEY SAND (SC)	48	33	19	14
▲ KB-1	31	CLAYEY SAND (SC)	49	32	20	12
× KB-2	11	CLAYEY SAND (SC)	41	31	22	9

Testing performed in general accordance with ASTM D4318.  
 NP = Nonplastic  
 NM = Not Measured

ATTERBERG LIMITS  
 PG&E Fulton-Fitch TSP Replacements  
 Santa Rosa, California

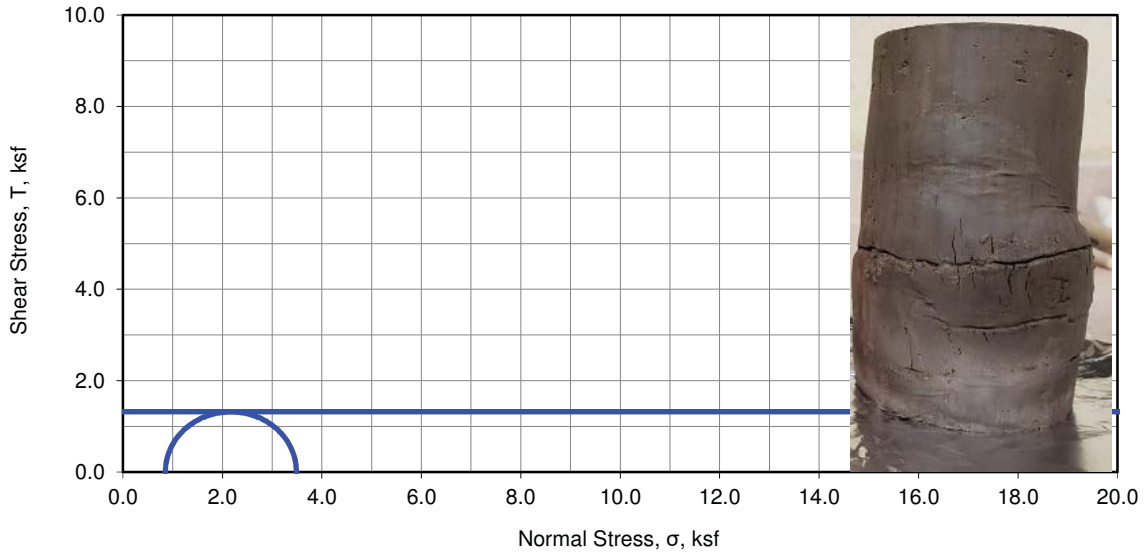
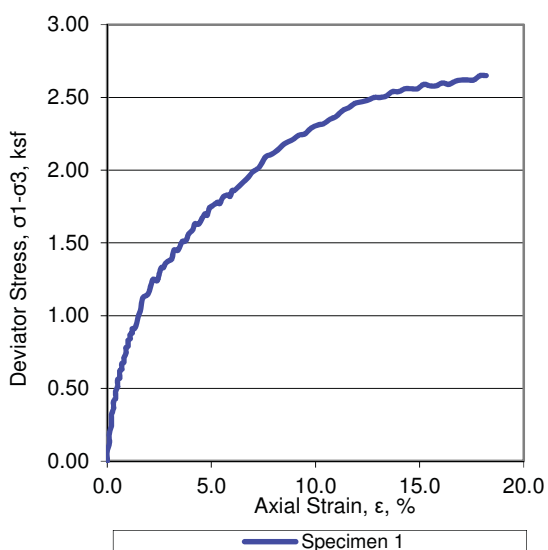
Specimen Shear Picture

Specimen No.		1
Initial	Diameter, in	D <sub>0</sub> 2.40
	Height, in	H <sub>0</sub> 4.37
	Water Content, %	w <sub>0</sub> 29.6
	Dry Density, lbs/ft <sup>3</sup>	γ <sub>d0</sub> 107.6
	Saturation, %	S <sub>0</sub> 146
Void Ratio		e <sub>0</sub> 0.537
Minor Principal Stress, ksf		σ <sub>3</sub> 0.85
Maximum Deviator Stress, ksf		(σ <sub>1</sub> -σ <sub>3</sub> ) <sub>max</sub> 2.65
Time to (σ <sub>1</sub> -σ <sub>3</sub> ) <sub>max</sub> , min		t <sub>f</sub> 14.83
Deviator Stress @ 15% Axial Strain, ksf		(σ <sub>1</sub> -σ <sub>3</sub> ) <sub>15%</sub> 2.56
Ultimate Deviator Stress, ksf		(σ <sub>1</sub> -σ <sub>3</sub> ) <sub>ult</sub> na
Rate of strain, %/min		'ε 1.00
Axial Strain at Failure, %		ε <sub>f</sub> 14.83

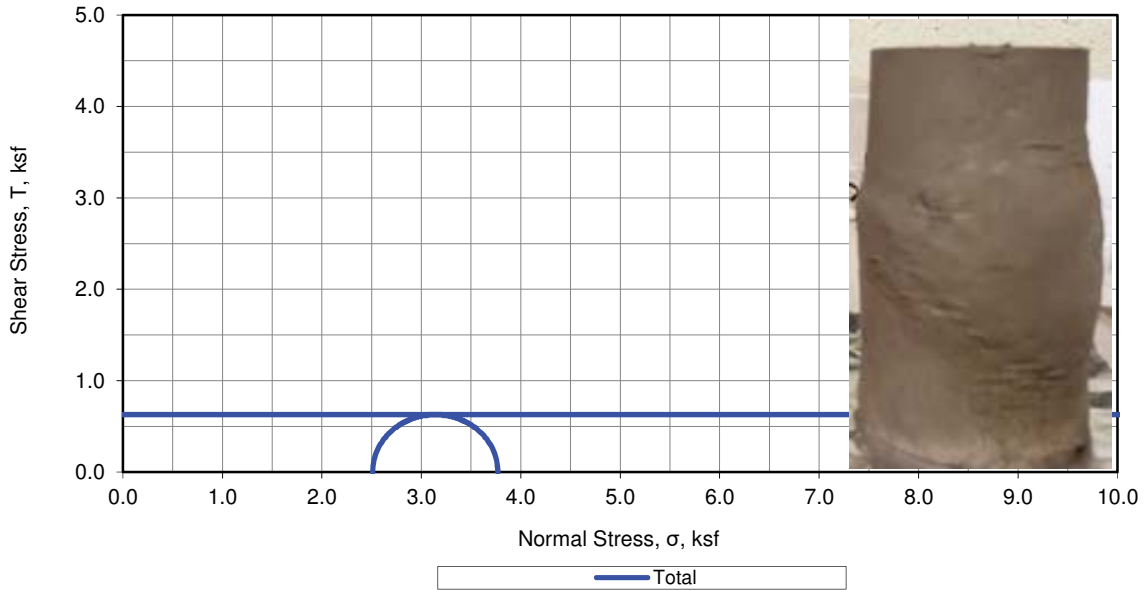
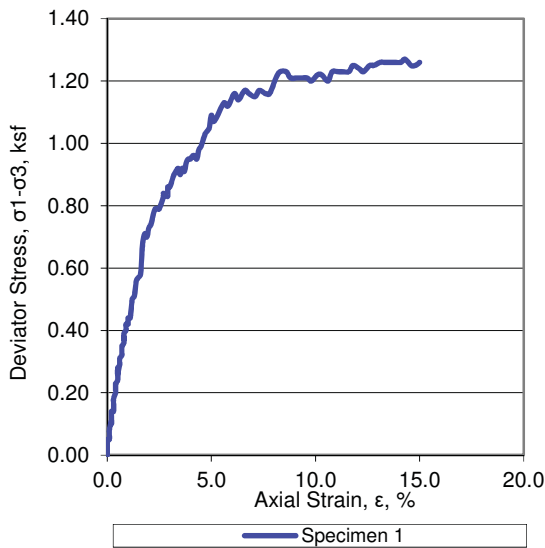
Specimen Shear Picture

Specimen No.		1
Initial	Diameter, in	D <sub>0</sub> 2.39
	Height, in	H <sub>0</sub> 5.36
	Water Content, %	w <sub>0</sub> 44.7
	Dry Density, lbs/ft <sup>3</sup>	γ <sub>d0</sub> 76.0
	Saturation, %	S <sub>0</sub> 101
Void Ratio		e <sub>0</sub> 1.176
Minor Principal Stress, ksf		σ <sub>3</sub> 2.51
Maximum Deviator Stress, ksf		(σ <sub>1</sub> -σ <sub>3</sub> ) <sub>max</sub> 1.27
Time to (σ <sub>1</sub> -σ <sub>3</sub> ) <sub>max</sub> , min		t <sub>f</sub> 14.33
Deviator Stress @ 15% Axial Strain, ksf		(σ <sub>1</sub> -σ <sub>3</sub> ) <sub>15%</sub> 1.26
Ultimate Deviator Stress, ksf		(σ <sub>1</sub> -σ <sub>3</sub> ) <sub>ult</sub> na
Rate of strain, %/min		'ε 1.00
Axial Strain at Failure, %		ε <sub>f</sub> 14.33

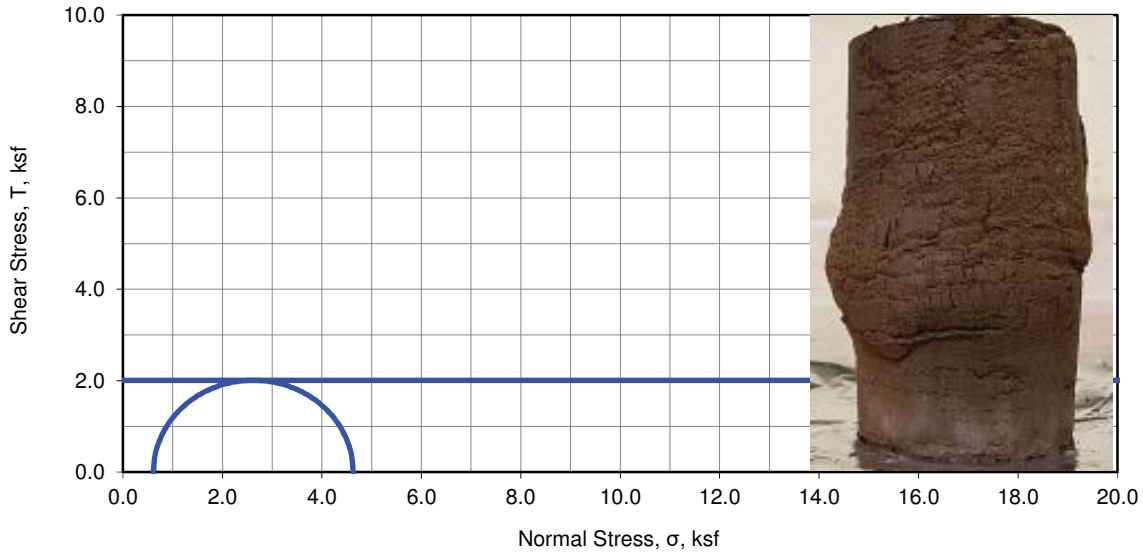
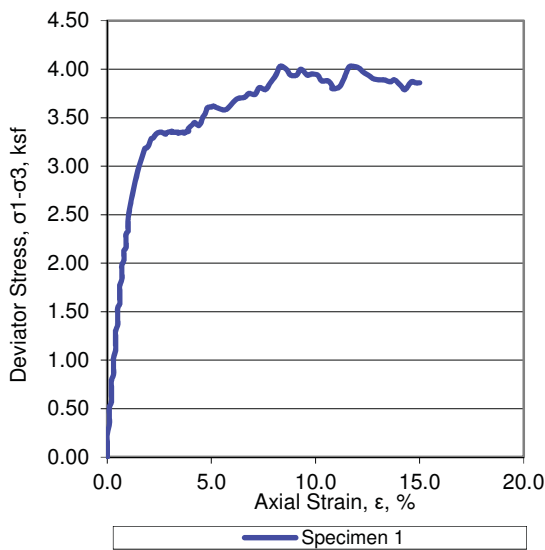
Specimen Shear Picture

Specimen No.		1
Initial	Diameter, in	D <sub>0</sub> 2.39
	Height, in	H <sub>0</sub> 5.67
	Water Content, %	w <sub>0</sub> 19.2
	Dry Density, lbs/ft <sup>3</sup>	γ <sub>d0</sub> 86.7
	Saturation, %	S <sub>0</sub> 56
Void Ratio		e <sub>0</sub> 0.907
Minor Principal Stress, ksf		σ <sub>3</sub> 0.60
Maximum Deviator Stress, ksf		(σ <sub>1</sub> -σ <sub>3</sub> ) <sub>max</sub> 4.03
Time to (σ <sub>1</sub> -σ <sub>3</sub> ) <sub>max</sub> , min		t <sub>f</sub> 8.33
Deviator Stress @ 15% Axial Strain, ksf		(σ <sub>1</sub> -σ <sub>3</sub> ) <sub>15%</sub> 3.86
Ultimate Deviator Stress, ksf		(σ <sub>1</sub> -σ <sub>3</sub> ) <sub>ult</sub> na
Rate of strain, %/min		'ε 1.00
Axial Strain at Failure, %		ε <sub>f</sub> 8.33
