**GEOTECHNICAL INVESTIGATION REPORT  
PACIFIC GAS AND ELECTRIC COMPANY  
FULTON-FITCH TSP REPLACEMENT PROJECT  
SONOMA COUNTY, CALIFORNIA**

**PROJECT NO. 20190527.001A**

**SEPTEMBER 6, 2018  
Revised February 6, 2019**

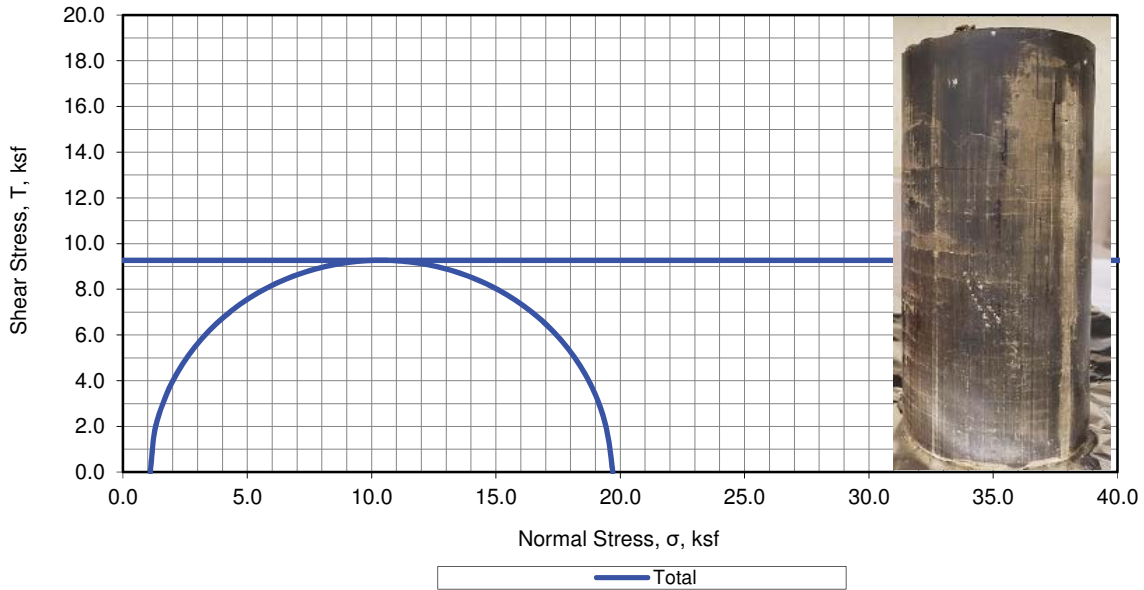
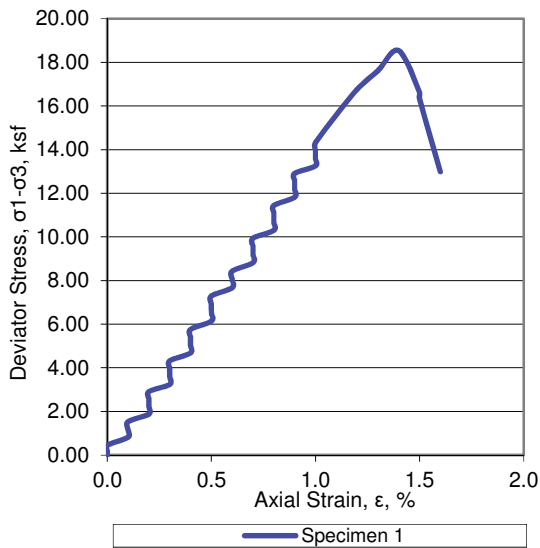
Specimen Shear Picture

Specimen No.		1
Initial	Diameter, in	D <sub>0</sub> 2.40
	Height, in	H <sub>0</sub> 5.30
	Water Content, %	w <sub>0</sub> 21.1
	Dry Density, lbs/ft <sup>3</sup>	γ <sub>d0</sub> 84.6
	Saturation, %	S <sub>0</sub> 59
Void Ratio		e <sub>0</sub> 0.955
Minor Principal Stress, ksf		σ <sub>3</sub> 1.09
Maximum Deviator Stress, ksf		(σ <sub>1</sub> -σ <sub>3</sub> ) <sub>max</sub> 18.54
Time to (σ <sub>1</sub> -σ <sub>3</sub> ) <sub>max</sub> , min		t <sub>f</sub> 1.45
Deviator Stress @ 15% Axial Strain, ksf		(σ <sub>1</sub> -σ <sub>3</sub> ) <sub>15%</sub> 12.99
Ultimate Deviator Stress, ksf		(σ <sub>1</sub> -σ <sub>3</sub> ) <sub>ult</sub> na
Rate of strain, %/min		'ε 1.00
Axial Strain at Failure, %		ε <sub>f</sub> 1.45

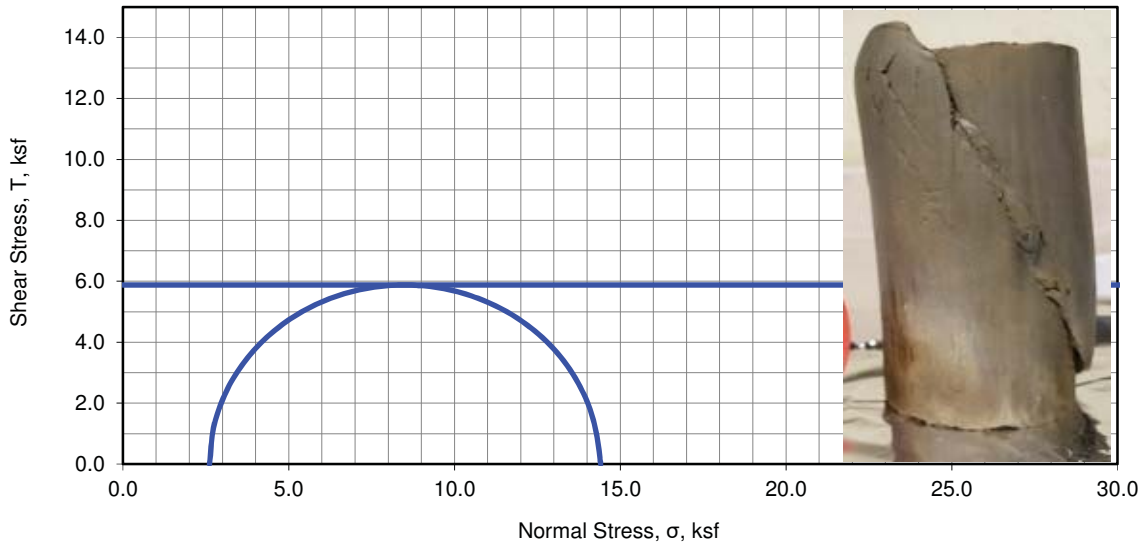
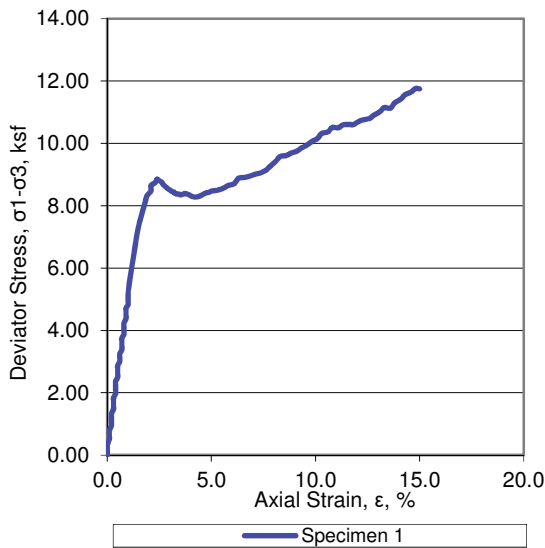
Specimen Shear Picture

Specimen No.		1
Initial	Diameter, in	D <sub>0</sub> 2.40
	Height, in	H <sub>0</sub> 5.47
	Water Content, %	ω <sub>0</sub> 28.6
	Dry Density, lbs/ft <sup>3</sup>	γ <sub>d0</sub> 89.3
	Saturation, %	S <sub>0</sub> 89
Void Ratio		e <sub>0</sub> 0.852
Minor Principal Stress, ksf		σ <sub>3</sub> 2.61
Maximum Deviator Stress, ksf		(σ <sub>1</sub> -σ <sub>3</sub> ) <sub>max</sub> 11.76
Time to (σ <sub>1</sub> -σ <sub>3</sub> ) <sub>max</sub> , min		t <sub>f</sub> 14.82
Deviator Stress @ 15% Axial Strain, ksf		(σ <sub>1</sub> -σ <sub>3</sub> ) <sub>15%</sub> 11.75
Ultimate Deviator Stress, ksf		(σ <sub>1</sub> -σ <sub>3</sub> ) <sub>ult</sub> na
Rate of strain, %/min		'ε 1.00
Axial Strain at Failure, %		ε <sub>f</sub> 14.82

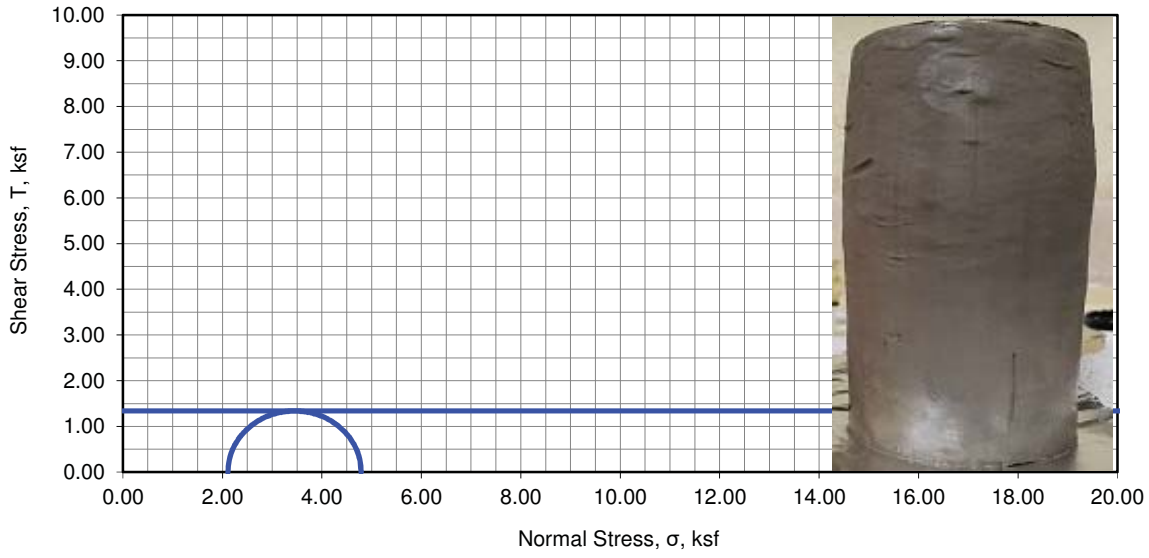
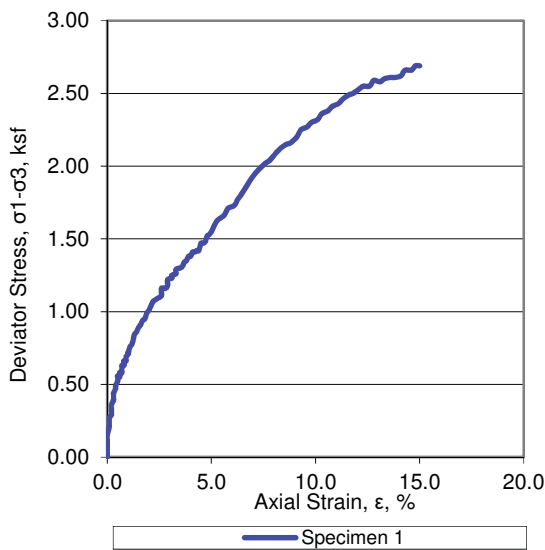
Specimen Shear Picture

Specimen No.		1
Initial	Diameter, in	D <sub>0</sub> 2.39
	Height, in	H <sub>0</sub> 5.35
	Water Content, %	w <sub>0</sub> 19.6
	Dry Density, lbs/ft <sup>3</sup>	γ <sub>d0</sub> 104.7
	Saturation, %	S <sub>0</sub> 90
Void Ratio		e <sub>0</sub> 0.579
Minor Principal Stress, ksf		σ <sub>3</sub> 2.10
Maximum Deviator Stress, ksf		(σ <sub>1</sub> -σ <sub>3</sub> ) <sub>max</sub> 2.69
Time to (σ <sub>1</sub> -σ <sub>3</sub> ) <sub>max</sub> , min		t <sub>f</sub> 14.83
Deviator Stress @ 15% Axial Strain, ksf		(σ <sub>1</sub> -σ <sub>3</sub> ) <sub>15%</sub> 2.69
Ultimate Deviator Stress, ksf		(σ <sub>1</sub> -σ <sub>3</sub> ) <sub>ult</sub> na
Rate of strain, %/min		'ε 1.00
Axial Strain at Failure, %		ε <sub>f</sub> 14.83

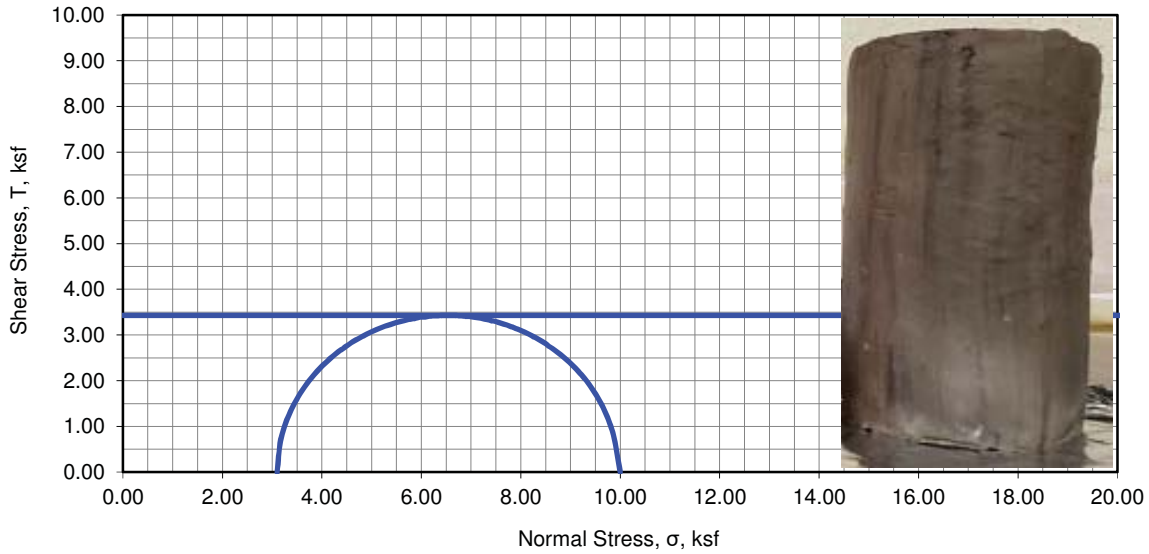
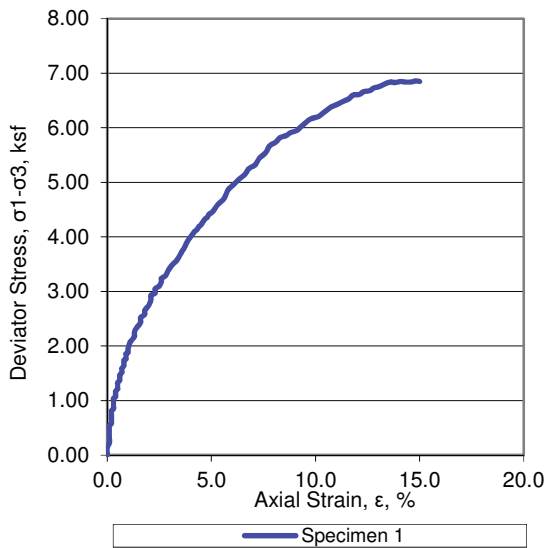
Specimen Shear Picture

Specimen No.		1
Initial	Diameter, in	D <sub>0</sub> 2.40
	Height, in	H <sub>0</sub> 5.05
	Water Content, %	w <sub>0</sub> 14.2
	Dry Density, lbs/ft <sup>3</sup>	γ <sub>d0</sub> 115.8
	Saturation, %	S <sub>0</sub> 88
	Void Ratio	e <sub>0</sub> 0.428
	Minor Principal Stress, ksf	σ <sub>3</sub> 3.10
	Maximum Deviator Stress, ksf	(σ <sub>1</sub> -σ <sub>3</sub> ) <sub>max</sub> 6.86
	Time to (σ <sub>1</sub> -σ <sub>3</sub> ) <sub>max</sub> , min	t <sub>f</sub> 14.82
	Deviator Stress @ 15% Axial Strain, ksf	(σ <sub>1</sub> -σ <sub>3</sub> ) <sub>15%</sub> 6.85
	Ultimate Deviator Stress, ksf	(σ <sub>1</sub> -σ <sub>3</sub> ) <sub>ult</sub> na
	Rate of strain, %/min	'ε 1.00
	Axial Strain at Failure, %	ε <sub>f</sub> 14.82
