Power Engineers
Riverside Transmission Reliability Project
Burrowing Owl and Riparian Bird Species Habitat Assessment

November 2006

Prepared by:
TRC Essex
1903 Wright Place, Suite
190
Carlsbad, California 92008
(760) 603-1740

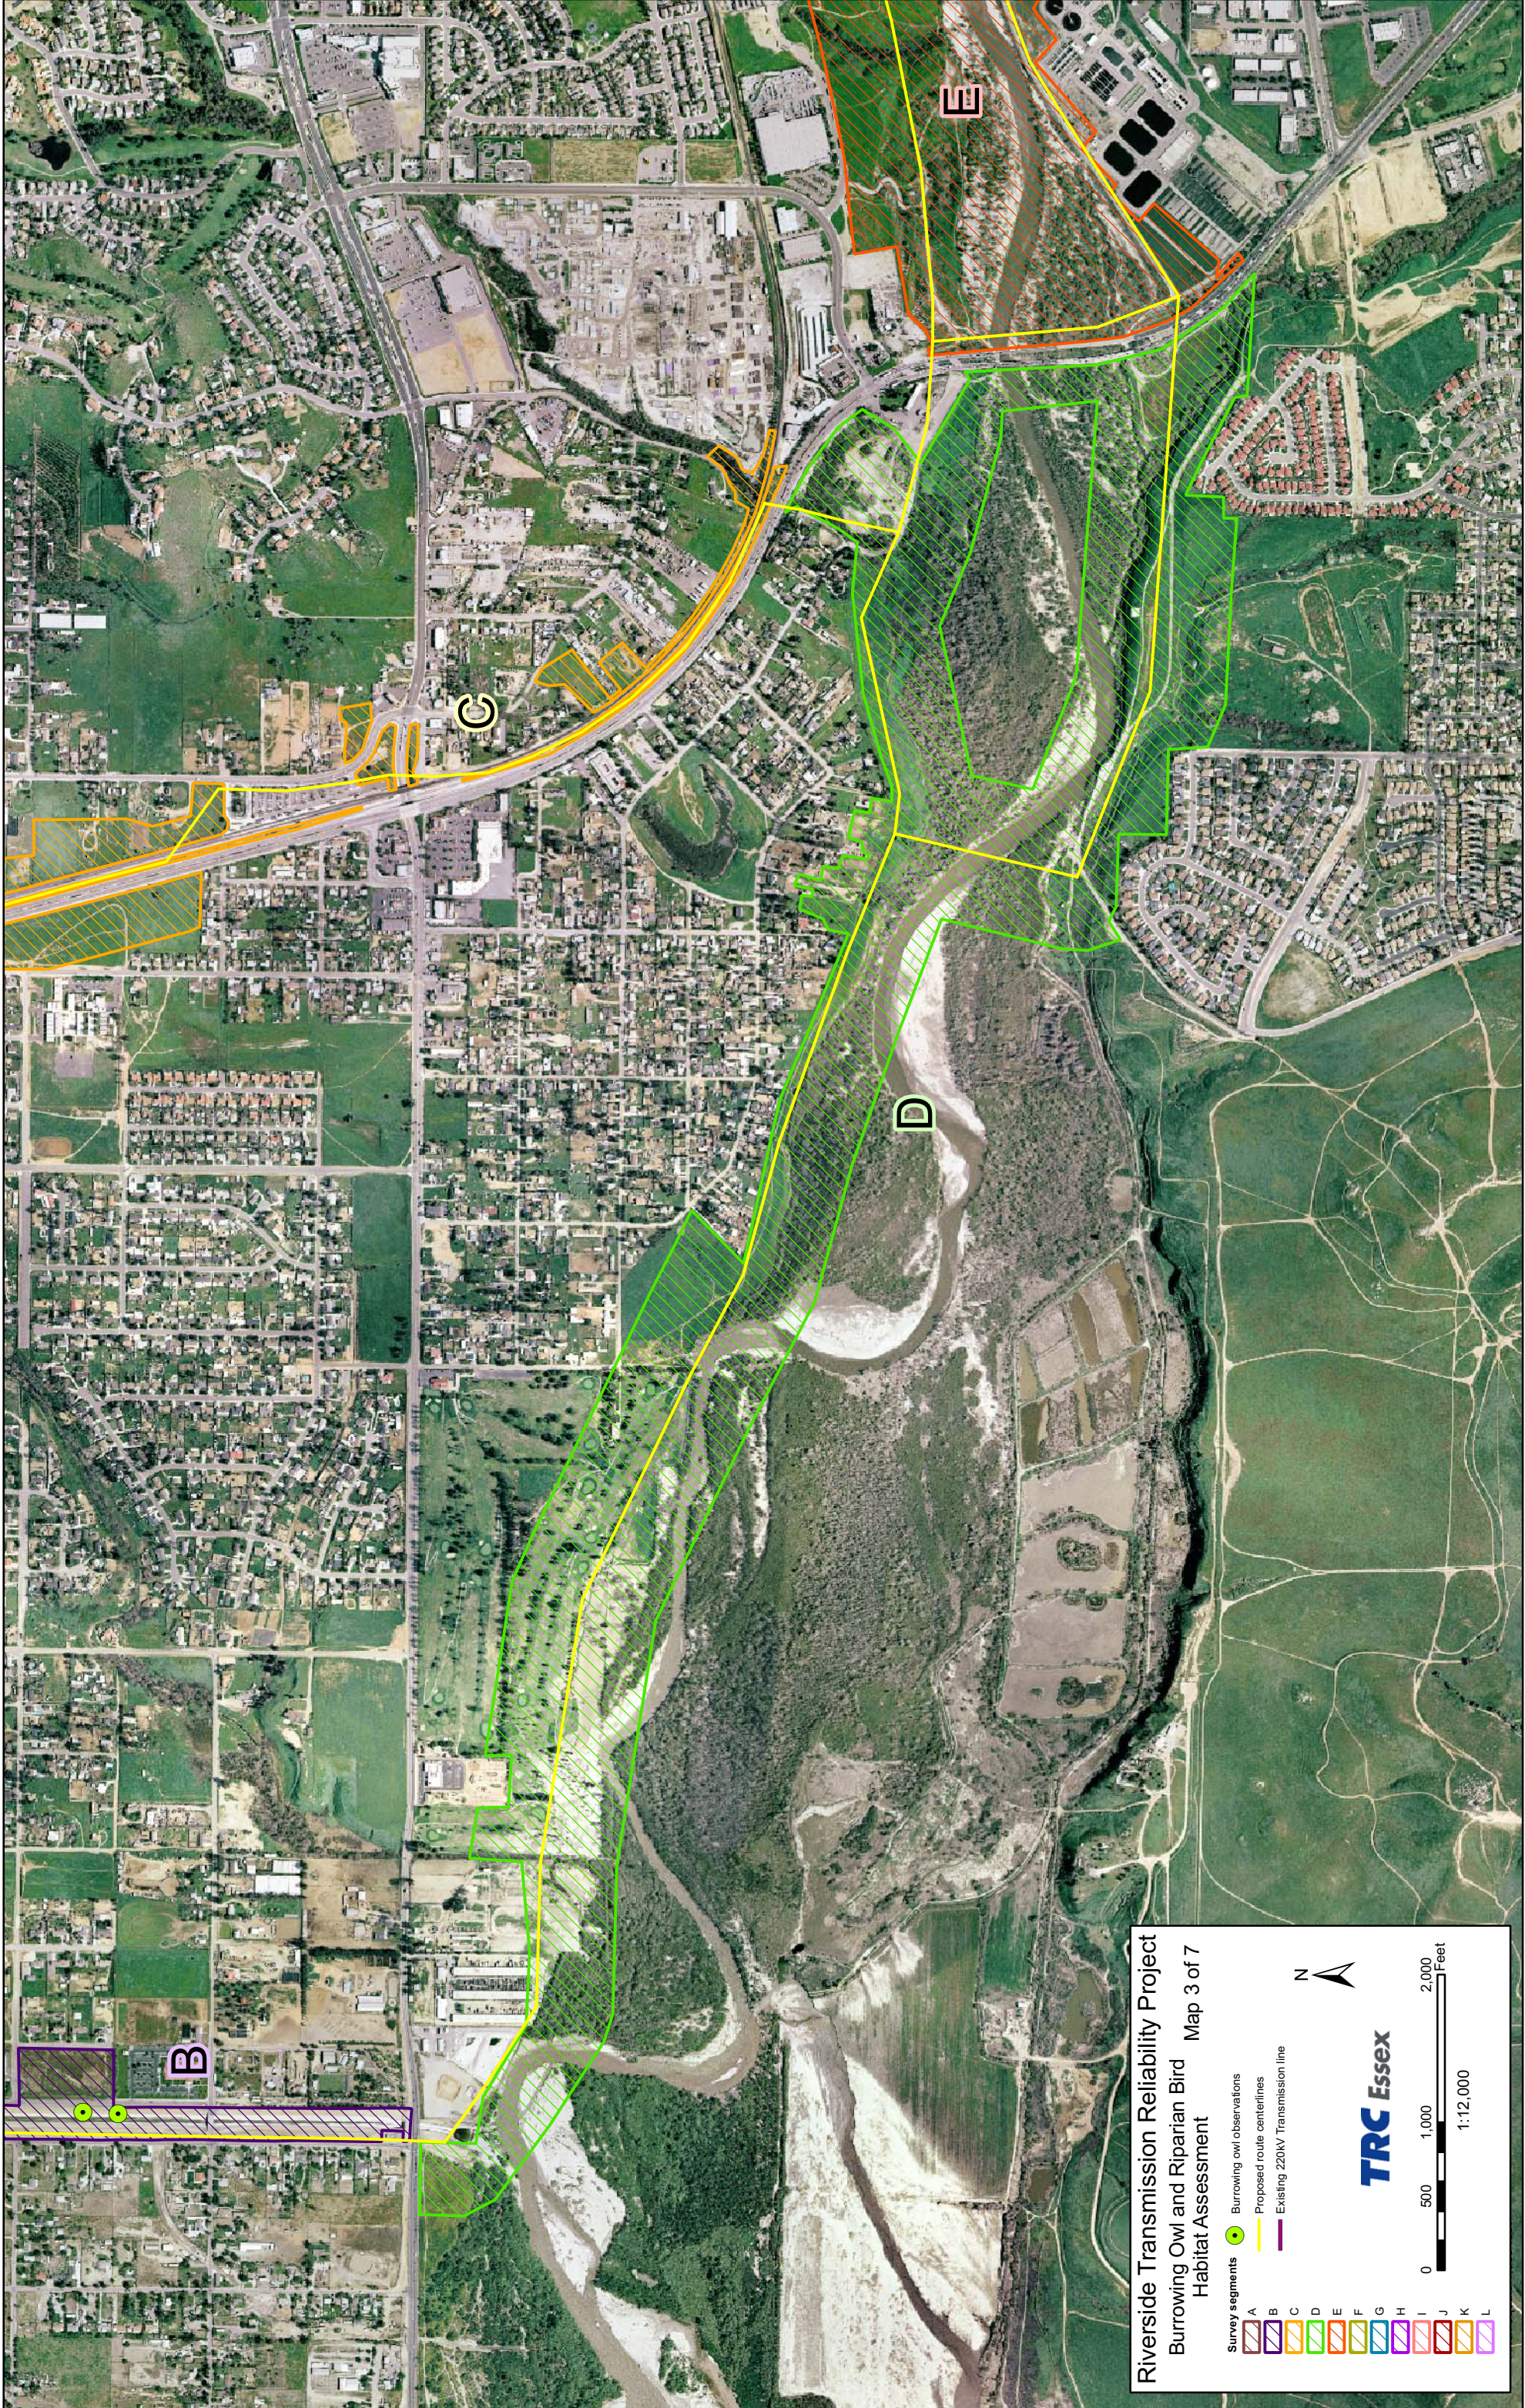
Map 3 of 7

This segment of the proposed route starts south of the intersection of Limonite Avenue and Bain Street and extends southeast along the Santa Ana River to the intersection of the Santa Ana River and Van Buren Boulevard. The proposed project route runs through a dirt access area which is adjacent to the west side of the large, fenced concrete flood control channel that extends the length of Bain Street continues approximately 250 feet south of Limonite Avenue. One potentially active burrowing owl burrow was observed within the fenced concrete drainage area. Whitewash and feathers were observed in and around the burrow entrance. No owls were observed. Ground squirrels were observed in the area within and outside of the fenced concrete flood control channel area.

The riparian area located south of the proposed route along this section consists of southern cottonwood willow riparian forest interspersed with dense sprawling areas of giant reed. Because the riparian area contains scattered patches of tall Fremont cottonwoods with a fairly dense under story, it is recommended that least Bell's vireo, southwestern willow flycatcher, and yellow-billed cuckoo surveys be conducted in the areas, starting from the eastern edge of the golf course to Van Buren Boulevard, that contain dense patches of southern cottonwood willow riparian forest. As the proposed route approaches Van Buren Boulevard, there is a large open lot that is currently under construction and a residential area to the northwest. At this point, there is a short leg of the proposed route that transverses this lot and connects to Segment C on Van Buren Boulevard. This area does not contain suitable habitat for least Bell's vireo, southwestern willow flycatcher, yellow-billed cuckoo, or burrowing owl.

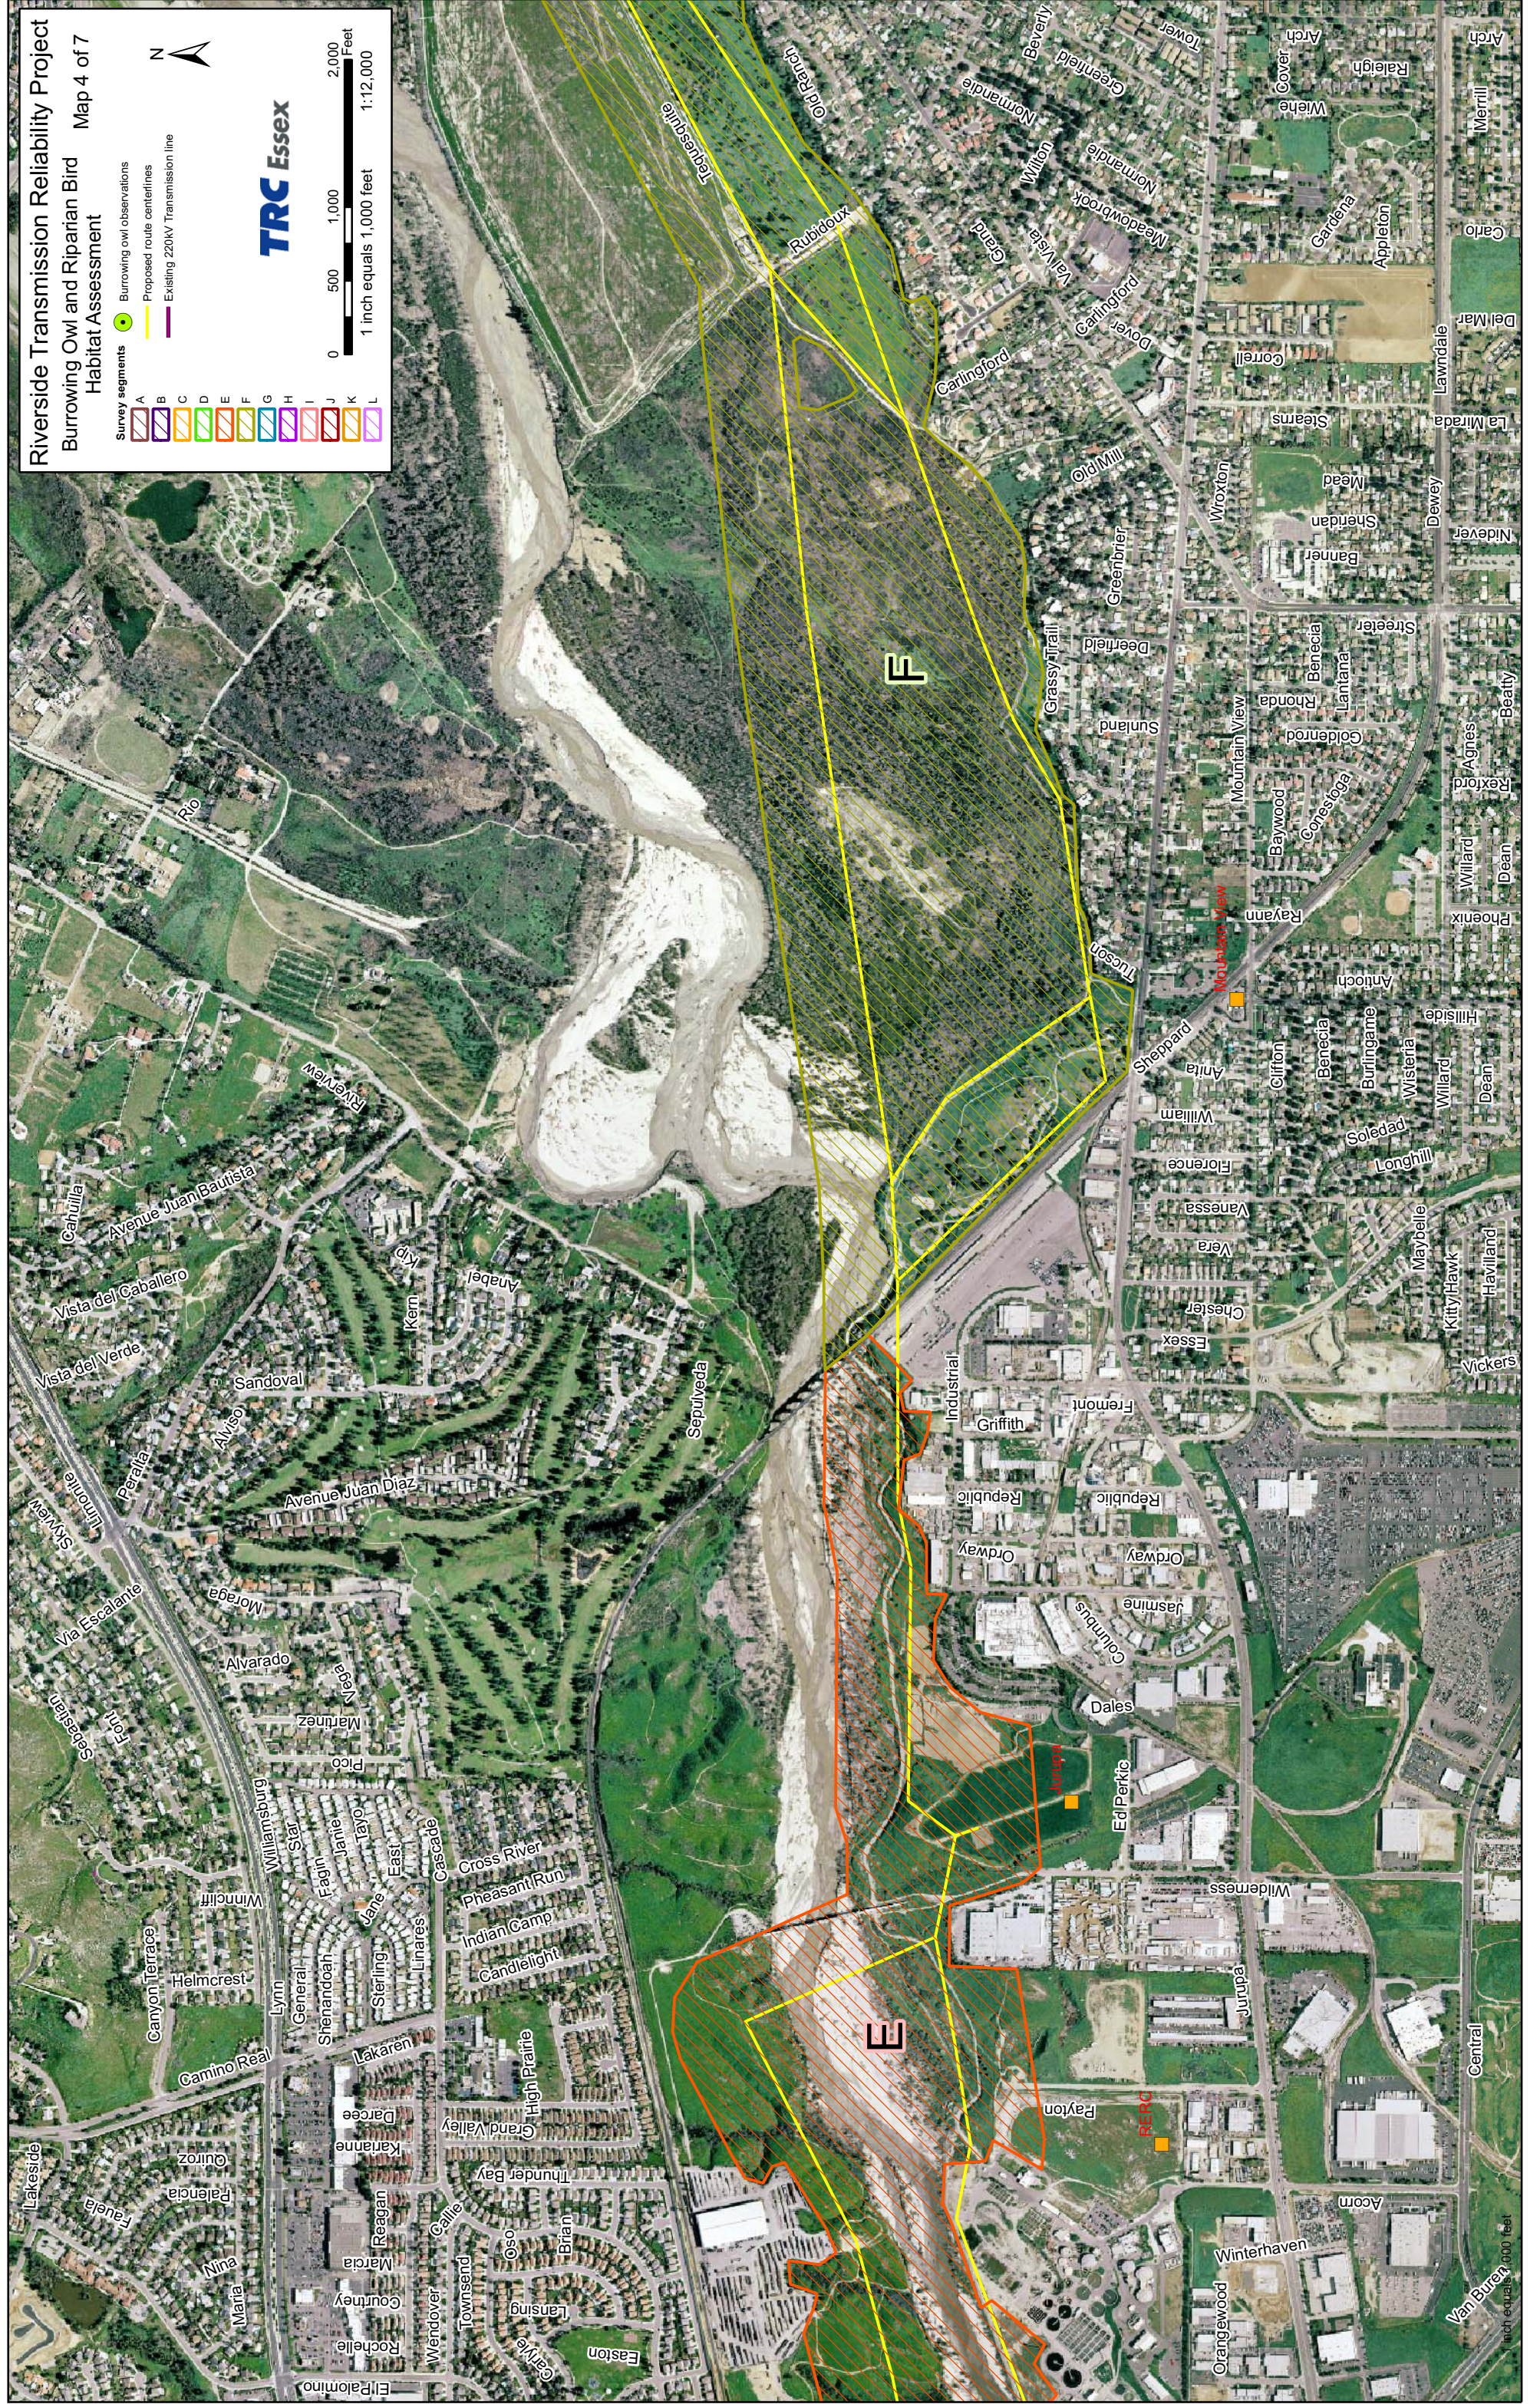
Map 4 of 7

This segment of the proposed route starts at the intersection of Van Buren Boulevard and the Santa Ana River and travels on both the north and south sides of the river east to the proposed Jurupa substation location. At this point the proposed route on the north side of the river crosses the river and merges with the route on the south side of the river for the remainder of the segment from the Jurupa substation east to the intersection of the river and the railroad trestle that spans the Santa Ana River.

No burrows, ground squirrels, or suitable substrate for burrows or burrowing owls was observed in the area of the proposed route adjacent to the water treatment plant. The disturbed area adjacent to the water treatment plant and west of Jurupa substation contains suitable burrows and ground squirrels were observed in the area.;therefore, it is recommended that focused burrowing owl surveys be conducted in this area. From Jurupa substation, the proposed route continues along the south side of the river, through disturbed areas and adjacent to commercial developments, to the train trestle that spans the Santa Ana River. The disturbed areas in this portion of the proposed route contain suitable burrows and ground squirrel activity. Therefore, it is recommended that burrowing owl surveys be conducted in this area.

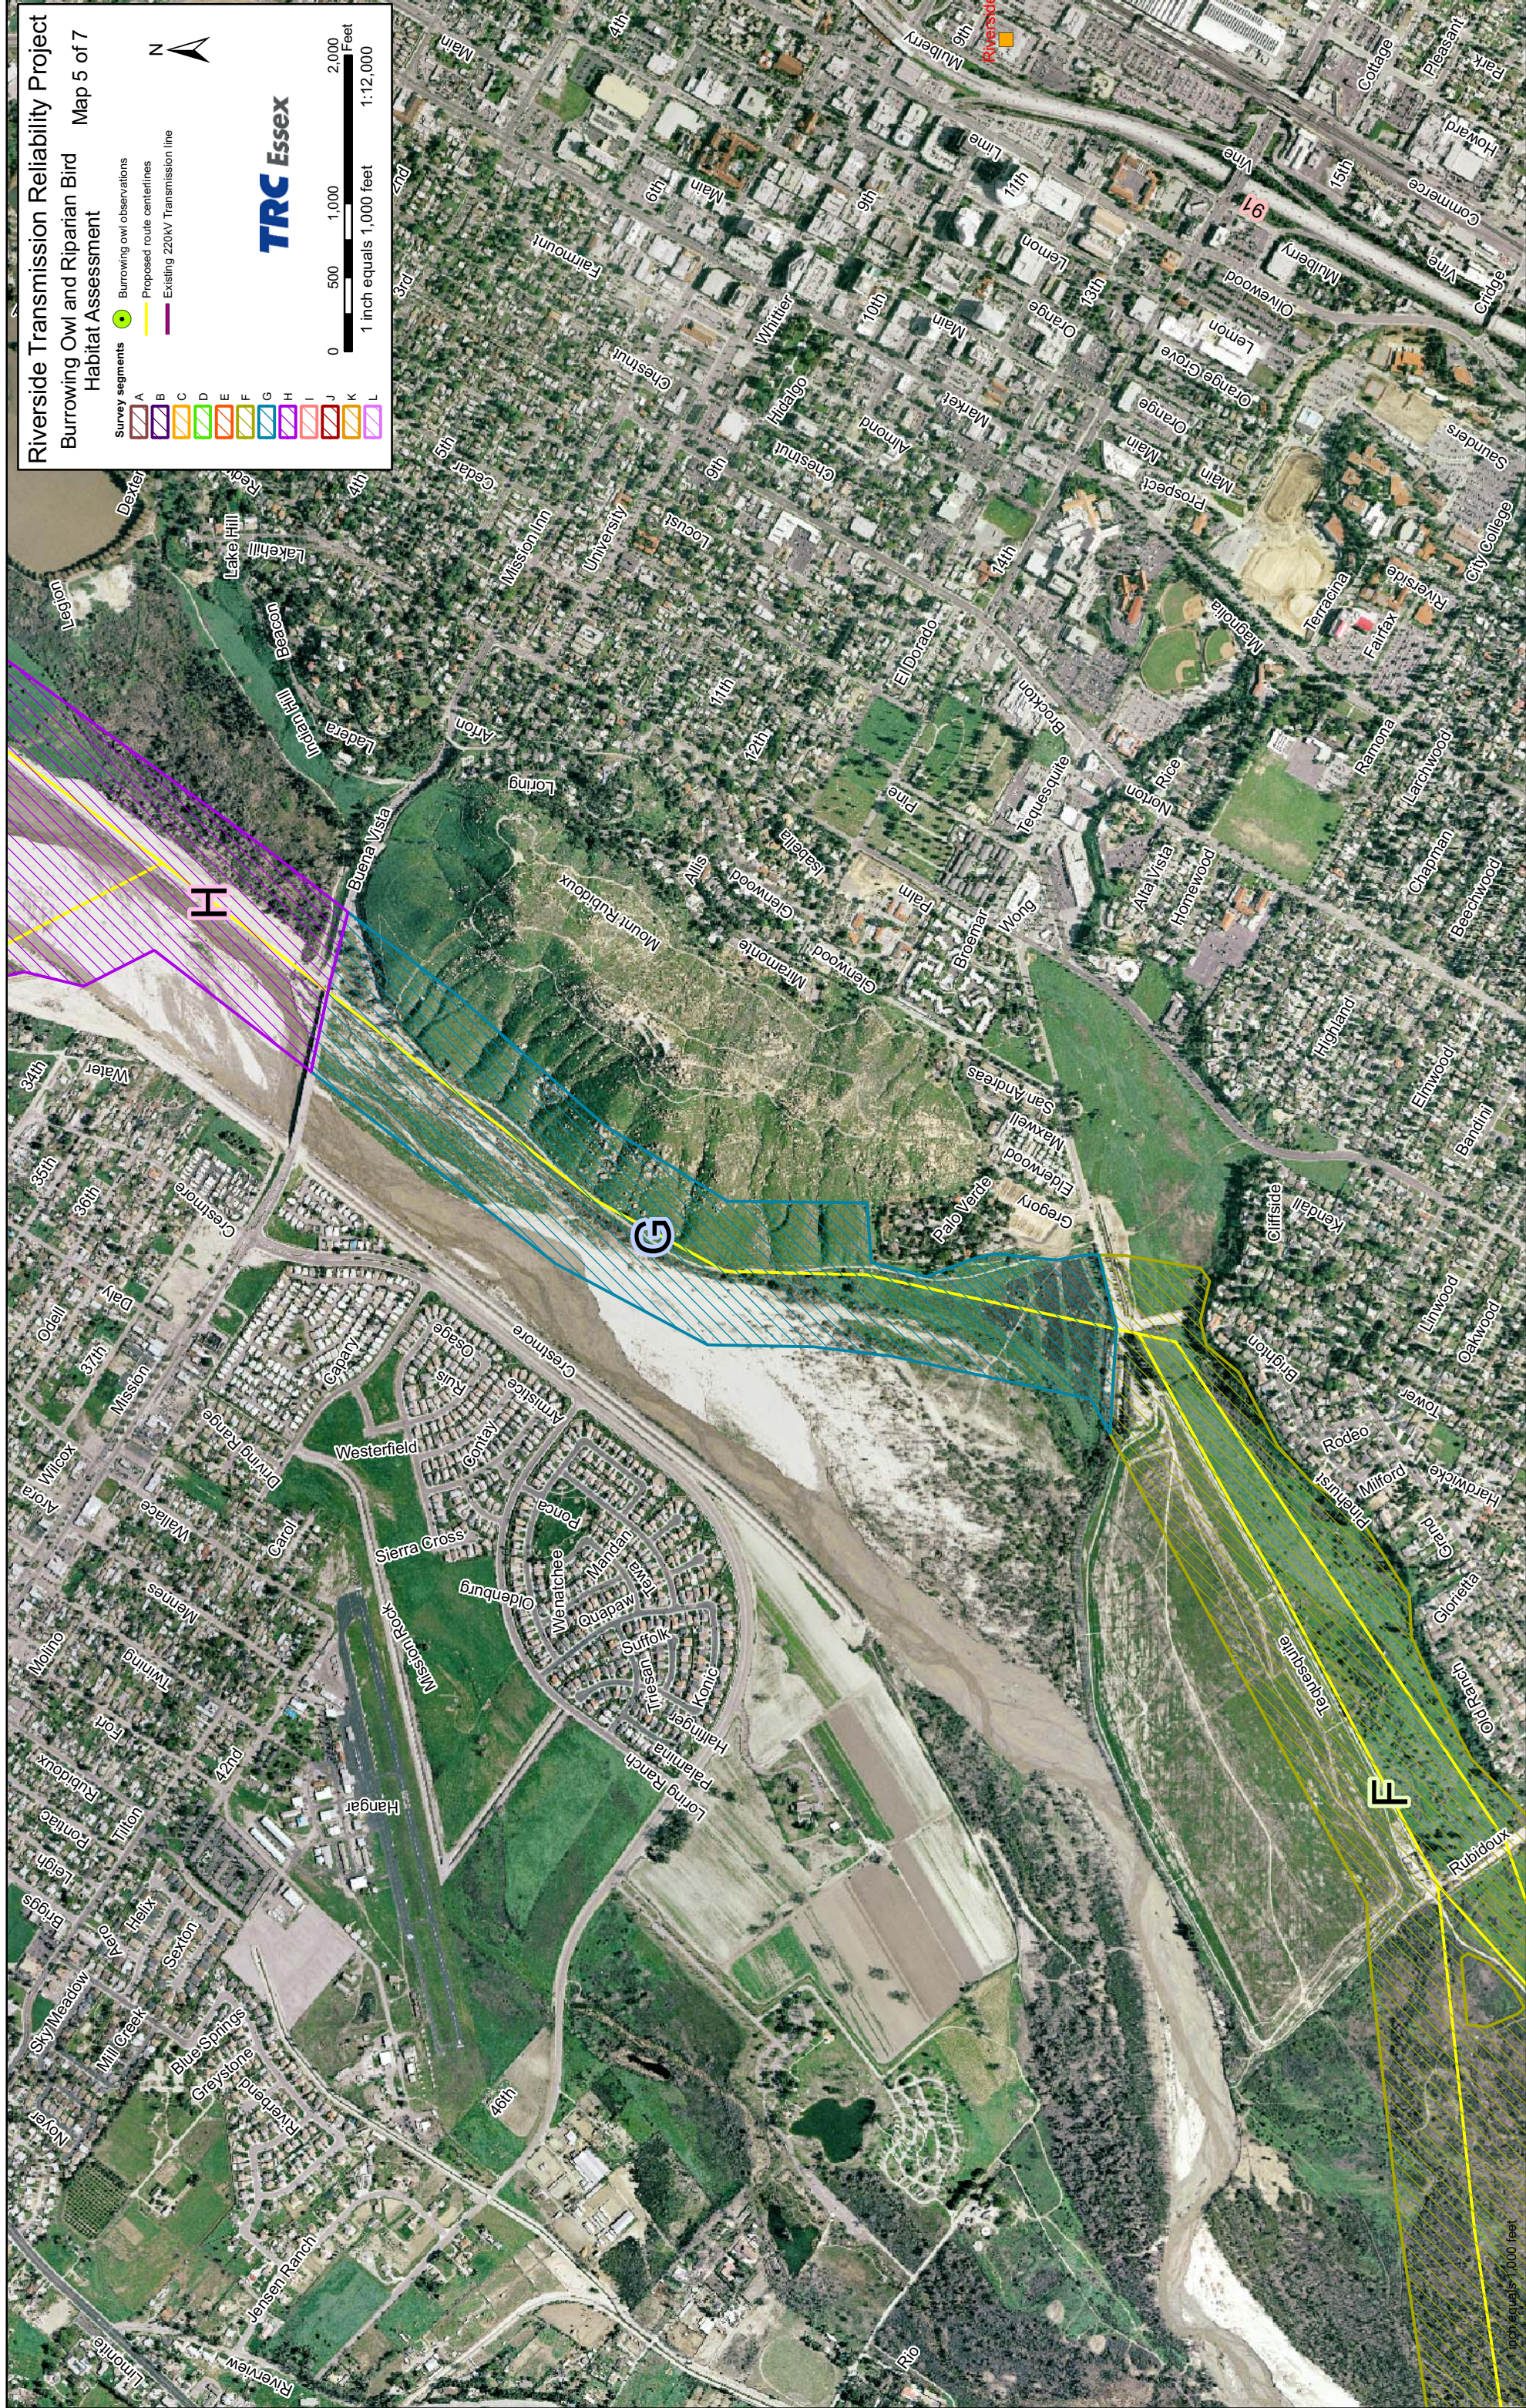
Riverside Transmission Reliability Project
Burrowing Owl and Riparian Bird
Habitat Assessment
 Map 5 of 7

From the train trestle crossing on the south bank of the Santa Ana River, Segment F branches out into three proposed alternate routes with one route extending east through riparian area [Links 20 and 22], one extending south adjacent to the train tracks on the west and Anza Narrows Park on the east [Link 19], and one extending east and then south, traveling along the east side of Anza Narrows Park [Links 20 and 21].

The buffer zone of the branch of Segment F that extends east [Link 22] crosses an expansive area of southern cottonwood willow riparian vegetation with sandy and gravelly well drained soils, open sand bars, and patches of dense giant reed. The riparian vegetation tends to be thicker and have more substantial under story in the area closer to the river. It is recommended that focused surveys for least Bell's vireo, southwestern willow flycatcher, and yellow-billed cuckoo be completed in sections of the proposed route that pass through these denser riparian areas. The riparian area then gives way to dense stands of arrowweed (*Pluchea sericea*), disturbed areas, and a former landfill that is regularly mowed. Segment F terminates at the eastern end of a former landfill. No burrows or ground squirrels were observed in the disturbed areas located between the stands of arrowweed, in addition, sandy soils make this area unlikely burrowing owl habitat. The adjacent former landfill is fenced and consists of

mowed non-native vegetation. Although no burrows were observed at the time of the survey, ground squirrels were observed in the area and foraging habitat is available nearby. Therefore, it is recommended that focused surveys for burrowing owl be completed in this area [Links 26].
