RE: Delineation Memo regarding Energy Division Data Request #17 (Question 7) for the SX to PQ 230kV Transmission Line CPCN Project

**Aquatic Resources Memorandum for the San Diego Gas & Electric Carmel Valley Staging Yard,
Sycamore to Penasquitos 230 Kilovolt Transmission Line Project,
San Diego County, California**

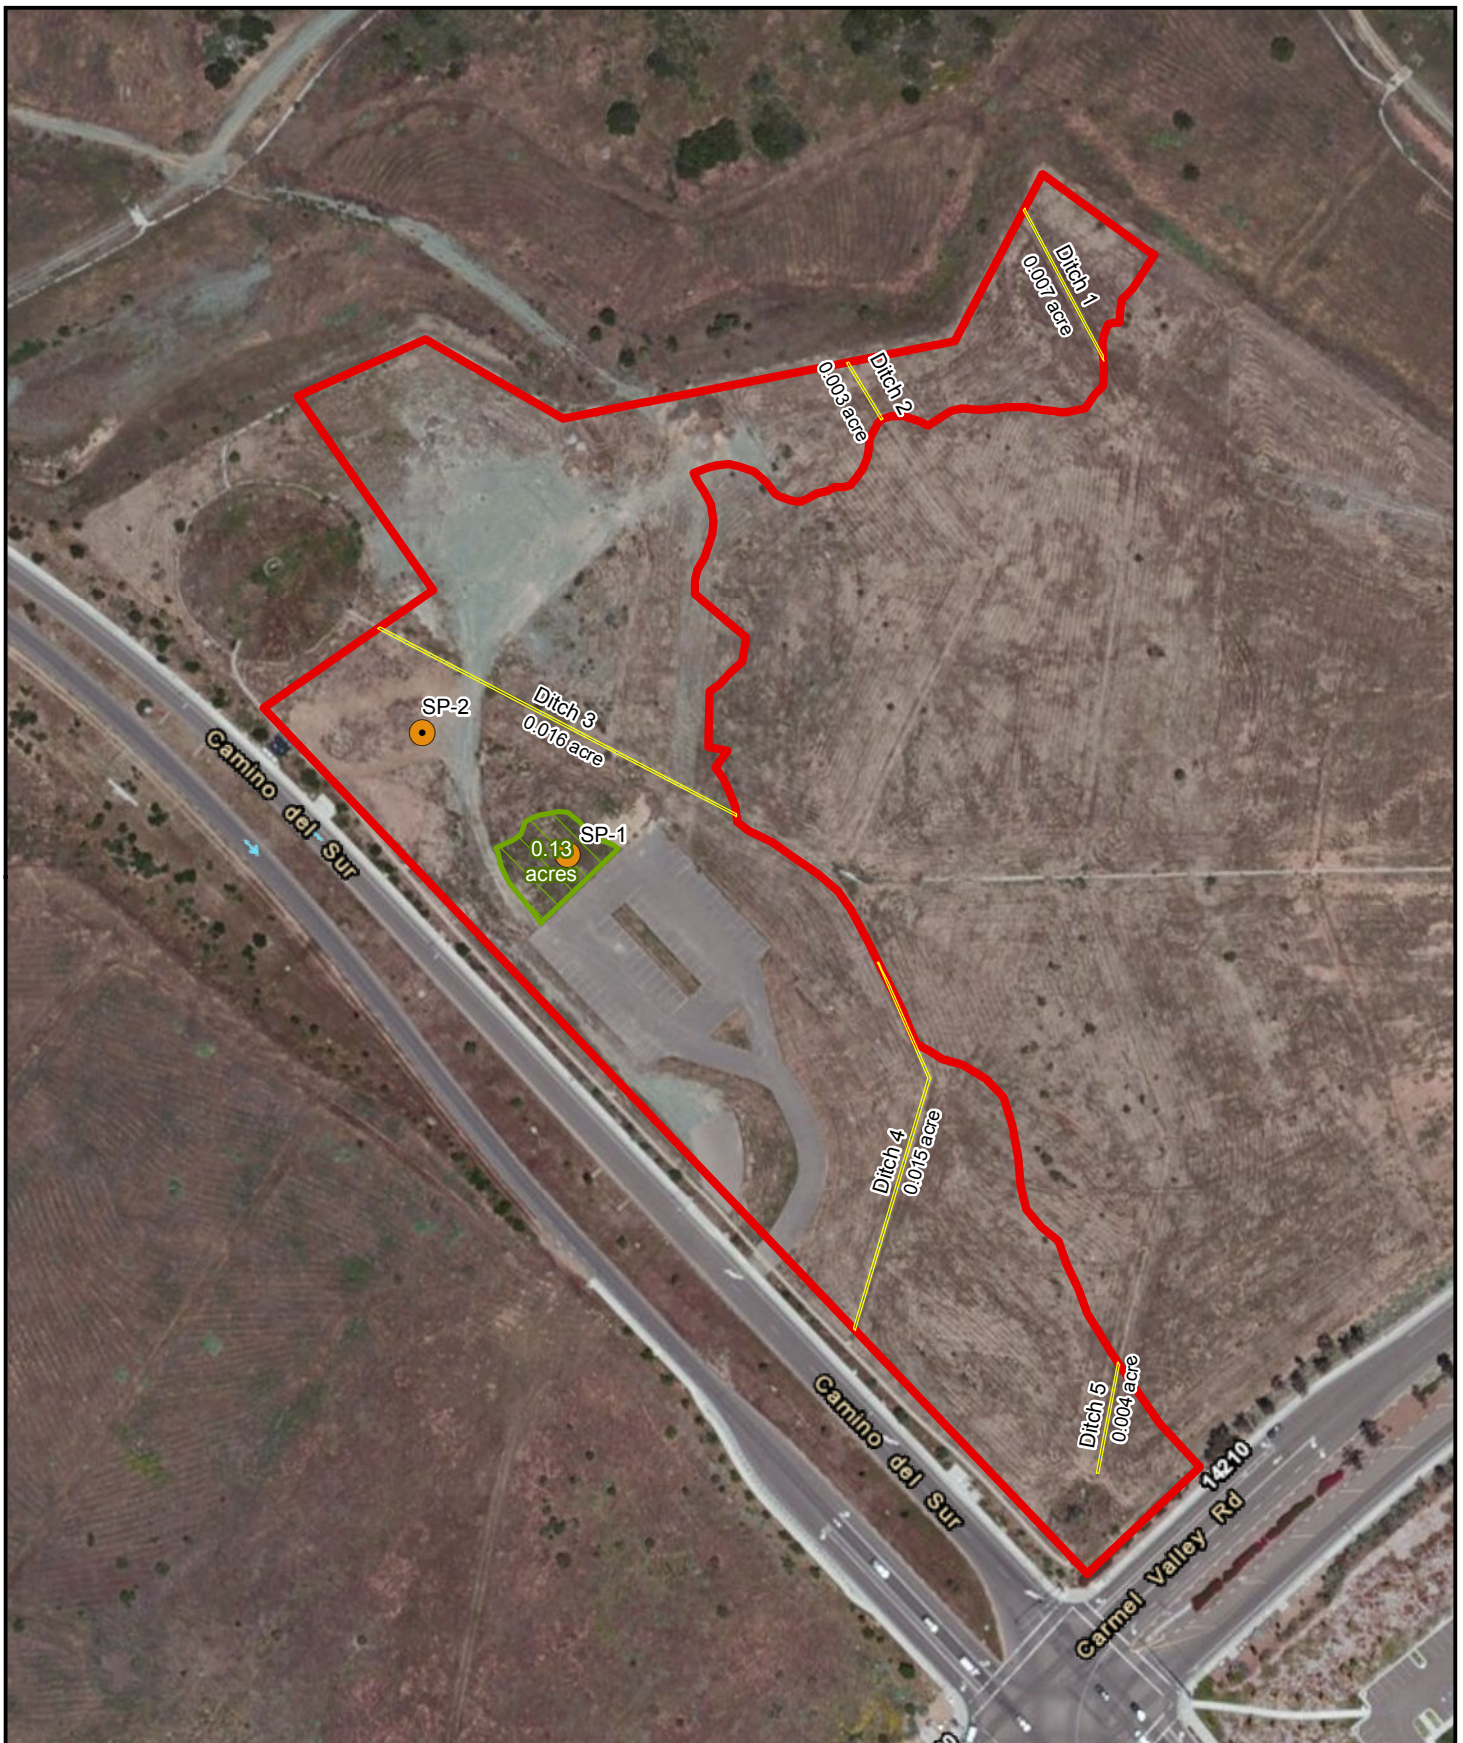
Figure 1
Delineation Results

Approximately 0.016 acre of un-vegetated man-made brow ditches constructed in uplands were mapped within the Study Area (Attachment B, Figure 1). These features are approximately 2-feet in width by 1 foot deep, and flow off of the Study Area to a detention basing located to the northwest. No culvert appears to provide flow from the basin into the San Dieguito River to the north. These features are man-made, and according to historical photographs and data, do not follow or direct formerly naturally occurring drainage features within the Study Area. As such, these features are not likely to be considered waters of the US or waters of the State. As such, brow ditches within the Study Area are considered non-jurisdictional by USACE, RWQCB, and CDFW.

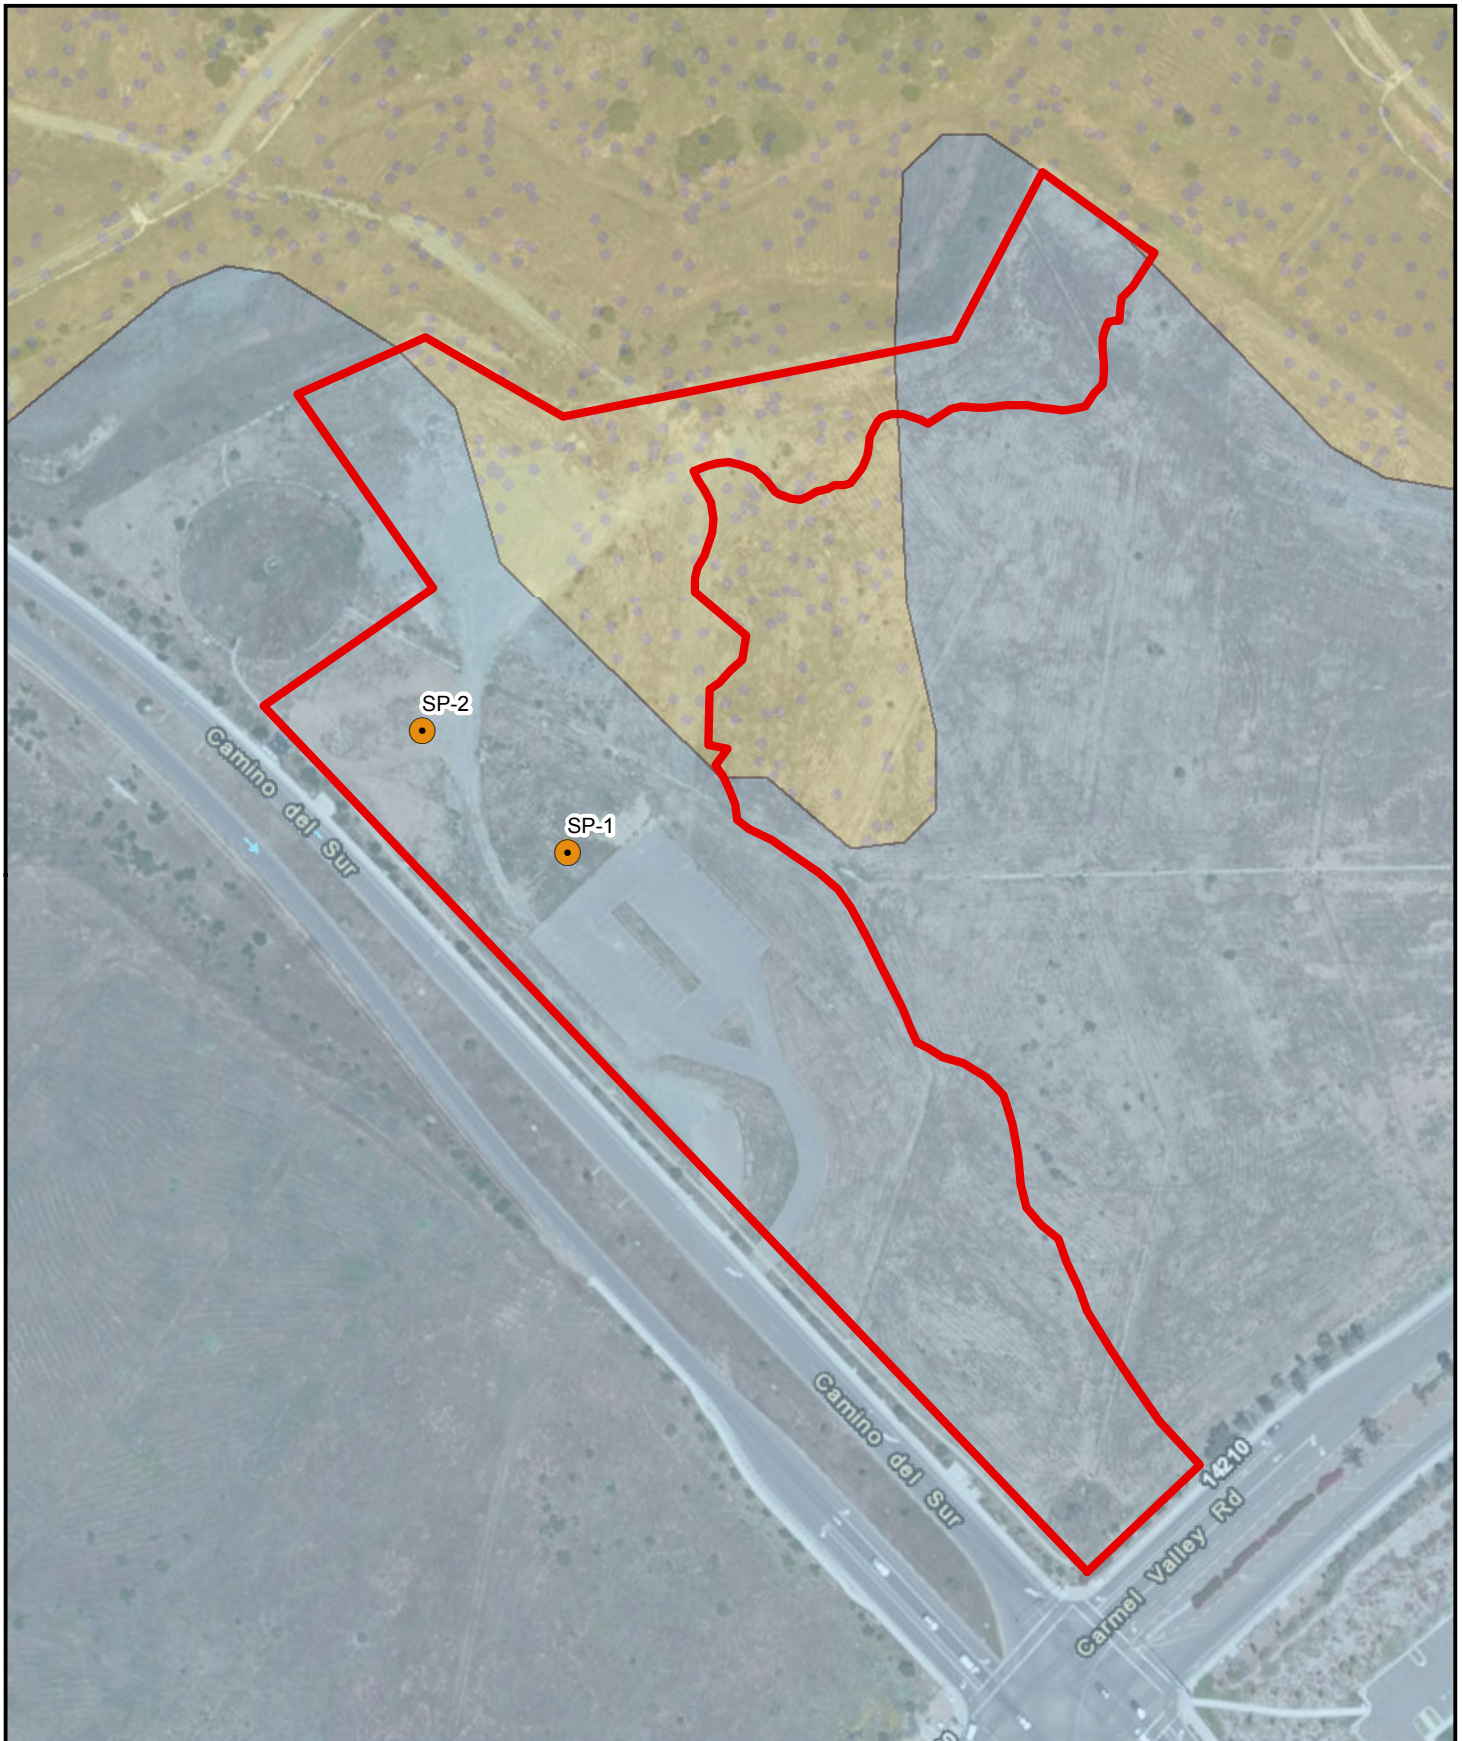
Figure 2
Soils Map

Two soil types occur onsite: Olivenhain cobbly loam 2 to 9 percent slopes and Las Flores loamy fine sand 9 to 15 percent slopes (Attachment B, Figure 2). Olivenhain cobbly loam is considered to be partially-hydric.

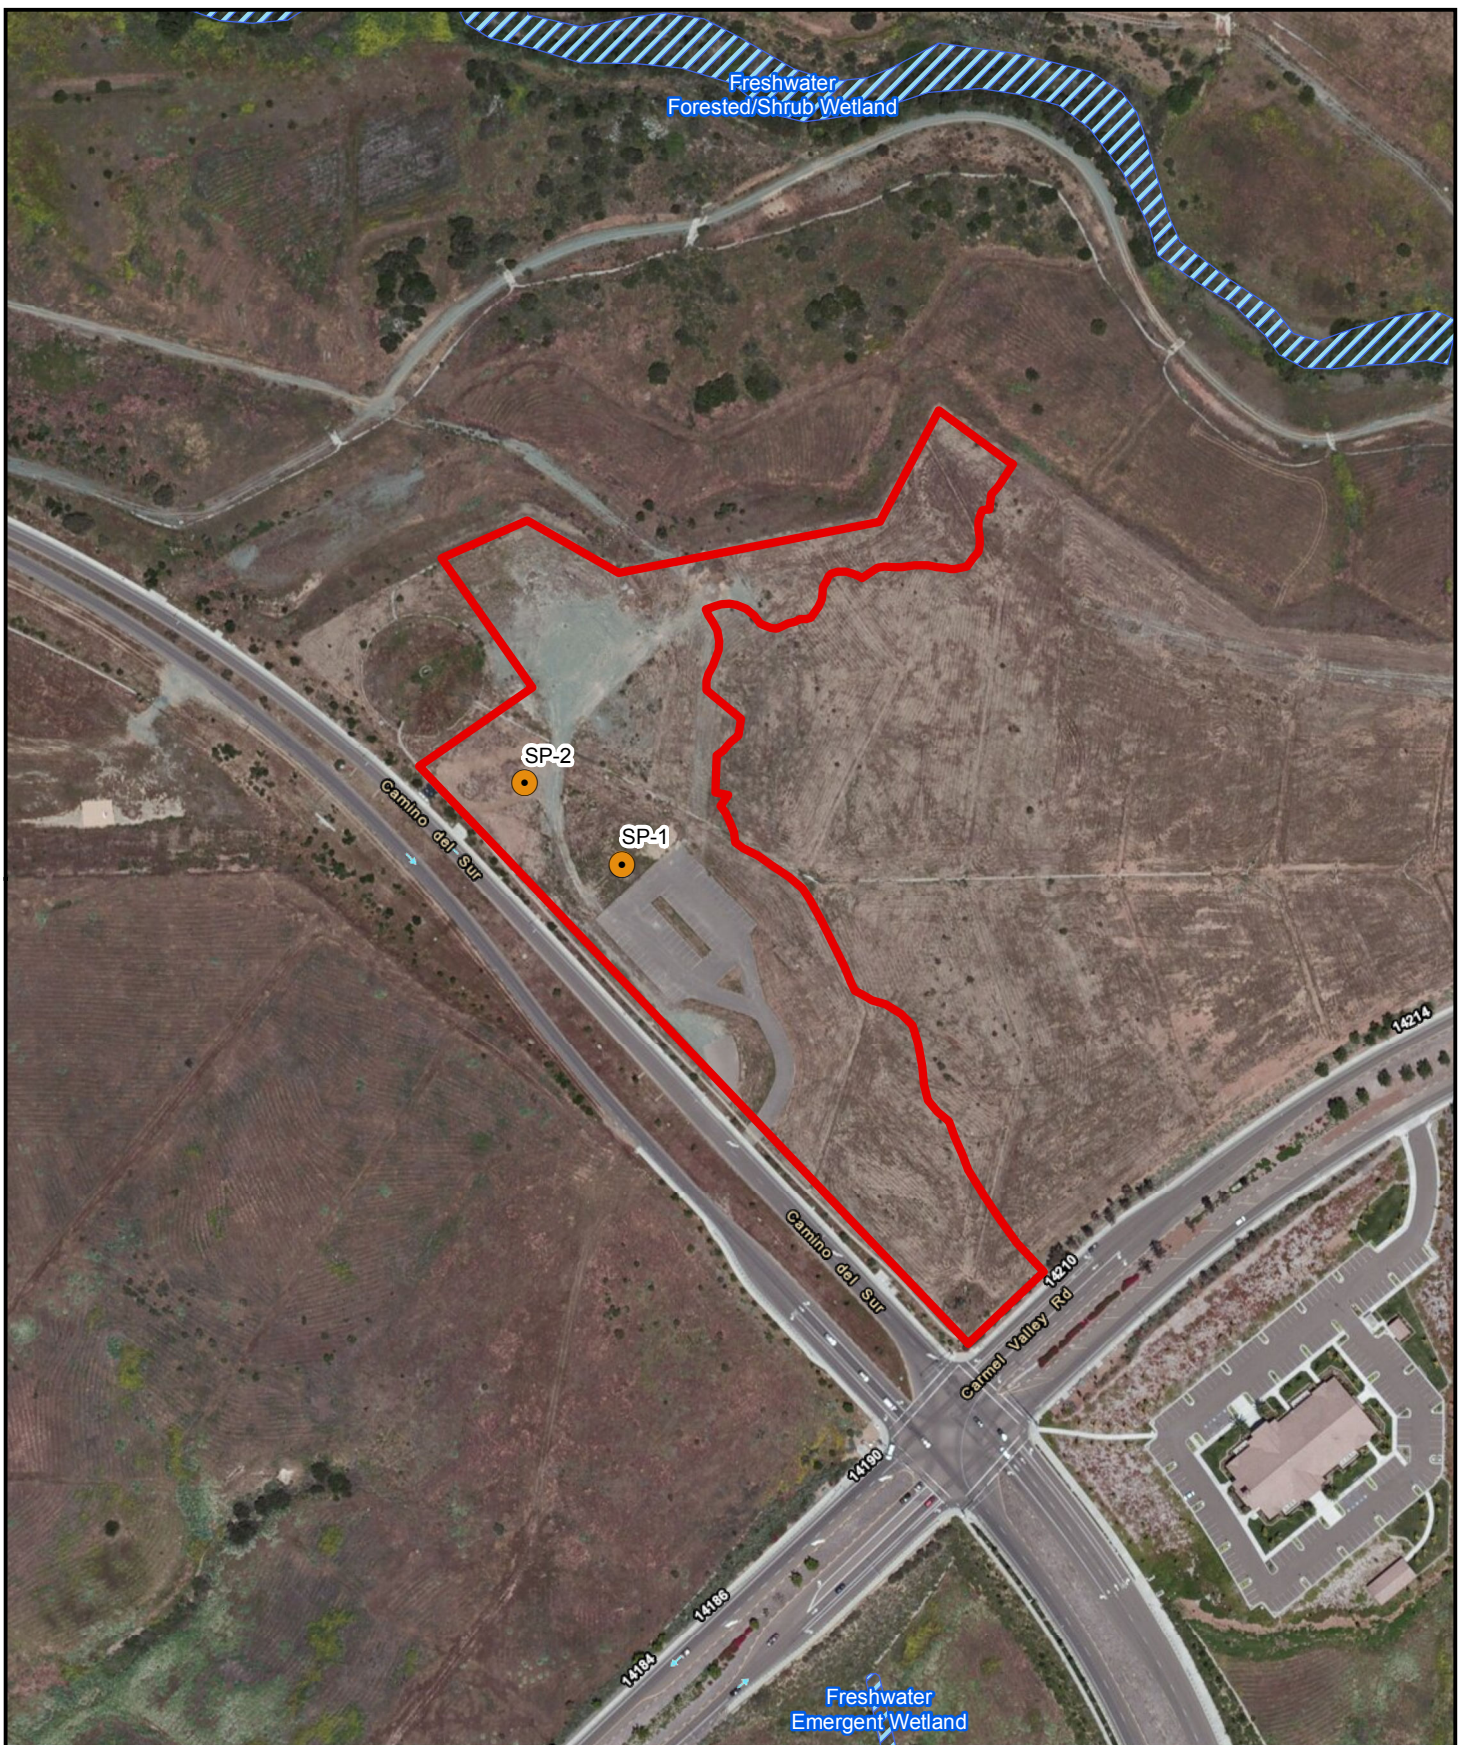
Figure 3
NWI Map

Based on topographic, USFWS NWI, and USGS maps, no naturally occurring drainage features or streambeds appear to occur within the Study Area (Attachment B, Figure 3) or connect to a jurisdictional waterway.

The NWI indicates that no wetland features or riparian areas occur within the Study Area. The NWI shows a freshwater forested/shrub wetland within the San Dieguito River approximately 500 feet north of the Study Area, and an emergent freshwater wetland area located approximately 1,000 feet west of the Study Area. However, no feature on site appears to convey waters to these features.

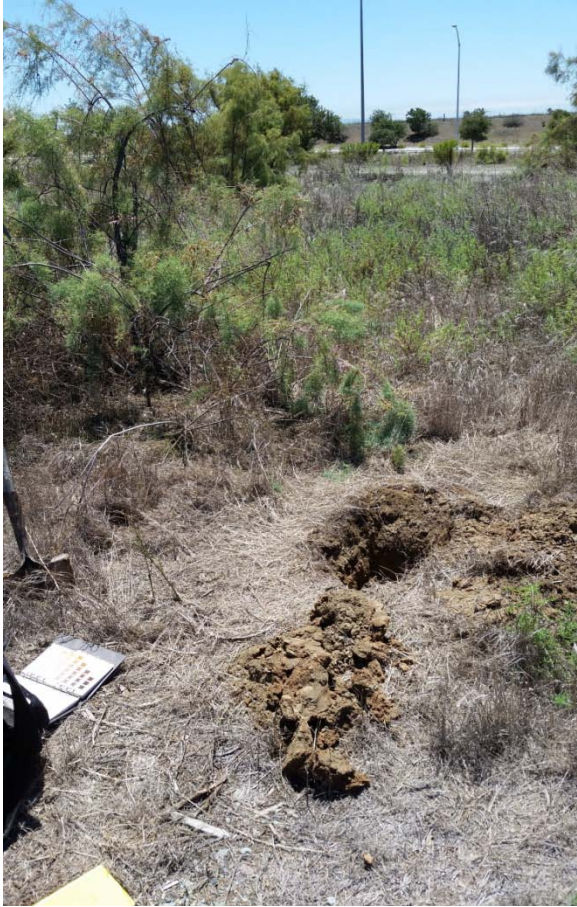
This habitat was not identified as a meadow/seep area based on the recent July 24, 2015 survey effort. Species identified within this area include: non-native Italian ryegrass (*Festuca perennis*; Facultative (FAC) species), wild oat (*Avena barbata*; Upland (UPL) species) fringed by tamarisk (*Tamarix* sp.; FAC), Russian thistle (*Salsola tragus*), bristly oxtongue (*Helminthotheca echiloides*; Facultative Upland (FACU) species), and scattered native slender creeping spike-rush (*Eleocharis montevidensis*; Facultative wet (FACW) species). This area also hosted one small pepper tree (*Schinus molle*) and is predominantly surrounded by Russian thistle (Attachment C, Photos). The slender creeping spike-rush and the non-native tamarisk each comprised approximately 10 percent of the soil pit location 1 Survey Area. The non-native Italian ryegrass comprised approximately 50 percent of the area within soil pit location 1, and occurs in both wet and dry environments. Although collectively these species pass the dominance test for hydrophytic vegetation for the soil pit location, the Italian ryegrass is the dominant species and is typically found in non-native grassland communities. Based on the topography, lack of hydrologic connectivity, and existing conditions of the surrounding area, this small 0.13 acre area has been re-classified as non-native grassland.

Photo 1. Soil Pit 1, within the non-native grassland habitat comprised of Italian ryegrass, wild oat, Russian thistle, bristly oxtongue, and scattered native slender creeping spike-rush fringed by tamarisk.

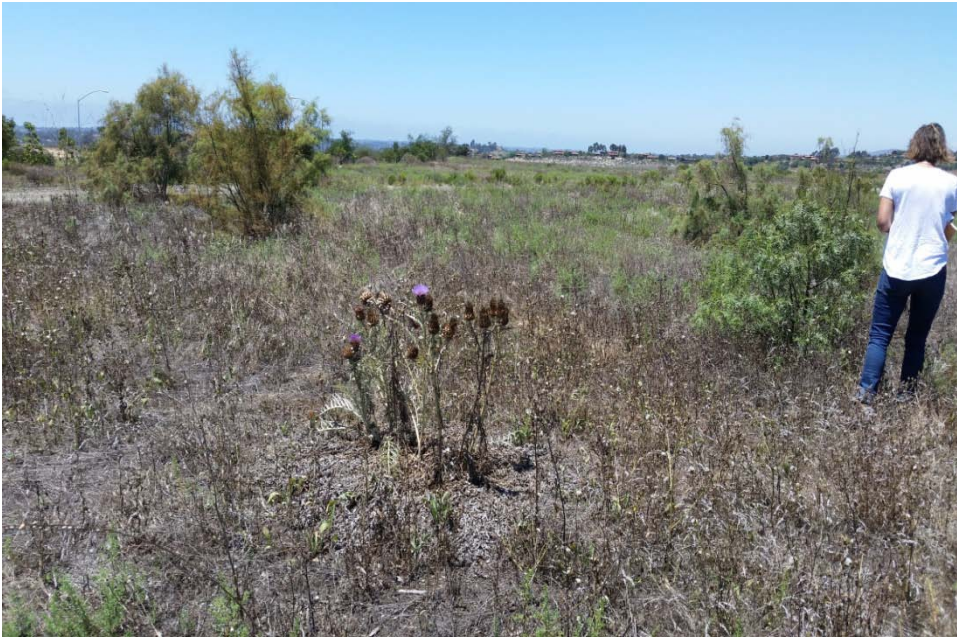
Photo 2. Area immediately surrounding the non-native grassland at Soil Pit 1. Species include non-native Russian thistle, ragweed, filaree, fennel, wild oat, mustard, and red brome, artichoke thistle, crab grass, cheeseweed, and smooth cats ear.

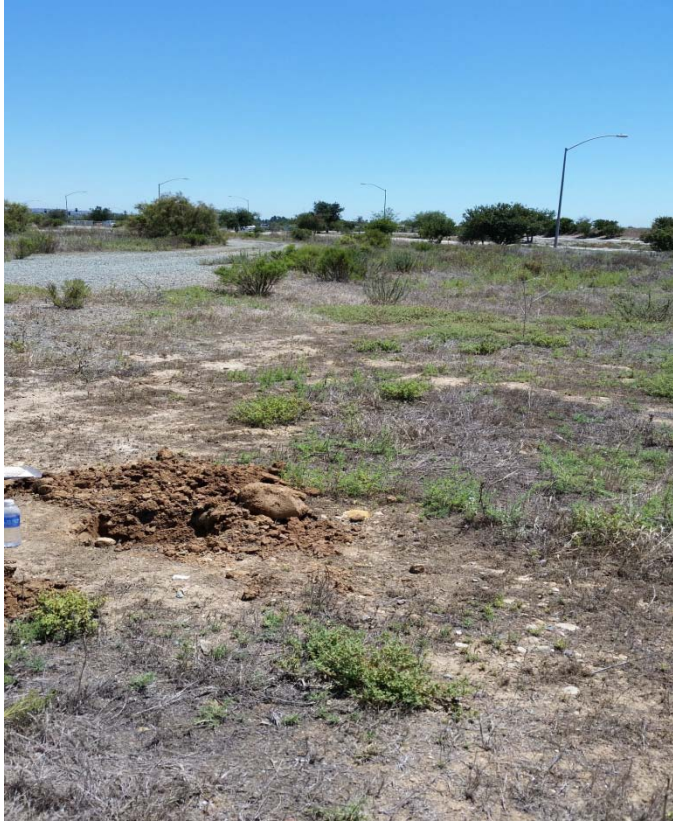
Photo 3. Soil Pit 2. Vegetation appeared previously mowed as evidenced by lower vegetation height than that in the surrounding areas (typically less than 1 foot in height compared to surrounding areas up to 2-3 feet in height).

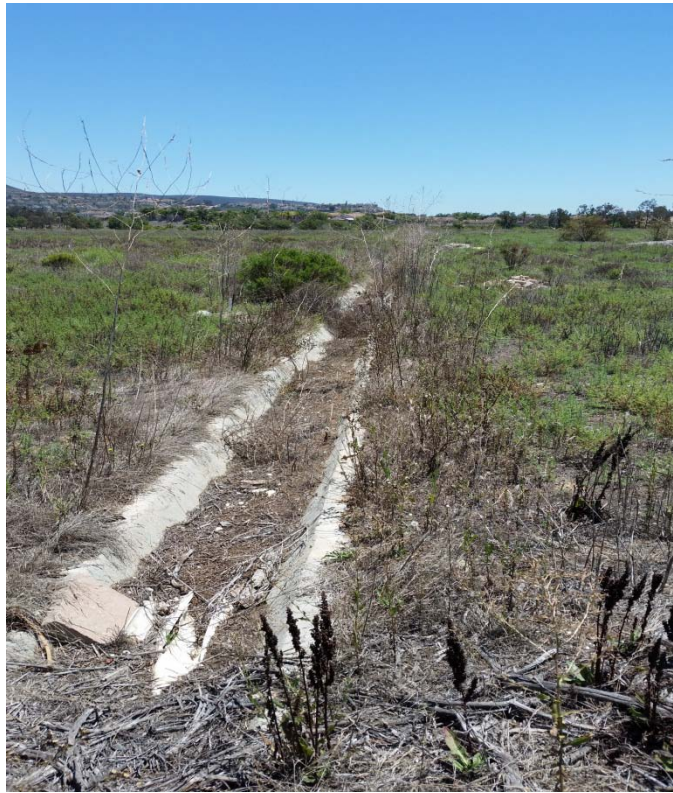
Photo 4. Brow ditches constructed within upland habitat within the Survey Area. These features are approximately 2-feet in width by 1 foot deep.
