**CONSUMER PROTECTION AND SAFETY DIVISION  
CALIFORNIA PUBLIC UTILITIES COMMISSION**

**REVISED  
REPORT AND TESTIMONY  
OF  
MARGARET FELTS**

**I.11-02-016**

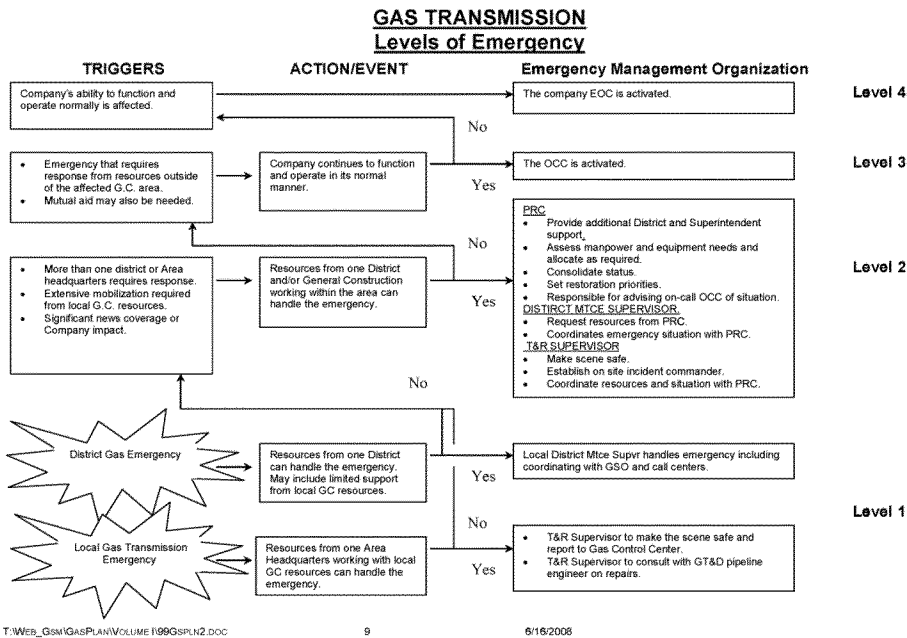
Figure 1

On the transcript of the audio recording made in the San Francisco Control Room during the emergency, it is clear that there was confusion about the emergency response plan.<sup>56</sup> Studying Figure 1, which is supposed to be the short-hand guide to responding to an emergency, confirms that the confusion was warranted. For example, it is not clear who in PG&E was supposed to be in charge of the response to the San Bruno incident, a level 4 emergency.<sup>57</sup>

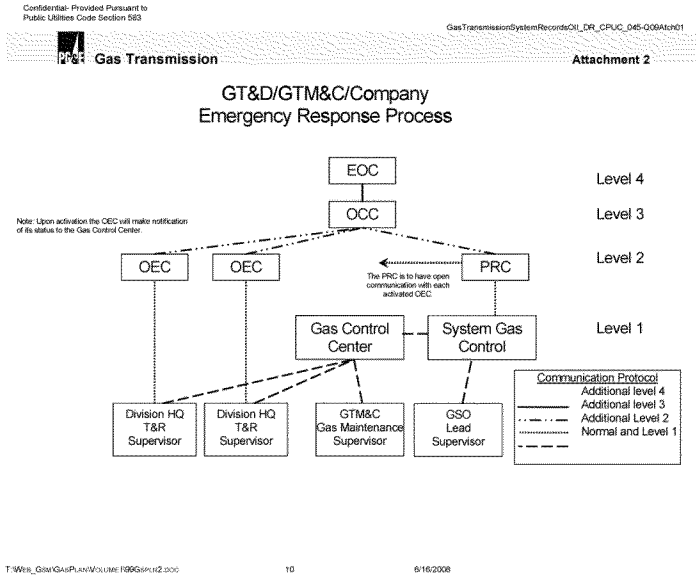
Figure 2

1 provides to its employees.<sup>58</sup> (Figure 2) Each center referenced is opened by a predefined  
 2 manager within PG&E.<sup>59</sup> “EOC” is the Corporate Emergency Operations Center. “OOC” is the  
 3 Operations Coordination Center. “OEC” is the Operations Emergency Center and “PRC” is the  
 4 Pipeline Restoration Center. Not shown on the diagram, but referenced in the Company-wide  
 5 Gas Emergency Response Plan is the “CCECC,” or Call Center Emergency Coordination  
 6 Center.<sup>60</sup>

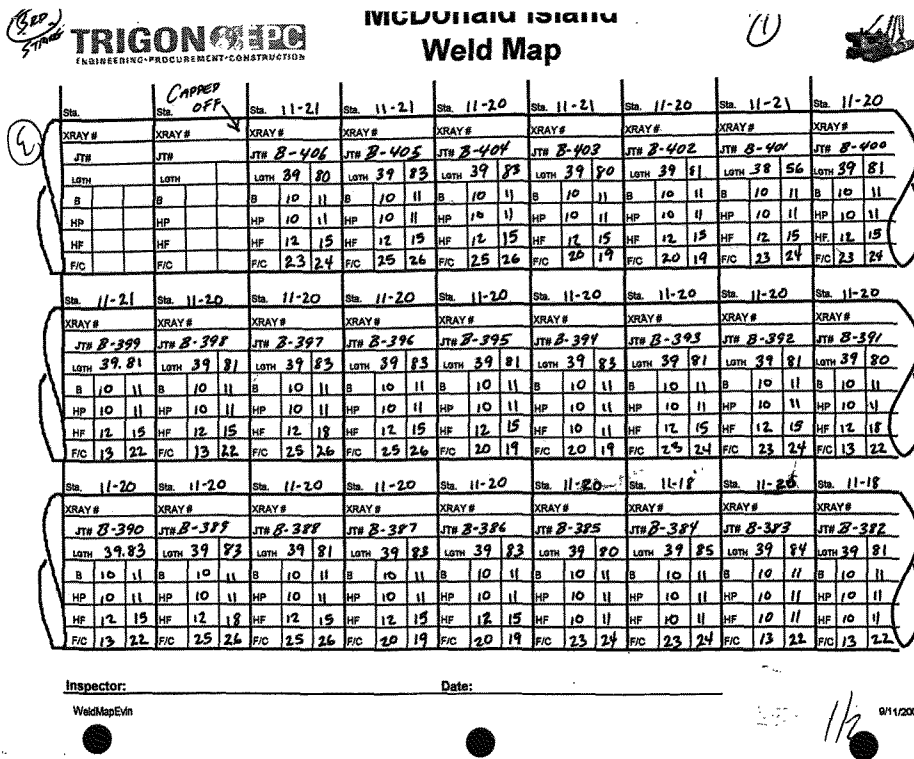
Figure 4<sup>145</sup>

4 The maps generated during a construction project that show the location and orientation  
 5 of welds on a pipeline are called Mainline and Tie-in Weld Maps.<sup>143</sup> A thorough review of many  
 6 job files in PG&E's new Enterprise Compliance Tracking System database revealed very few  
 7 such weld maps, even though they should have been retained in the master Job File according to  
 8 PG&E's policies.<sup>144</sup> These missing weld maps would provide invaluable information to PG&E in  
 9 its current efforts to locate and evaluate welds.

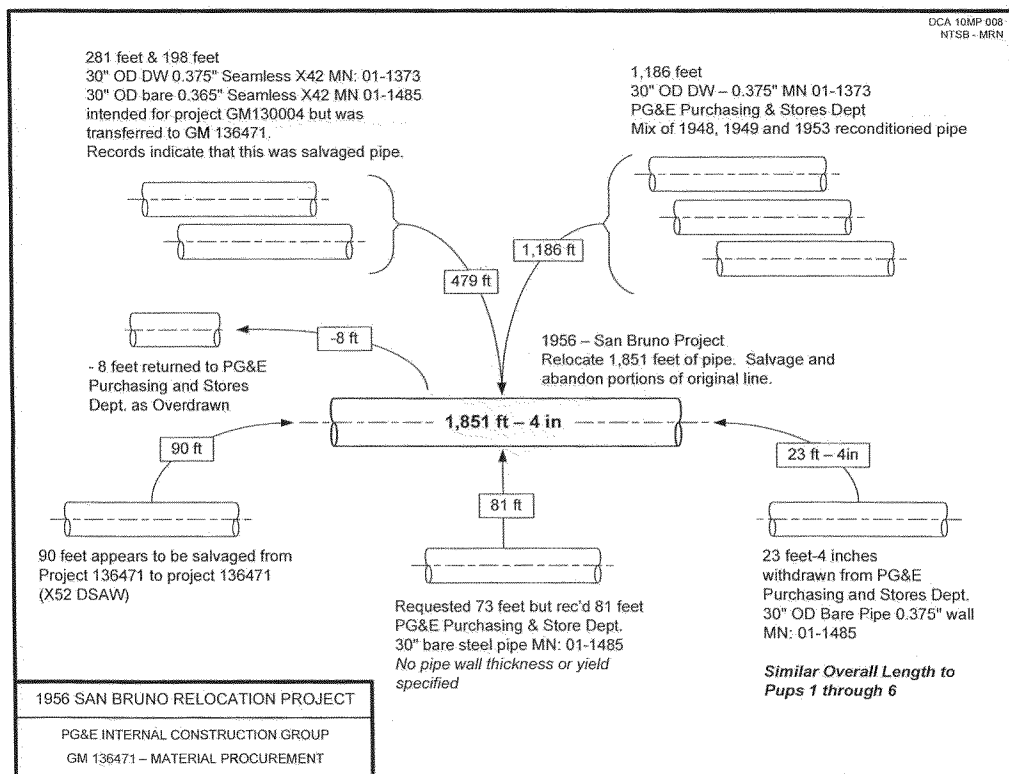
Figure 5<sup>182</sup>

<sup>181</sup> Figure 5 - From Response to NTSB Exhibit 2-DV. File #460235.
