# Sonoma County Vegetation Management

May 2013

PG&E is performing VM maintenance work on 39 miles of critical 230kV transmission line in Sonoma County from the Geysers to Novato.

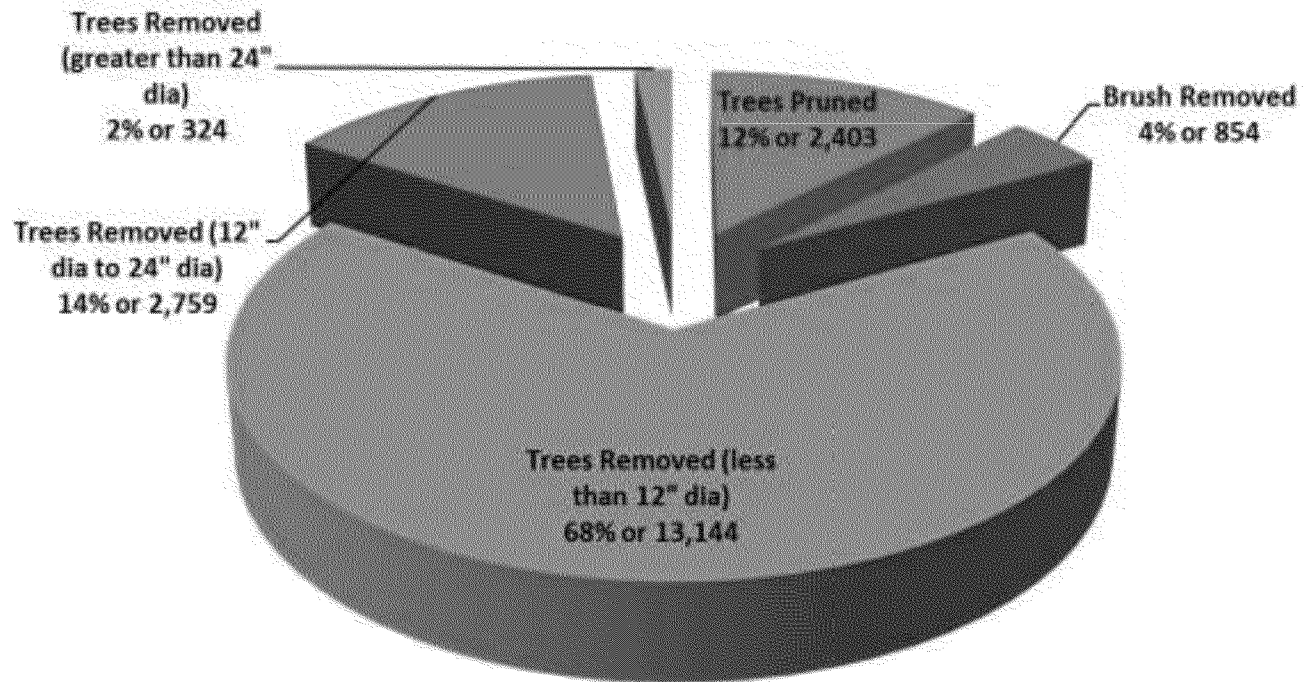
### Total Vegetation Work Performed to Date

- 98% of removals are immature trees less than 24 inches in diameter,
- 82% are less than 12 inches in diameter.
