# Noncompliant Weld Inspection Techniques

## Line 114 Non Destructive Examination Final Report

Issue Date December 5, 2013

### Assessment of PHMSA UC concerns on welds 738, 760, 770, 771, 781

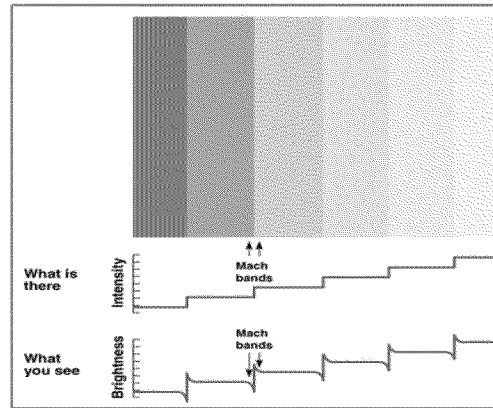
**Figure 1 – Machs Bands Effects**

- 2.3 ATS performed digital radiographic thickness measurements on Weld 162, using the parent material & image quality indicator (IQI) wires as step calibration. This activity was performed to rule out Machs Bands (Figure 1) severity effects, which can influence the interpretation of undercut, and also to provide ROM estimation of any actual undercut conditions.

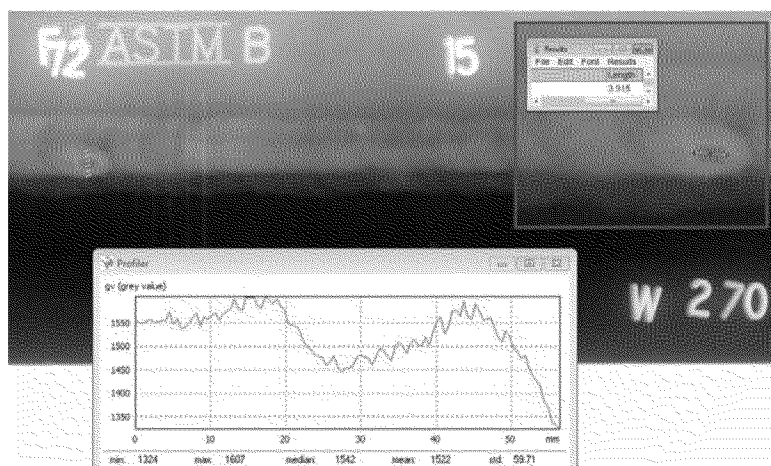
**Figure 2 – Weld 270 Indication with measurement inset showing length of 0.157” (3.9mm)**

- 3.1 Weld 270, digitized in the region of interest is depicted in Figure 2. Here it can be seen, due to low change in density which is less than the adjacent parent material, and the presence of a halo, that the indication is one of Burn-Through (BT), and is acceptable per section 9.3.7 of API-1104. The weld repair process confirmed this result where the indication was found at the root.

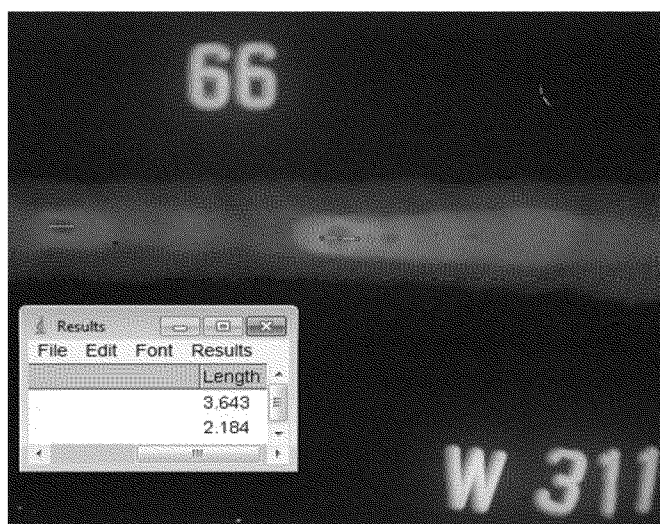
**Figure 3 – Weld 311 with acceptable BT length of 0.141” and acceptable small pores**

3.2 Weld 311, digitized in the region of interest, is depicted in Figure 3. Similarly we have one indication of burn-through and 3 small pores, all of which are acceptable per sections 9.3.7 & 9.3.9 of API 1104. For both welds 270 and 311, the repair process had to proceed to the root before the indications were eliminated, confirming that they were caused by burn through.

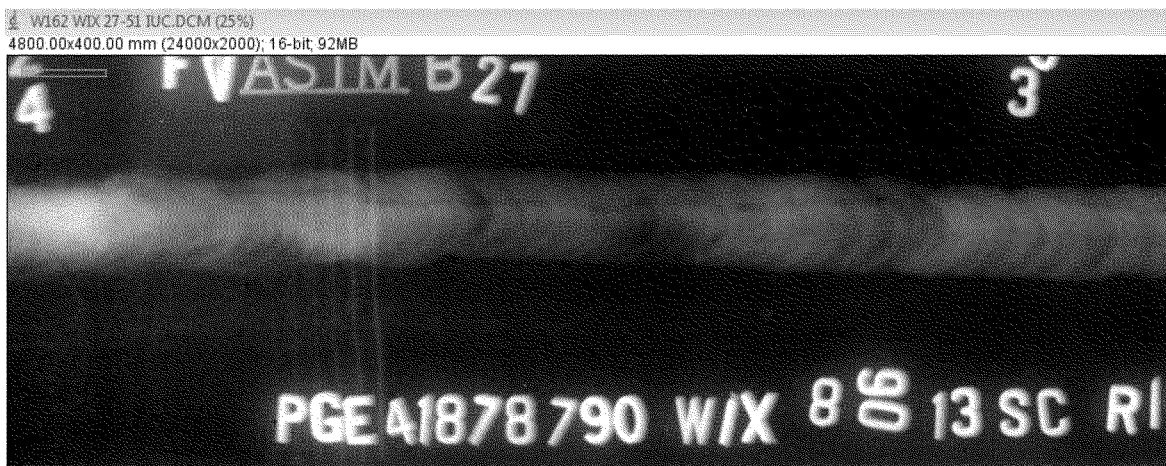
**Figure 4 – Weld 162 with acceptable indications of undercut**

3.3 Weld 162 indication was digitized as shown below in Figure 4. Radiographic density measurements indicate that no portion of the indication has an indication of undercut which is greater than 0.016” deep, indicating that it is acceptable per section 9.3.11& 9.3.7 of API 1104.

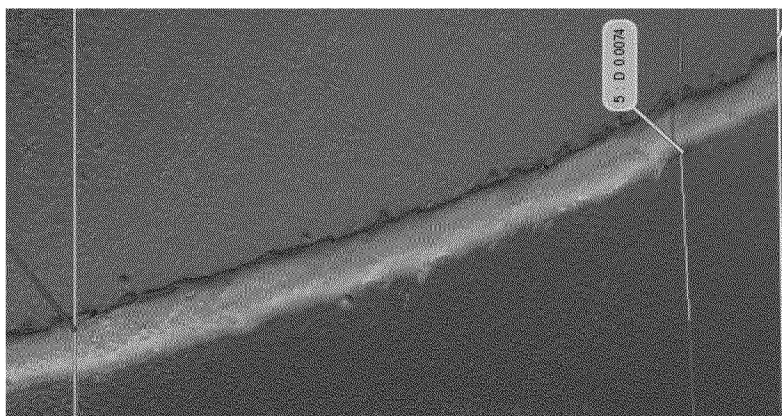
**Figure 5 – Measured IUC on W162 depicted in Figure 4**

- 3.4 To validate the digital radiographic measurements, external visual, UC gaging and dial indicator measurements revealed that only small areas within the called ROI (25-29) had bottoms estimated below the adjacent parent material surface. Measurements had thus low repeatability due to topography. This result led to the decision for the Creaform photogrammetry with its calibrated 40 micron spatial resolution and accuracy to within 0.002”.
- 3.5 Creaform photogrammetry results were obtained for the radiographic ROI (25-29 in Figure 4). The measurements confirm that no portion of the indicated area of concern radiographically, has a depth greater than 0.016 inches, and is therefore acceptable per sections 9.3.11 & 9.7. Figure 5 below depicts worst case of 0.0074” in radiographic ROI.

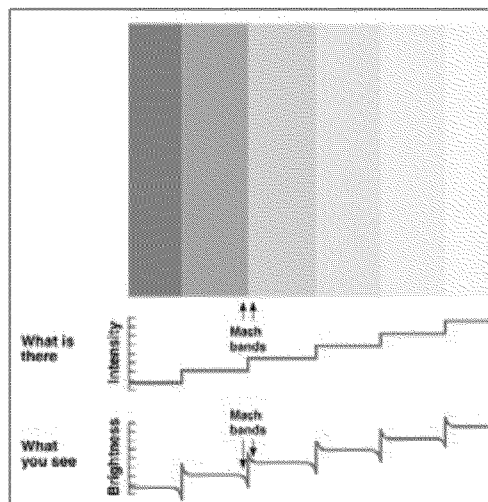
Figure 1 – Machs Bands Effects

- 2.1 Upon notification of the audit results, ATS requested the NDT contractor, Western Industrial X-ray (WIX), to perform a second film interpretation review of the audit noted regions of interest.
- 2.2 ATS NDT Level III personnel reviewed the WIX film interpretation. ATS also performed digital radiographic thickness measurements, using the parent material & Image Quality Indicator (IQI) wires as step calibration. This activity was performed to rule out Machs Bands severity effects, depicted in Figure 1, on interpretation, and also provide ROM estimation of any actual undercut conditions.

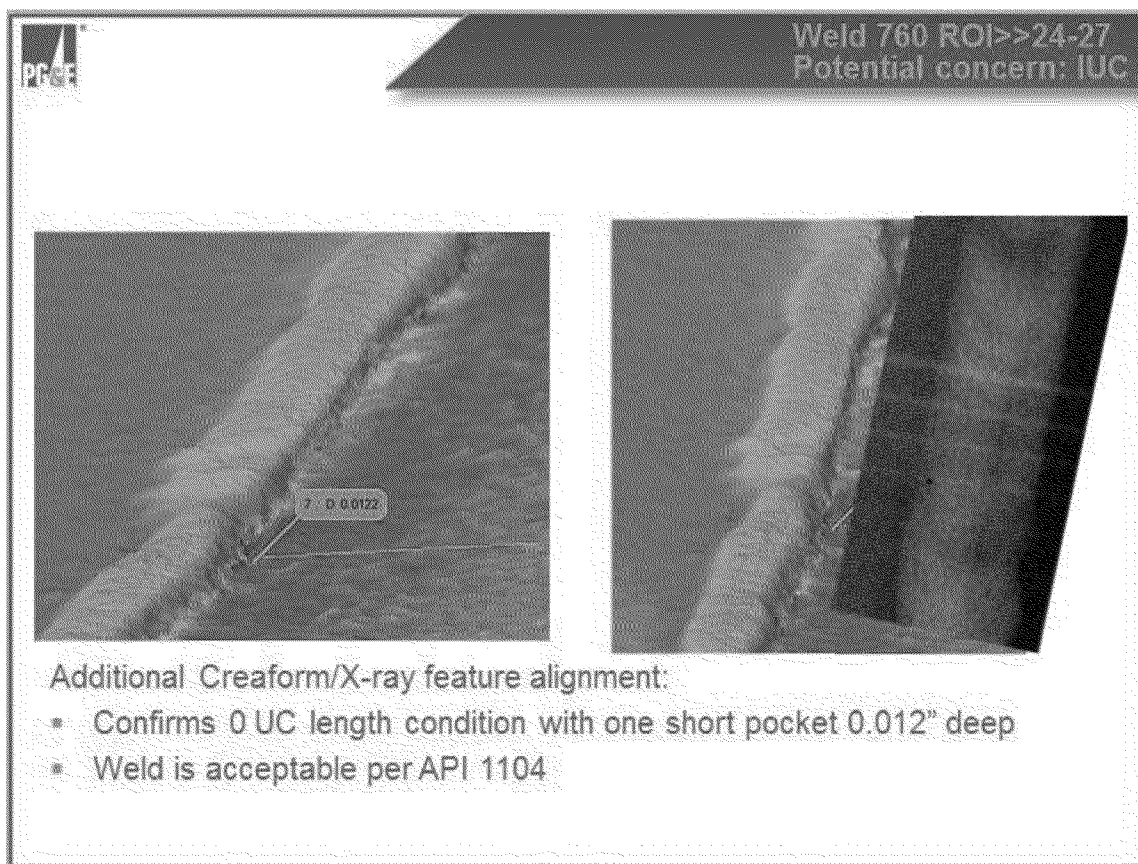
Figure 1 – Assessment of Weld 760 IUC region of interest

3.5 Creafom photogrammetry results were obtained for all the radiographic ROI's. The criteria applied to these results were API 1104 section 9.7, Table 4, "Maximum Dimensions of Undercutting". Applying the further criteria of depth from this requirement, to the documented radiographic and visual measurement data for length, all welds were found acceptable. Figure 2, from slide 5 in Appendix I, summarizes the typical physical condition for the audit identified indications of concern.

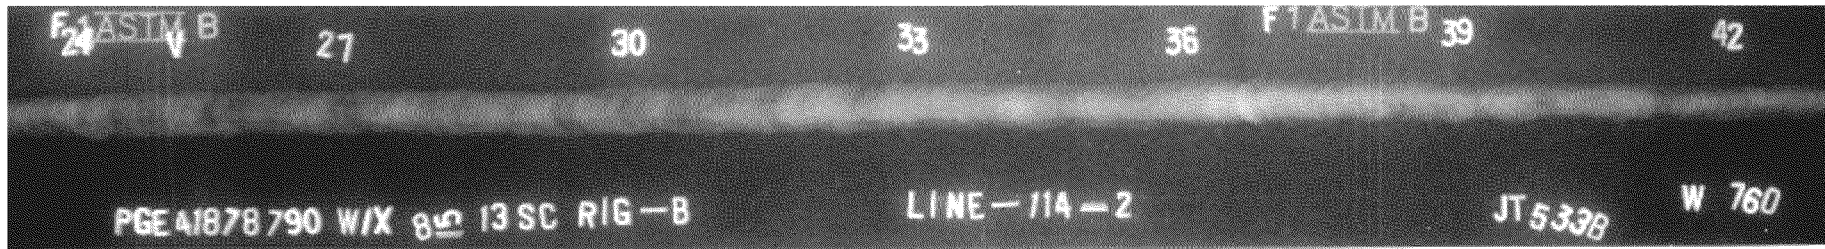
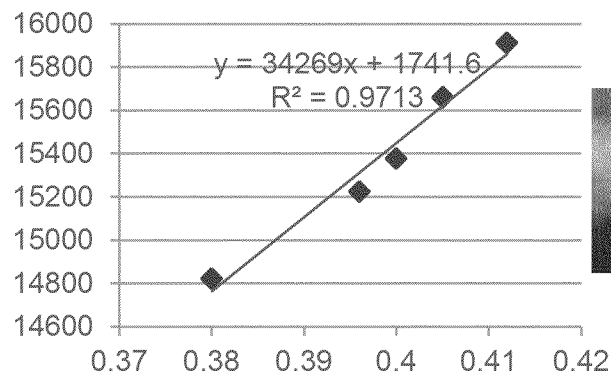
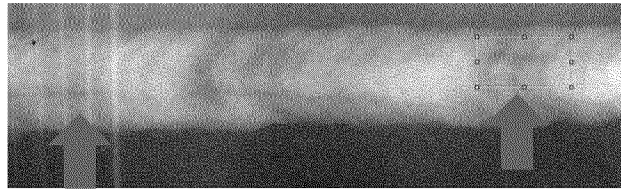
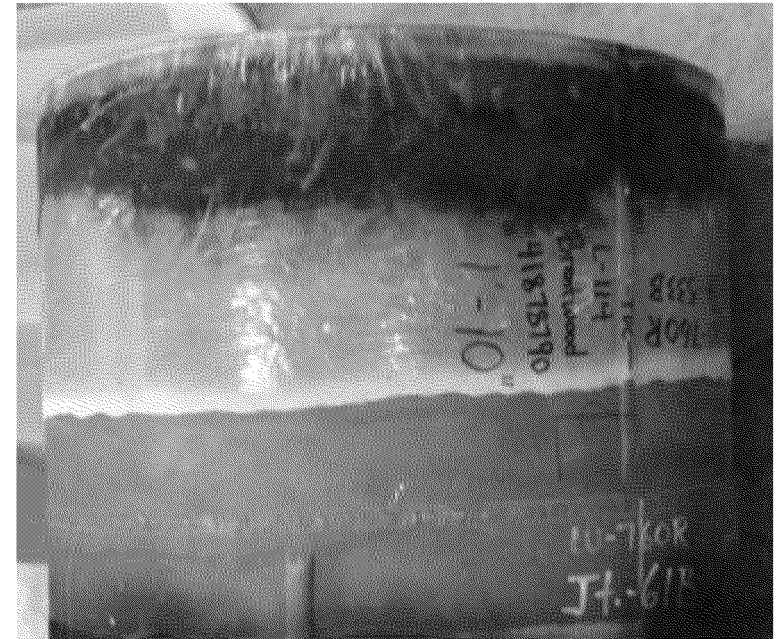
**Excised weld photo-documented and ROI aligned with weld features**

**Depth of most severe indications estimated by change in x-ray density**

**RT estimated depths of 0.012 – 0.028 inches**

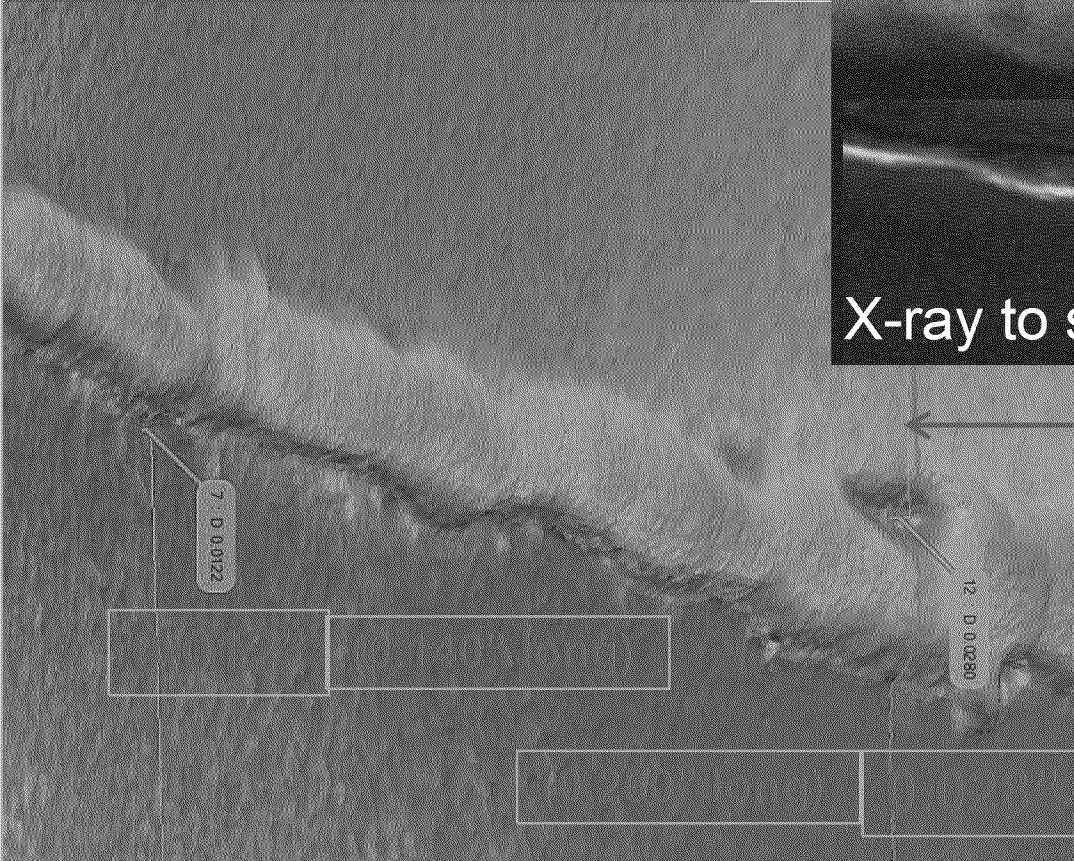
X-ray to surface alignment

Creaform 3D (+/- 0.002") surface profile:

Confirms indications are mostly diffraction effects on minor hi/lo condition with 0 UC

Two small pockets are 12 and 28 mils deep with greatest length of 0.250"

Weld is acceptable per API 1104

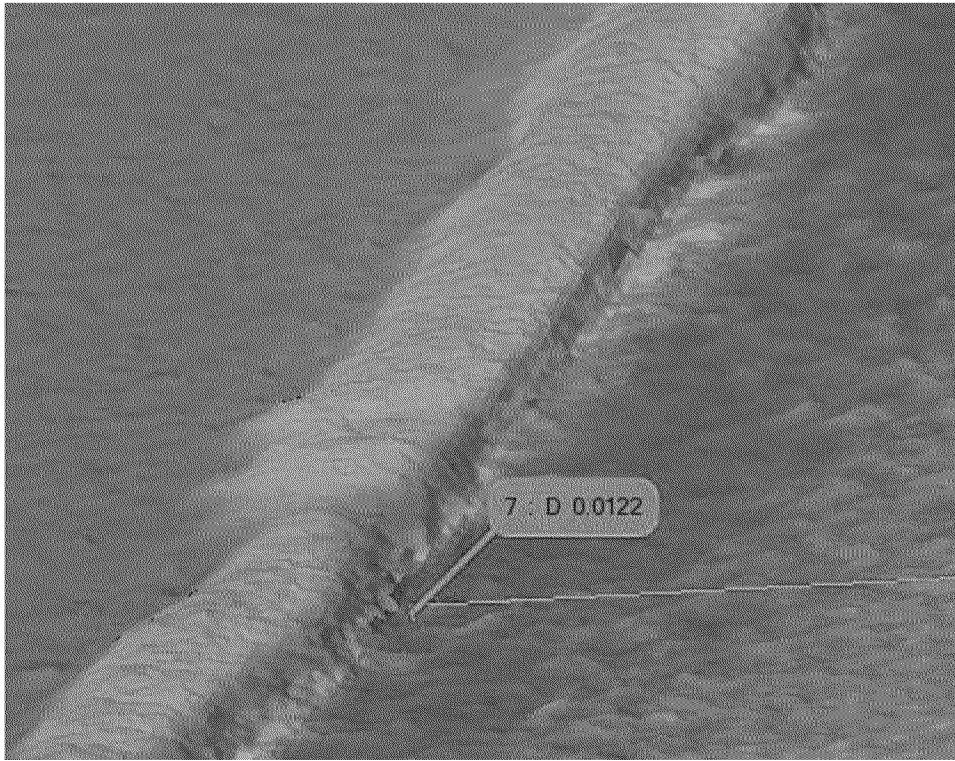
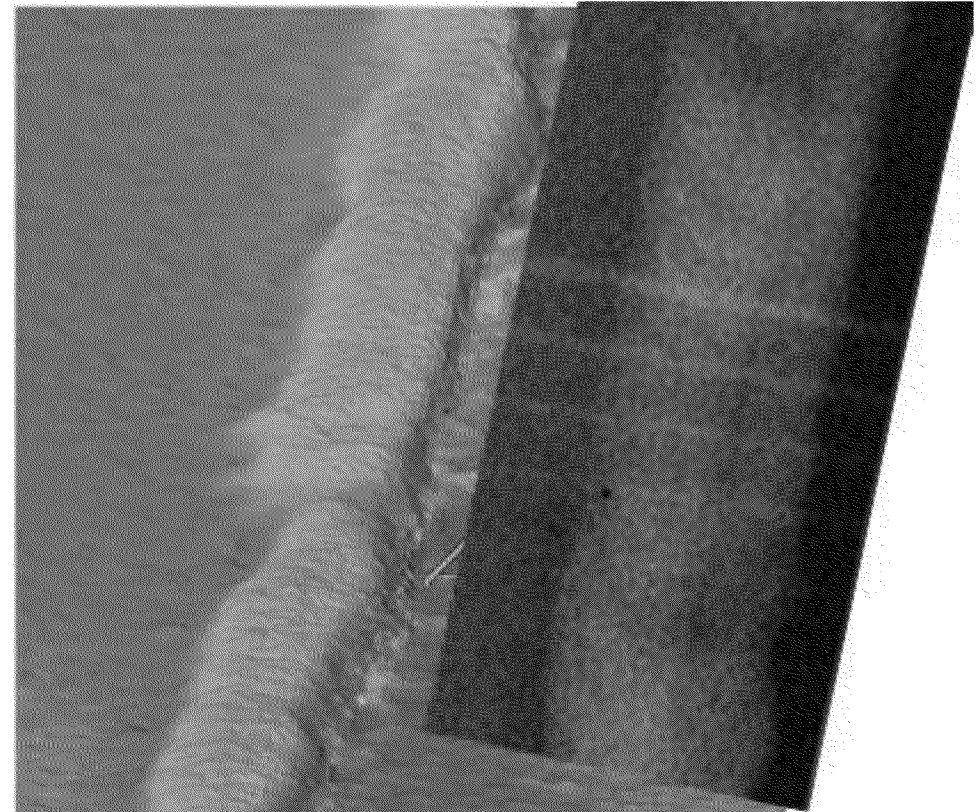
Additional Creaform/X-ray feature alignment:

- \* Confirms 0 UC length condition with one short pocket 0.012" deep
- \* Weld is acceptable per API 1104

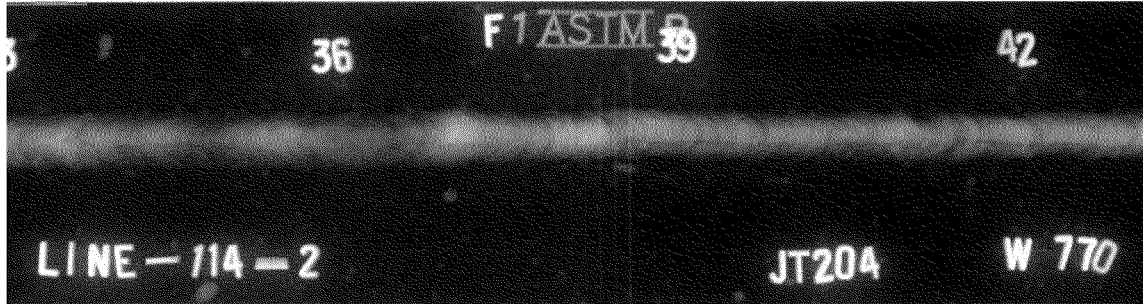
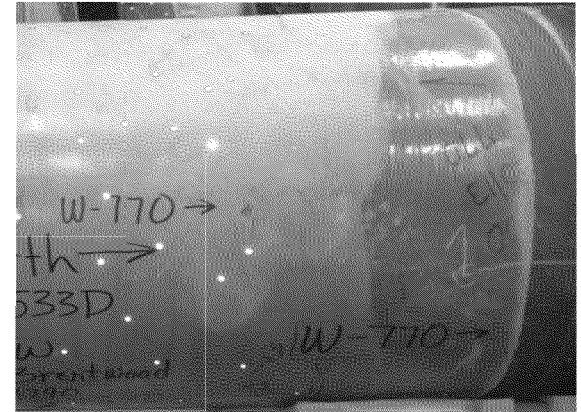
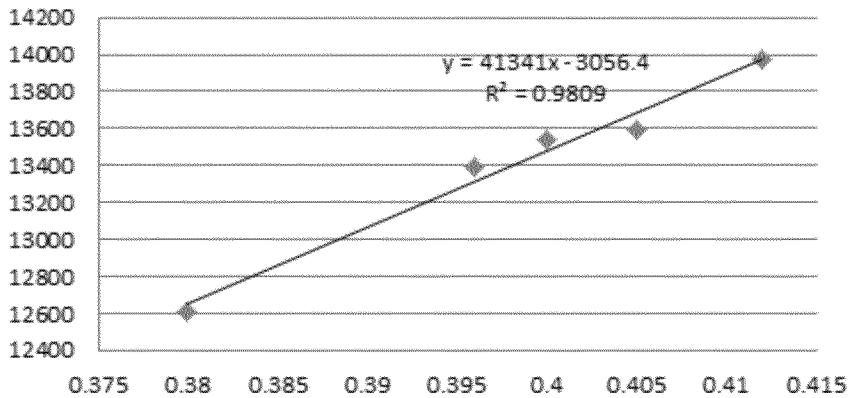
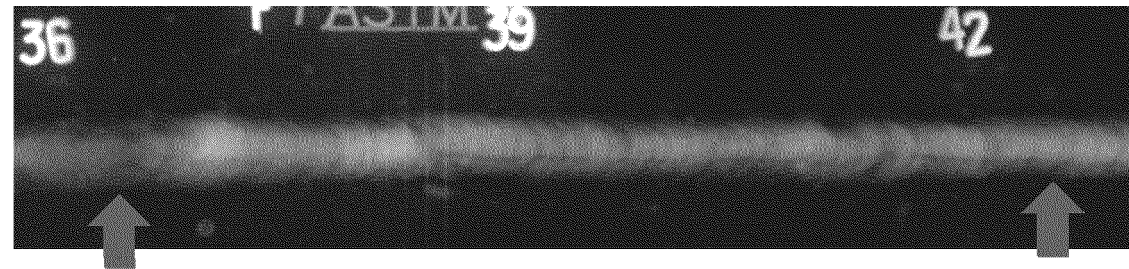
Weld 770 cited for indications of internal undercut from 36-42  
Excised weld photo-documented and ROI aligned with weld features  
Depth of most severe indications estimated by change in x-ray density

RT estimated depths of up to 0.008 inches

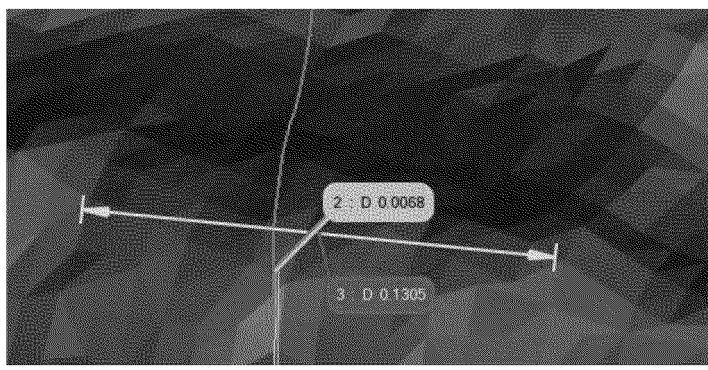
### Creaform 3D (+/- 0.002") surface profile:

- Confirms indications are, in the majority, diffraction effects on minor hi/lo condition with 0 UC
- One small pocket observed at 0.007" deep x 0.130" long
- One unrelated pocket opposite ROI of 0.017" deep x 0.195" long
- Weld is acceptable per API 1104

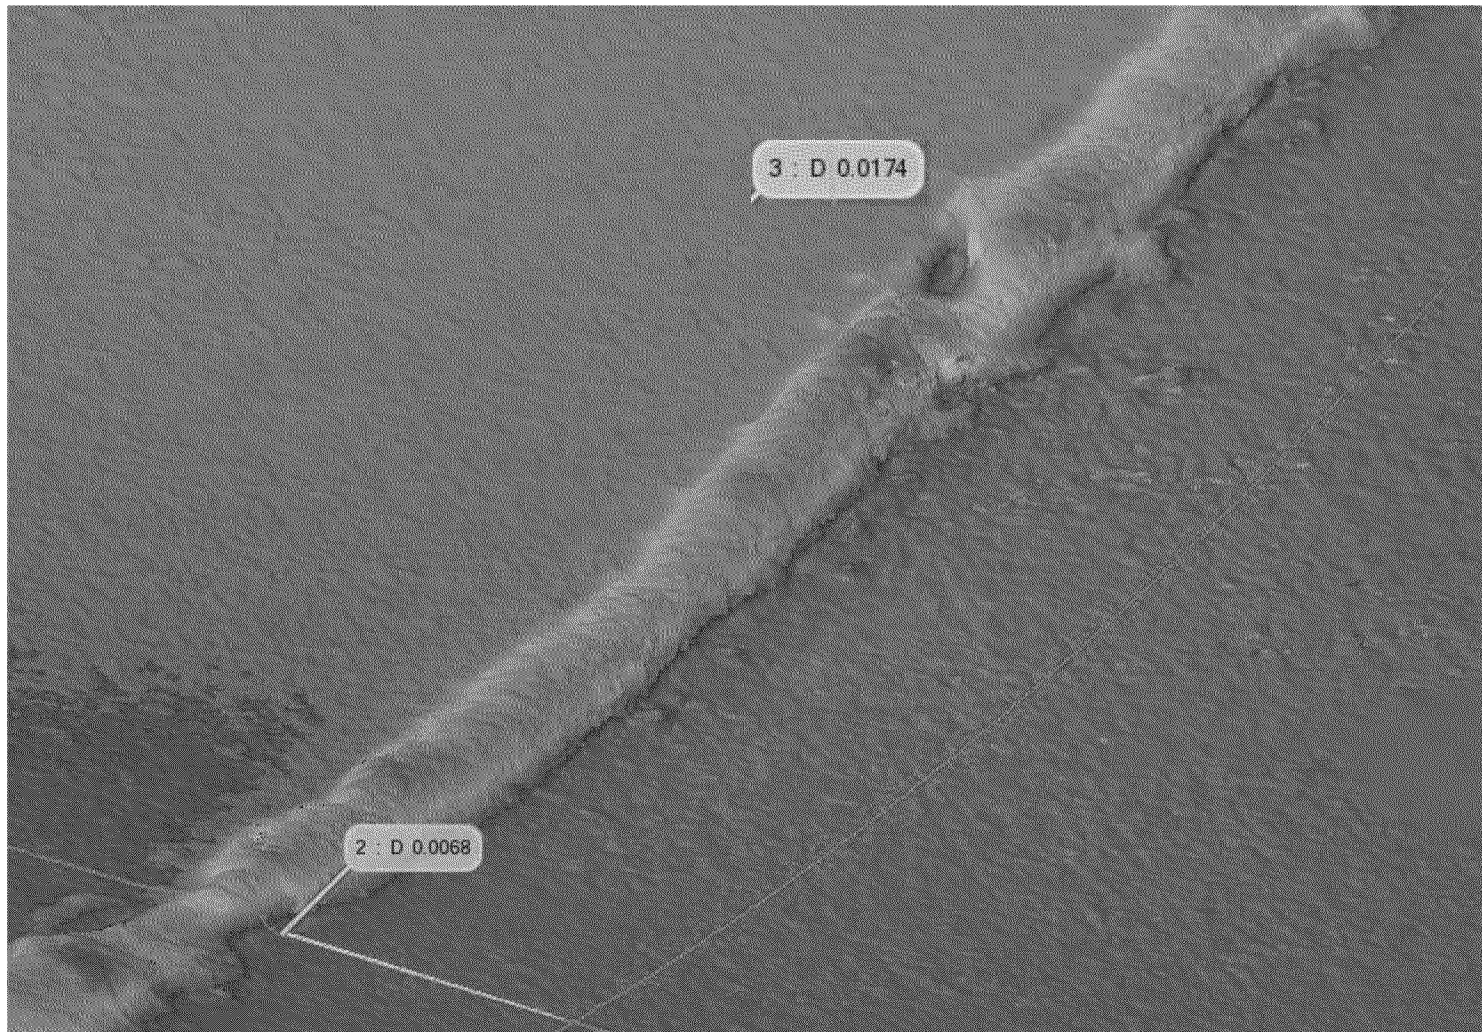
Additional Creaform/Polyworks perspective of ROI 36-42:

- \* Confirms UC indication is diffraction/"shadowing" from high/low condition
- \* Weld is acceptable per API 1104

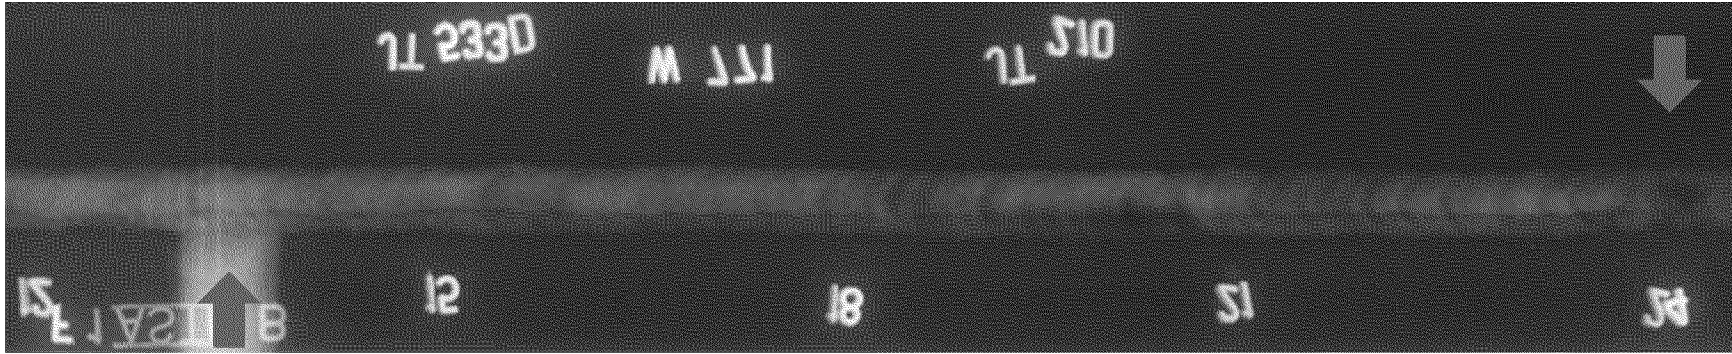
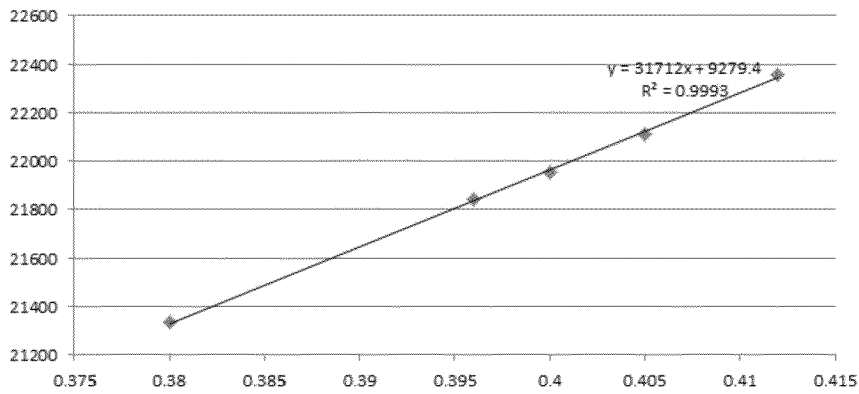
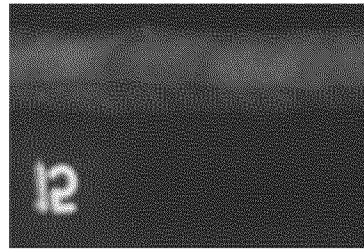
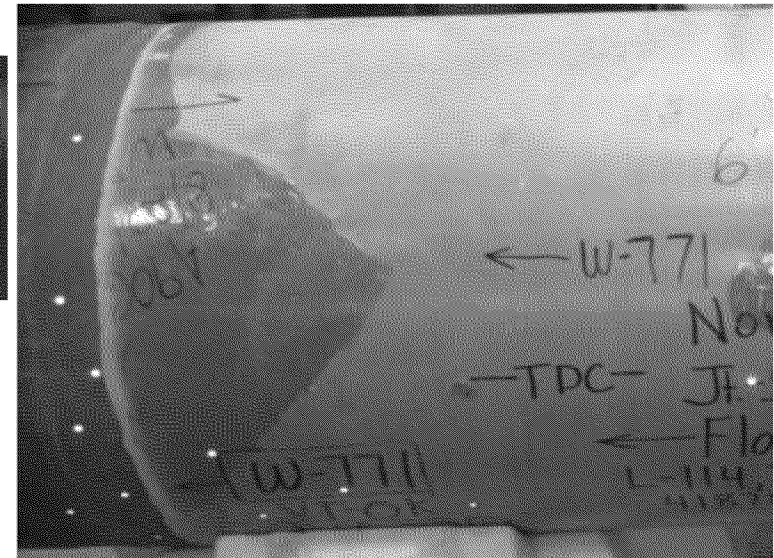
Excised weld photo-documented and ROI aligned with weld features

Depth of most severe indications estimated by change in x-ray density

RT estimated depths of up to 0.008 inches

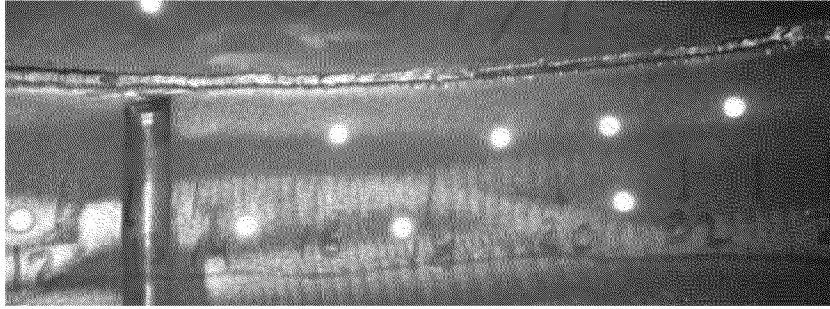
Creaform 3D (+/- 0.002") surface profile:

- Confirms indications are mostly diffraction effects on minor hi/lo condition with 0 UC
- Deepest region along length is 0.006 inches
- Weld is acceptable per API 1104

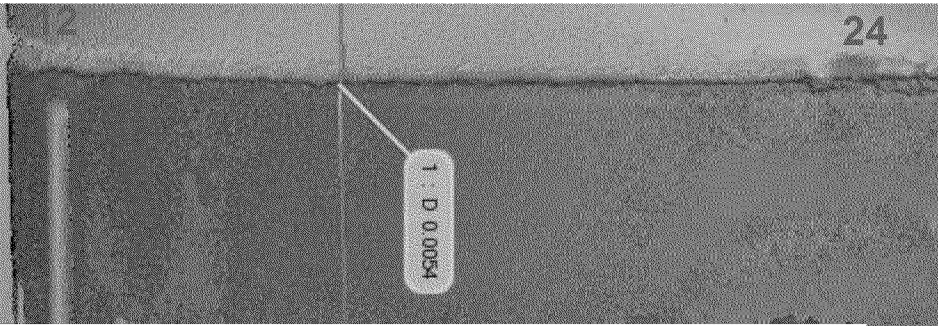
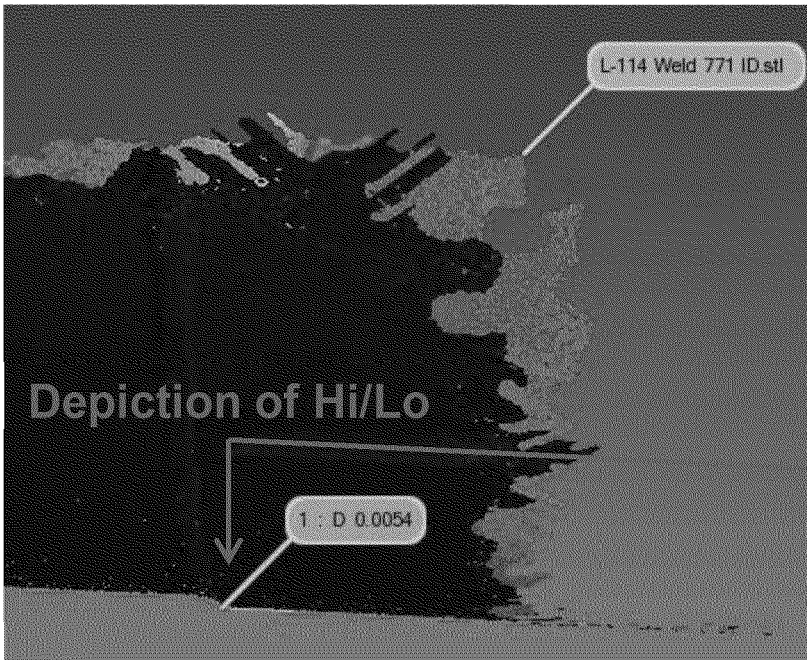
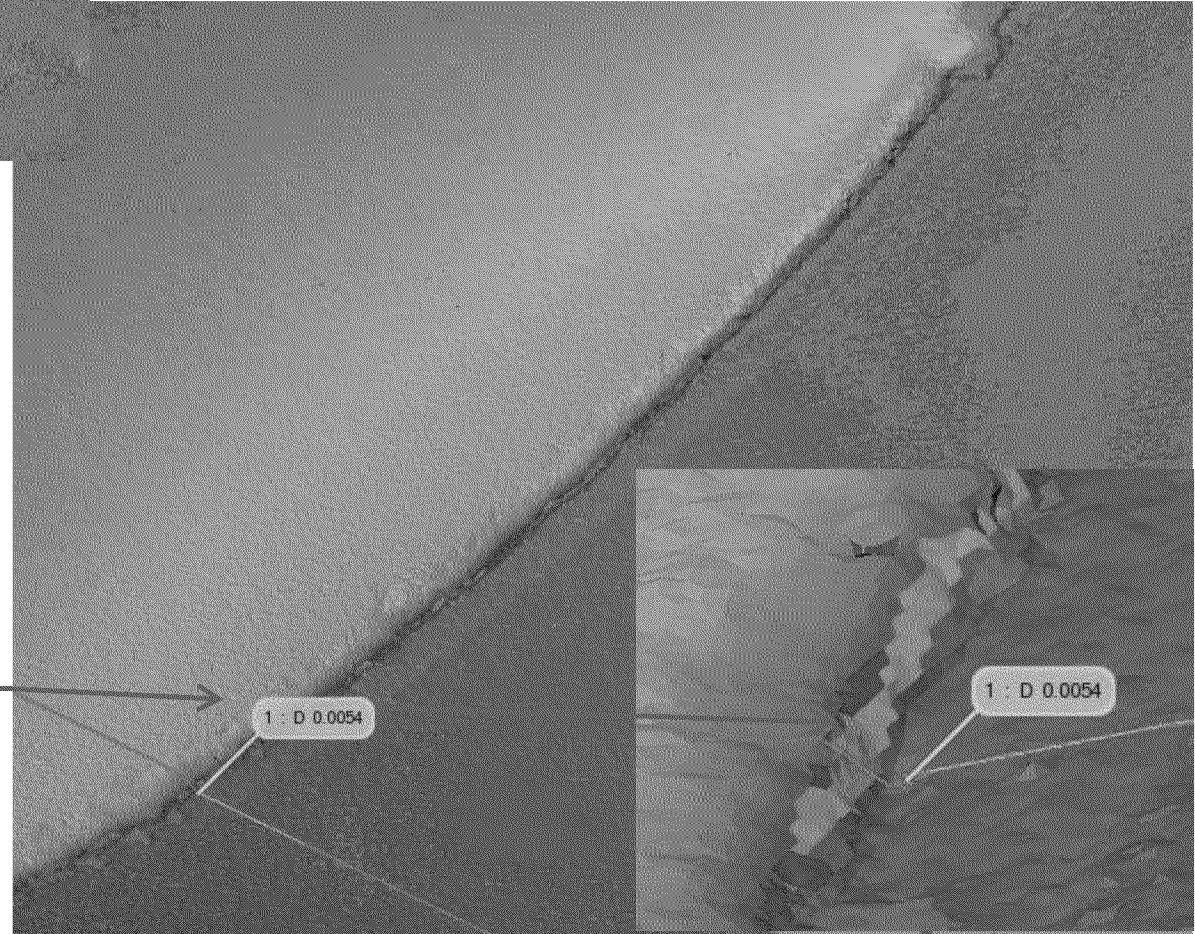
Additional Creaform/Polyworks perspective of ROI 12-24:

- \* Confirms UC indication is diffraction/"shadowing" from high/low condition
- \* Weld is acceptable per API 1104

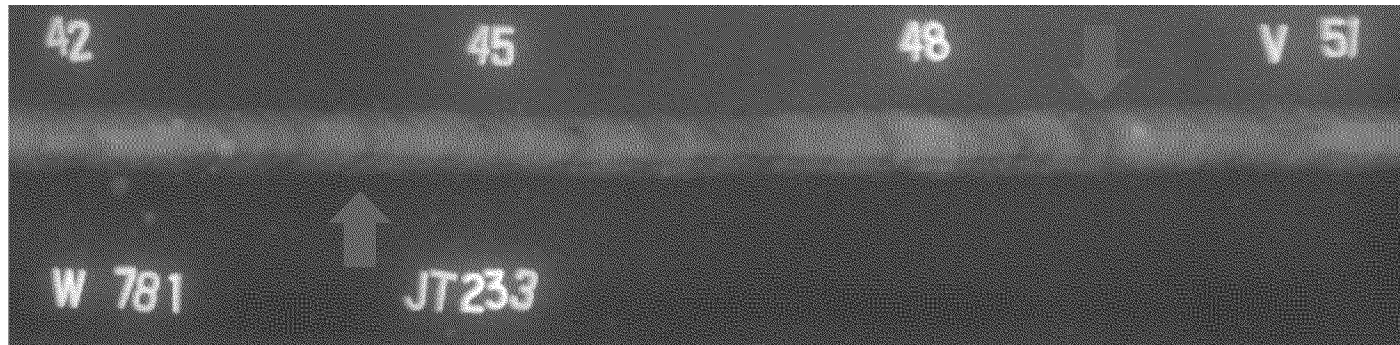
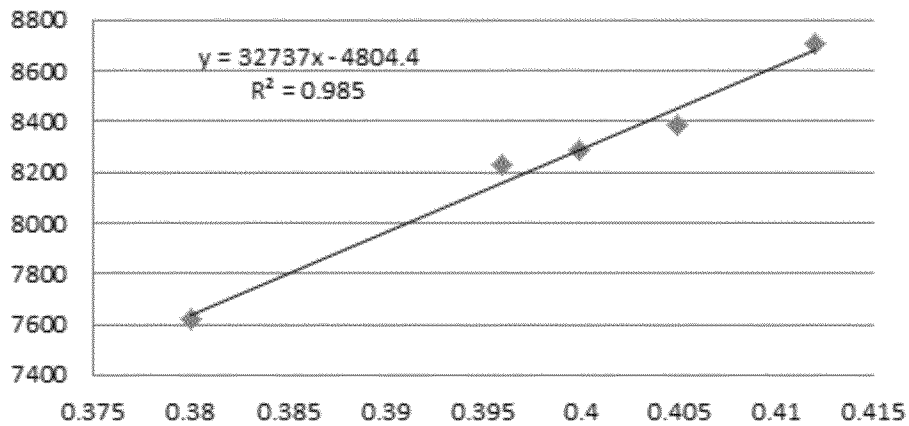
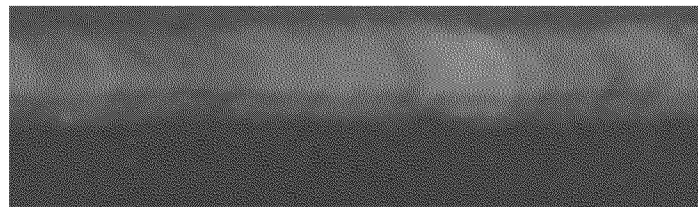
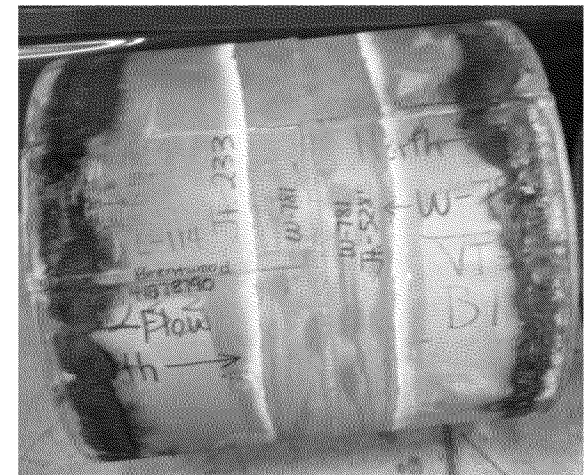
Excised weld photo-documented and ROI aligned with weld features

Depth of most severe indications estimated by change in x-ray density

RT estimated depths of up to 0.015 inches

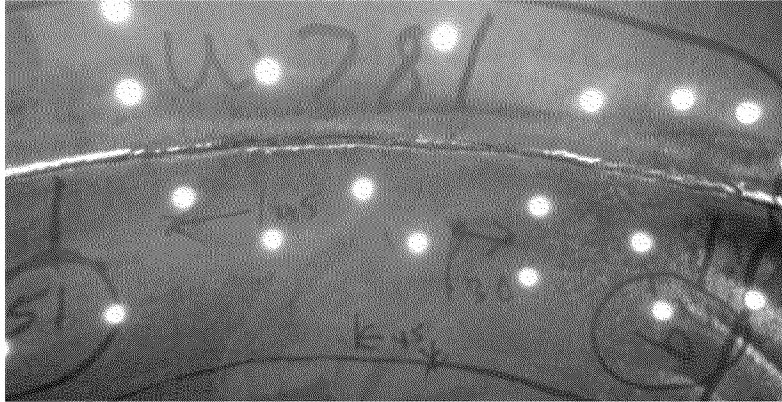
Creaform 3D (+/- 0.002") surface profile:

Confirms indications are mostly diffraction effects on minor hi/lo condition with 0 UC

Largest region is 1.5 long x up to 0.015 inches deep

Weld is acceptable per API 1104

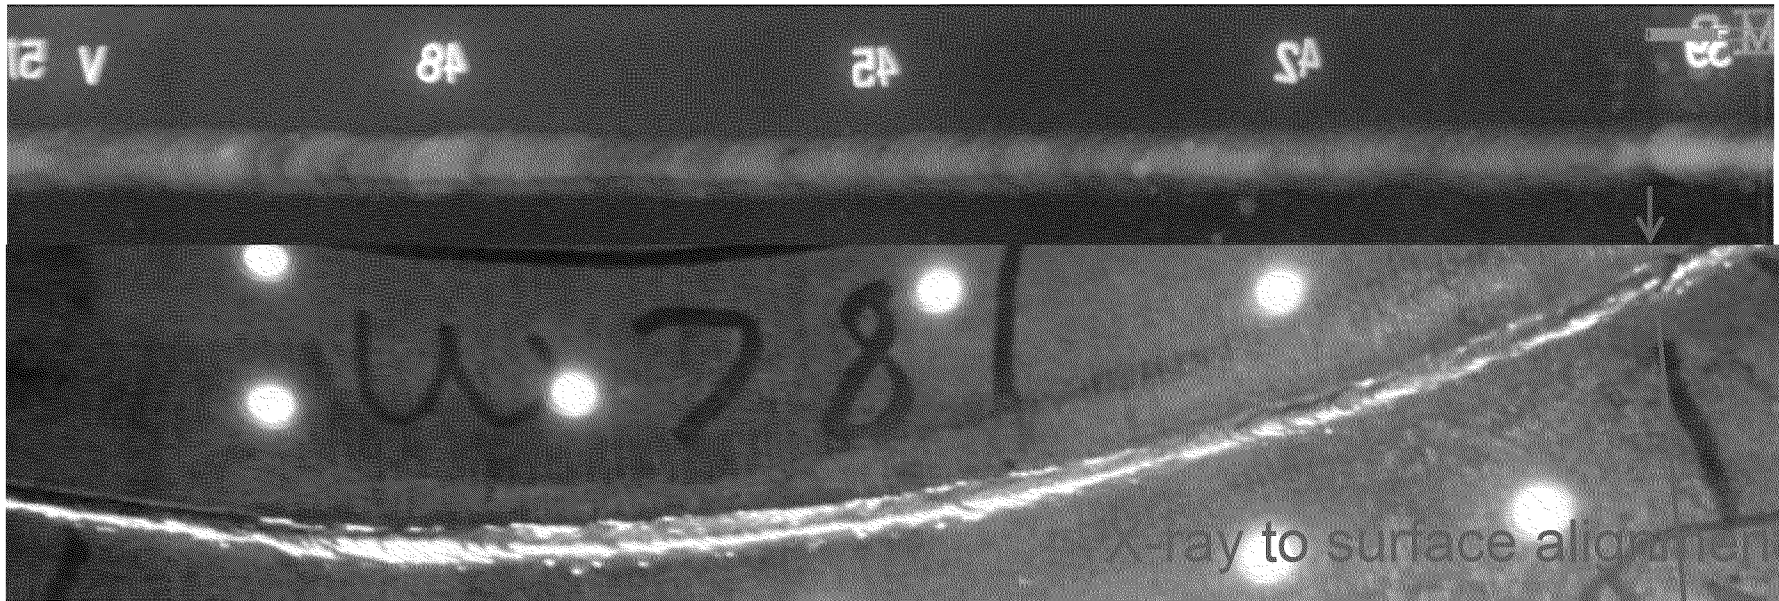
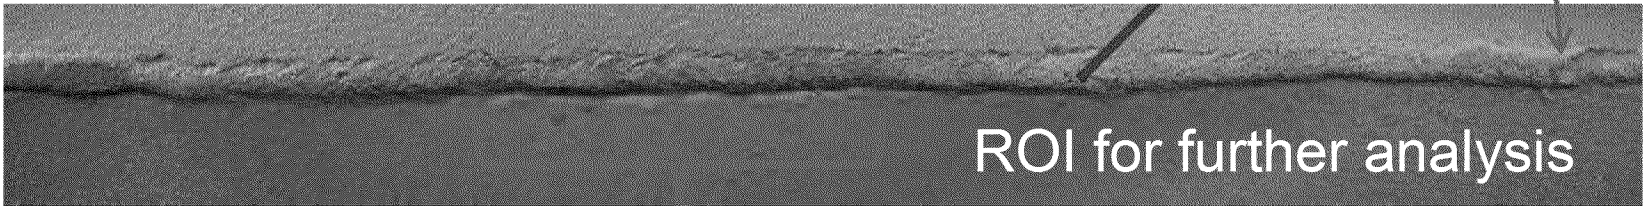
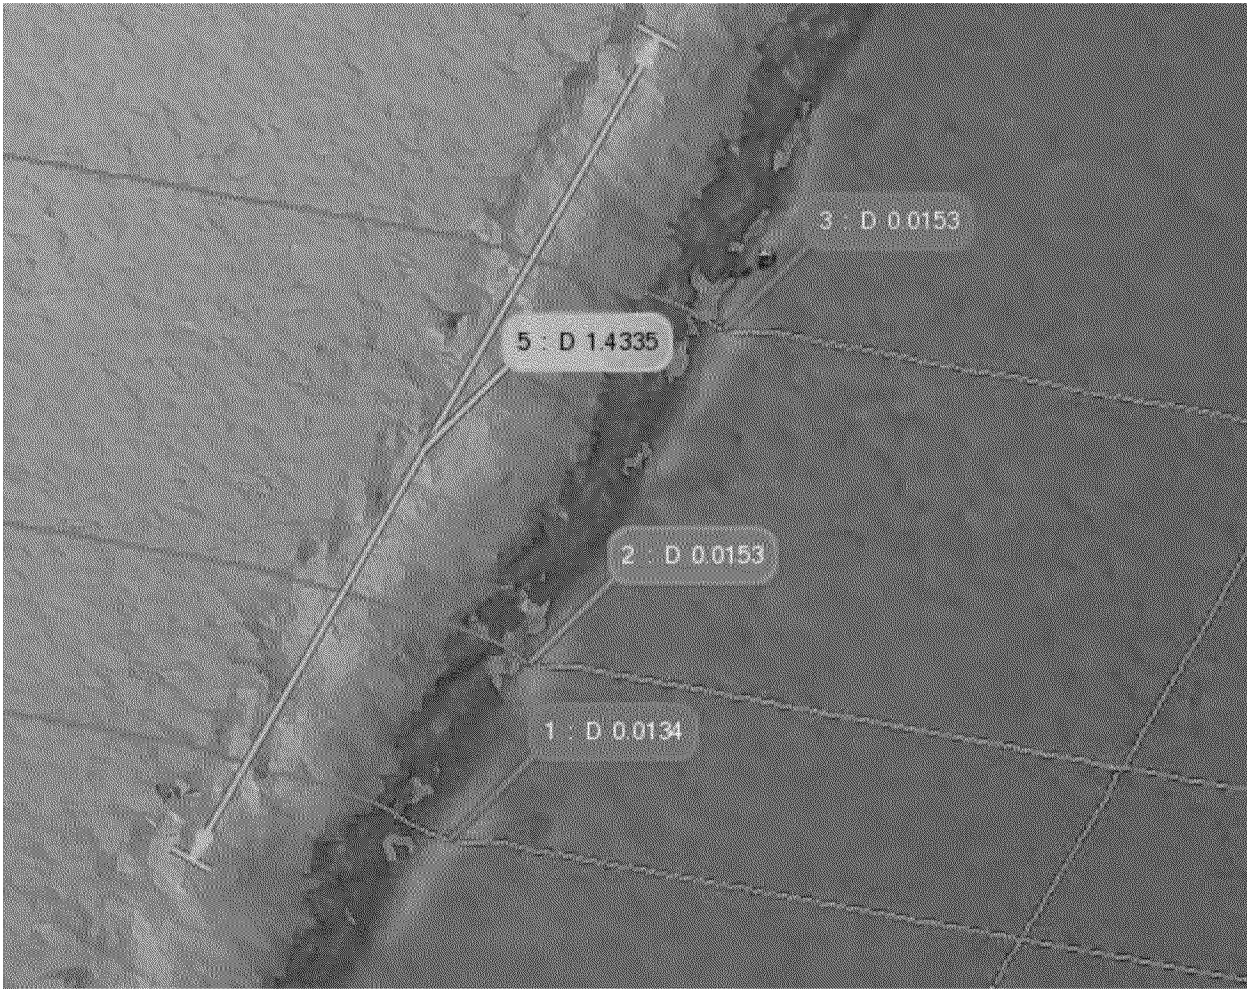
#### Additional Creafom/Polyworks perspective of ROI 44-49:

- \* Confirms UC indication is, in the majority, diffraction/"shadowing" from high/low condition with less than 2 inches of up to 0.015 inches deep IUC
- \* Weld is acceptable per API 1104

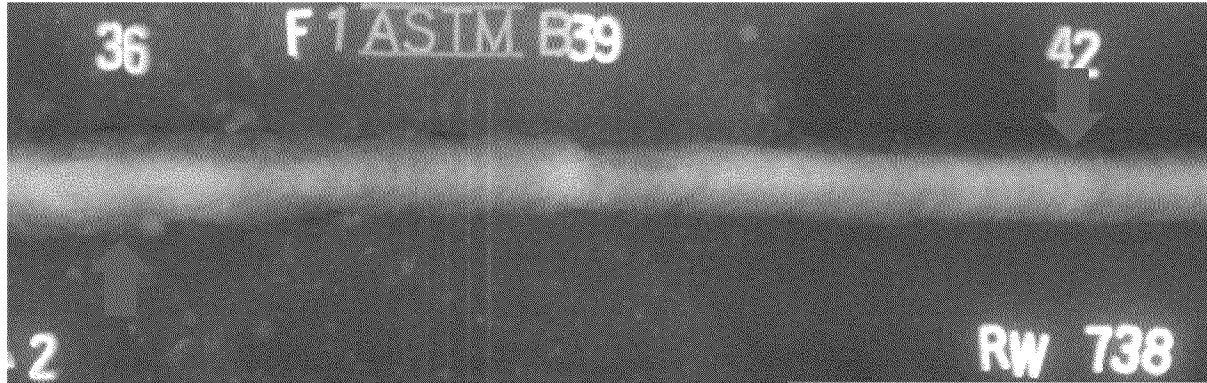
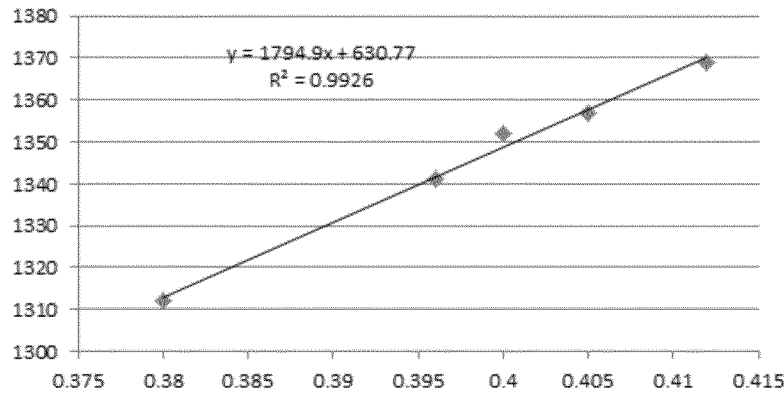
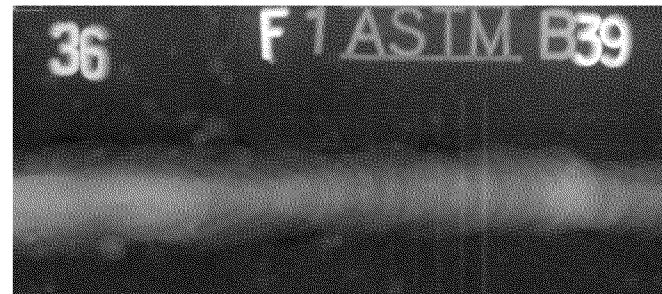
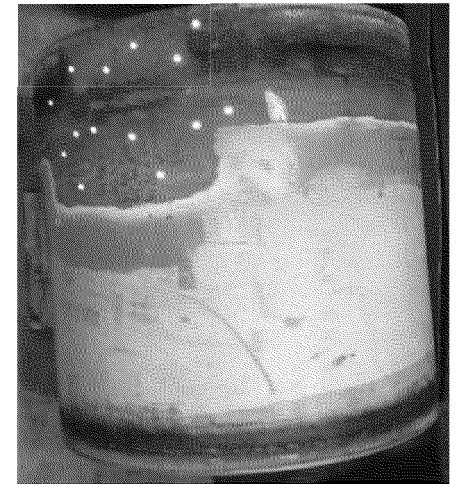
Excised weld photo-documented and ROI aligned with weld features

Depth of most severe indications estimated by change in x-ray density

RT estimated depths of up to 0.030 inches

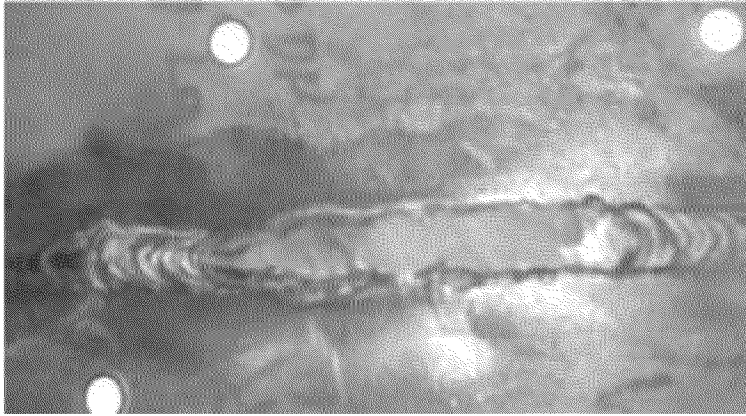
Creaform 3D (+/- 0.002") surface profile:

External undercut identified up to 0.030" deep

Sum of UC lengths < 1.5"

Weld is acceptable per API 1104

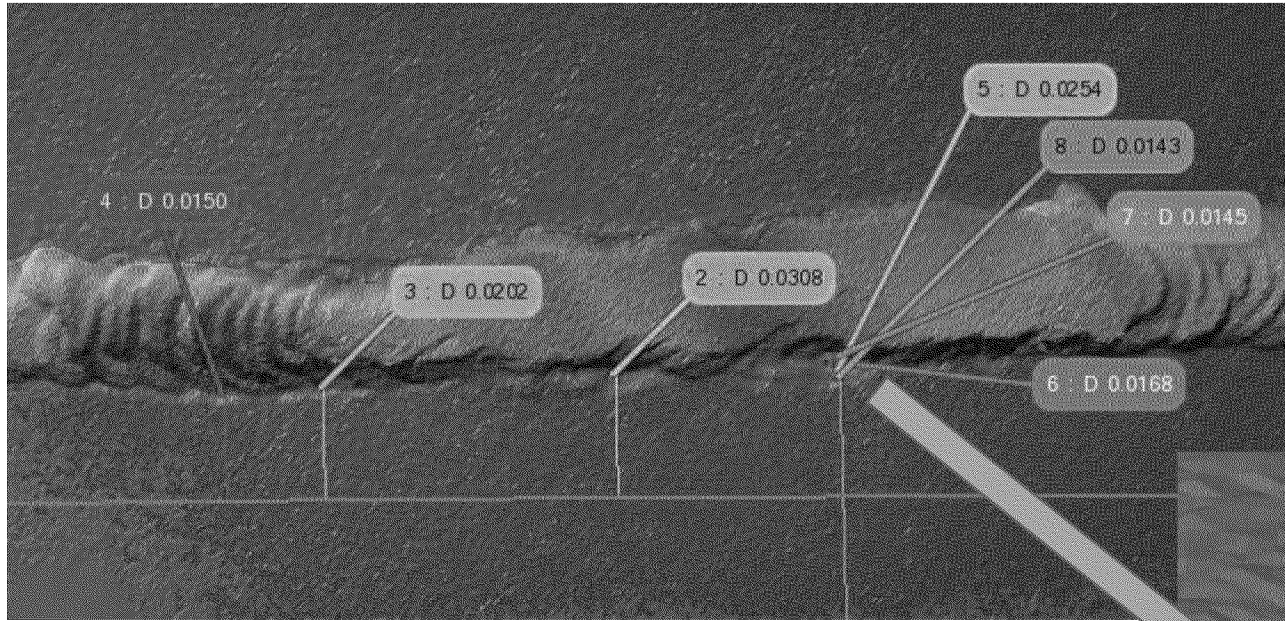
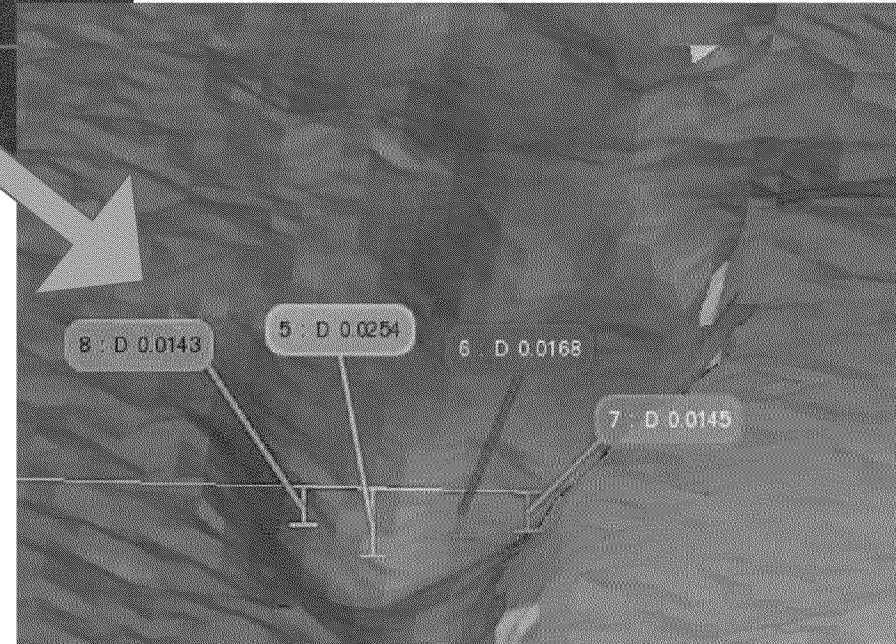
Additional Creaform/Polyworks perspective of ROI 36-42:

- \* EUC noted in several short segments totaling less than 1.5"
- \* Weld is acceptable per API 1104
