# Noncompliant Weld Inspection Techniques

## Line 114 Non Destructive Examination Final Report

Issue Date December 5, 2013

### Assessment of PHMSA UC concerns on welds 738, 760, 770, 771, 781

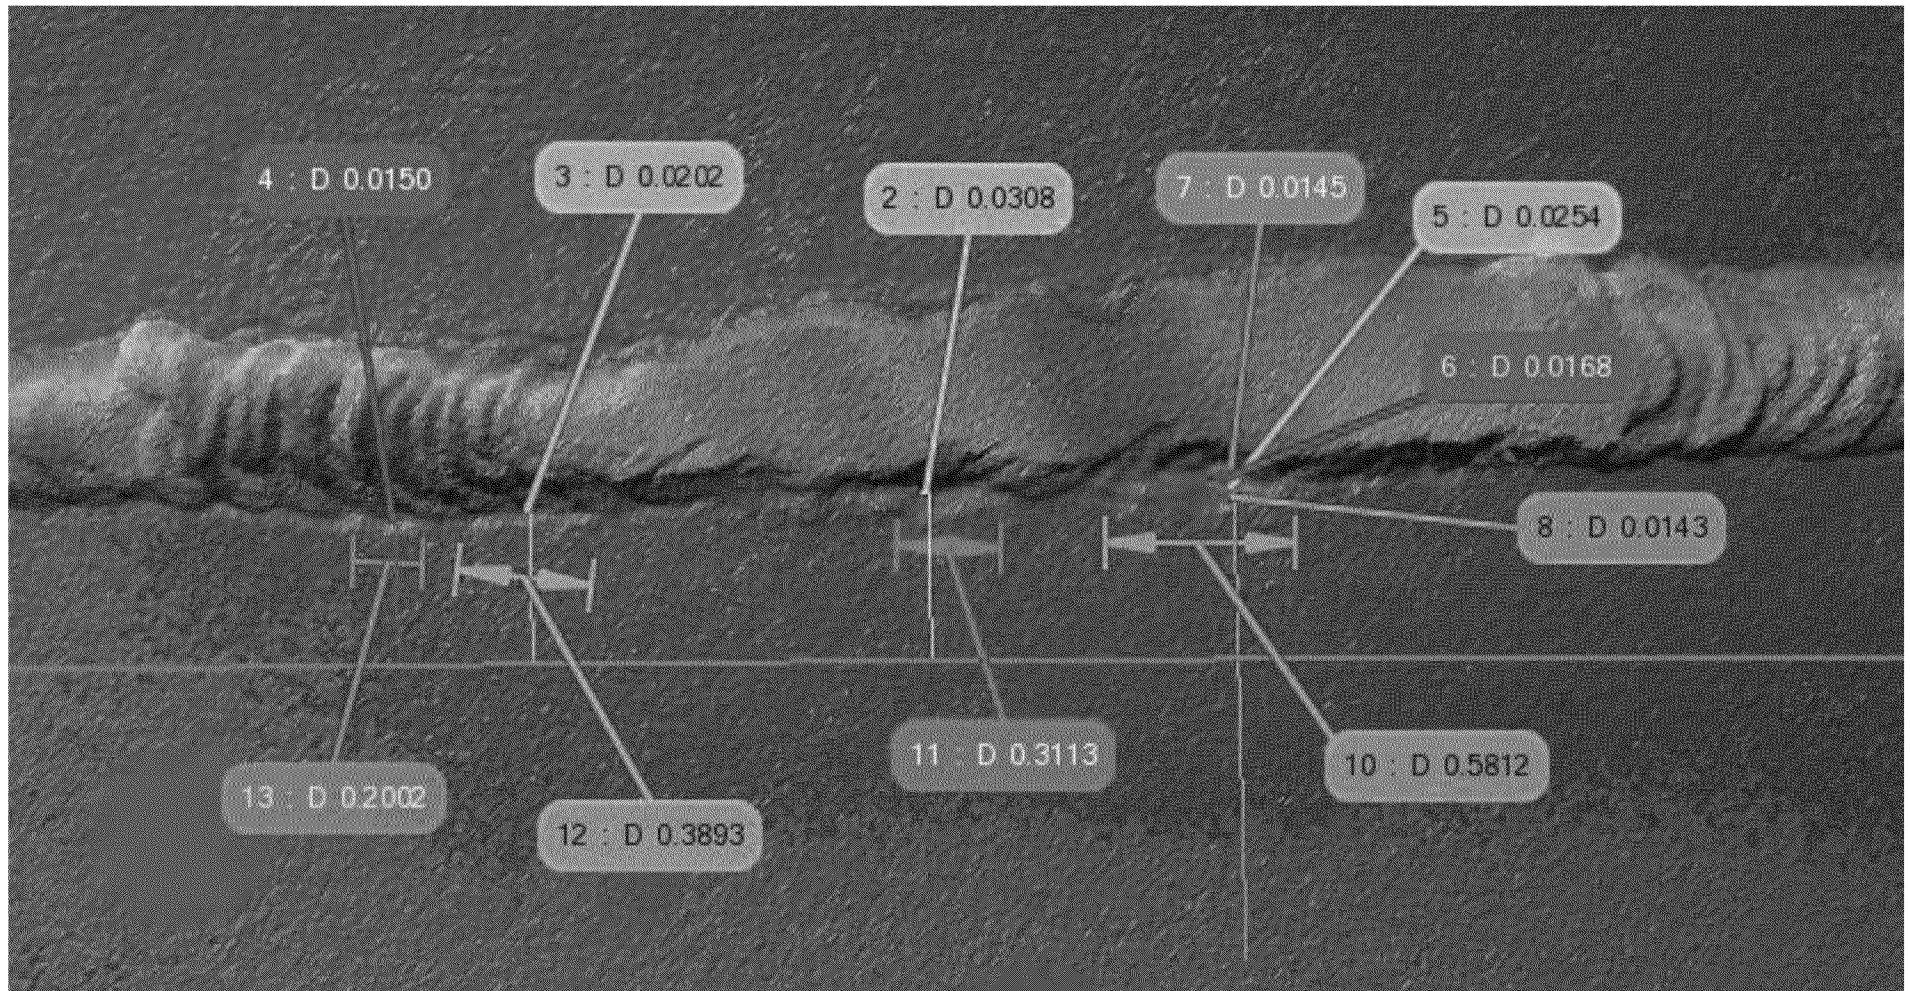
Additional Creaform/Polyworks perspective of ROI 36-42:

- \* EUC noted in several short segments totaling less than 1.5"
- \* Weld is acceptable per API 1104
