# Noncompliant Weld Inspection Techniques

## Line 114 Non Destructive Examination Final Report

Issue Date December 5, 2013

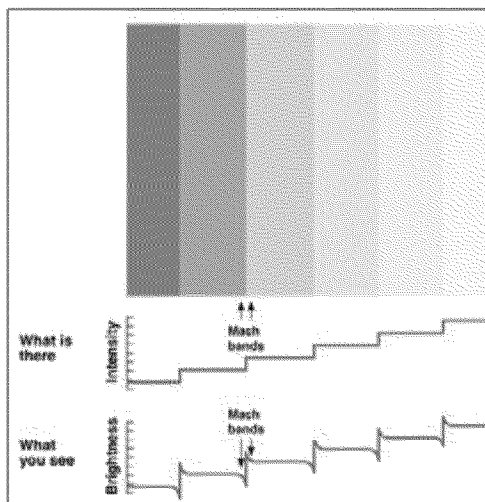
**Figure 1 – Machs Bands Effects**

2.2 ATS NDT Level III personnel reviewed the WIX film interpretation. ATS also performed digital radiographic thickness measurements, using the parent material & Image Quality Indicator (IQI) wires as step calibration. This activity was performed to rule out Machs Bands severity effects, depicted in Figure 1, on interpretation, and also provide ROM estimation of any actual undercut conditions.

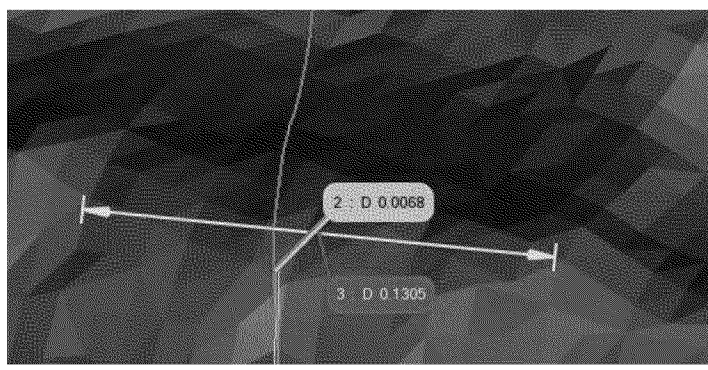
### Digital surface profile tool alignment

- Confirms indications are, in the majority, diffraction effects on minor hi/lo condition with 0 UC
- One small pocket observed at 0.007" deep x 0.130" long
- One unrelated pocket opposite ROI of 0.017" deep x 0.195" long
- Weld is acceptable per API 1104

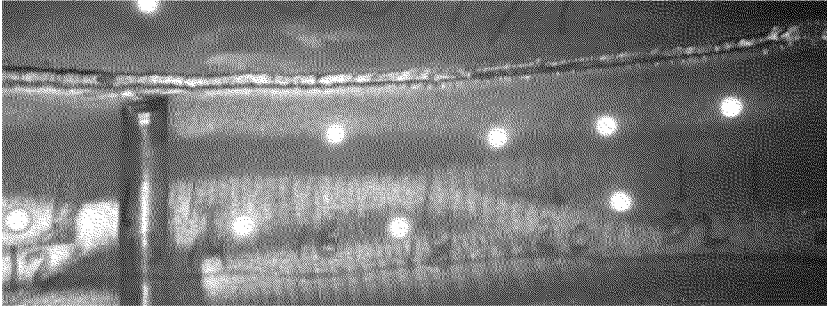
### Digital surface profile tool alignment

- Confirms indications are mostly diffraction effects on minor hi/lo condition with 0 UC
- Deepest region along length is 0.006 inches
- Weld is acceptable per API 1104

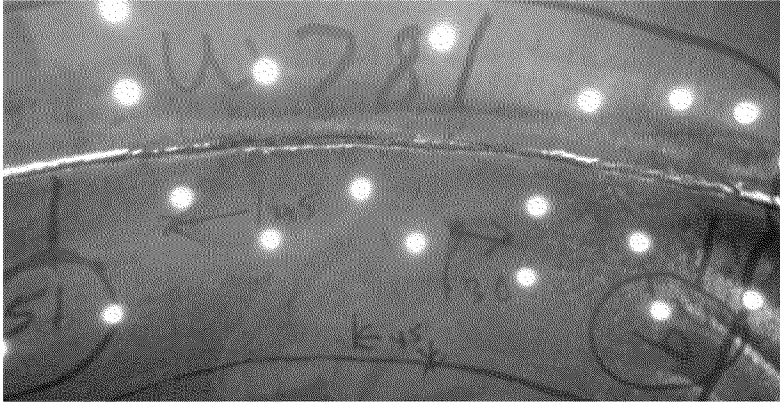
### Digital surface profile tool alignment

Confirms indications are mostly diffraction effects on minor hi/lo condition with 0 UC

Largest region is 1.5 long x up to 0.015 inches deep

Weld is acceptable per API 1104

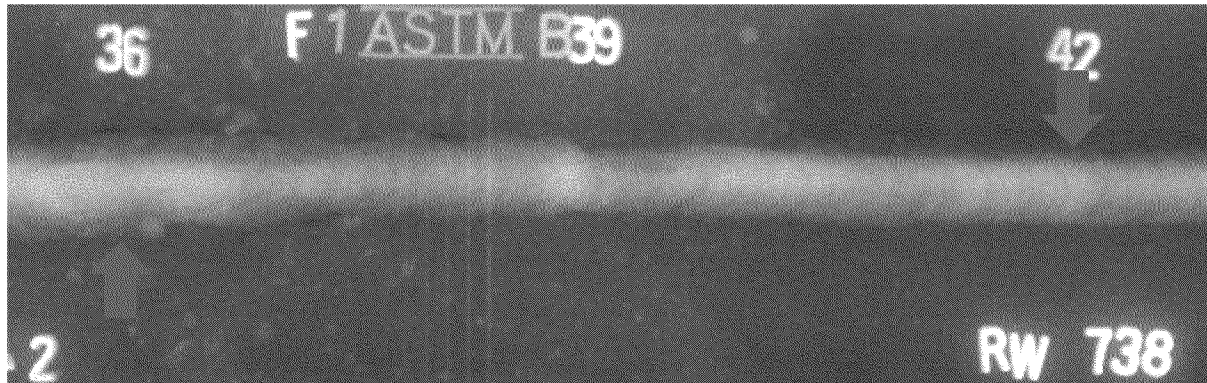
Excised weld photo-documented and ROI aligned with weld features

Depth of most severe indications estimated by change in x-ray density

RT estimated depths of up to 0.030 inches

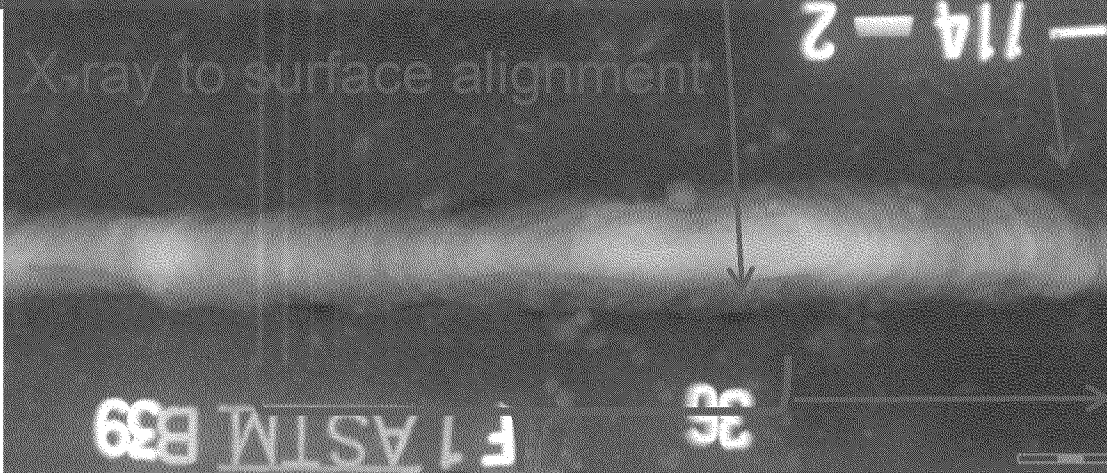
External undercut identified up to 0.030" deep

Sum of UC lengths < 1.5"

Weld is acceptable per API 1104
