Noncompliant Weld Inspection Techniques

Line 114 Non Destructive Examination Final Report

Issue Date December 5, 2013

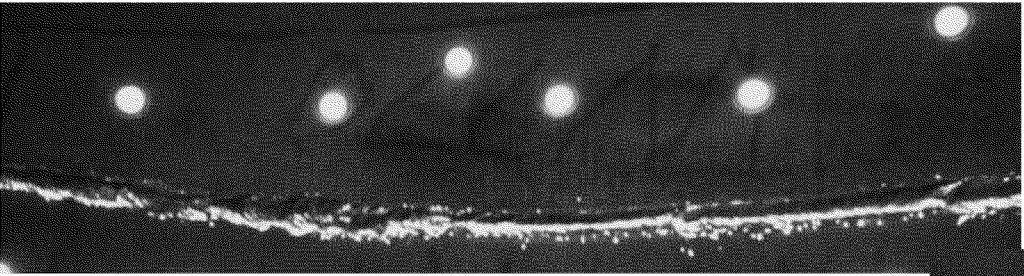
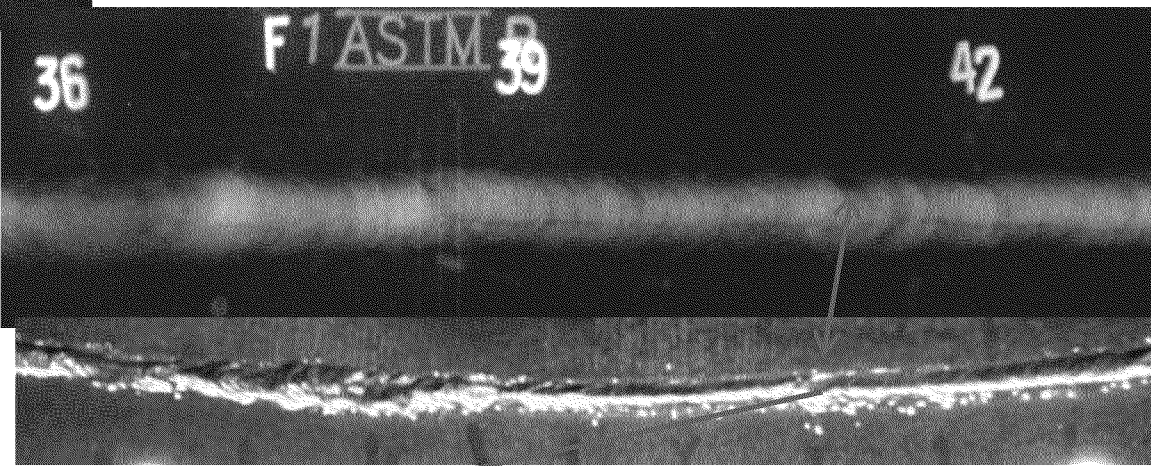
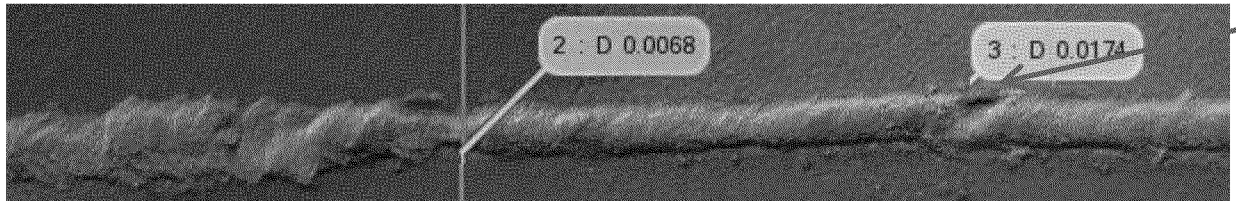
Digital surface profile tool alignment

Creaform 3D (+/- 0.002") surface profile:

- Confirms indications are, in the majority, diffraction effects on minor hi/lo condition with 0 UC
- One small pocket observed at 0.007" deep x 0.130" long
- One unrelated pocket opposite ROI of 0.017" deep x 0.195" long
- Weld is acceptable per API 1104

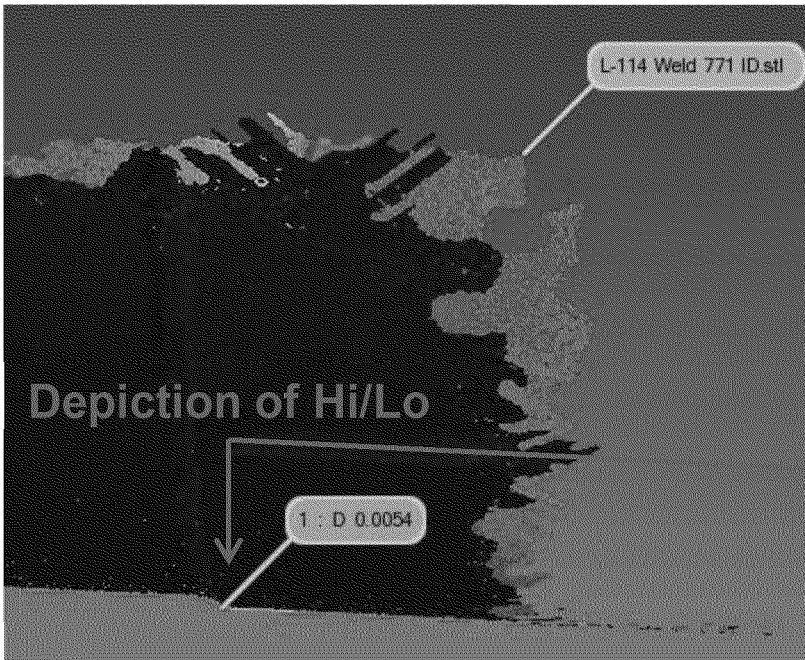
Additional Creaform/Polyworks perspective of ROI 12-24:

- * Confirms UC indication is diffraction/"shadowing" from high/low condition
- * Weld is acceptable per API 1104

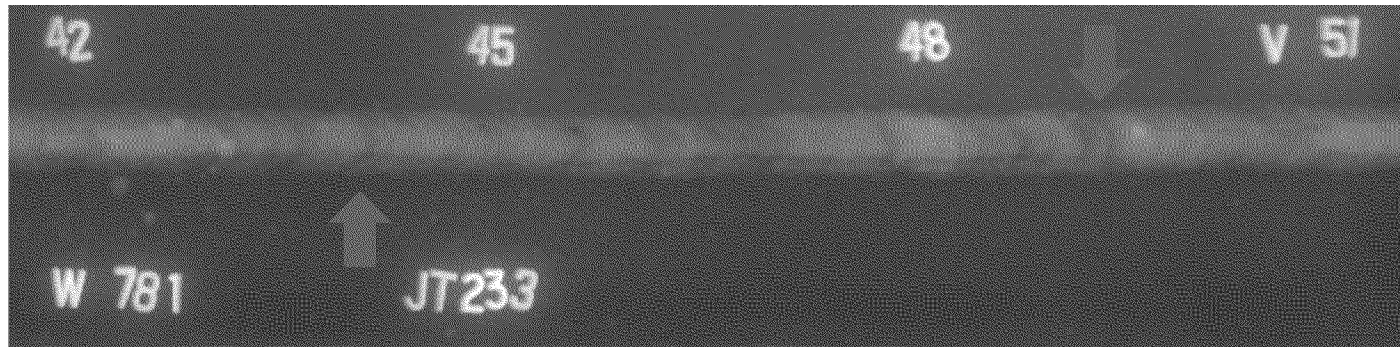
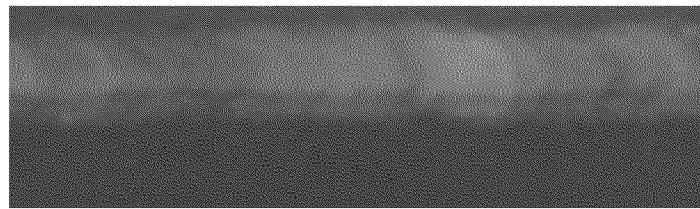
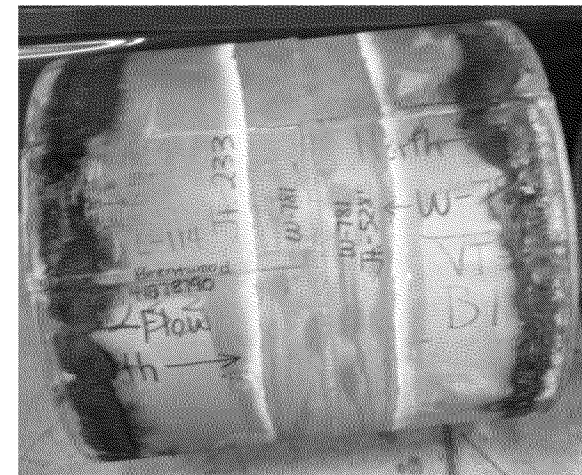
Excised weld photo-documented and ROI aligned with weld features

Depth of most severe indications estimated by change in x-ray density

RT estimated depths of up to 0.015 inches

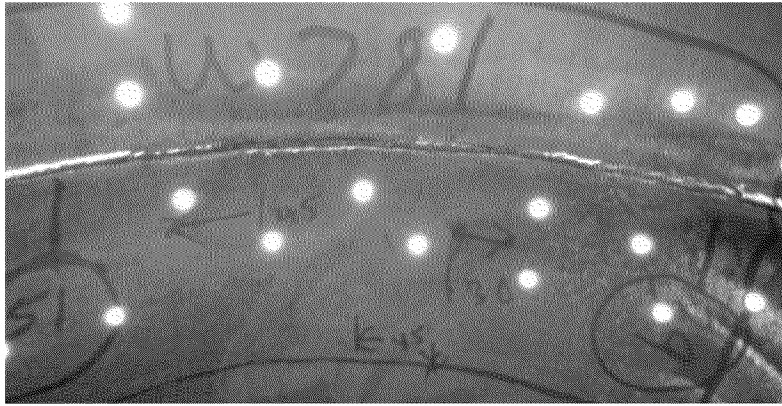
Digital surface profile tool alignment

Creaform 3D (+/- 0.002") surface profile:

Confirms indications are mostly diffraction effects on minor hi/lo condition with 0 UC

Largest region is 1.5 long x up to 0.015 inches deep

Weld is acceptable per API 1104

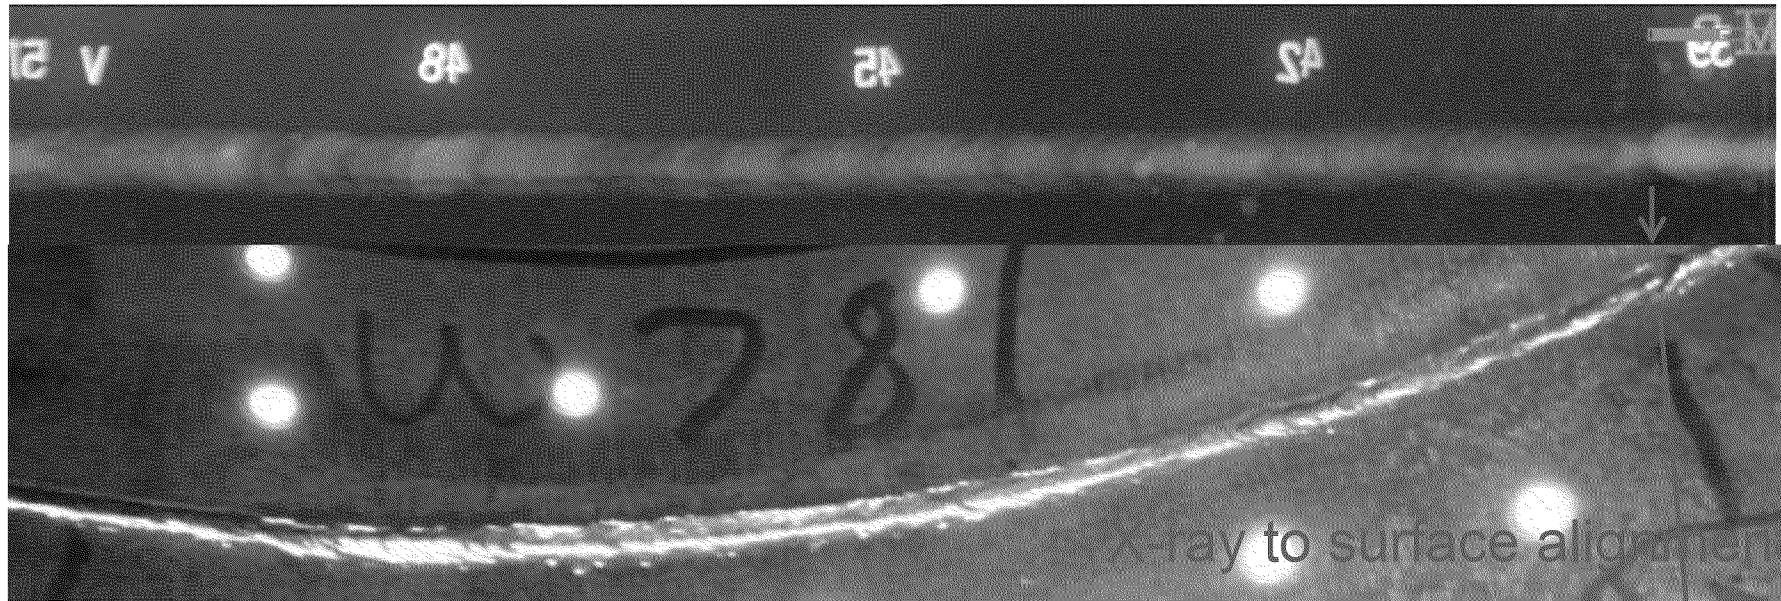
Additional Creaform/Polyworks perspective of ROI 44-49:

- * Confirms UC indication is, in the majority, diffraction/"shadowing" from high/low condition with less than 2 inches of up to 0.015 inches deep IUC
- * Weld is acceptable per API 1104

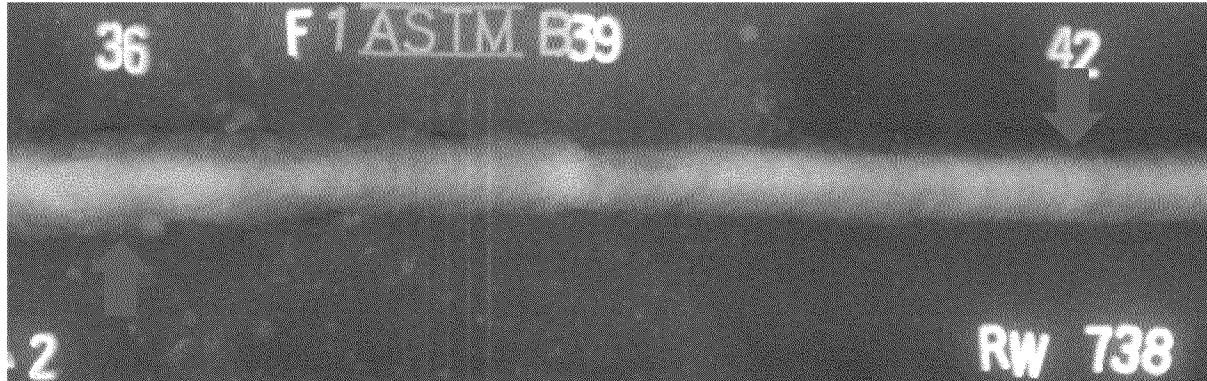
Excised weld photo-documented and ROI aligned with weld features

Depth of most severe indications estimated by change in x-ray density

RT estimated depths of up to 0.030 inches

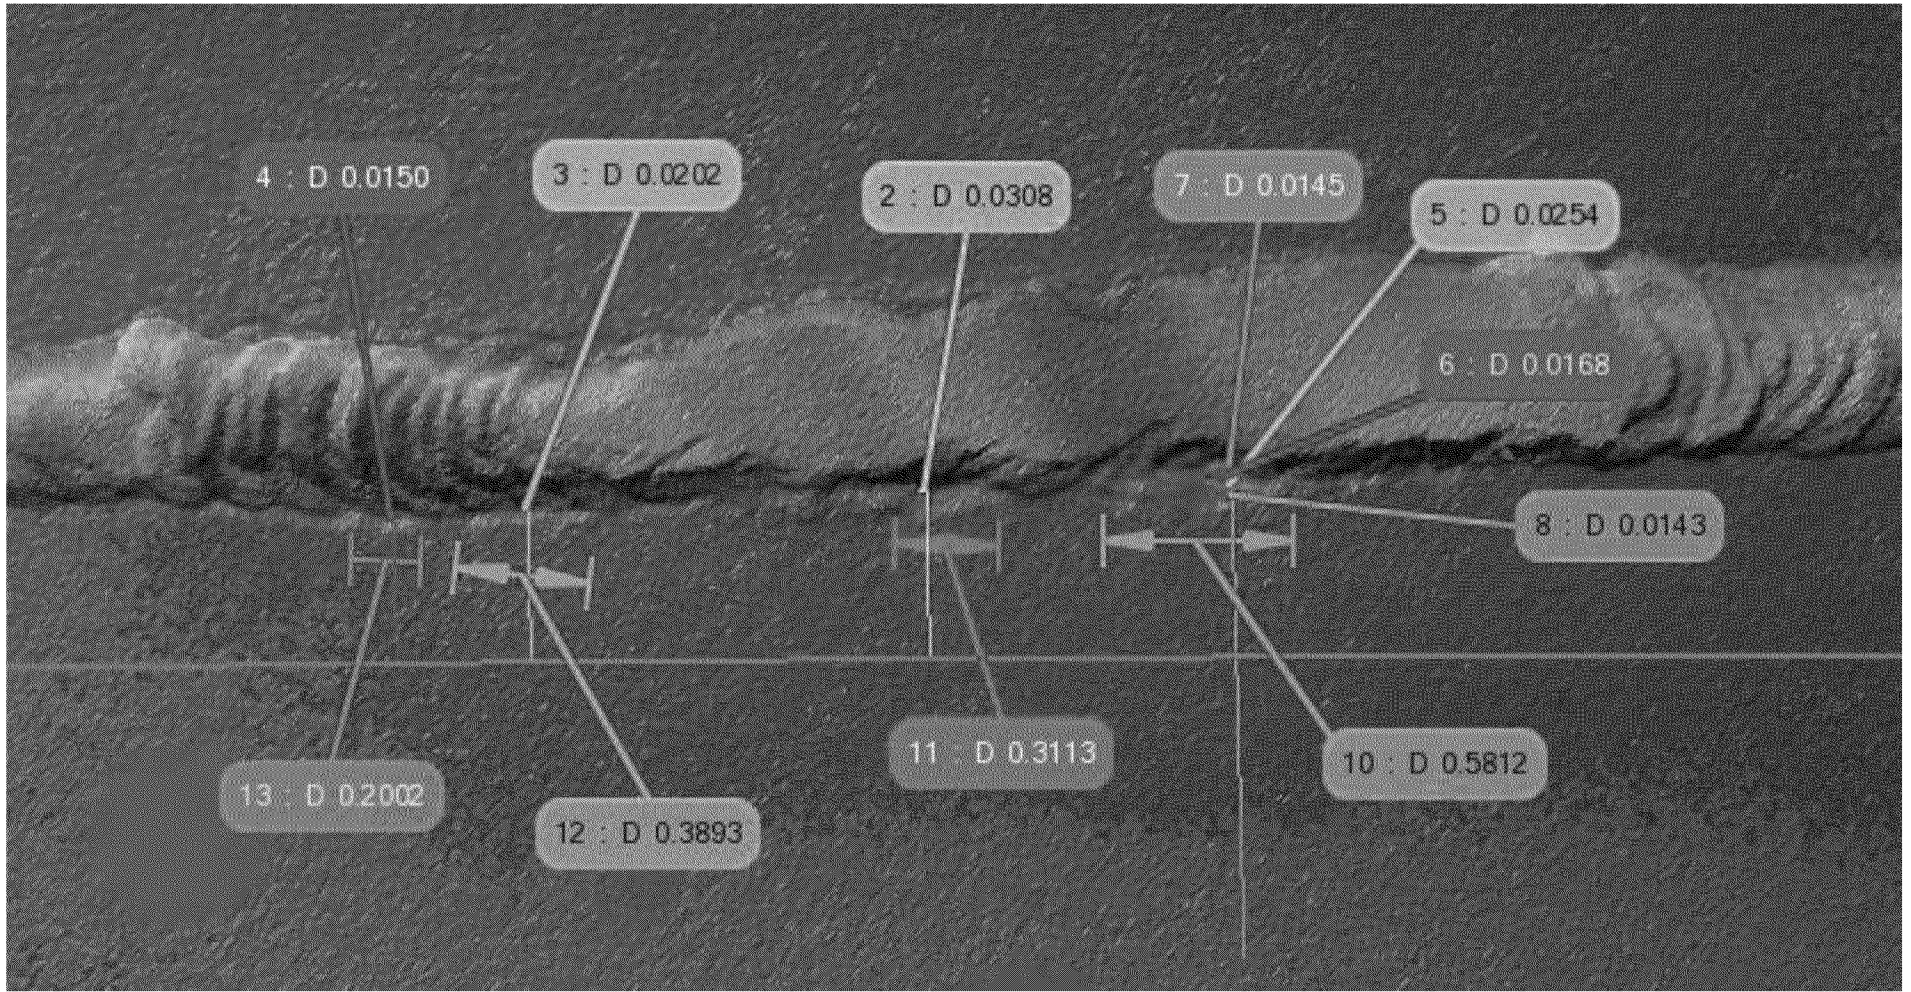
Additional Creaform/Polyworks perspective of ROI 36-42:

- * EUC noted in several short segments totaling less than 1.5"
- * Weld is acceptable per API 1104
