Noncompliant Weld Inspection Techniques

Line 114 Non Destructive Examination Final Report

Issue Date December 5, 2013

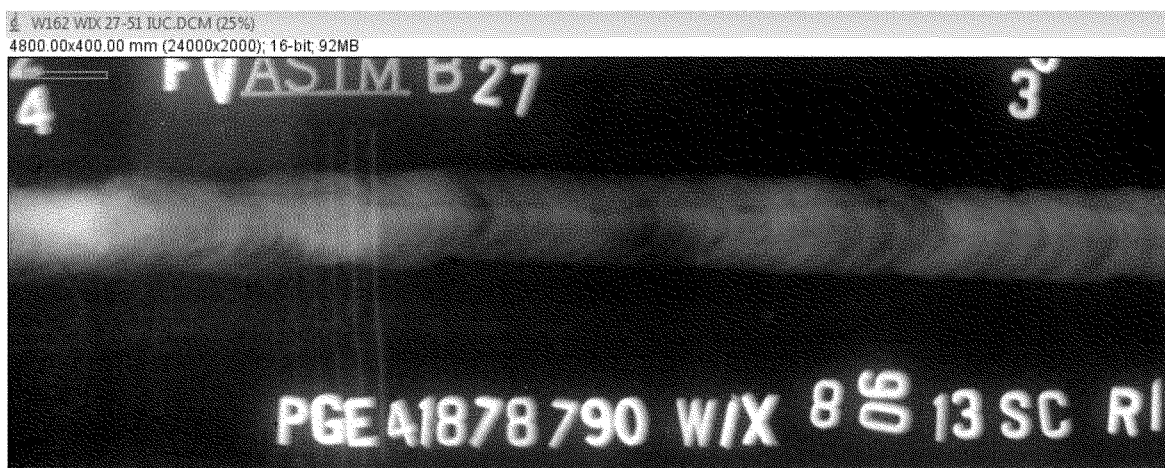
Figure 4 – Weld 162 with acceptable indications of undercut

3.3 Weld 162 indication was digitized as shown below in Figure 4. Radiographic density measurements indicate that no portion of the indication has an indication of undercut which is greater than 0.016” deep, indicating that it is acceptable per section 9.3.11& 9.3.7 of API 1104.

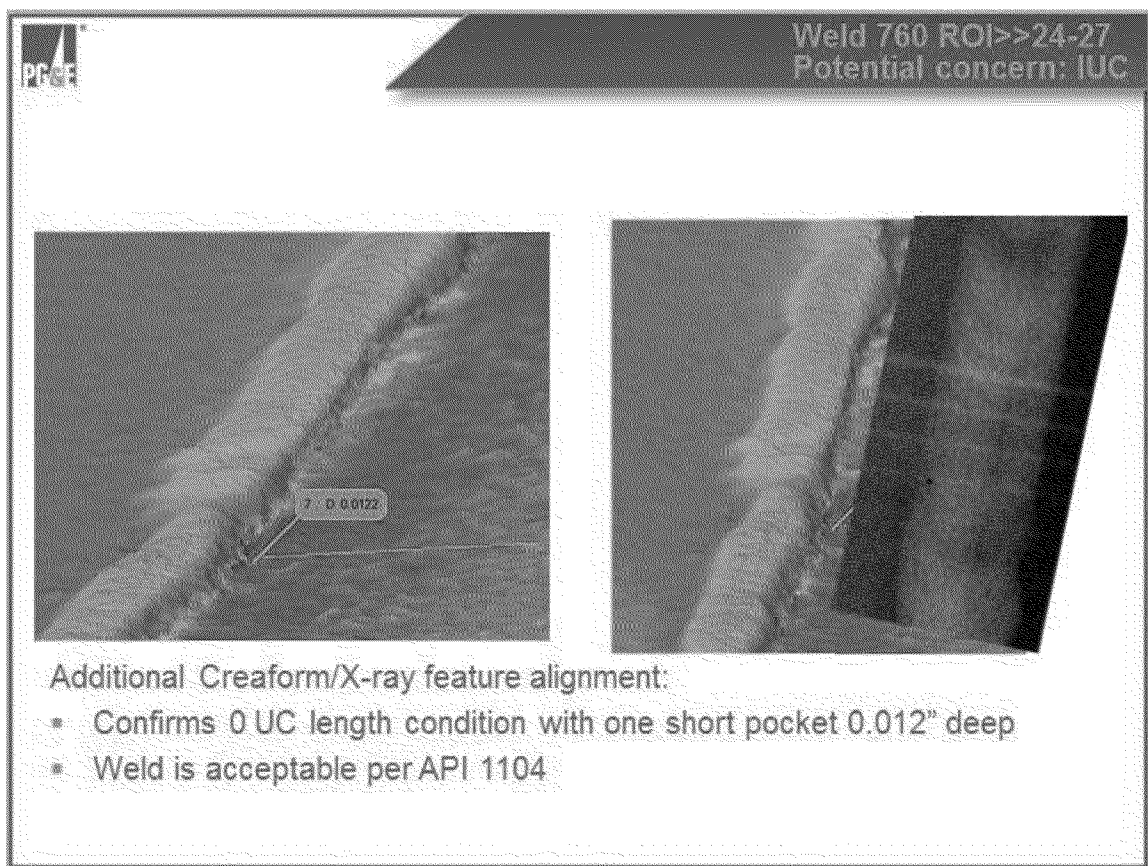
Figure 1 – Assessment of Weld 760 IUC region of interest

3.5 Creafom photogrammetry results were obtained for all the radiographic ROI's. The criteria applied to these results were API 1104 section 9.7, Table 4, "Maximum Dimensions of Undercutting". Applying the further criteria of depth from this requirement, to the documented radiographic and visual measurement data for length, all welds were found acceptable. Figure 2, from slide 5 in Appendix I, summarizes the typical physical condition for the audit identified indications of concern.

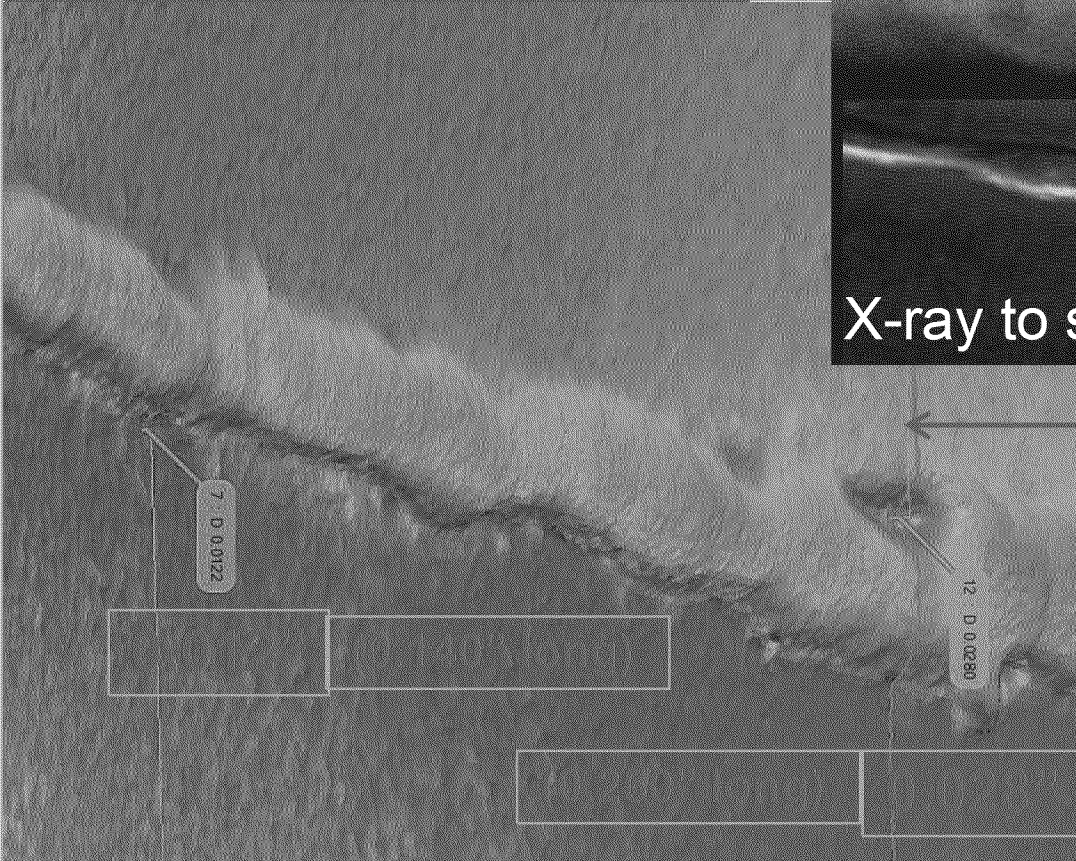
X-ray to surface alignment

Creaform 3D (+/- 0.002") surface profile:

Confirms indications are mostly diffraction effects on minor hi/lo condition with 0 UC

Two small pockets are 12 and 28 mils deep with greatest length of 0.250"

Weld is acceptable per API 1104

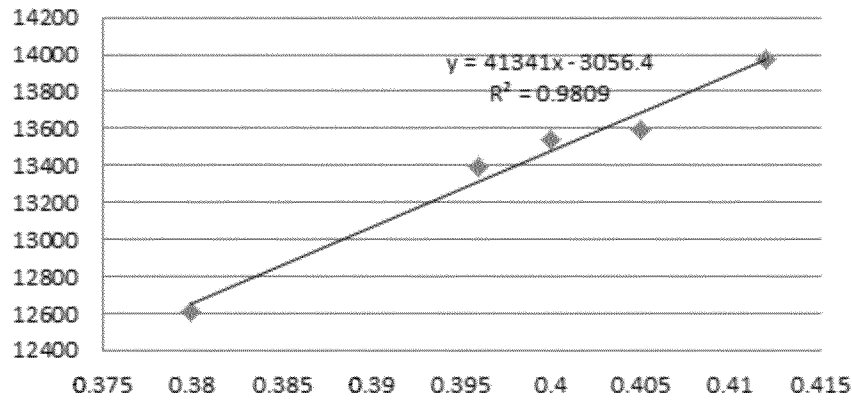
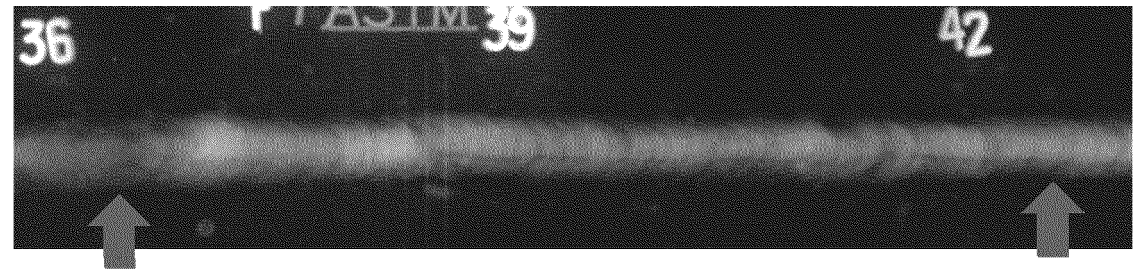
Excised weld photo-documented and ROI aligned with weld features

Depth of most severe indications estimated by change in x-ray density

RT estimated depths of up to 0.008 inches

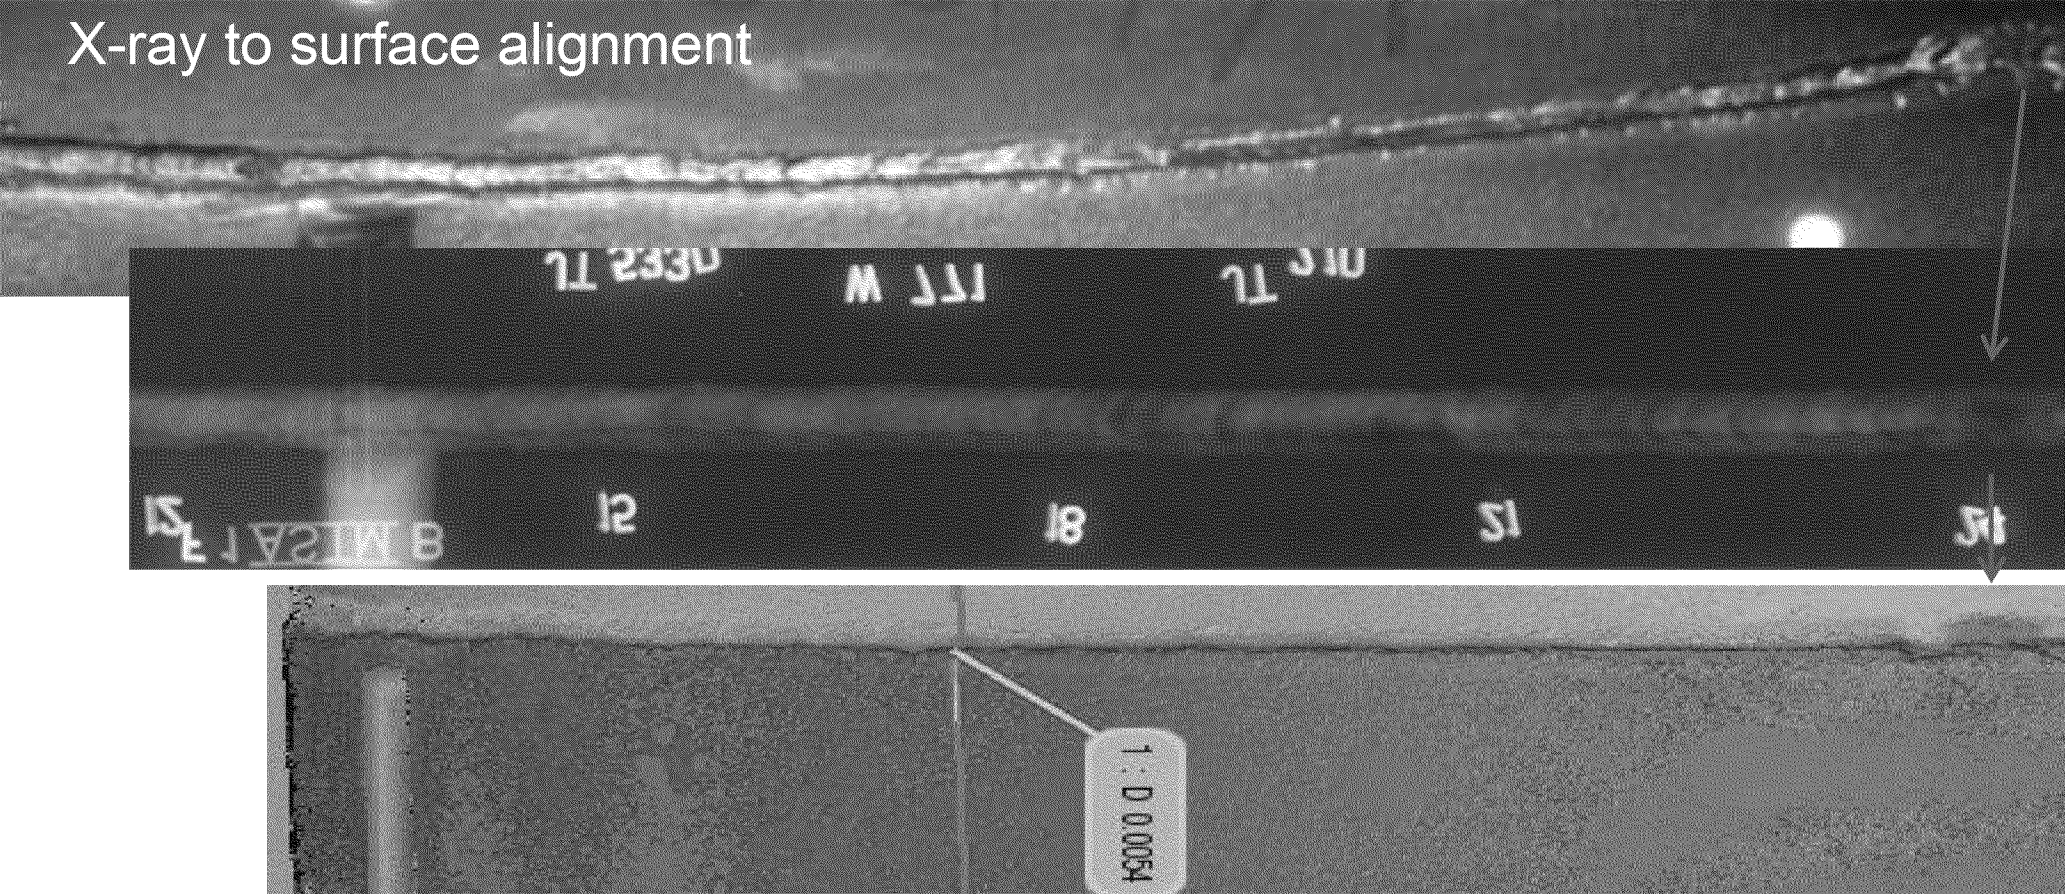
X-ray to surface alignment

- Confirms indications are mostly diffraction effects on minor hi/lo condition with 0 UC
- Deepest region along length is 0.006 inches
- Weld is acceptable per API 1104

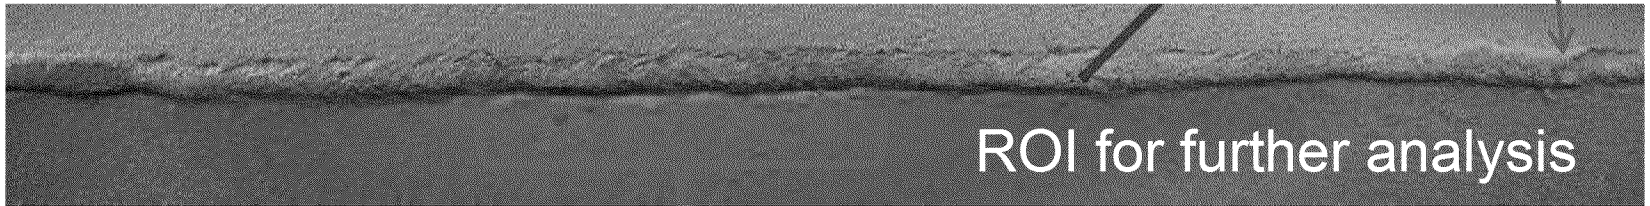
ROI for further analysis

Confirms indications are mostly diffraction effects on minor hi/lo condition with 0 UC

Largest region is 1.5 long x up to 0.015 inches deep

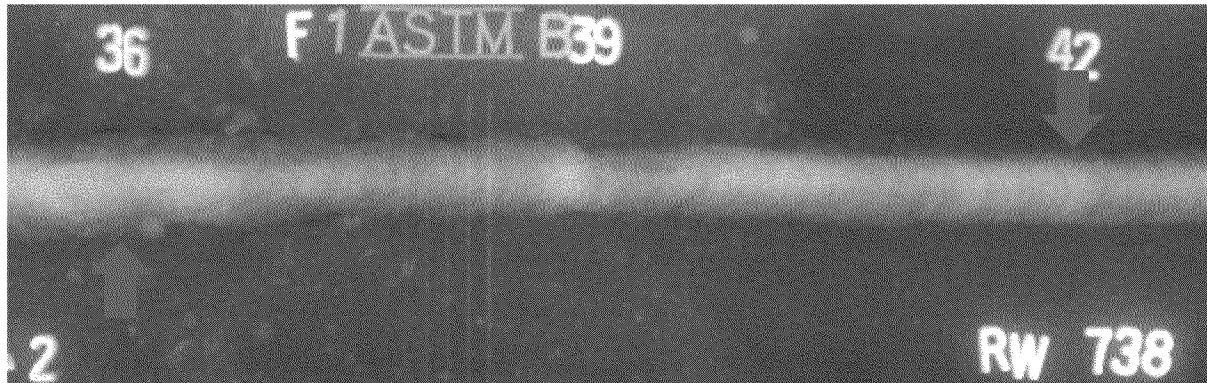
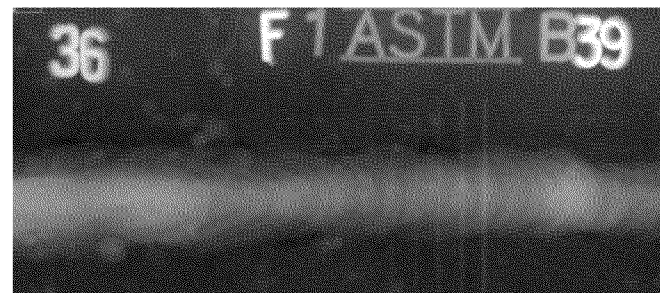
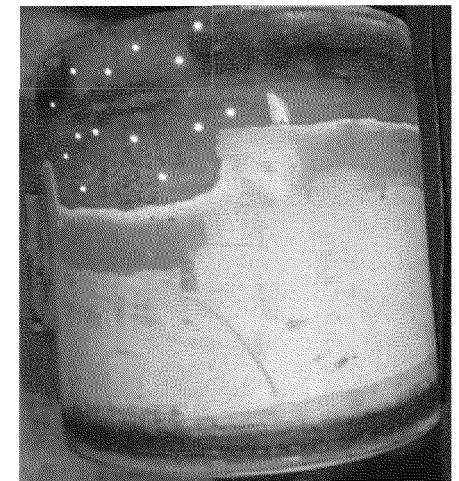
Excised weld photo-documented and ROI aligned with weld features

Depth of most severe indications estimated by change in x-ray density

RT estimated depths of up to 0.030 inches
