Noncompliant Weld Inspection Techniques

Line 114 Non Destructive Examination Final Report

Issue Date December 5, 2013

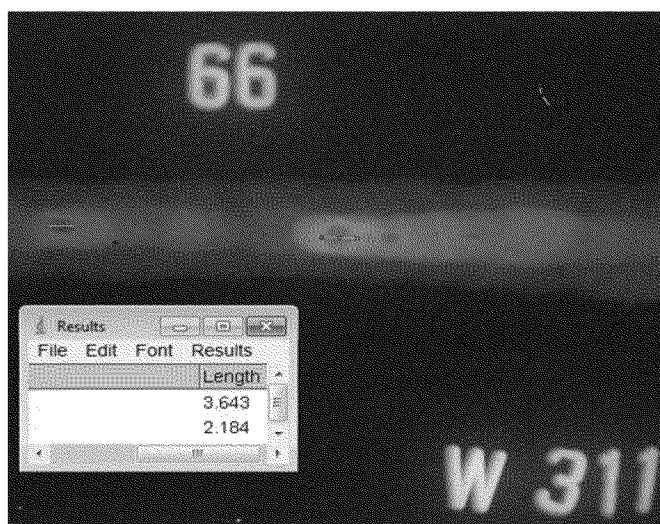
Figure 3 – Weld 311 with acceptable BT length of 0.141” and acceptable small pores

3.2 Weld 311, digitized in the region of interest, is depicted in Figure 3. Similarly we have one indication of burn-through and 3 small pores, all of which are acceptable per sections 9.3.7 & 9.3.9 of API 1104. For both welds 270 and 311, the repair process had to proceed to the root before the indications were eliminated, confirming that they were caused by burn through.

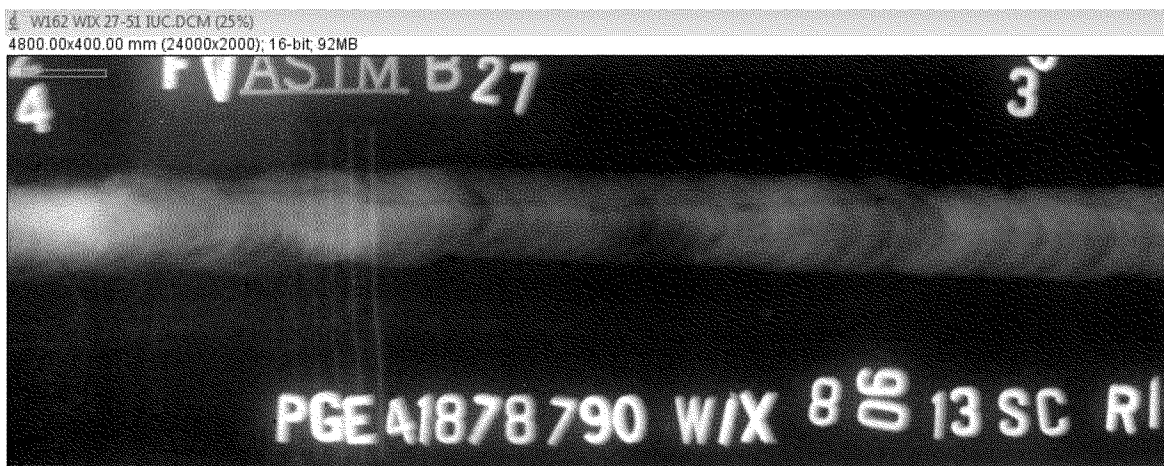
Figure 4 – Weld 162 with acceptable indications of undercut

3.3 Weld 162 indication was digitized as shown below in Figure 4. Radiographic density measurements indicate that no portion of the indication has an indication of undercut which is greater than 0.016” deep, indicating that it is acceptable per section 9.3.11& 9.3.7 of API 1104.

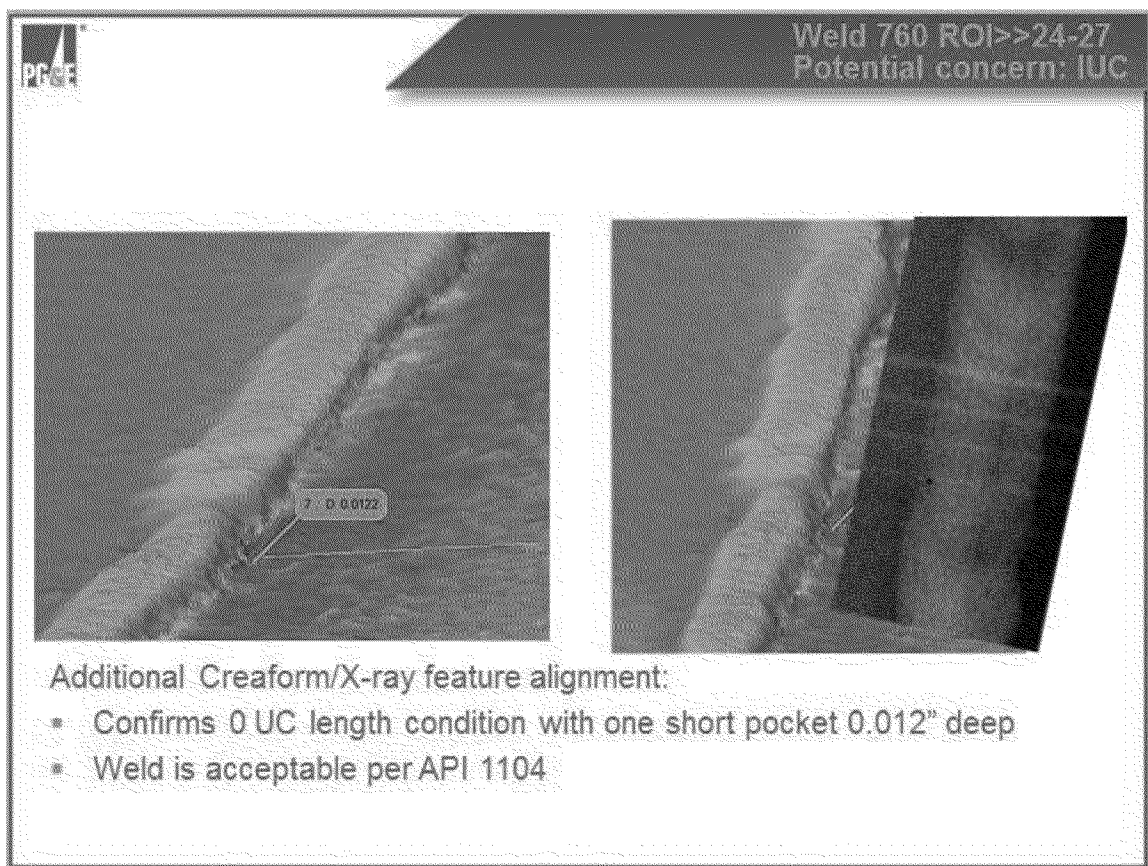
Figure 1 – Assessment of Weld 760 IUC region of interest

3.5 Creafom photogrammetry results were obtained for all the radiographic ROI's. The criteria applied to these results were API 1104 section 9.7, Table 4, "Maximum Dimensions of Undercutting". Applying the further criteria of depth from this requirement, to the documented radiographic and visual measurement data for length, all welds were found acceptable. Figure 2, from slide 5 in Appendix I, summarizes the typical physical condition for the audit identified indications of concern.

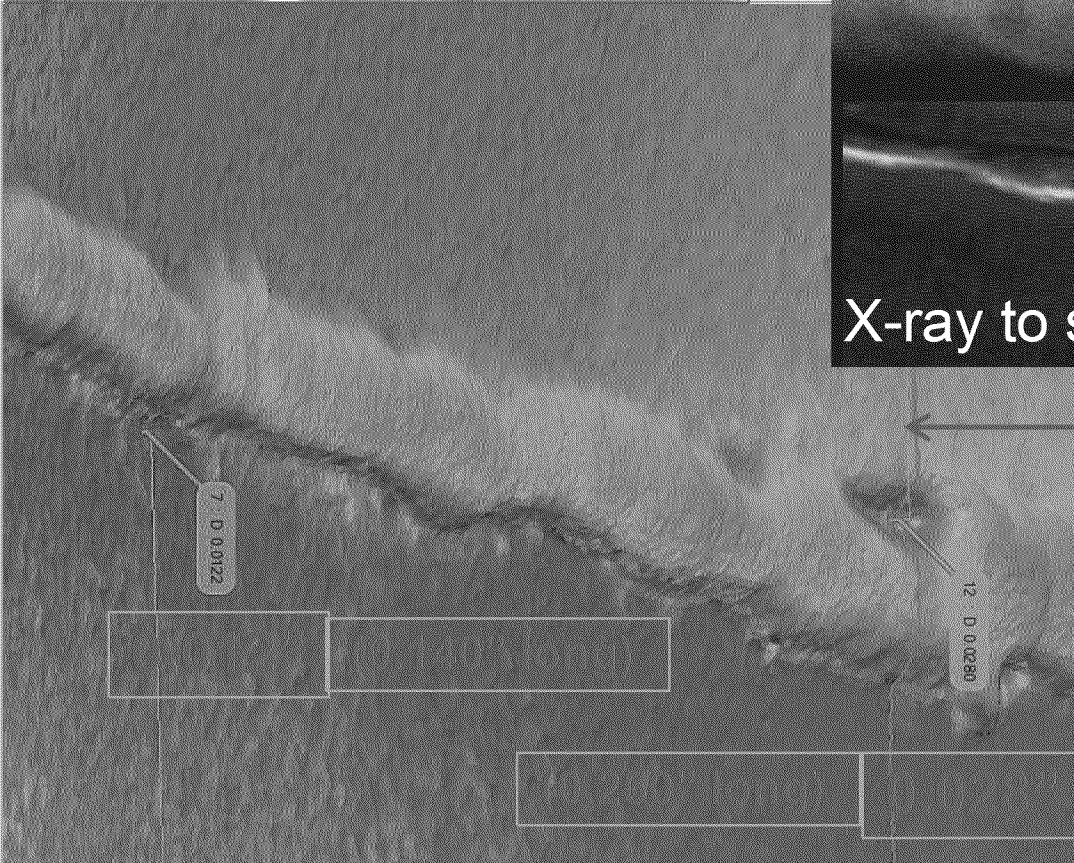
X-ray to surface alignment

Creaform 3D (+/- 0.002") surface profile:

Confirms indications are mostly diffraction effects on minor hi/lo condition with 0 UC

Two small pockets are 12 and 28 mils deep with greatest length of 0.250"

Weld is acceptable per API 1104

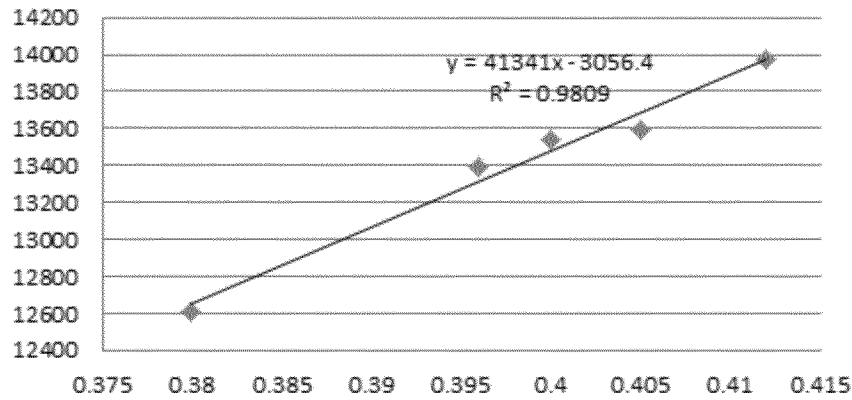
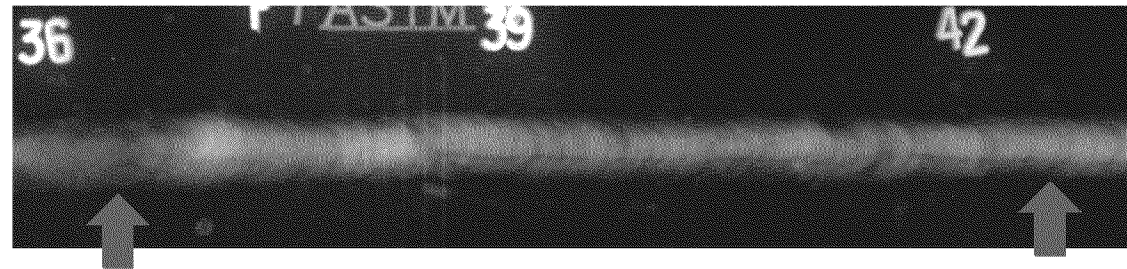
Weld 770 cited for indications of internal undercut from 36-42
Excised weld photo-documented and ROI aligned with weld features
Depth of most severe indications estimated by change in x-ray density

RT estimated depths of up to 0.008 inches

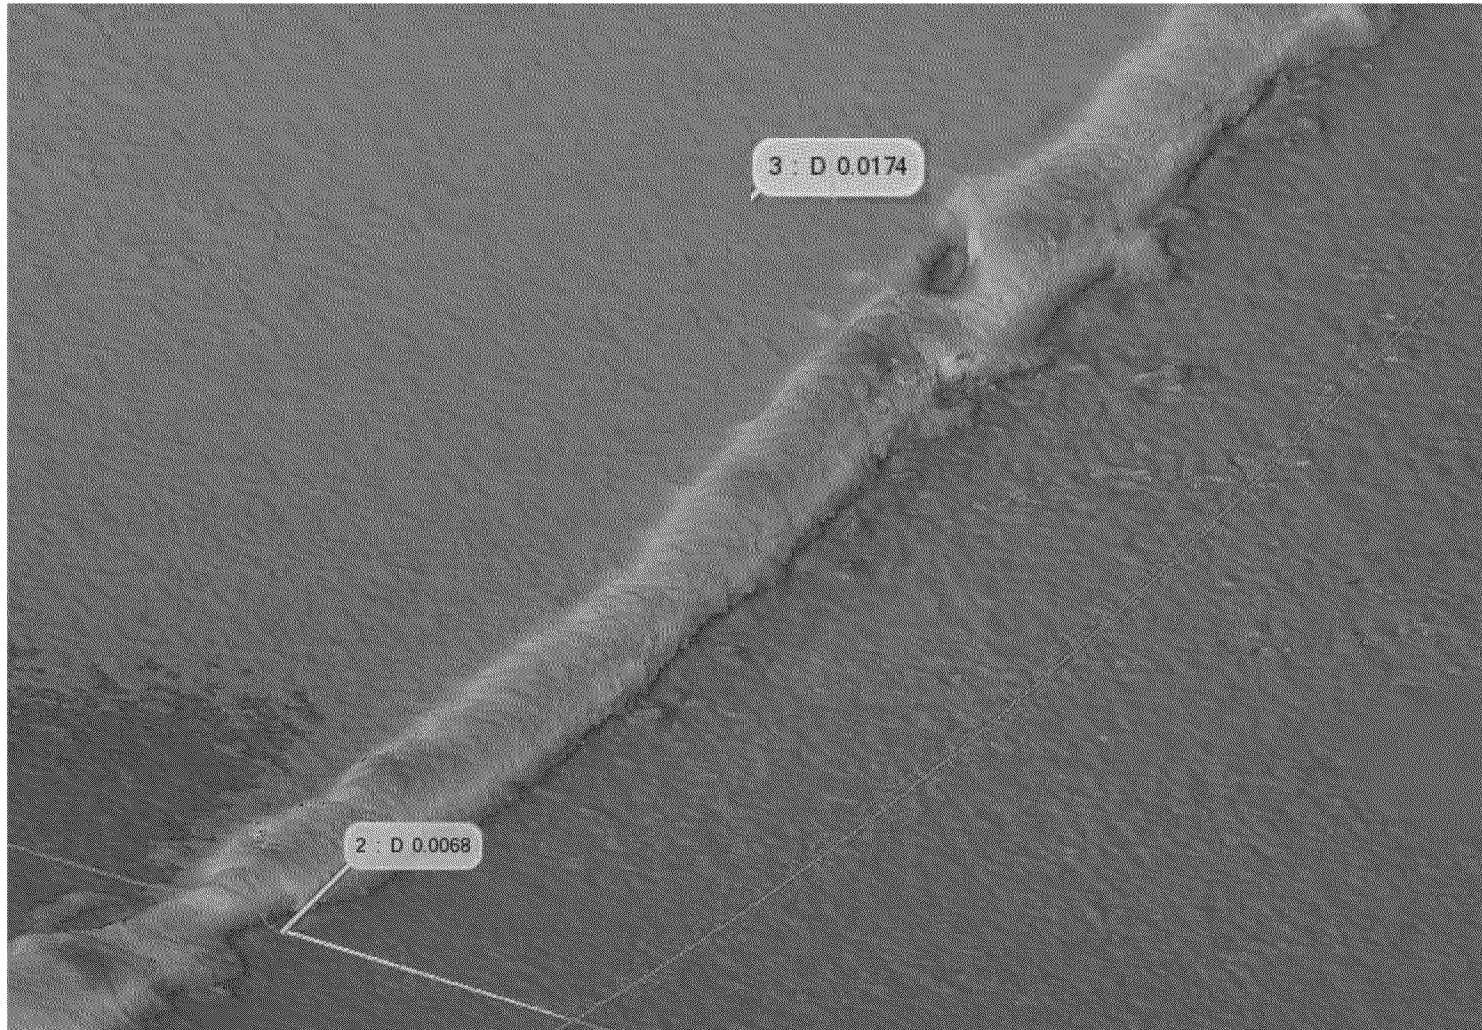
Additional Creaform/Polyworks perspective of ROI 36-42:

- * Confirms UC indication is diffraction/"shadowing" from high/low condition
- * Weld is acceptable per API 1104

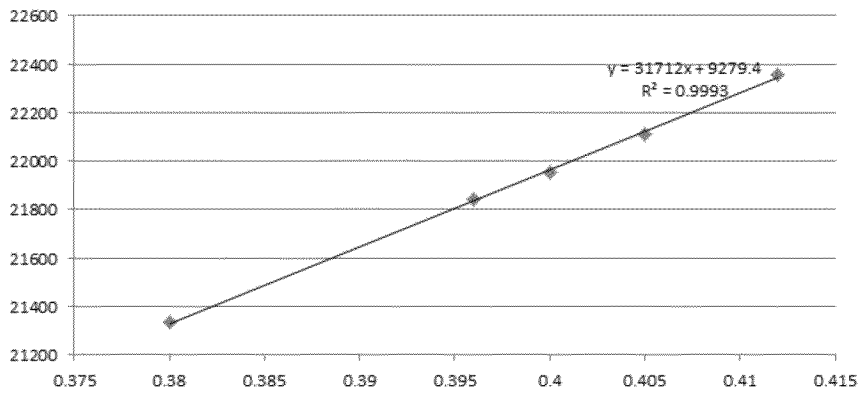
Excised weld photo-documented and ROI aligned with weld features

Depth of most severe indications estimated by change in x-ray density

RT estimated depths of up to 0.008 inches

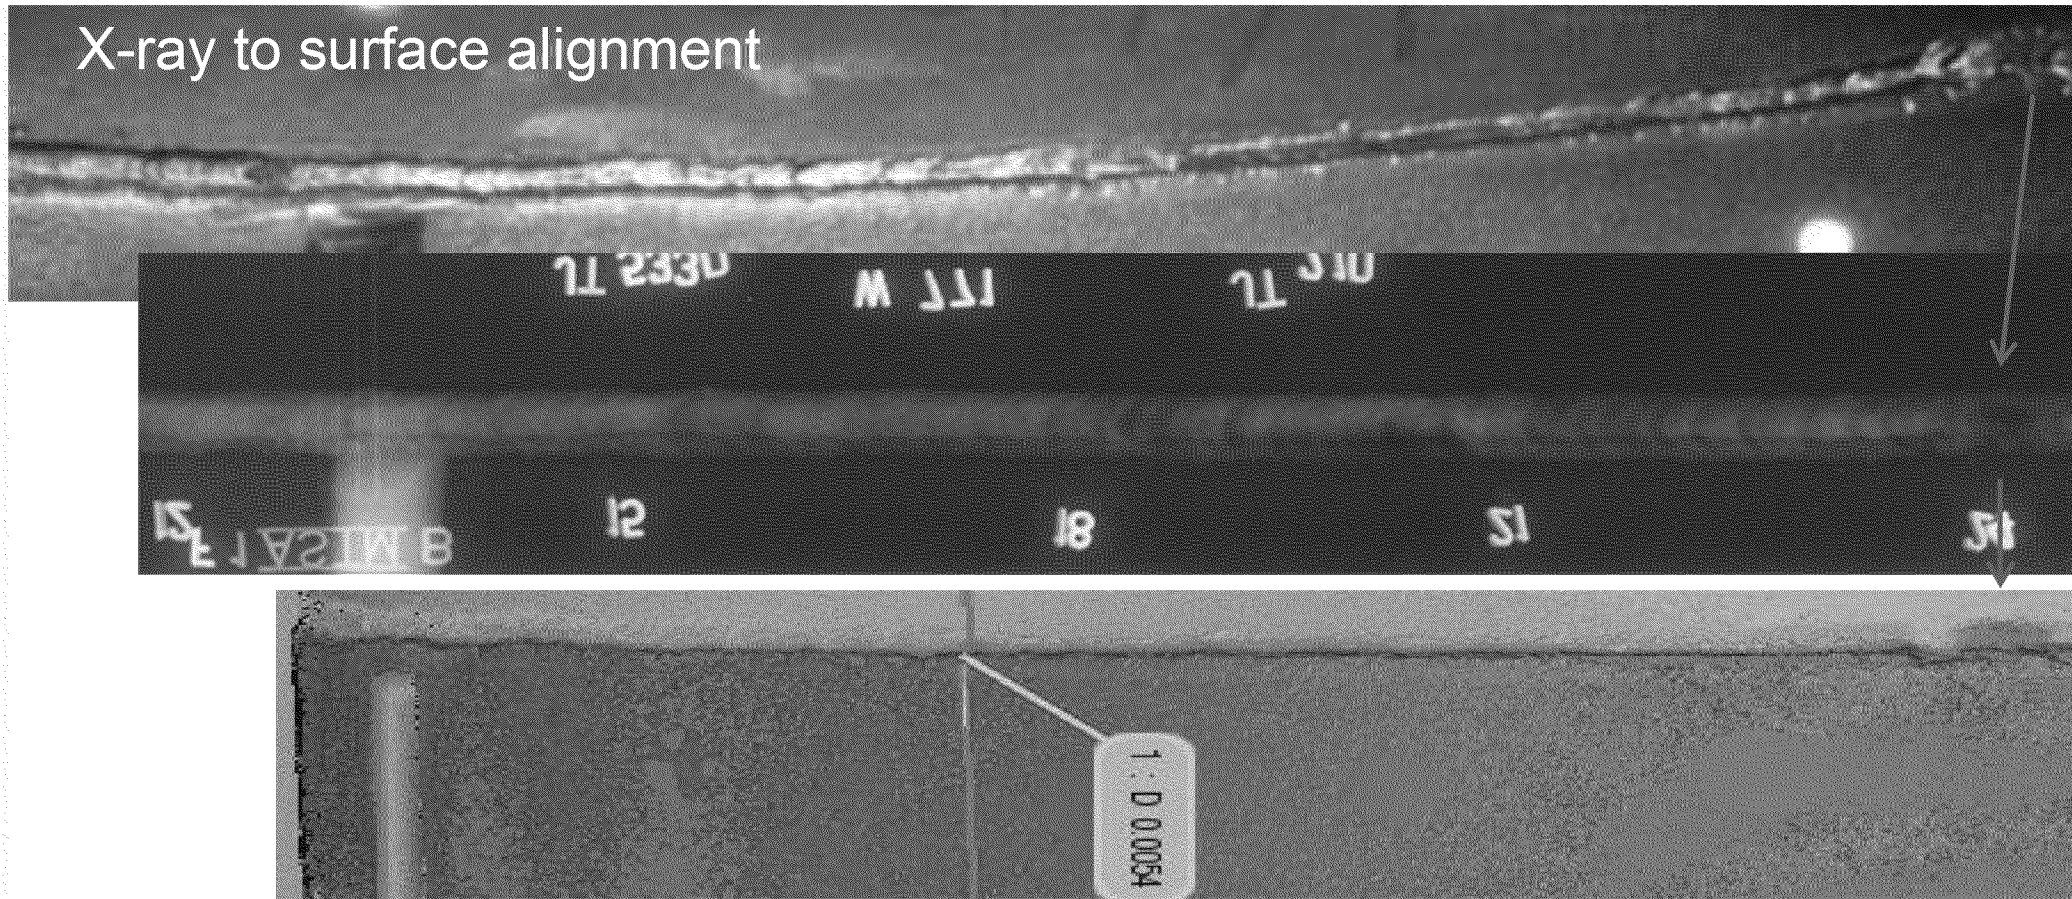
X-ray to surface alignment

Creaform 3D (+/- 0.002") surface profile:

- Confirms indications are mostly diffraction effects on minor hi/lo condition with 0 UC
- Deepest region along length is 0.006 inches
- Weld is acceptable per API 1104

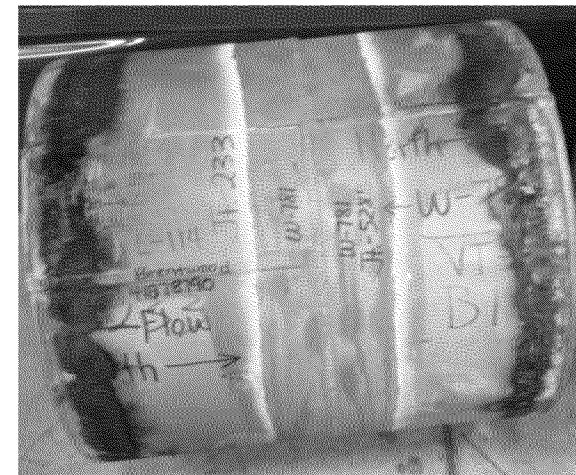
Excised weld photo-documented and ROI aligned with weld features

Depth of most severe indications estimated by change in x-ray density

RT estimated depths of up to 0.015 inches

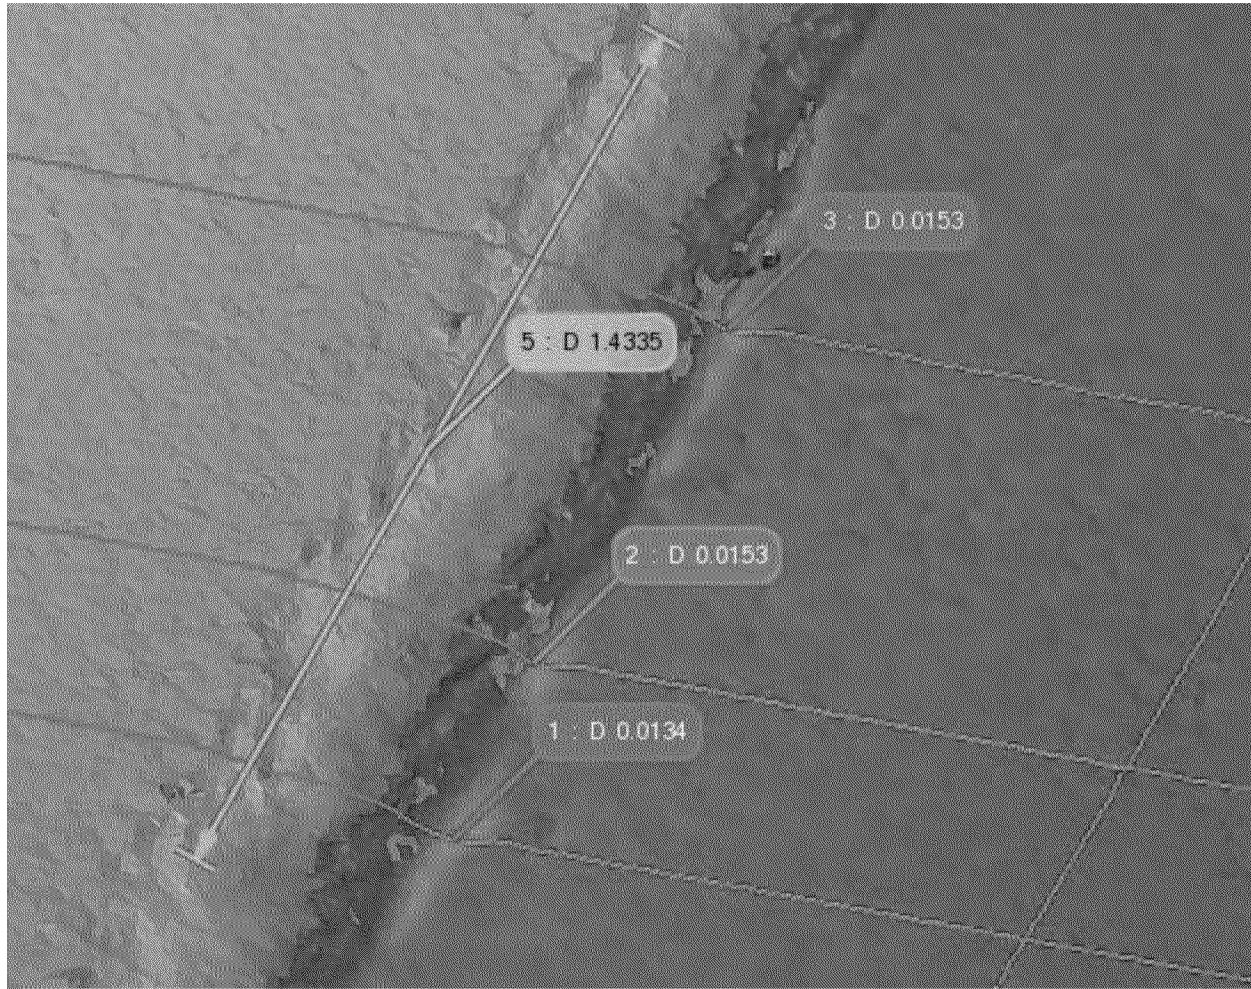
Additional Creafom/Polyworks perspective of ROI 44-49:

- * Confirms UC indication is, in the majority, diffraction/"shadowing" from high/low condition with less than 2 inches of up to 0.015 inches deep IUC
- * Weld is acceptable per API 1104

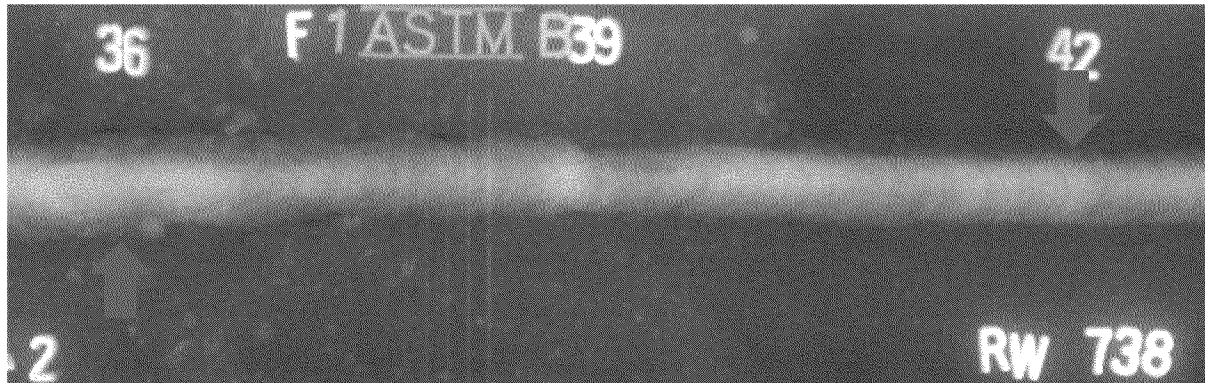
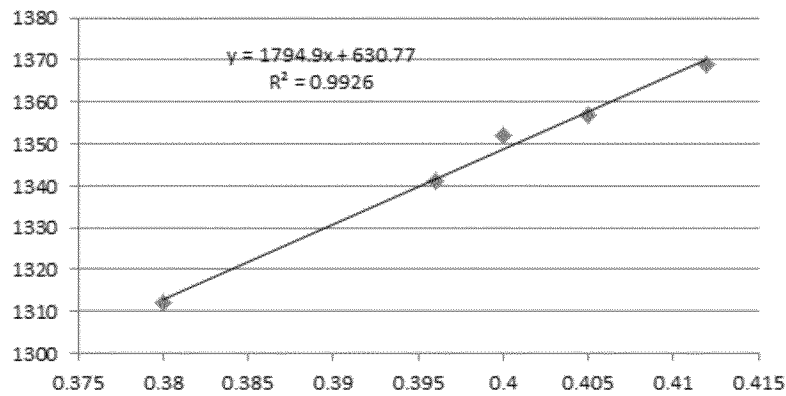
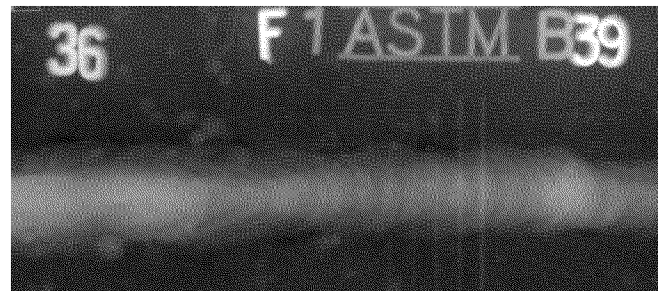
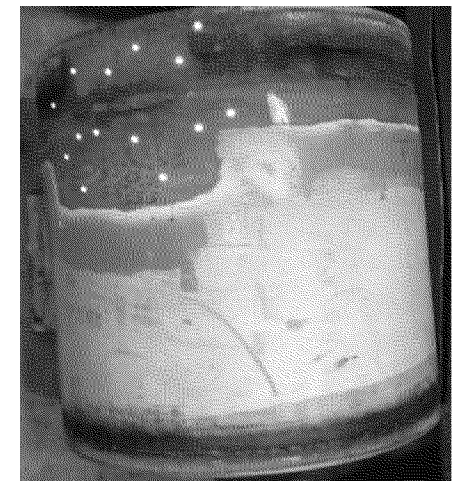
Excised weld photo-documented and ROI aligned with weld features

Depth of most severe indications estimated by change in x-ray density

RT estimated depths of up to 0.030 inches

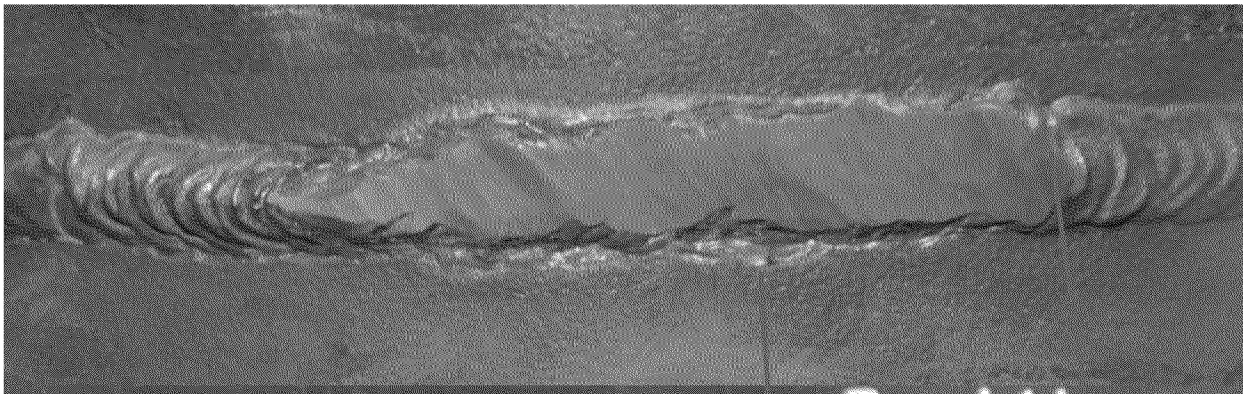
Creaform 3D (+/- 0.002") surface profile:

External undercut identified up to 0.030" deep

Sum of UC lengths < 1.5"

Weld is acceptable per API 1104

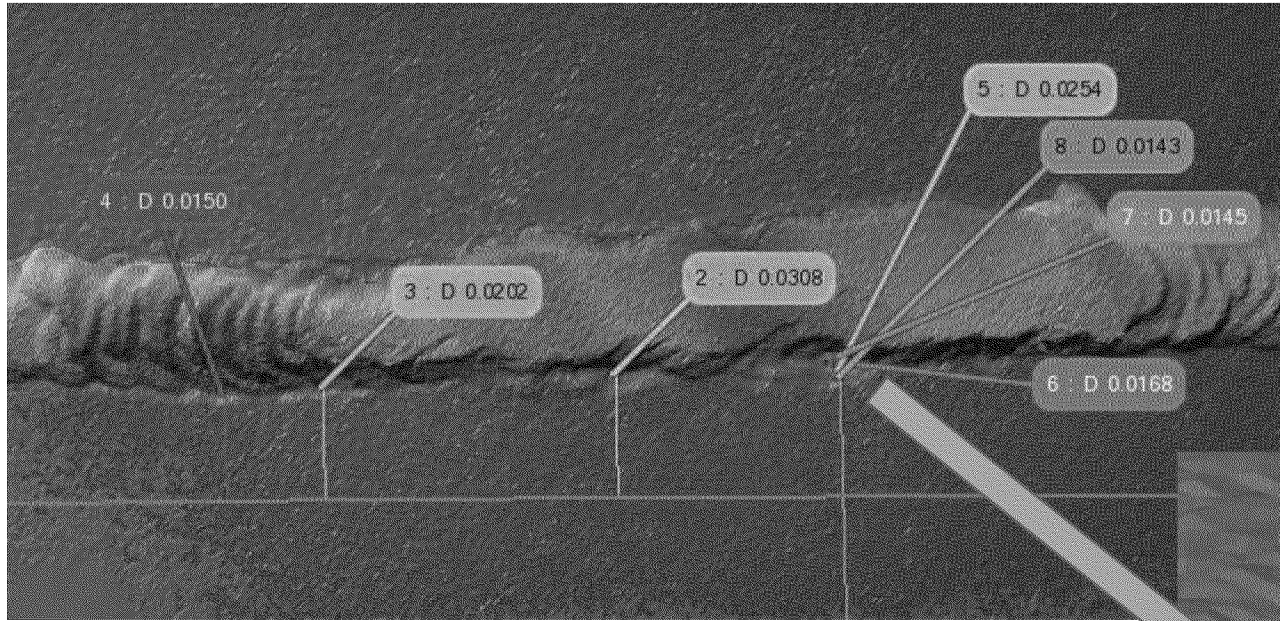
Additional Creaform/Polyworks perspective of ROI 36-42:

- * EUC noted in several short segments totaling less than 1.5"
- * Weld is acceptable per API 1104

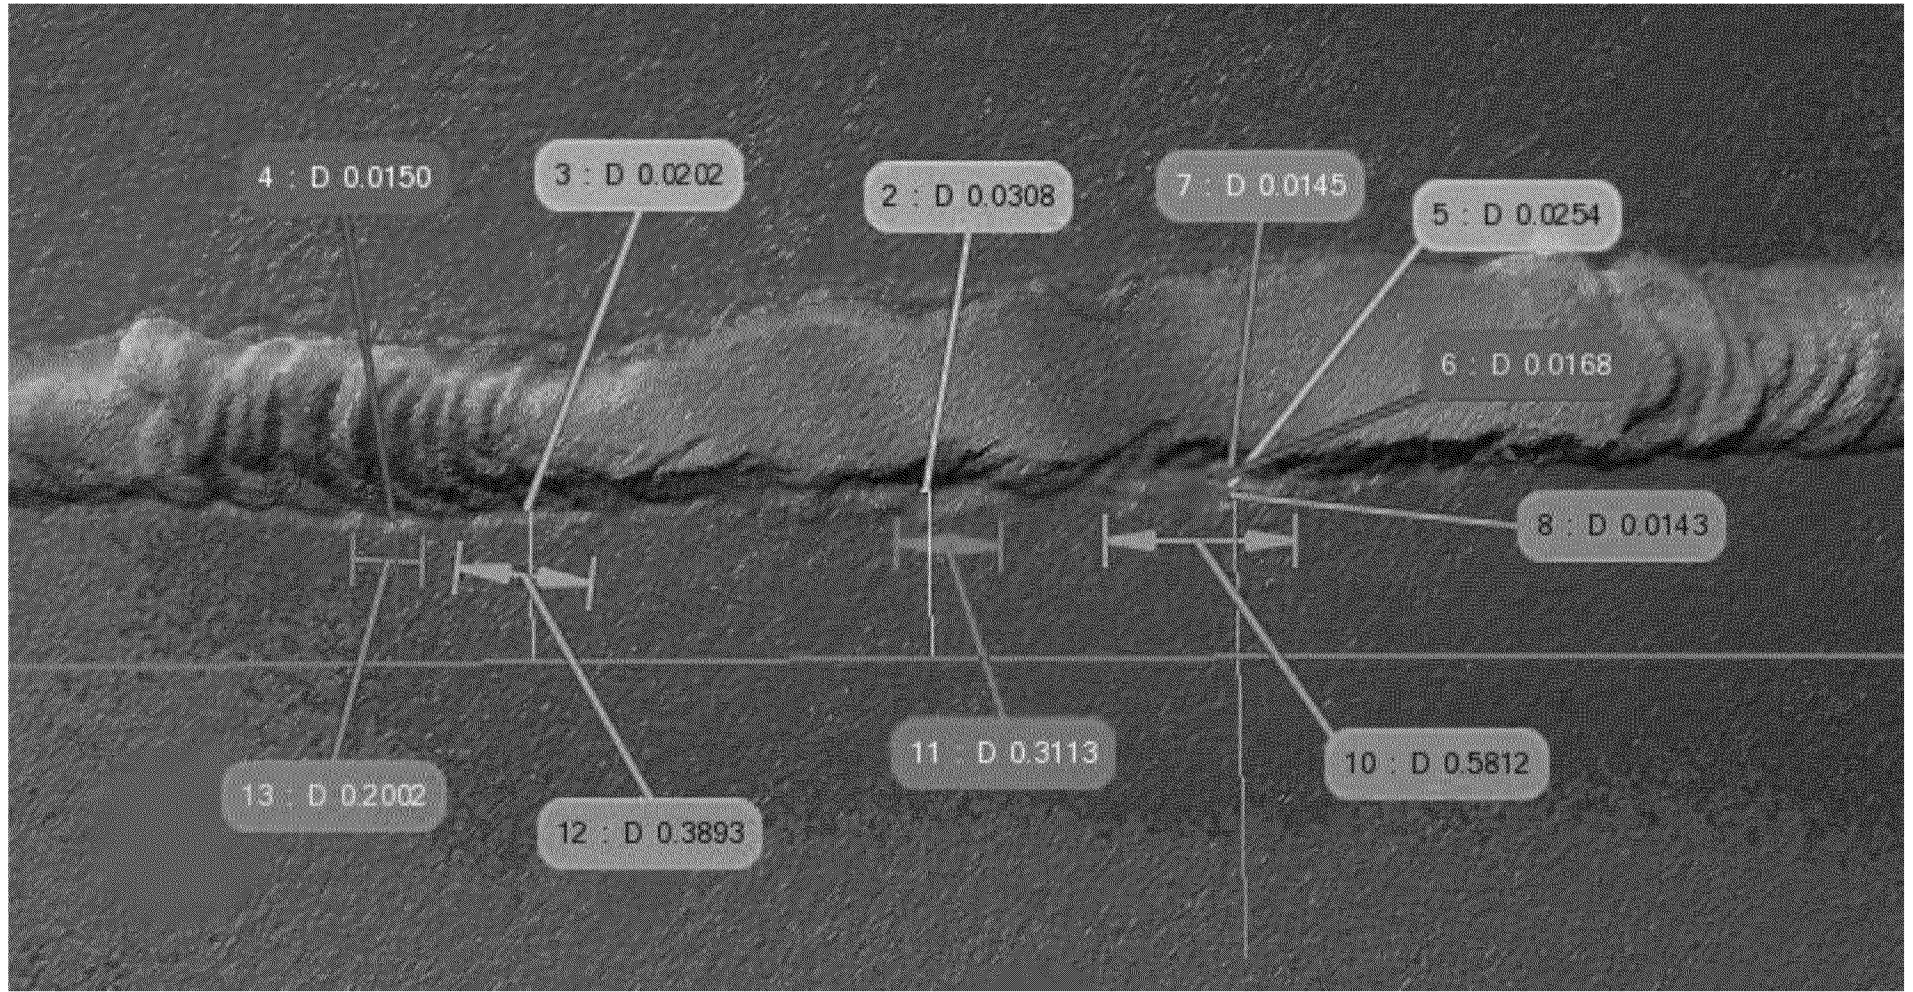
Additional Creaform/Polyworks perspective of ROI 36-42:

- * EUC noted in several short segments totaling less than 1.5"
- * Weld is acceptable per API 1104
