# Noncompliant Weld Inspection Techniques

## Line 114 Non Destructive Examination Final Report

Issue Date December 5, 2013

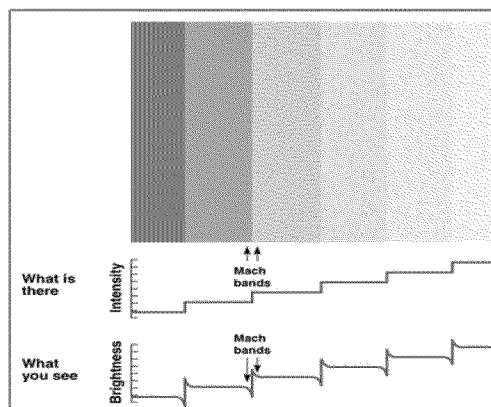
**Figure 1 – Machs Bands Effects**

- 2.3 ATS performed digital radiographic thickness measurements on Weld 162, using the parent material & image quality indicator (IQI) wires as step calibration. This activity was performed to rule out Machs Bands (Figure 1) severity effects, which can influence the interpretation of undercut, and also to provide ROM estimation of any actual undercut conditions.

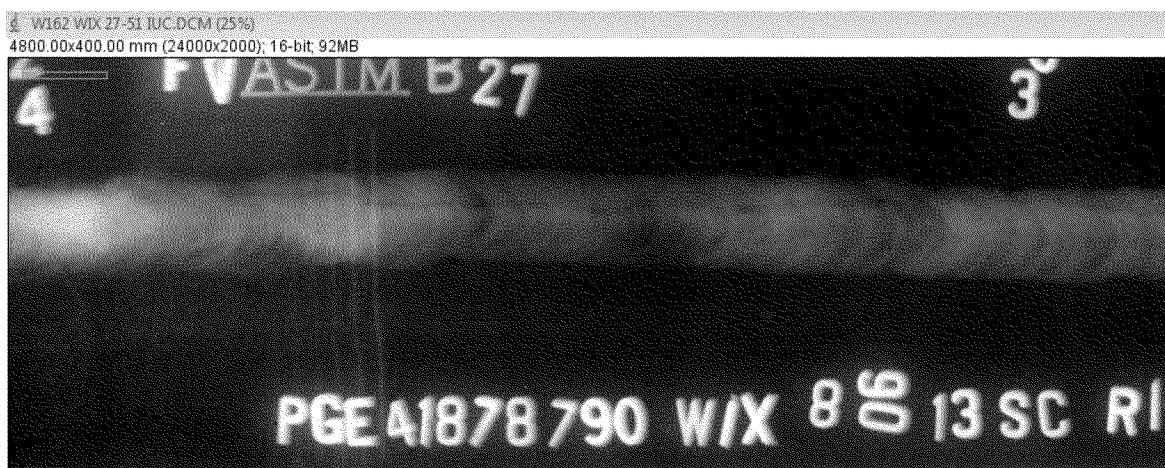
3.3 Weld 162 indication was digitized as shown below in Figure 4. Radiographic density measurements indicate that no portion of the indication has an indication of undercut which is greater than 0.016” deep, indicating that it is acceptable per section 9.3.11& 9.3.7 of API 1104.

**Figure 4 – Weld 162 with acceptable indications of undercut**

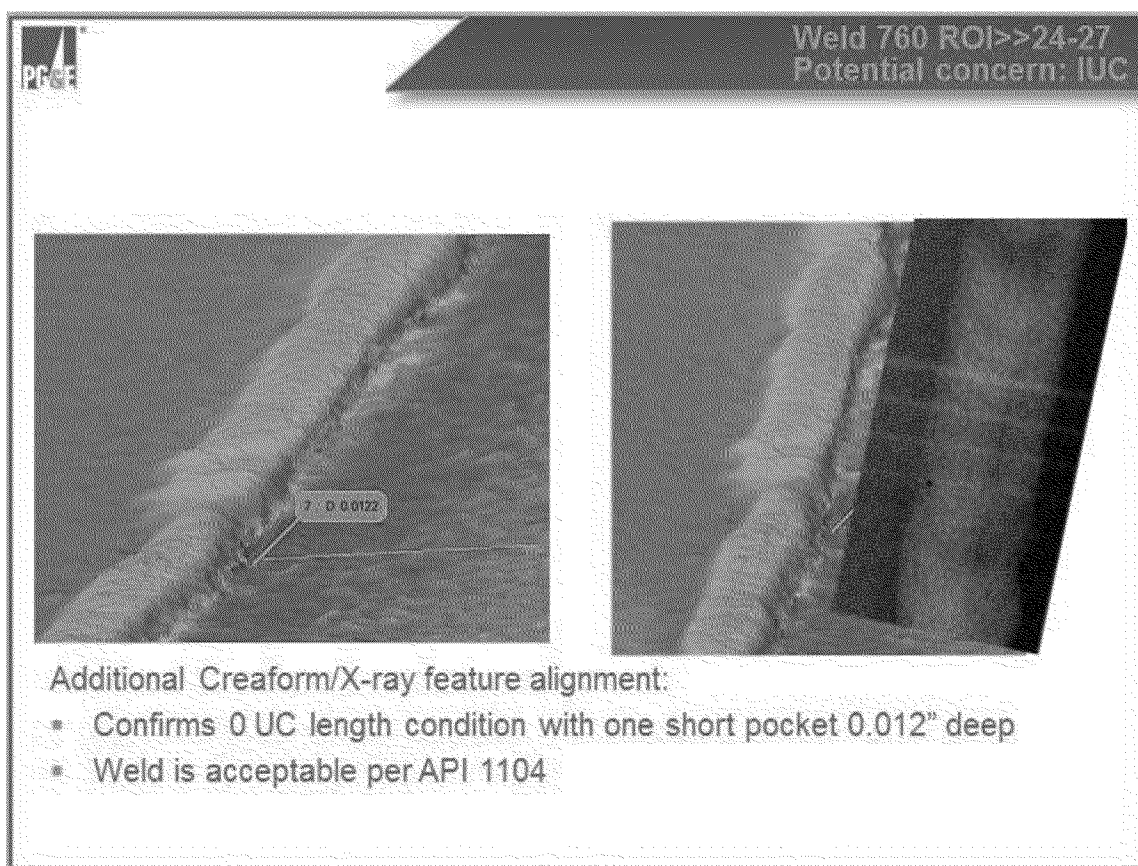
3.5 Creafom photogrammetry results were obtained for all the radiographic ROI's. The criteria applied to these results were API 1104 section 9.7, Table 4, "Maximum Dimensions of Undercutting". Applying the further criteria of depth from this requirement, to the documented radiographic and visual measurement data for length, all welds were found acceptable. Figure 2, from slide 5 in Appendix I, summarizes the typical physical condition for the audit identified indications of concern.

Figure 1 – Assessment of Weld 760 IUC region of interest

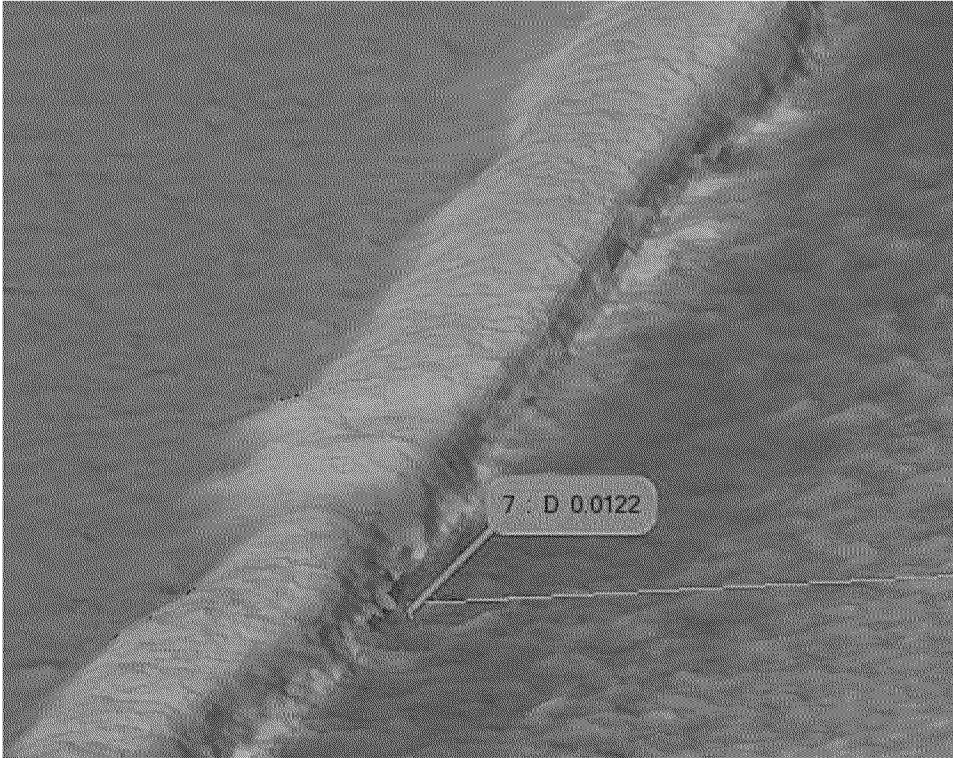
### Creaform 3D (+/- 0.002") surface profile:

Confirms indications are mostly diffraction effects on minor hi/lo condition with 0 UC

Two small pockets are 12 and 28 mils deep with greatest length of 0.250"

Weld is acceptable per API 1104

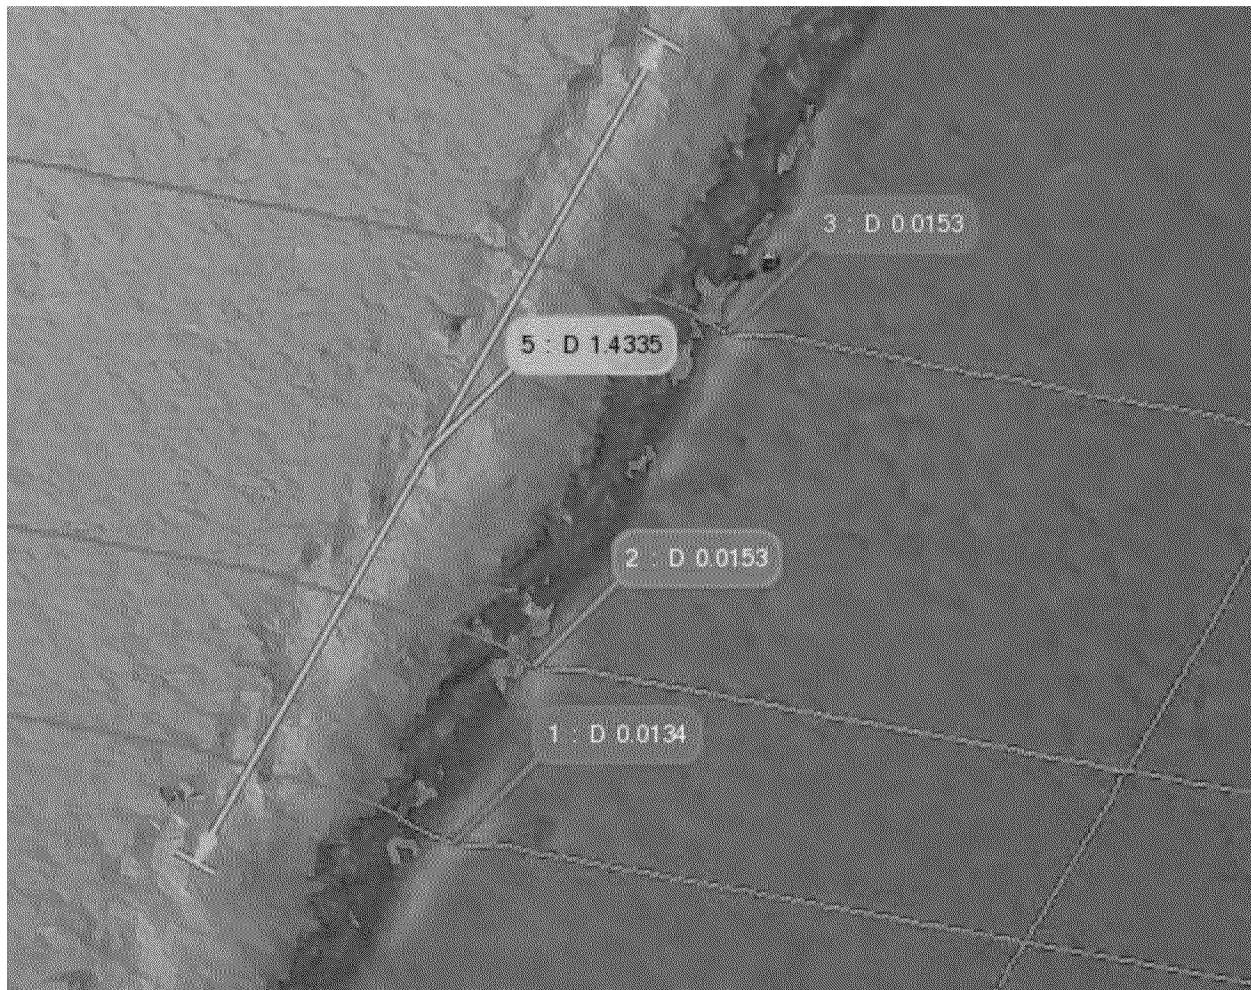
#### Additional Creafom/Polyworks perspective of ROI 44-49:

- \* Confirms UC indication is, in the majority, diffraction/"shadowing" from high/low condition with less than 2 inches of up to 0.015 inches deep IUC
- \* Weld is acceptable per API 1104

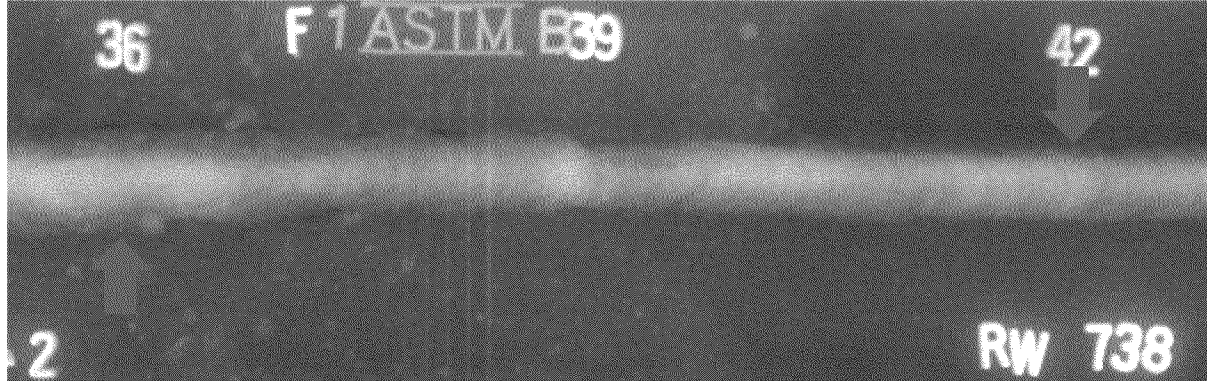
Excised weld photo-documented and ROI aligned with weld features

Depth of most severe indications estimated by change in x-ray density

RT estimated depths of up to 0.030 inches

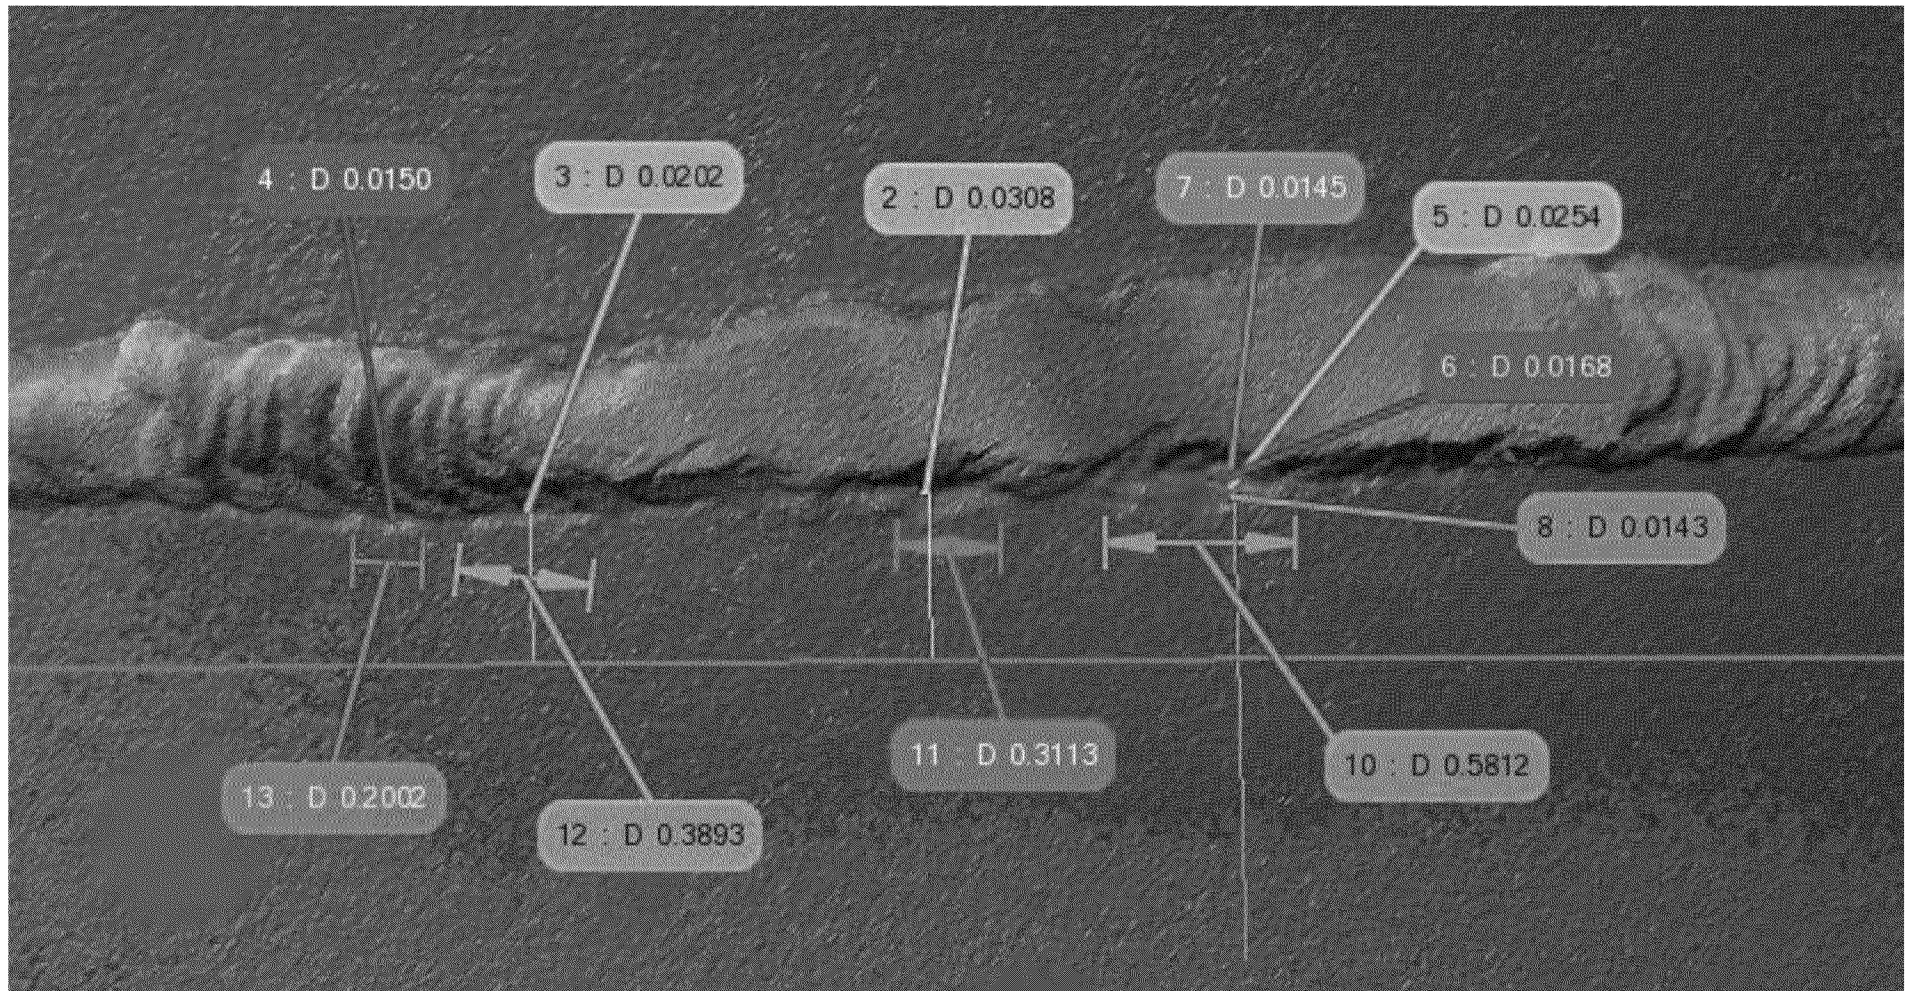
Additional Creaform/Polyworks perspective of ROI 36-42:

- \* EUC noted in several short segments totaling less than 1.5"
- \* Weld is acceptable per API 1104
