Noncompliant Weld Inspection Techniques

Line 114 Non Destructive Examination Final Report

Issue Date December 5, 2013

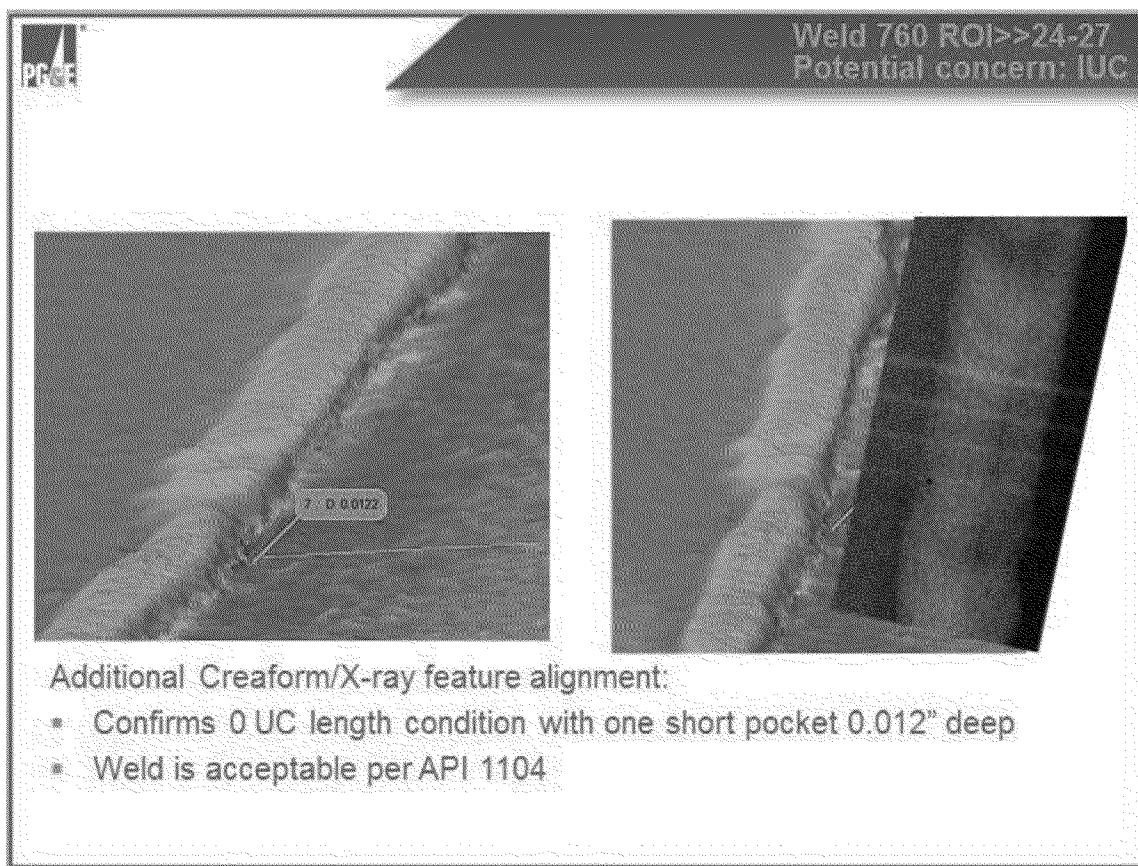
Figure 1 – Assessment of Weld 760 IUC region of interest

3.5 Creafom photogrammetry results were obtained for all the radiographic ROI's. The criteria applied to these results were API 1104 section 9.7, Table 4, "Maximum Dimensions of Undercutting". Applying the further criteria of depth from this requirement, to the documented radiographic and visual measurement data for length, all welds were found acceptable. Figure 2, from slide 5 in Appendix I, summarizes the typical physical condition for the audit identified indications of concern.

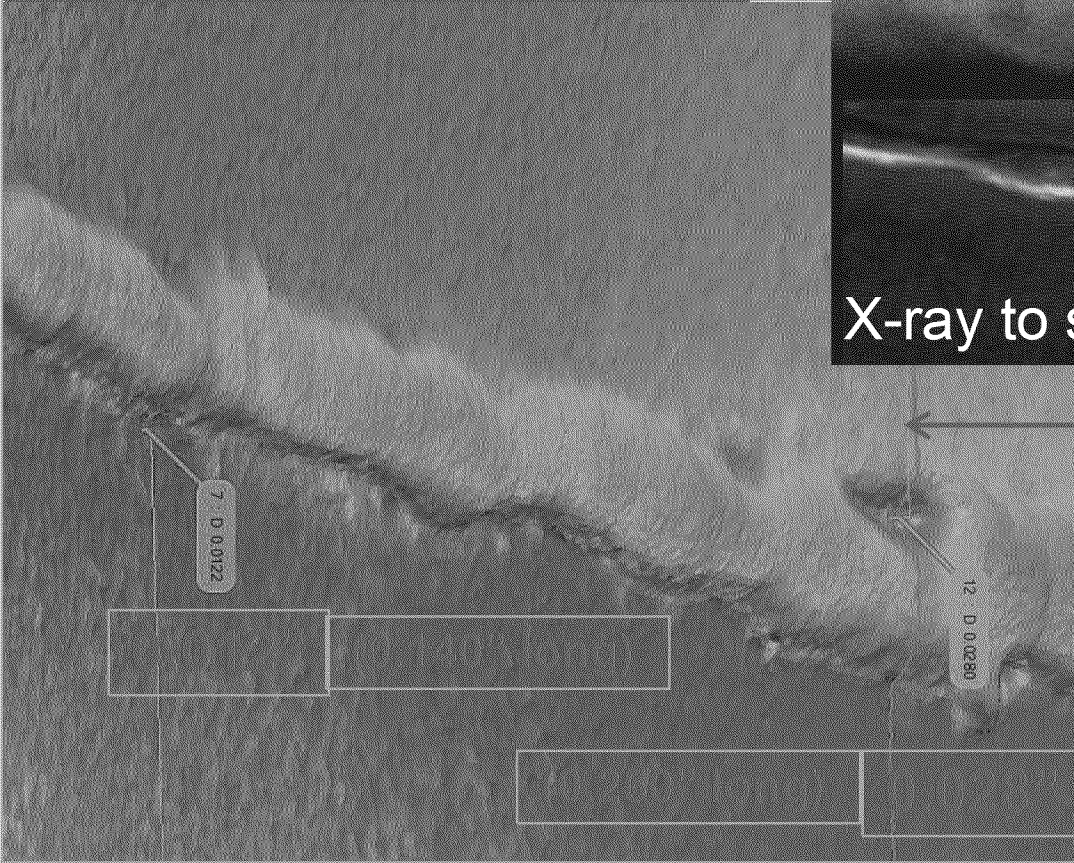
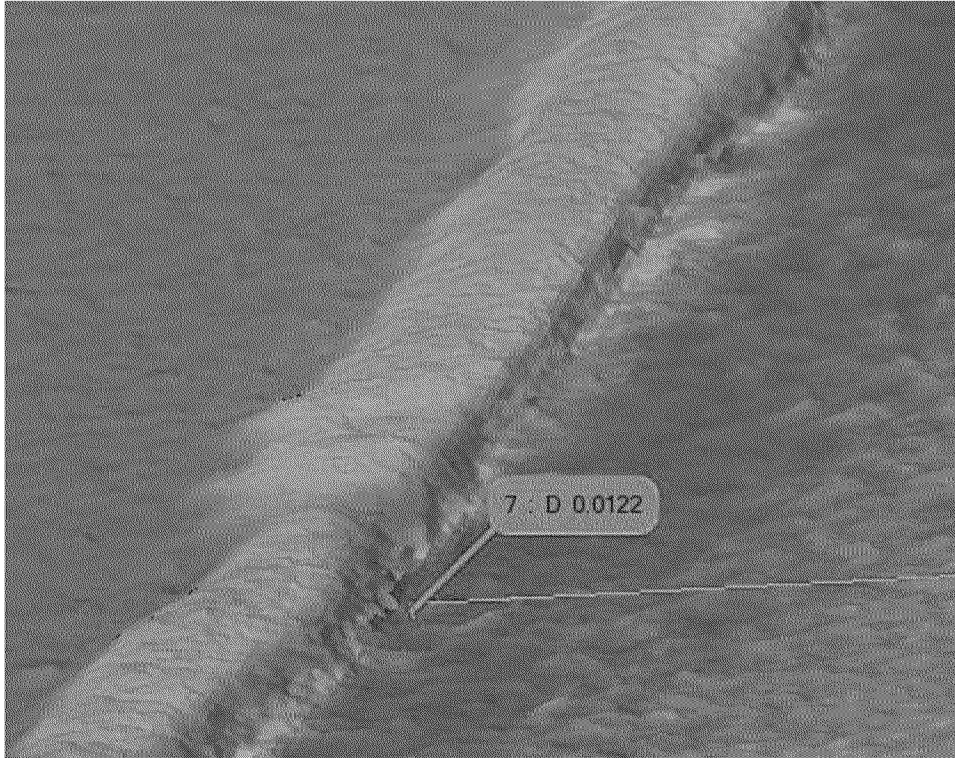
Creaform 3D (+/- 0.002") surface profile:

Confirms indications are mostly diffraction effects on minor hi/lo condition with 0 UC

Two small pockets are 12 and 28 mils deep with greatest length of 0.250"

Weld is acceptable per API 1104

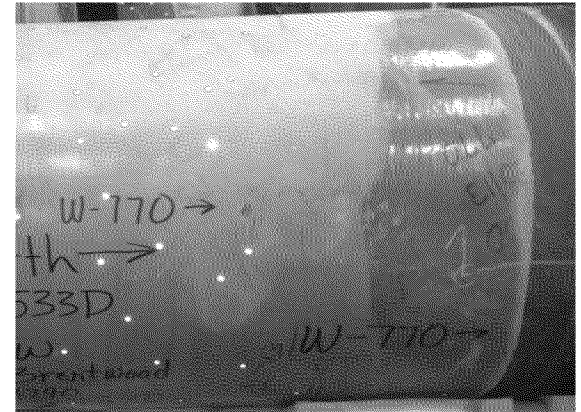
Weld 770 cited for indications of internal undercut from 36-42
Excised weld photo-documented and ROI aligned with weld features
Depth of most severe indications estimated by change in x-ray density

RT estimated depths of up to 0.008 inches

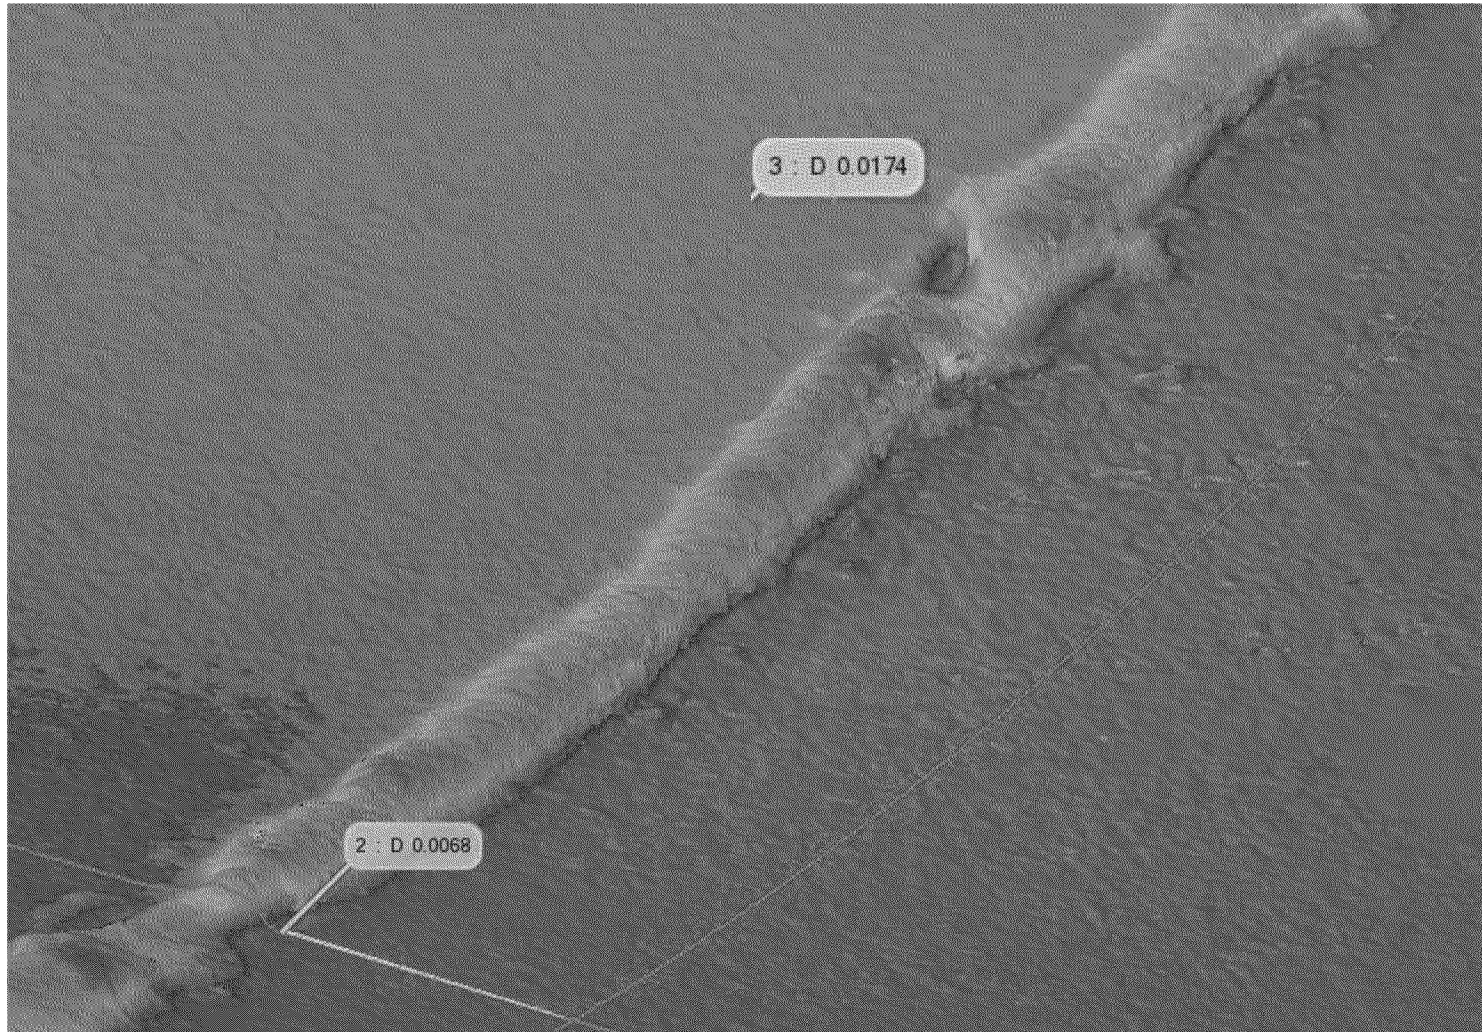
Additional Creaform/Polyworks perspective of ROI 36-42:

- * Confirms UC indication is diffraction/"shadowing" from high/low condition
- * Weld is acceptable per API 1104

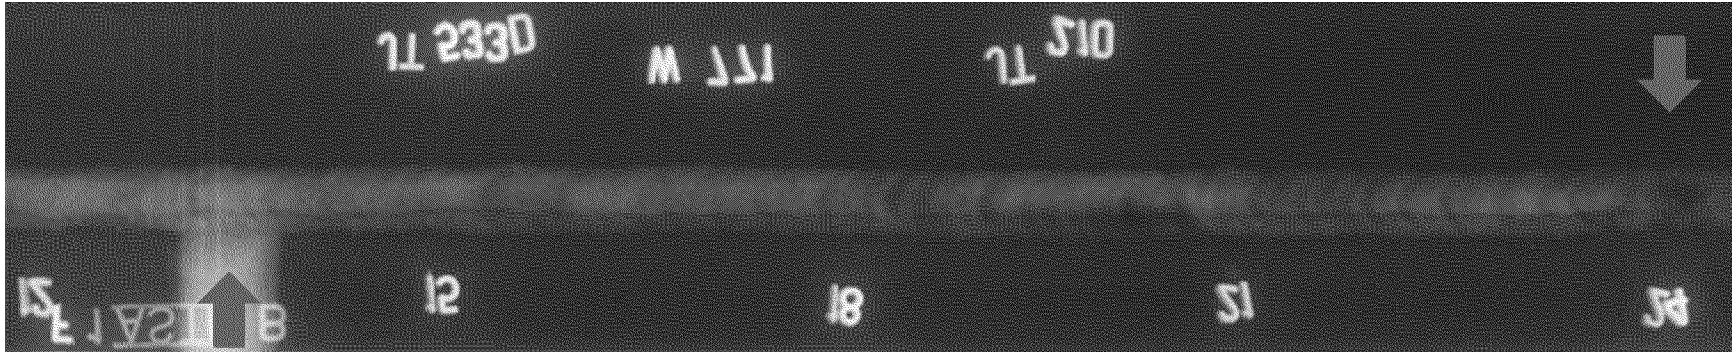
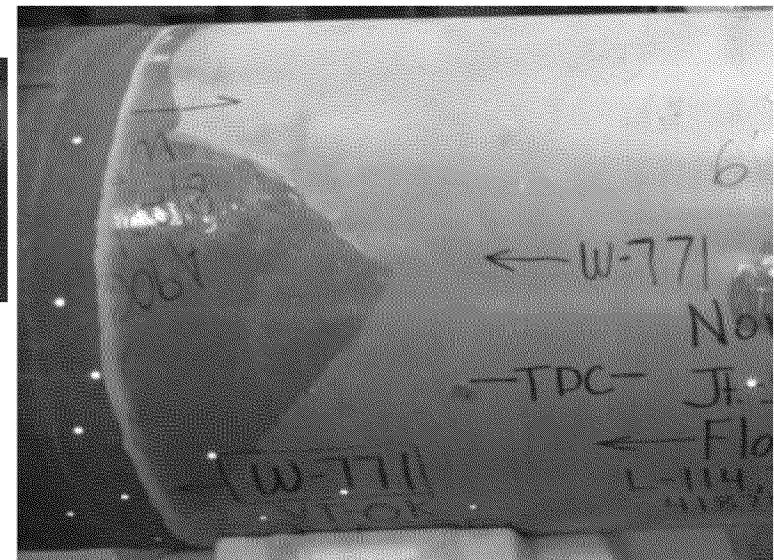
Excised weld photo-documented and ROI aligned with weld features

Depth of most severe indications estimated by change in x-ray density

RT estimated depths of up to 0.008 inches

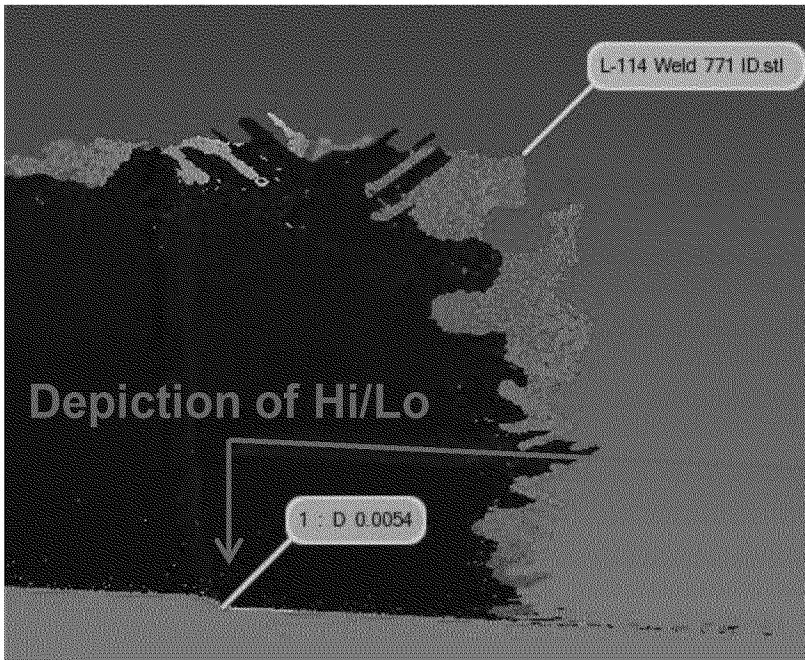
Additional Creaform/Polyworks perspective of ROI 12-24:

- * Confirms UC indication is diffraction/"shadowing" from high/low condition
- * Weld is acceptable per API 1104

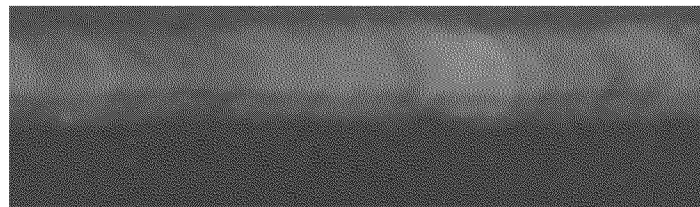
Excised weld photo-documented and ROI aligned with weld features

Depth of most severe indications estimated by change in x-ray density

RT estimated depths of up to 0.015 inches

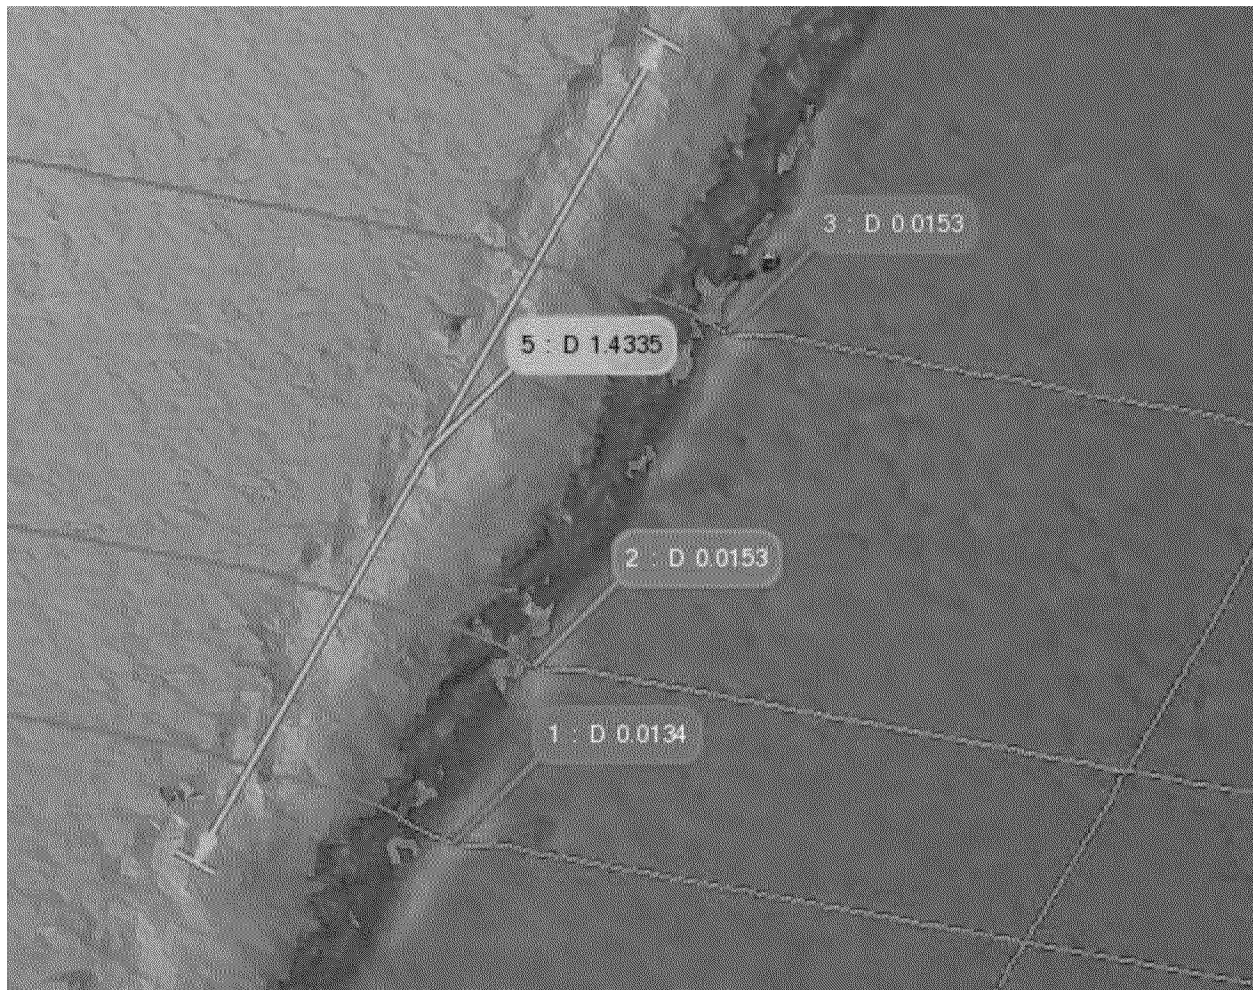
Additional Creafom/Polyworks perspective of ROI 44-49:

- * Confirms UC indication is, in the majority, diffraction/"shadowing" from high/low condition with less than 2 inches of up to 0.015 inches deep IUC
- * Weld is acceptable per API 1104

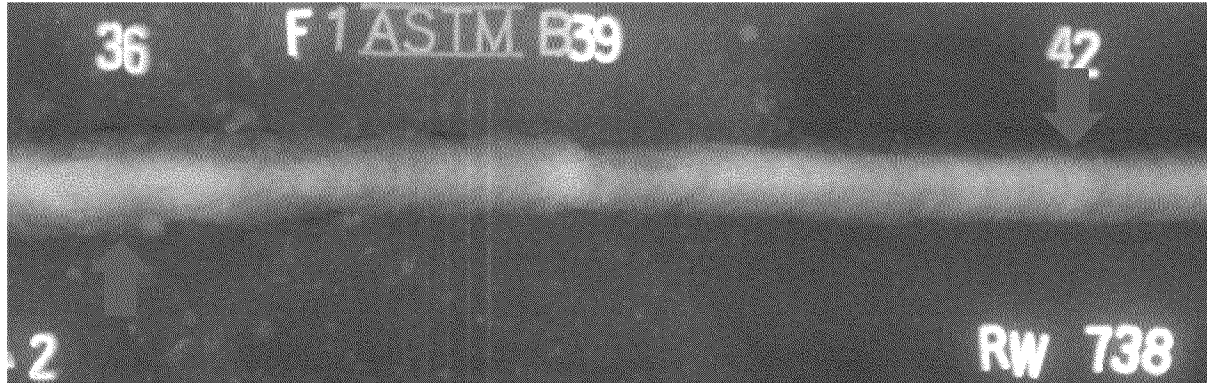
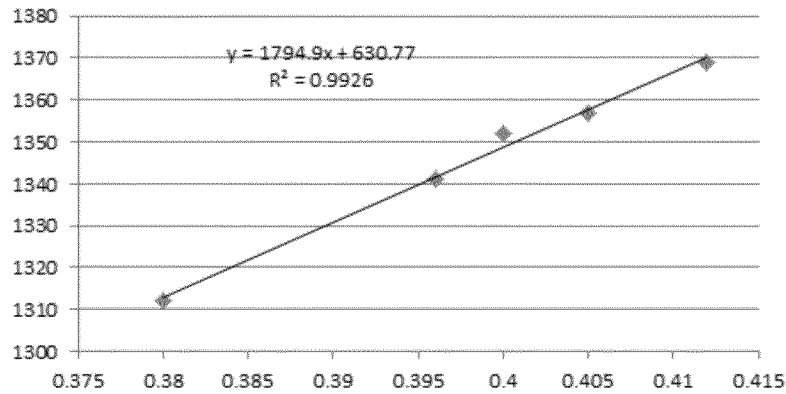
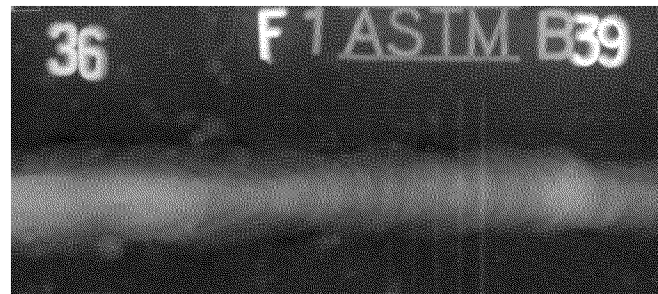
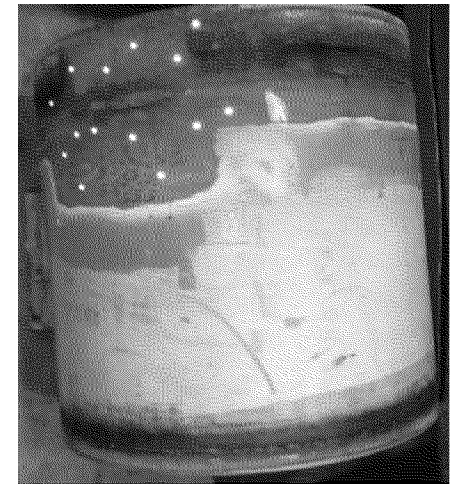
Excised weld photo-documented and ROI aligned with weld features

Depth of most severe indications estimated by change in x-ray density

RT estimated depths of up to 0.030 inches

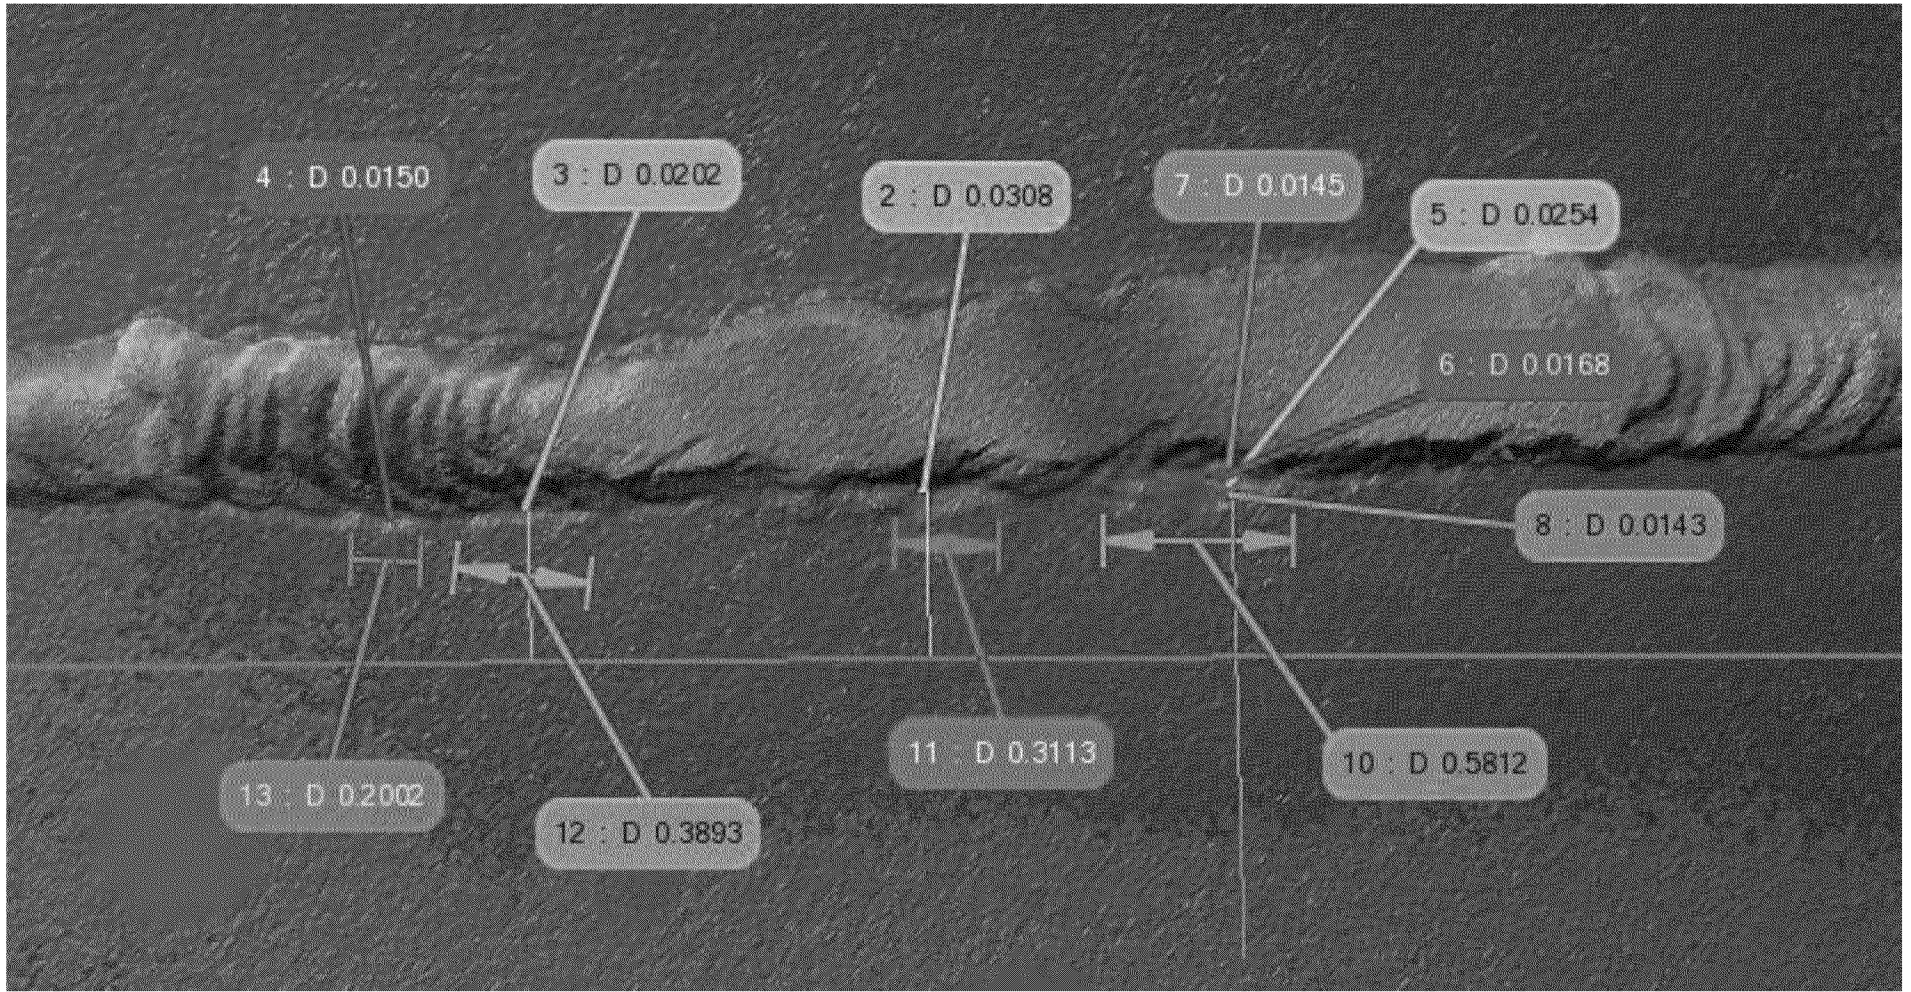
Additional Creaform/Polyworks perspective of ROI 36-42:

- * EUC noted in several short segments totaling less than 1.5"
- * Weld is acceptable per API 1104
