Figure 3.14-11a
Existing Conditions
for KOP-North-9
Godde Hill Road
(Alternative 2, Segment 5)

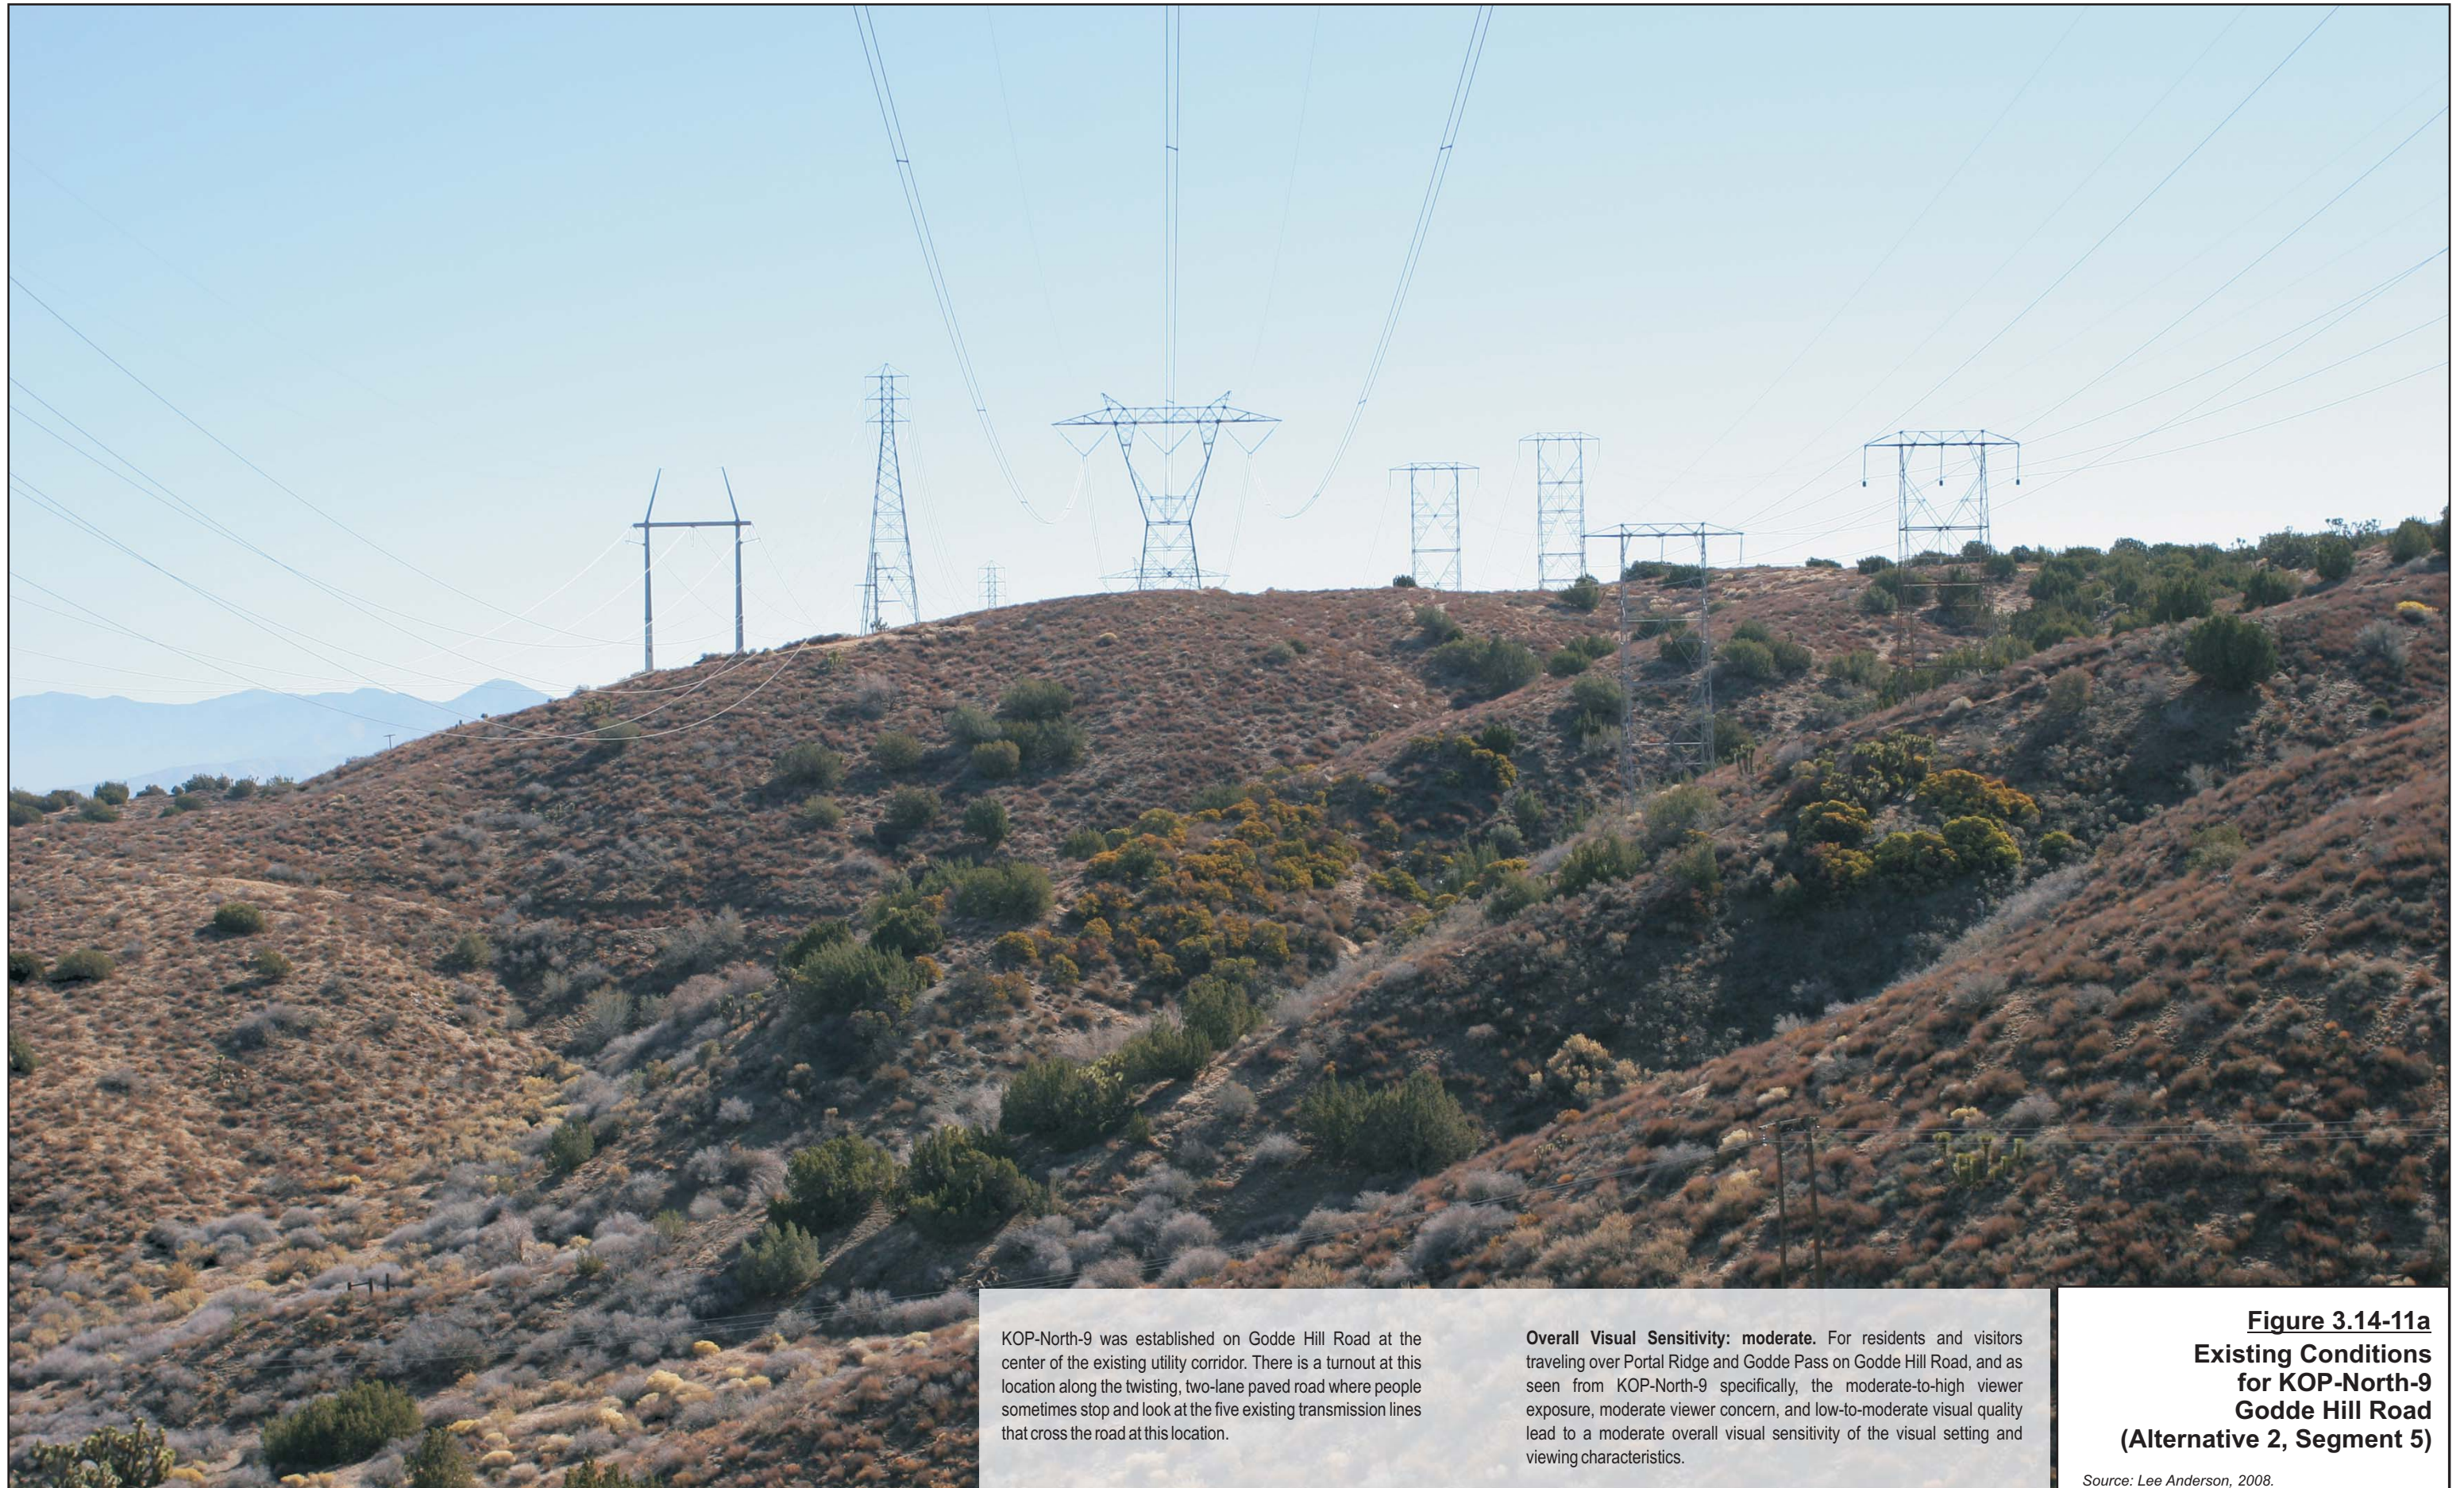
KOP-North-9 was established on Godde Hill Road at the center of the existing utility corridor. There is a turnout at this location along the twisting, two-lane paved road where people sometimes stop and look at the five existing transmission lines that cross the road at this location.

Overall Visual Sensitivity: moderate. For residents and visitors traveling over Portal Ridge and Godde Pass on Godde Hill Road, and as seen from KOP-North-9 specifically, the moderate-to-high viewer exposure, moderate viewer concern, and low-to-moderate visual quality lead to a moderate overall visual sensitivity of the visual setting and viewing characteristics.
