**Figure 3.14-16a**  
**Existing Conditions**  
**for KOP-Center-1**  
**Southbound Angeles Forest**  
**Highway (Alternative 2,**  
**Segment 6)**

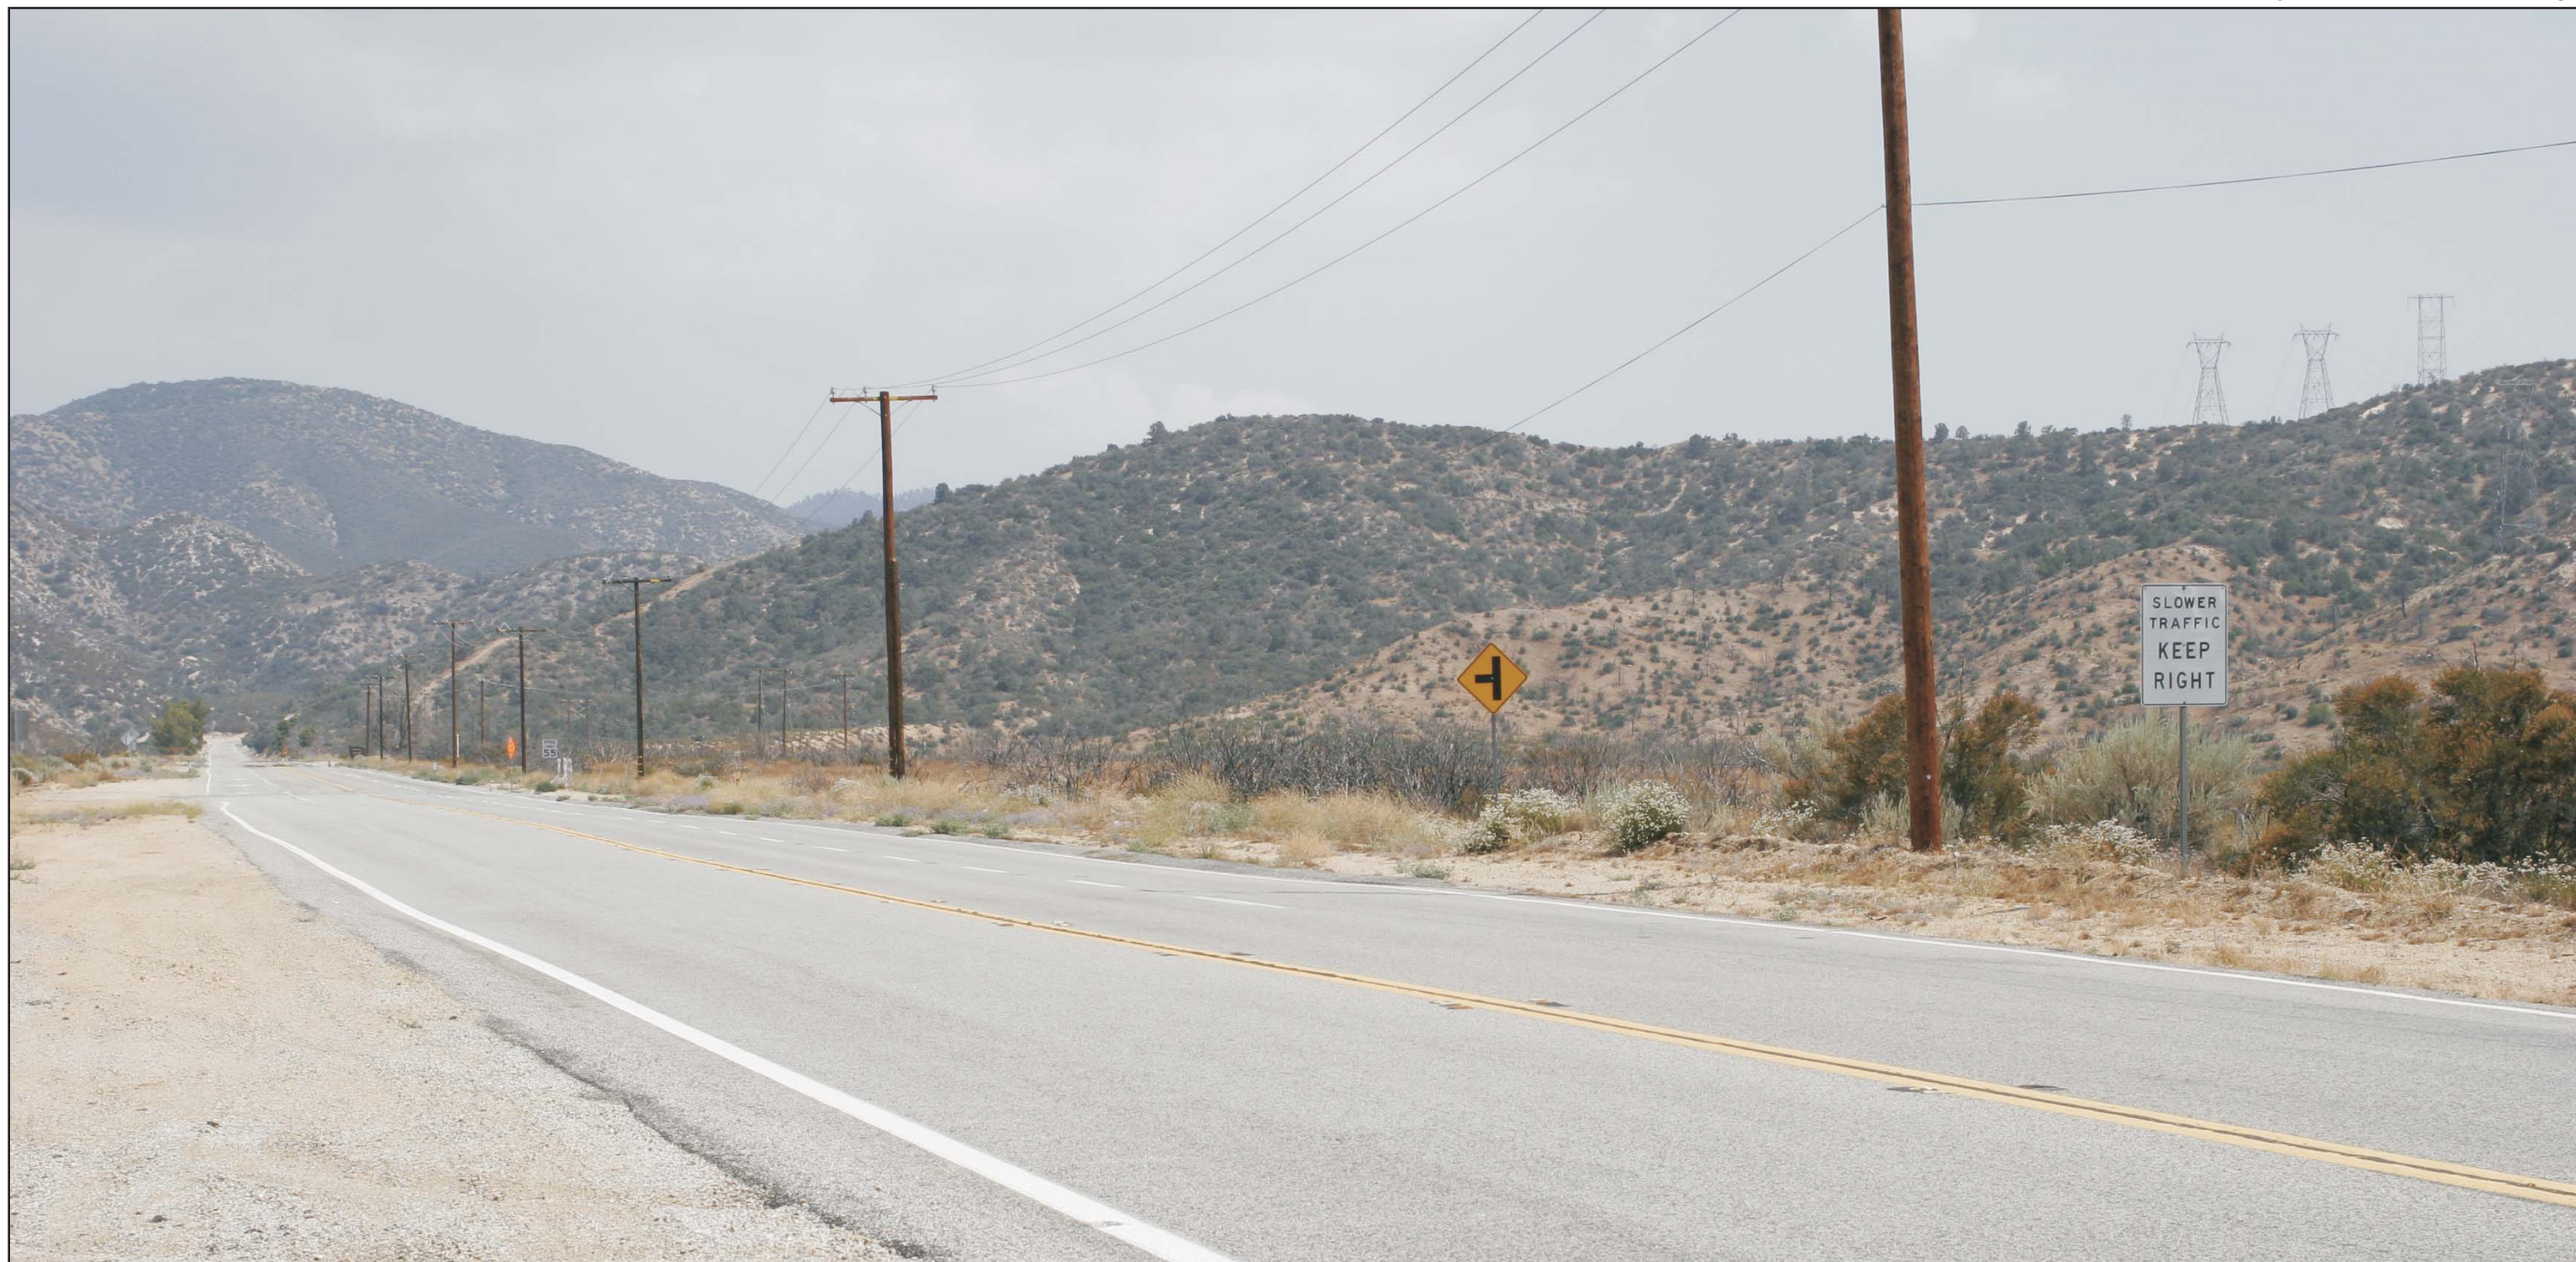
**Existing Scenic Integrity: High, with Areas of Low.** KOP-Center-1 is located on the Angeles Forest Highway near the intersection of Mount Emma Road. This view is looking south along the Angeles Forest Highway and it is common to the area south of the Vincent Substation leading into the ANF. Landforms are typically rolling hills covered with sparse, low-growing vegetation of sagebrush and chemise, giving the landscape a mottled appearance. Vegetation is so short that it does not provide screening, but landforms provide some visual screening. Transmission towers are visible on the skyline, disrupting the horizon. Wooden utility poles follow the highway and create additional visual contrasts. Other than these utility structures, the landscape has high scenic integrity.

Although the immediate foreground is dominated by the highway itself, NFS lands visible from the Angeles Forest Highway are predominantly natural-appearing, consisting of middleground and background views to brush-covered hillsides and rounded landforms. The landscape exhibits a high degree of intactness and coherence of form and character with a moderate amount of visual variety. However, this harmony of form and character is punctuated on the skyline by the dark gray vertical lines and geometric forms of three separate existing 220-kV transmission line towers. Several existing lattice steel towers are situated between the skyline and the viewer; however, they tend to blend with the landform backdrop and are barely visible in this photograph. Still, these back-dropped structures are visually evident from on-the-ground. Overall, the existing scenic integrity of this NFS landscape is high, with no deviations of form, line, color, texture, or scale; however, the existing sky-lined transmission towers, with their inherent industrial character, attract attention and begin to dominate the valued landscape character being viewed, and they reduce these certain areas of the existing landscape to levels of low scenic integrity.

**Scenic Integrity Objective: High.** In the 2005 Forest Plan, the entire landscape in this vicinity is mapped as High SIO, where the management direction states that human activities should not be visually evident. Human-caused deviations may be present but must repeat the form, line, color, texture, and pattern common to the natural landscape character so completely and at such a scale that they are not evident.
