**Figure 3.14-20a**  
**Existing Conditions**  
**for KOP-Center-5**  
**Northbound Angeles**  
**Forest Highway**  
**(Alternative 2, Segment 6)**

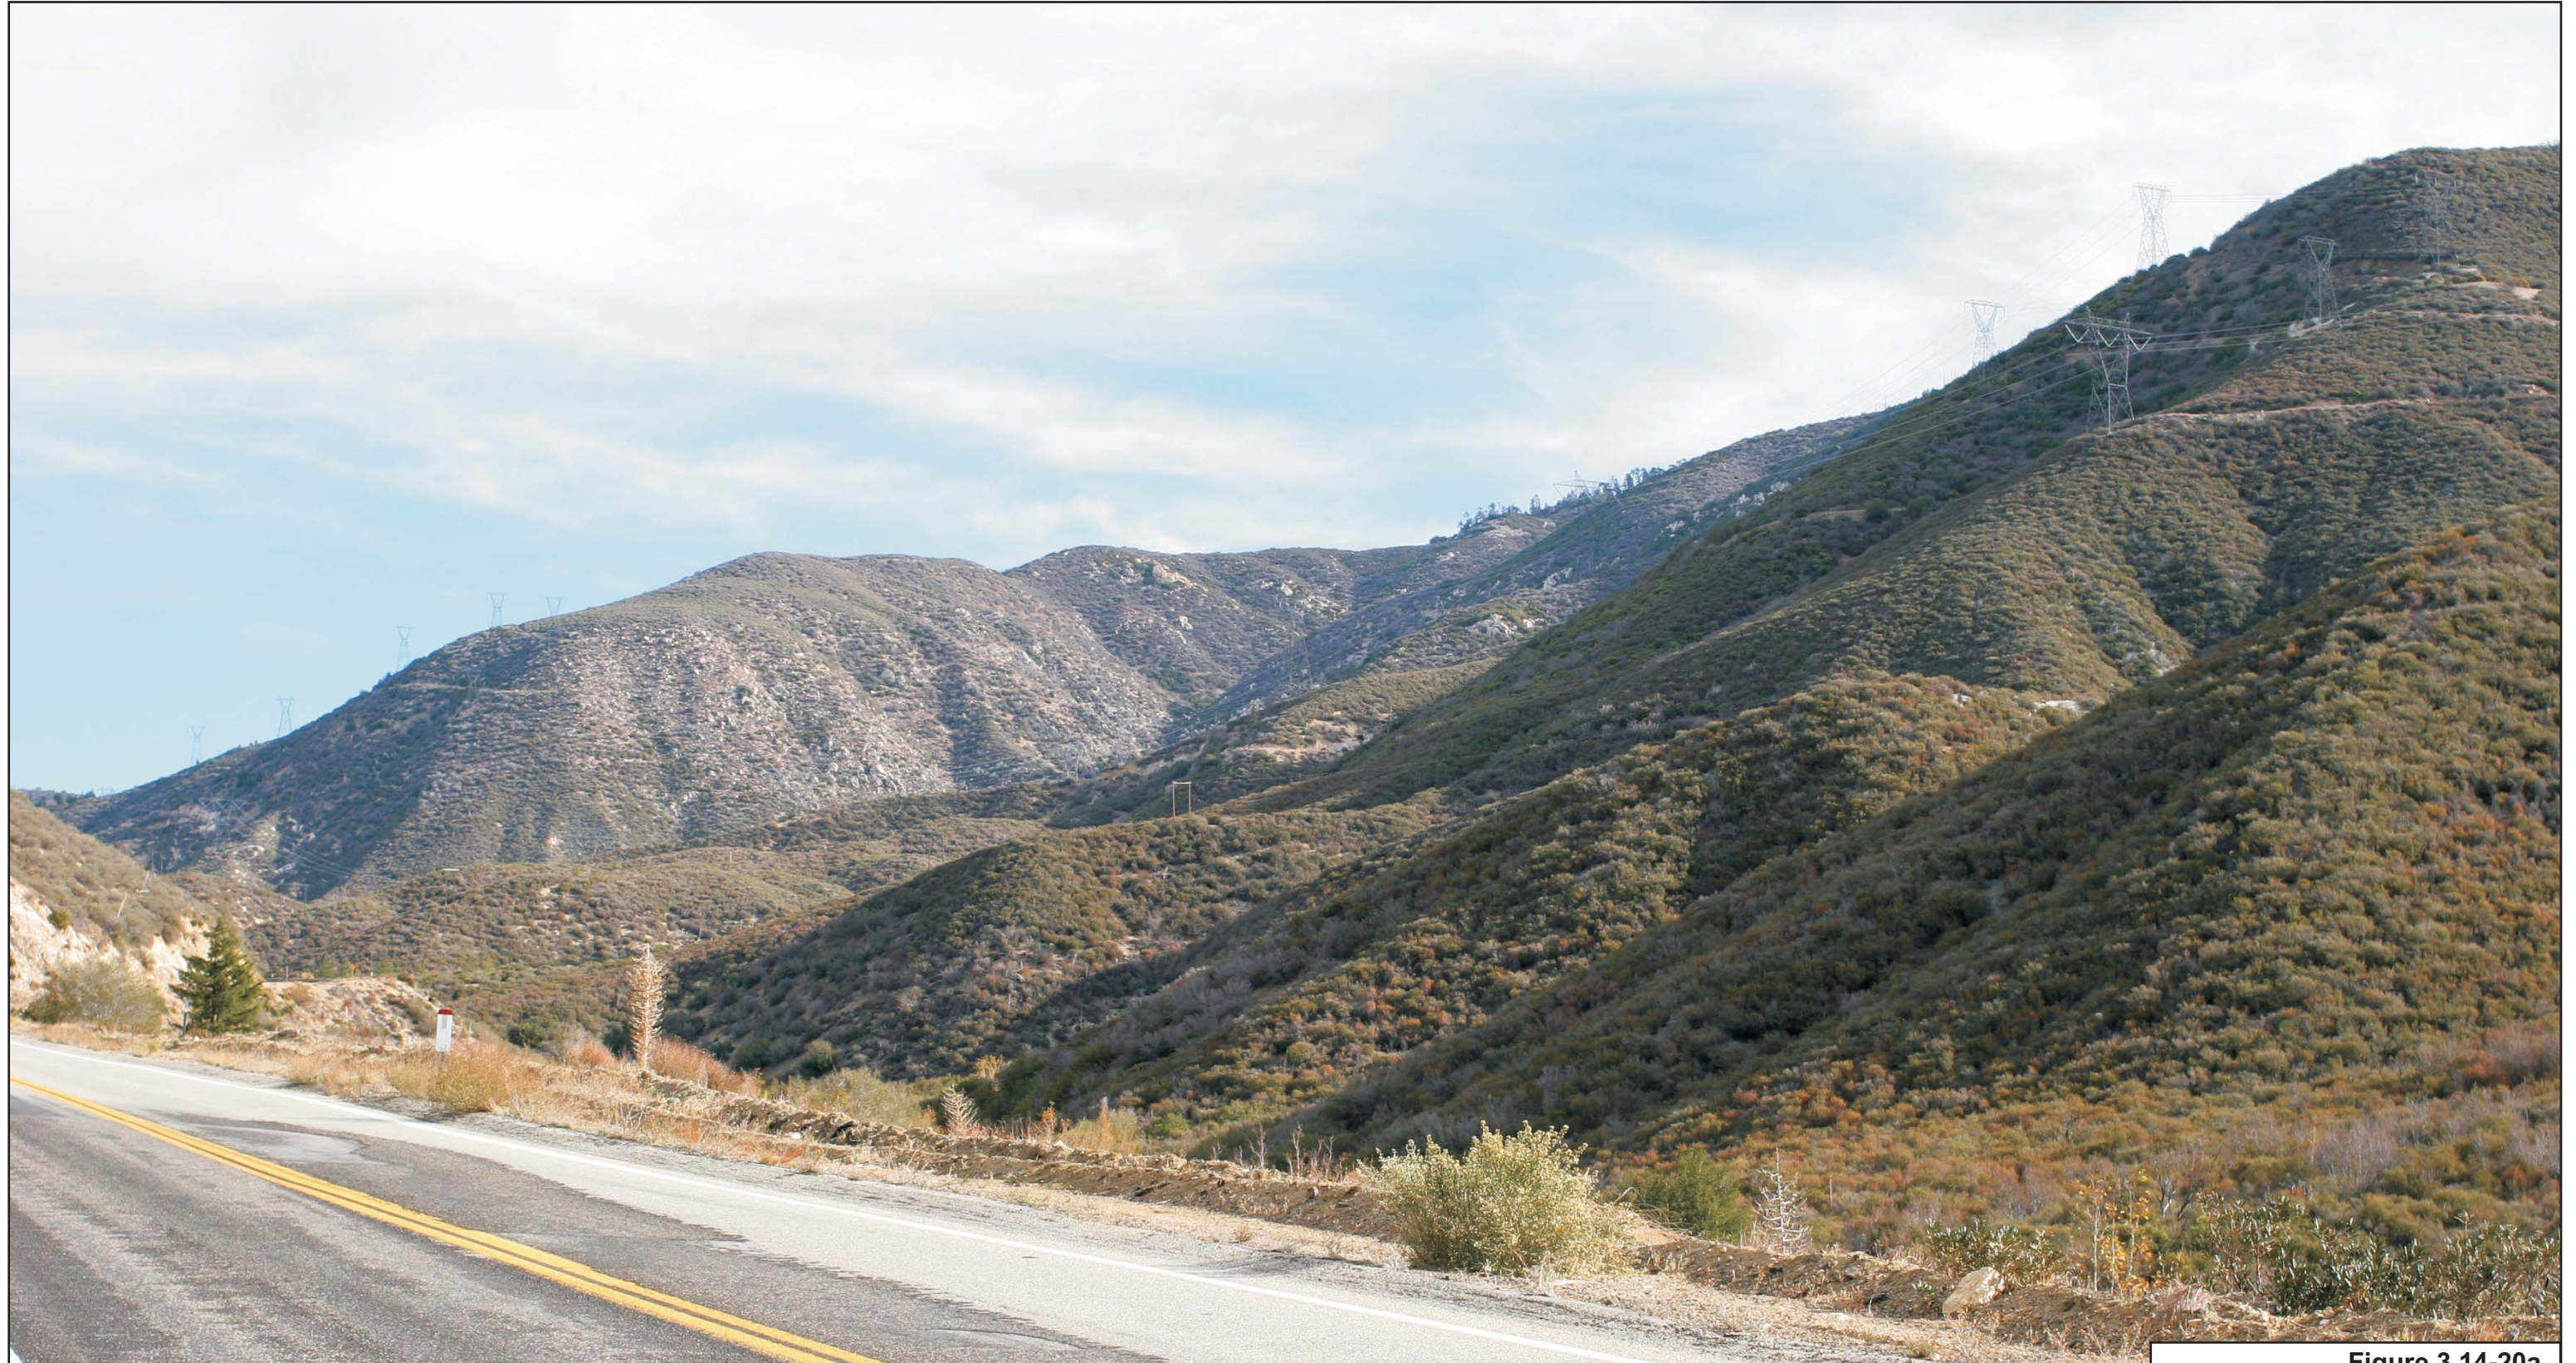
**Existing Scenic Integrity: High, with Areas of Low.** This existing landscape view is taken from northbound Angeles Forest Highway, about three miles south of KOP-North-4, looking north toward Mill Creek Summit and northeast toward proposed Segment 6. The landscape visible from the Angeles Forest Highway in general, and KOP-Center-5 specifically, is predominantly natural-appearing, consisting of foreground, middleground, and background landscapes with dense, dark green chemise and chaparral covered mountainsides. There is very little vegetative pattern in this landscape view. The sun angle and shadows emphasize the ruggedness of the steep slopes and broken terrain. The natural landscape has a coherent form and character with substantial visual variety created by the rugged, folded terrain. The natural landscape exhibits a high degree of intactness and scenic integrity, but the highly discordant transmission line structures and the access and spur roads leading to those towers are visually evident and moderately alter the valued landscape character, leading to a rating of low scenic integrity for the utility corridor.

**Scenic Integrity Objective: High.** In the 2005 Forest Plan, the entire landscape in this vicinity is mapped as High SIO, where the management direction states that human activities should not be visually evident. Human-caused deviations may be present but must repeat the form, line, color, texture, and pattern common to the natural landscape character so completely and at such a scale that they are not evident.
