**Figure 3.14-23a**  
**Existing Conditions**  
**for KOP-Center-8**  
**Vetter Mountain Lookout**  
**(Alternative 2, Segment 6)**

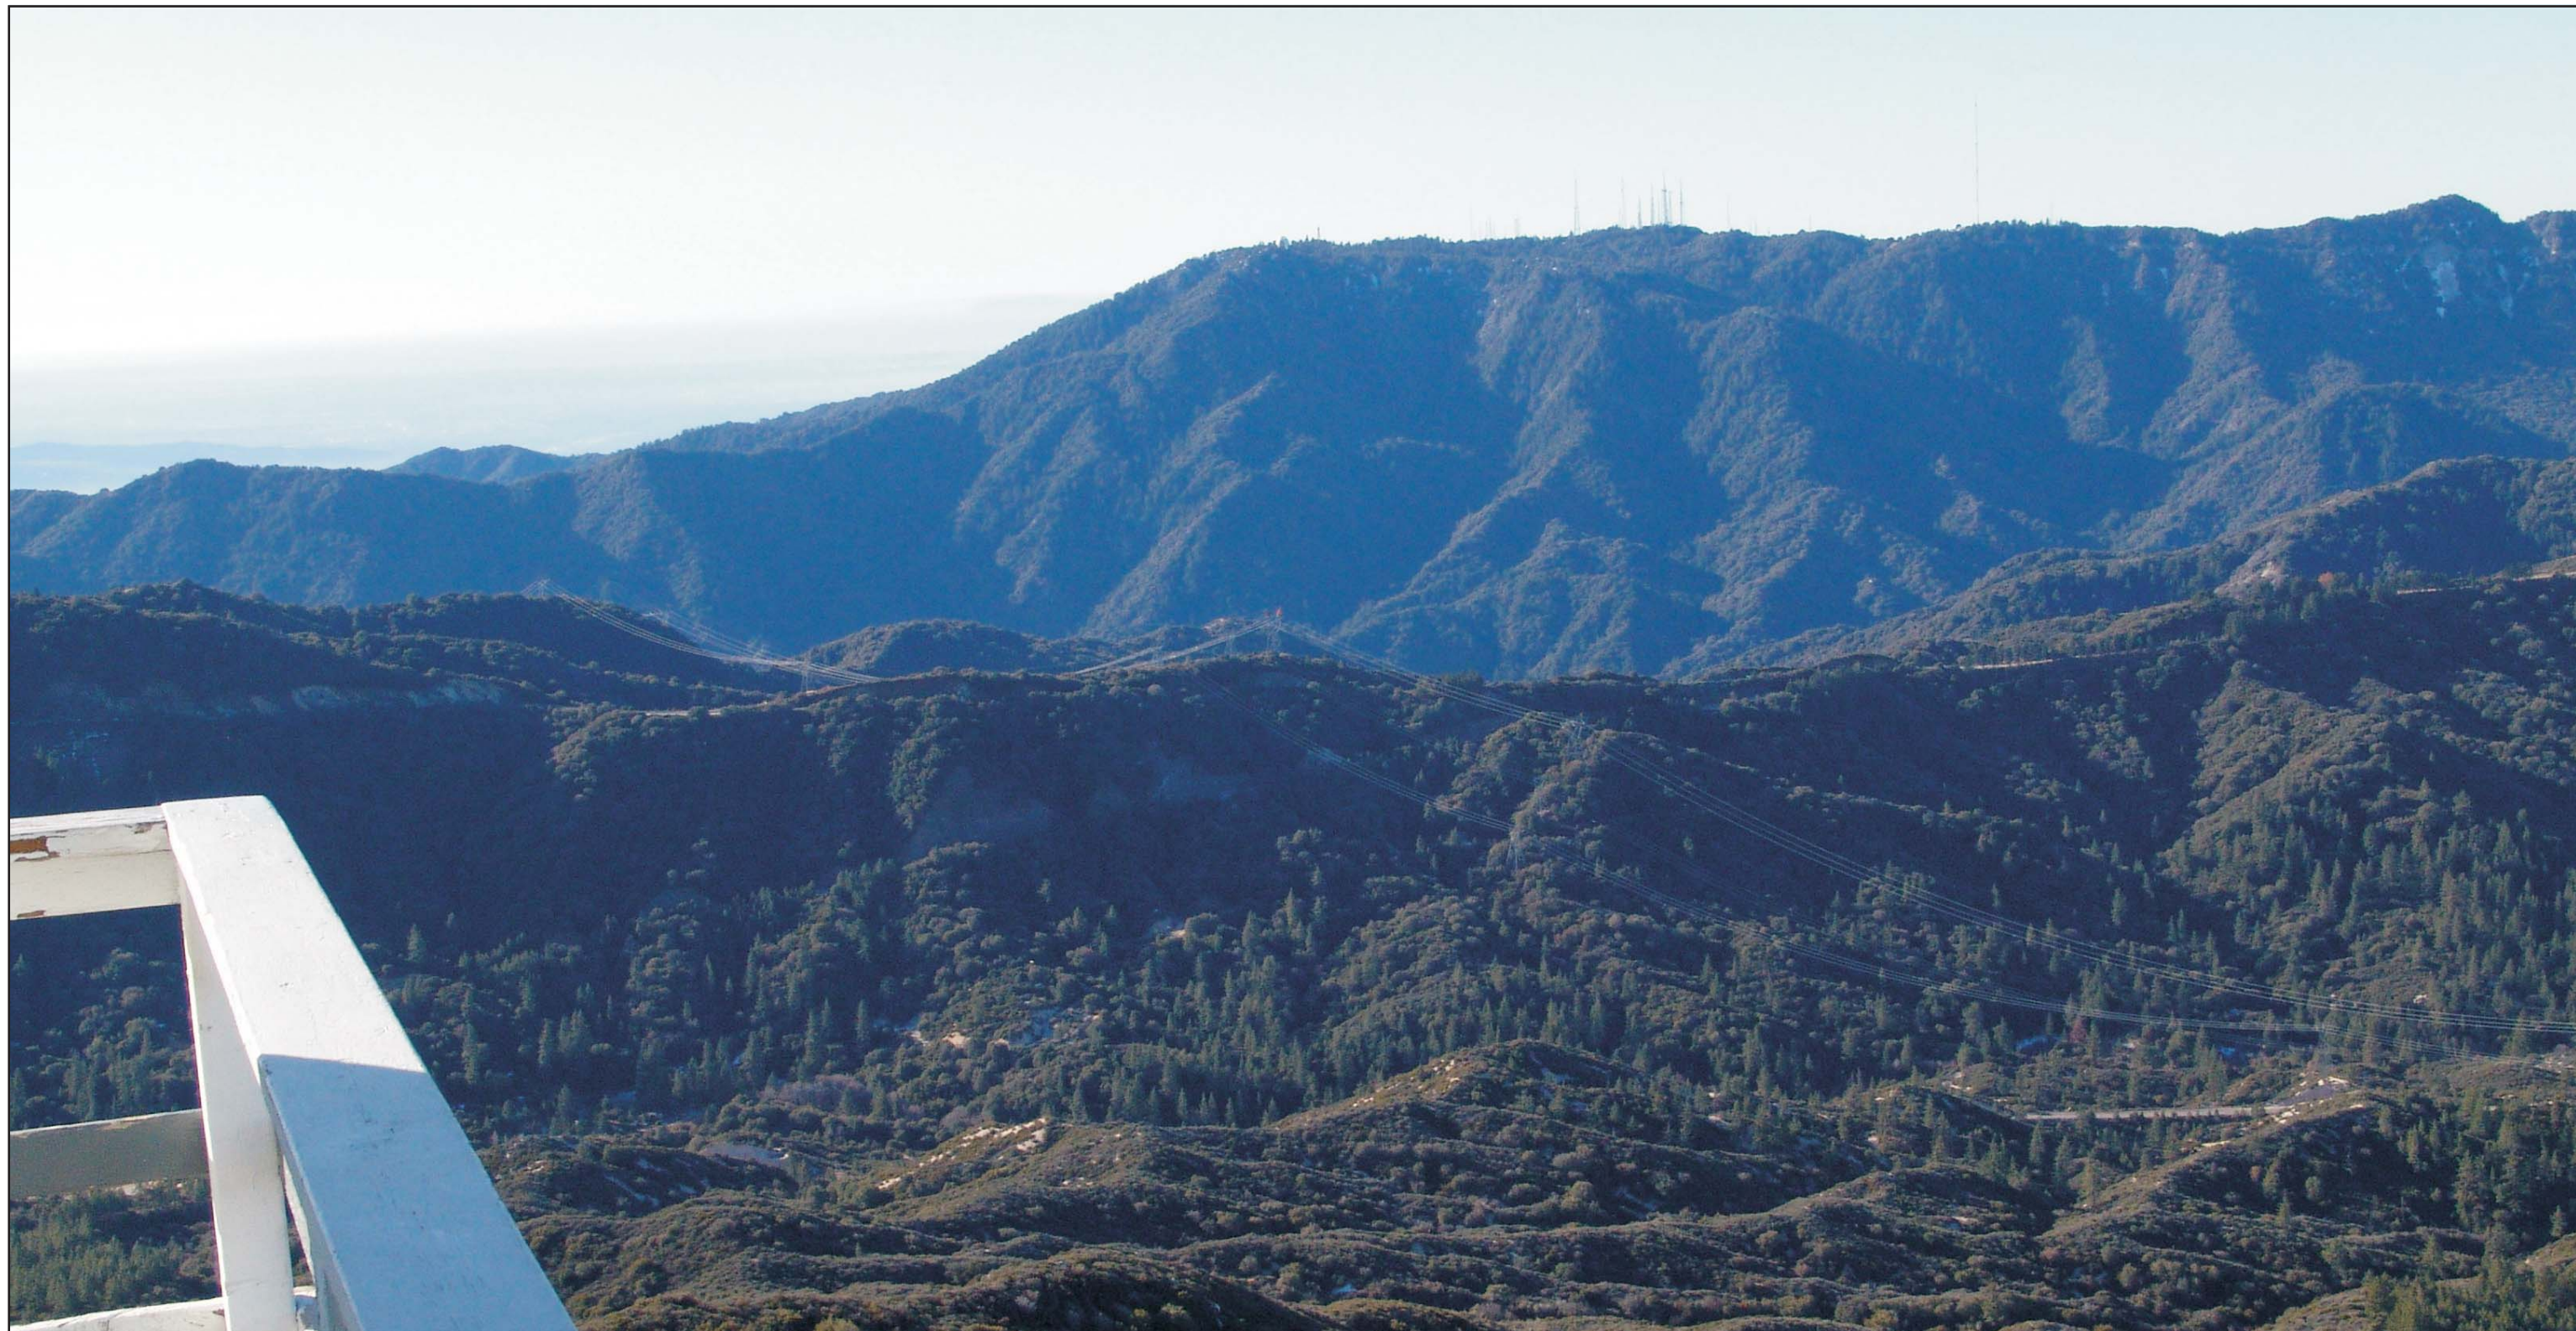
**Existing Scenic Integrity: High, with Areas of Moderate.** This existing landscape view is taken from Vetter Mountain Lookout at an elevation of approximately 5,890 feet, looking southwest toward Mt. Wilson electronic site on the skyline. The landscape visible from Vetter Mountain Lookout (and Charlton Flats) in general, and KOP-Center-8 specifically, is predominantly natural-appearing, consisting of foreground, middleground, and background landscapes with dense, dark green chaparral and evergreen tree-covered mountainsides. There are interesting vegetative patterns in this landscape view that are created by the folded terrain and microclimates. The sun angle and shadows emphasize the ruggedness of the steep slopes and broken terrain. The natural landscape has a coherent form and character with substantial visual variety created by the rugged, folded terrain. On the skyline, electronic facilities at Mount Wilson are visible and attract attention. On the midslope, the existing utility corridor contains 220-kV and 500-kV transmission lines. Also on the midslope, existing highway cutslopes are partially shielded from view by dark shadows. The natural landscape exhibits a high degree of intactness and scenic integrity, except for the visually discordant electronic sites, transmission line structures, and highway cutslopes. Access and spur roads to the existing towers are evident beyond the Angeles Crest Highway, and further detract from scenic integrity, leading to a rating of moderate scenic integrity for the utility corridor. This landscape currently does not meet the ANF High SIO because of the presence of these human-made features.

**Scenic Integrity Objective: High.** In the 2005 Forest Plan, the entire landscape in this vicinity is mapped as High SIO, where the management direction states that human activities should not be visually evident. Human-caused deviations may be present but must repeat the form, line, color, texture, and pattern common to the natural landscape character so completely and at such a scale that they are not evident.
