Figure 3.14-48a
Existing Conditions
for KOP-South-13
**Intersection of Avenida Anita/
Avenida Compadres,**
Chino Hills (Alternative 2,
Segment 8)
Source: SCE, 2007.

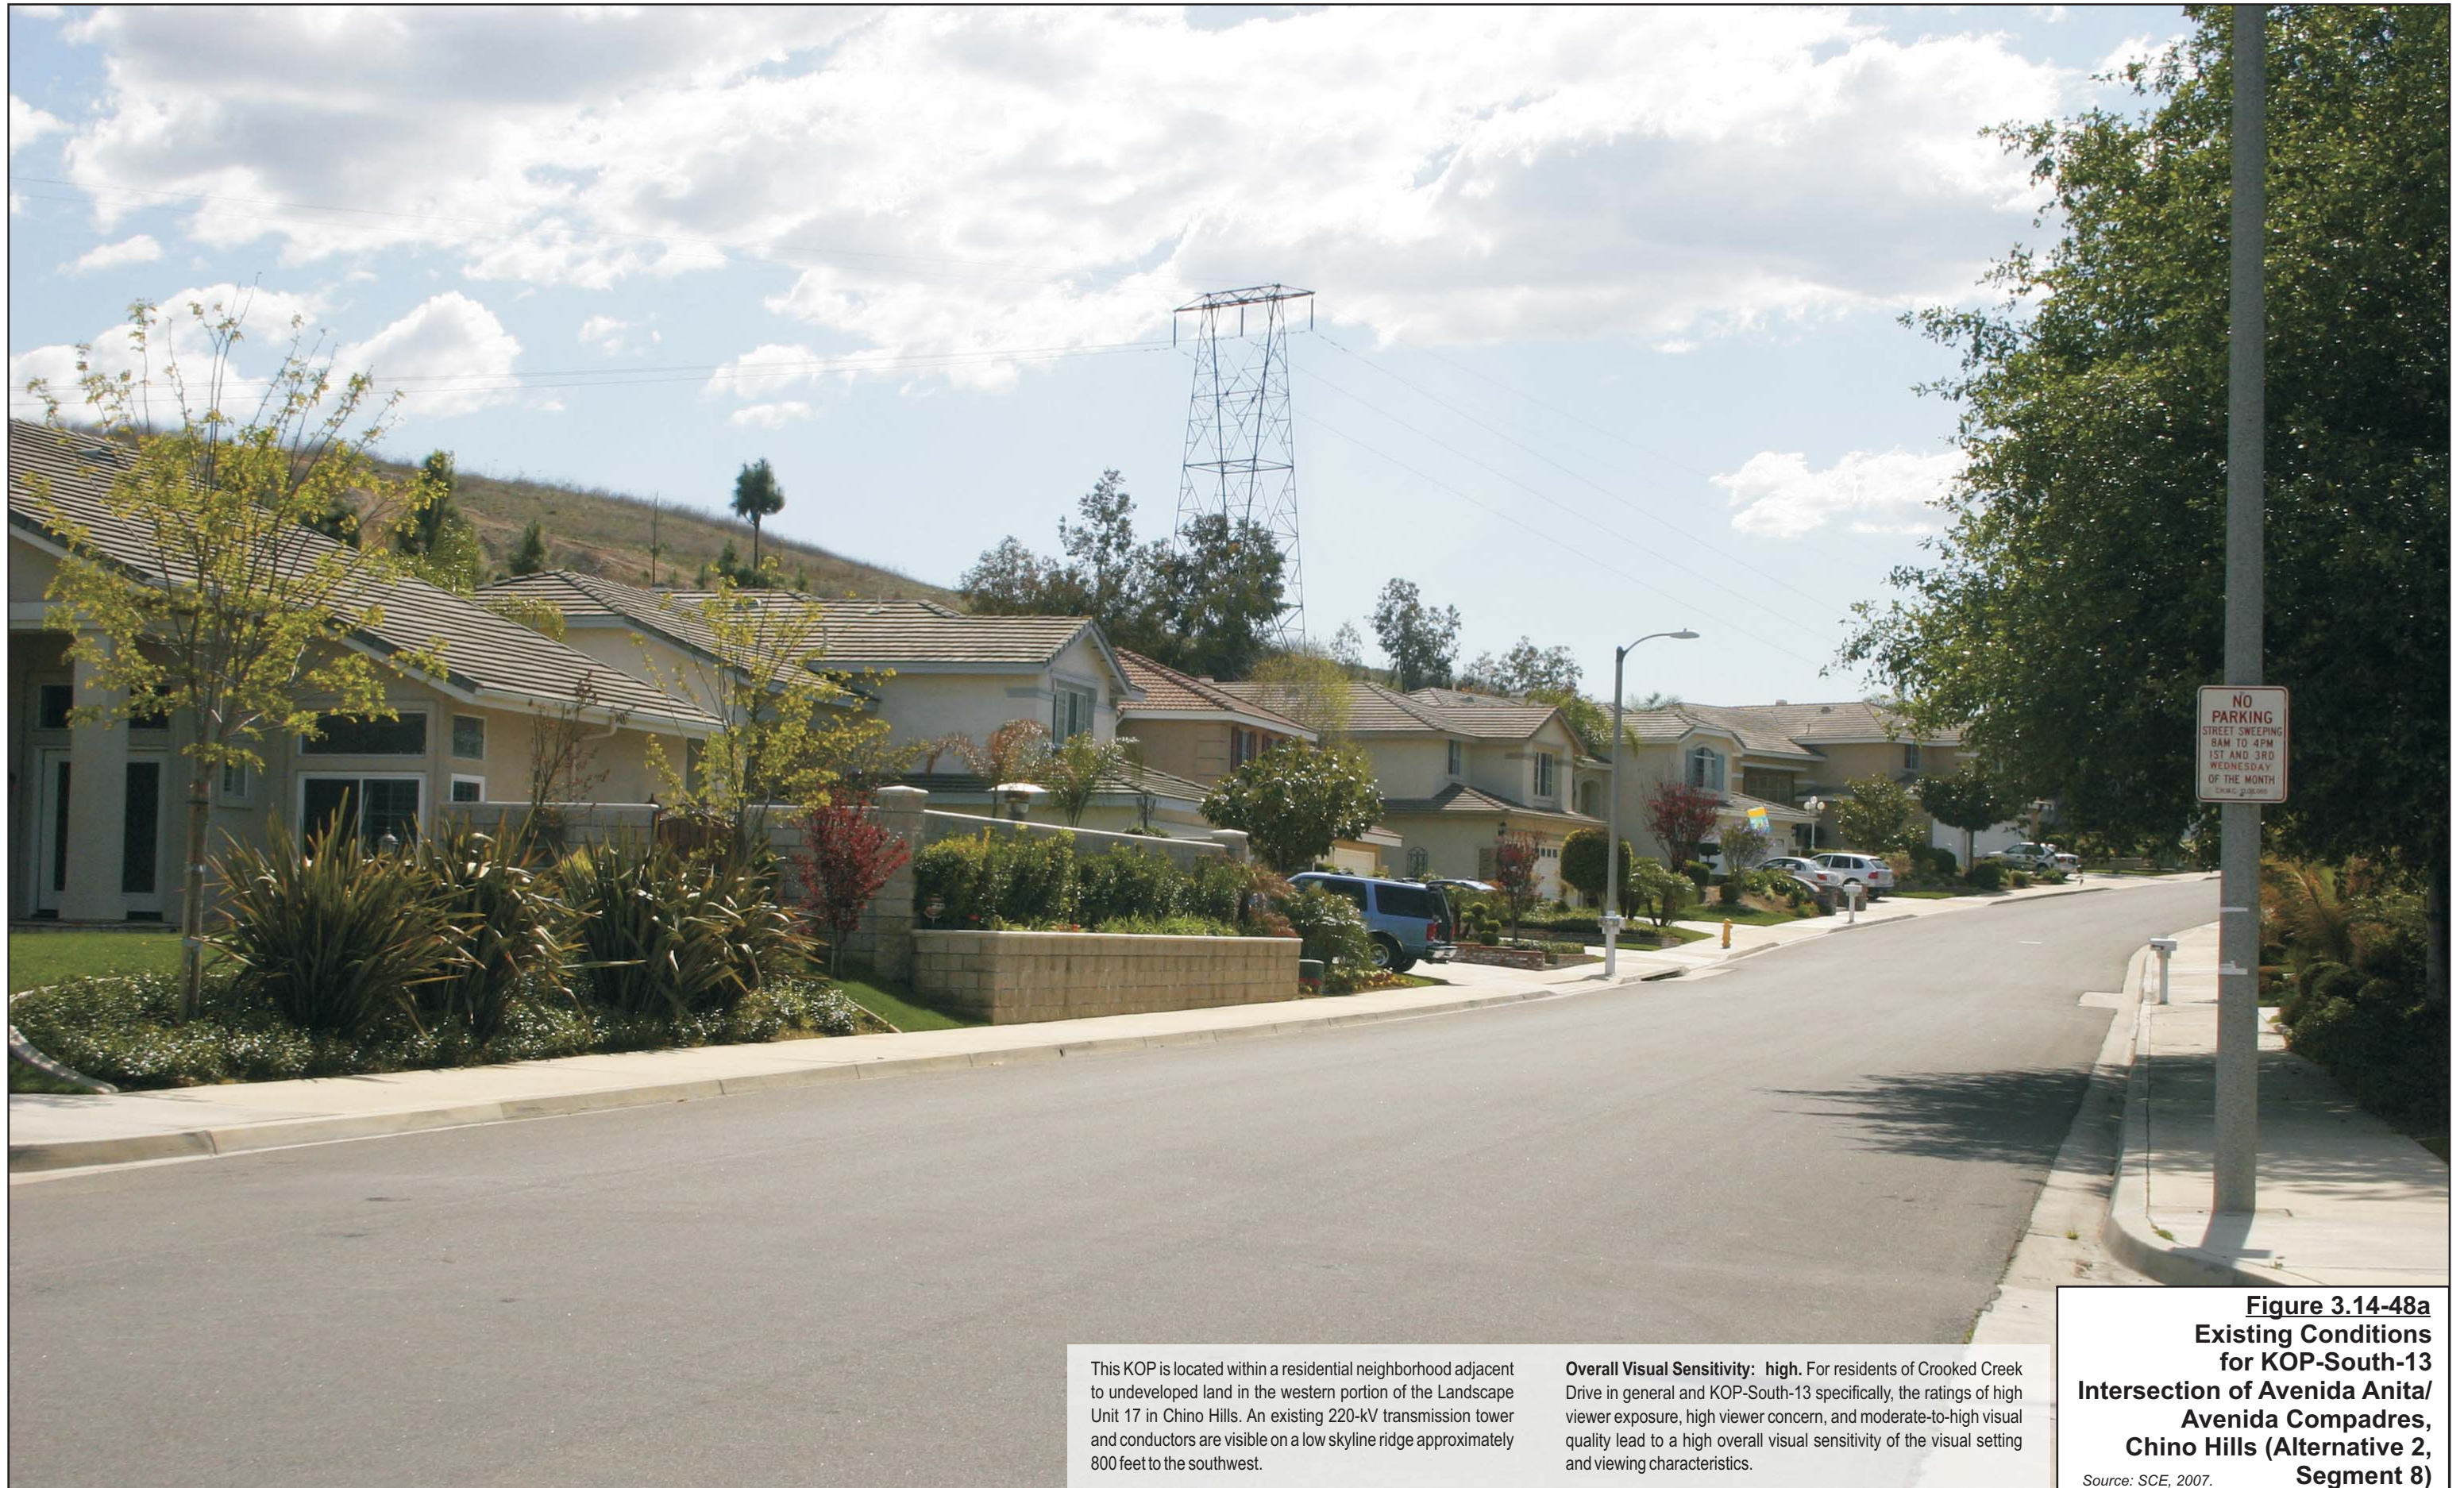
This KOP is located within a residential neighborhood adjacent to undeveloped land in the western portion of the Landscape Unit 17 in Chino Hills. An existing 220-kV transmission tower and conductors are visible on a low skyline ridge approximately 800 feet to the southwest.

Overall Visual Sensitivity: high. For residents of Crooked Creek Drive in general and KOP-South-13 specifically, the ratings of high viewer exposure, high viewer concern, and moderate-to-high visual quality lead to a high overall visual sensitivity of the visual setting and viewing characteristics.
