Figure 3.14-69a
Existing Conditions
for KOP-Center-6
Southbound Upper Big Tujunga
Canyon Road
(Alternative 6, Segment 6)

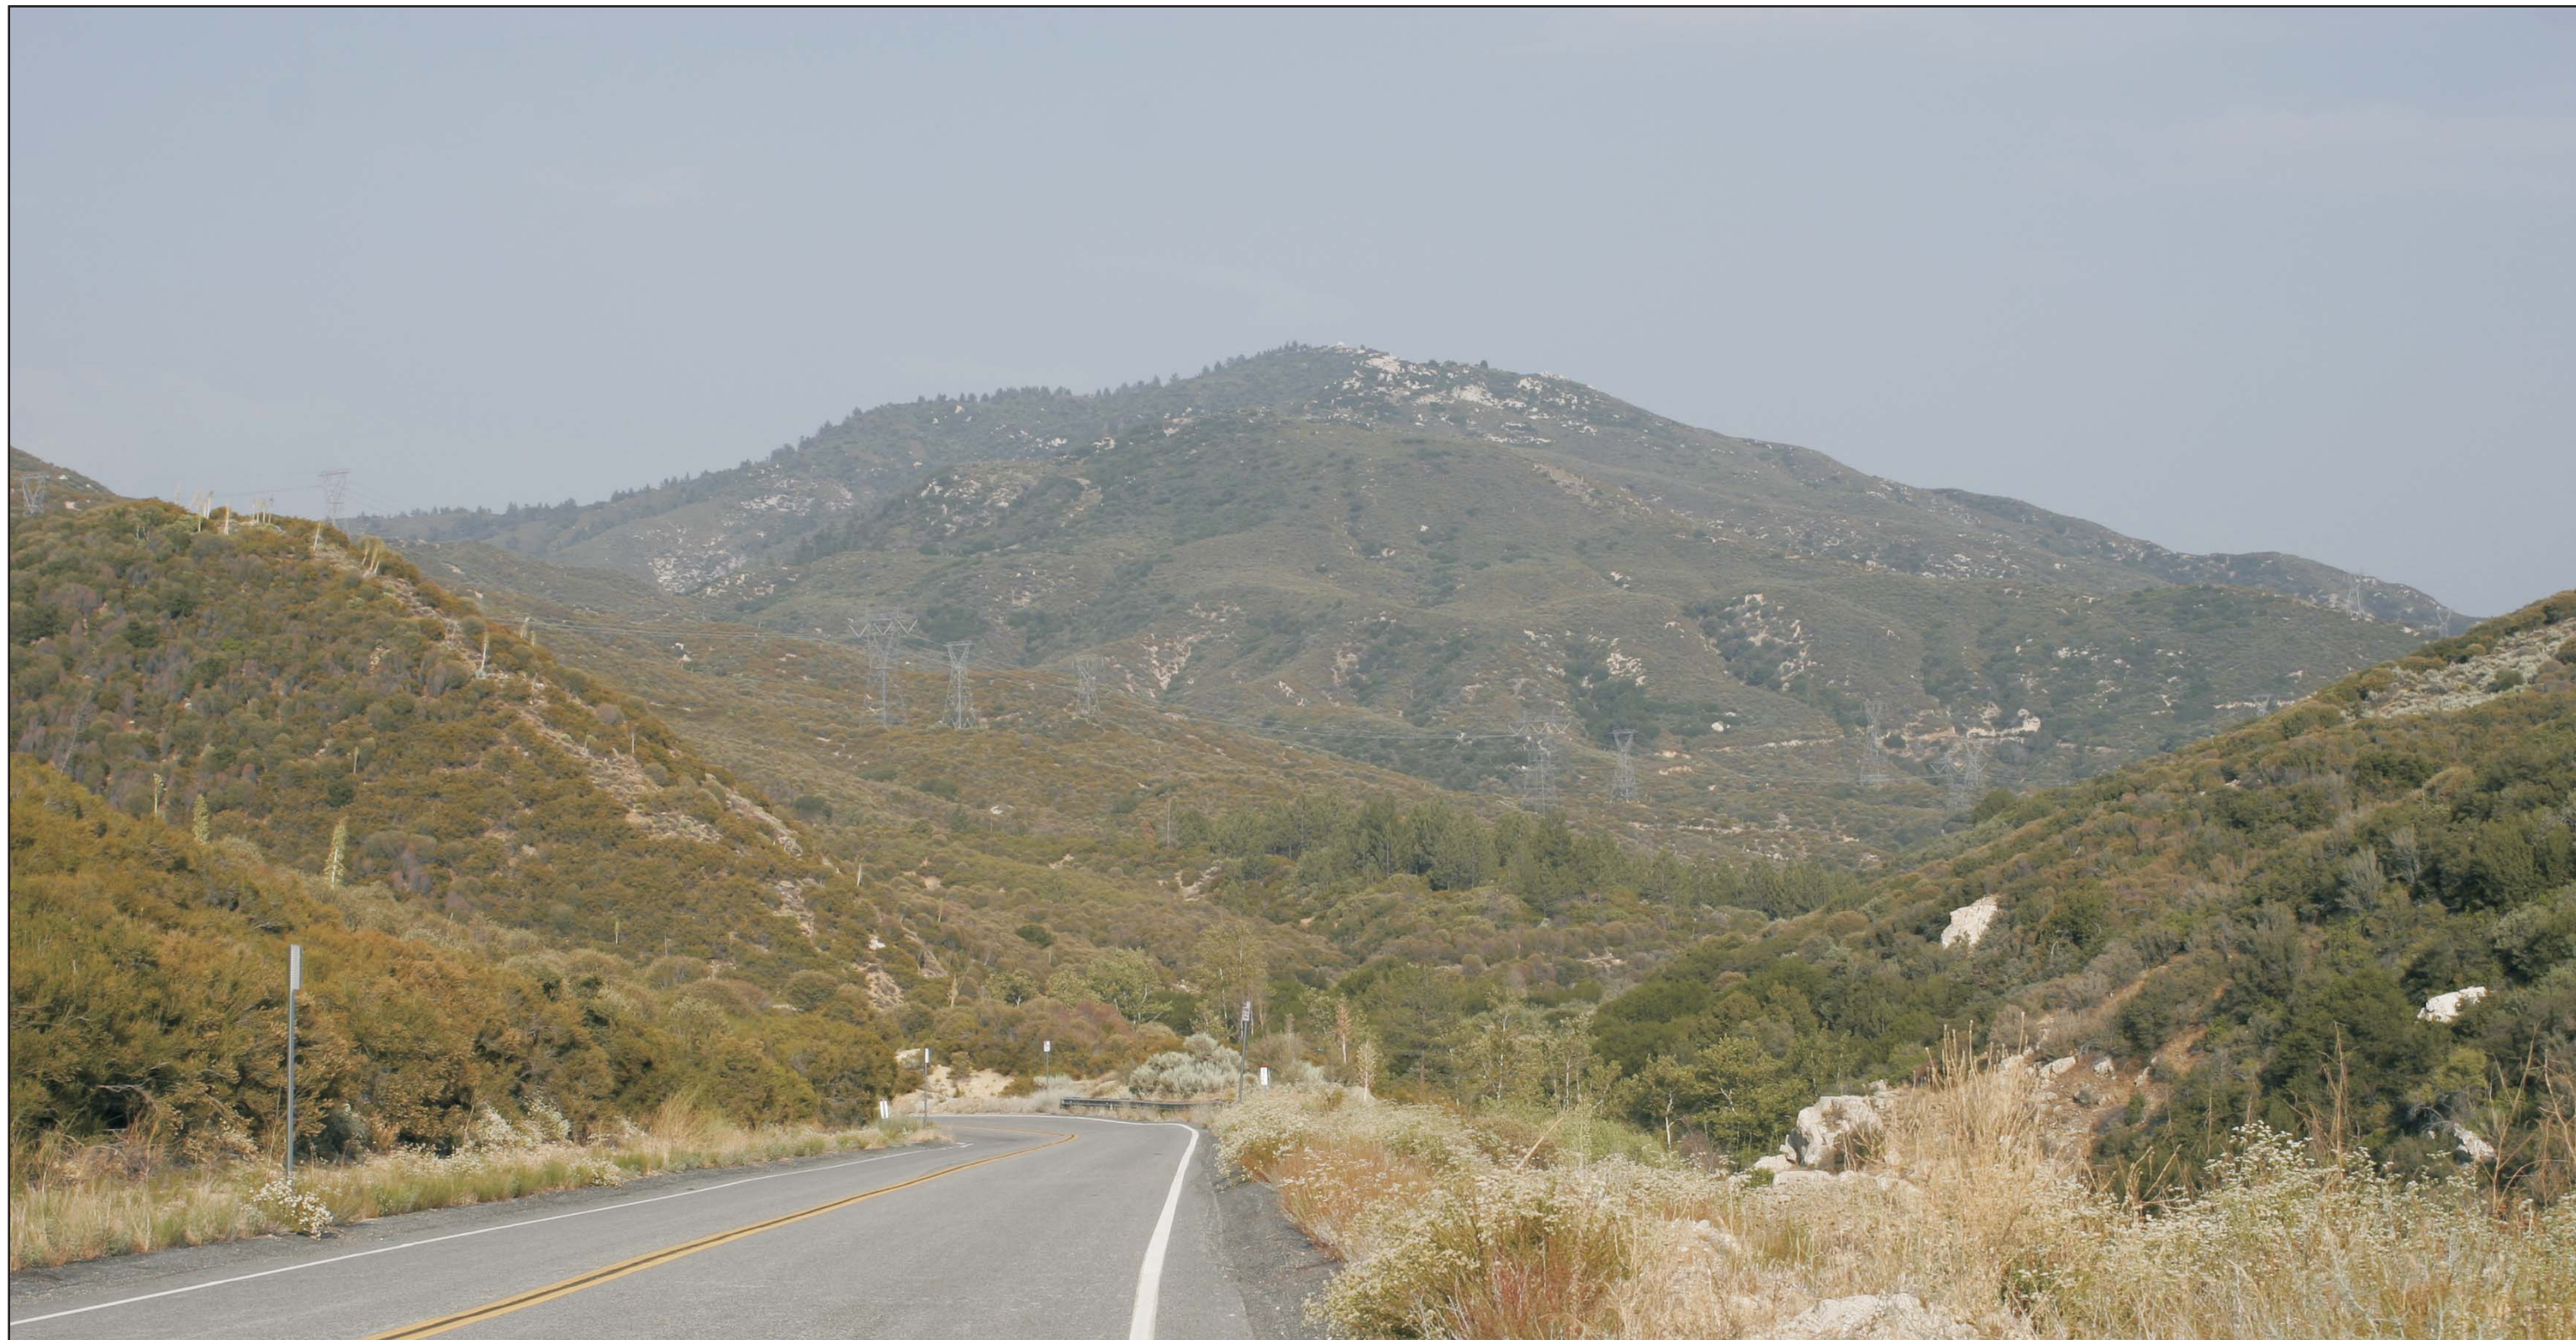
Existing Scenic Integrity: High, with Areas of Very Low. KOP-Center-6 is located on Upper Big Tujunga Canyon Road, approximately one mile northwest of KOP-Center-7 and approximately two-air-miles north of the Angeles Crest Scenic Byway. This view is typical for the southbound traveler on Upper Big Tujunga Canyon Road, looking south. The landscape visible from Upper Big Tujunga Canyon Road in general, and KOP-Center-6 specifically, is predominantly natural-appearing, consisting of foreground, middleground, and background landscapes with dense, dark green chaparral and evergreen tree-covered mountainsides. There are interesting vegetative patterns in this landscape view that are created by the folded terrain and microclimates. The sun angle and shadows emphasize the ruggedness of the steep slopes and broken terrain. The moderate slopes and rolling terrain are not as visually dominant as the terrain in many other parts of the Forest and therefore the existing transmission lines in this corridor have a stronger visual presence. The natural landscape has a coherent form and character with substantial visual variety created by the rugged, folded terrain. In this utility corridor, the existing 220-kV and 500-kV transmission lines were constructed prior to development and application of the Forest Service Visual Management System or the new Scenery Management System. The natural landscape exhibits a high degree of intactness and scenic integrity, except for the discordant transmission line structures and access road cutslopes, which further detract from scenic integrity, leading to a rating of low scenic integrity for the utility corridor. This landscape currently does not meet the ANF High SIO because of the presence of human-made features.

Scenic Integrity Objective: High. In the 2005 Forest Plan, the entire landscape in this vicinity is mapped as High SIO, where the management direction states that human activities should not be visually evident. Human-caused deviations may be present but must repeat the form, line, color, texture, and pattern common to the natural landscape character so completely and at such a scale that they are not evident.
