Visual Simulation for KOP-Center-6 Southbound Upper Big Tujunga Canyon Road (Alternative 6, Segment 6)

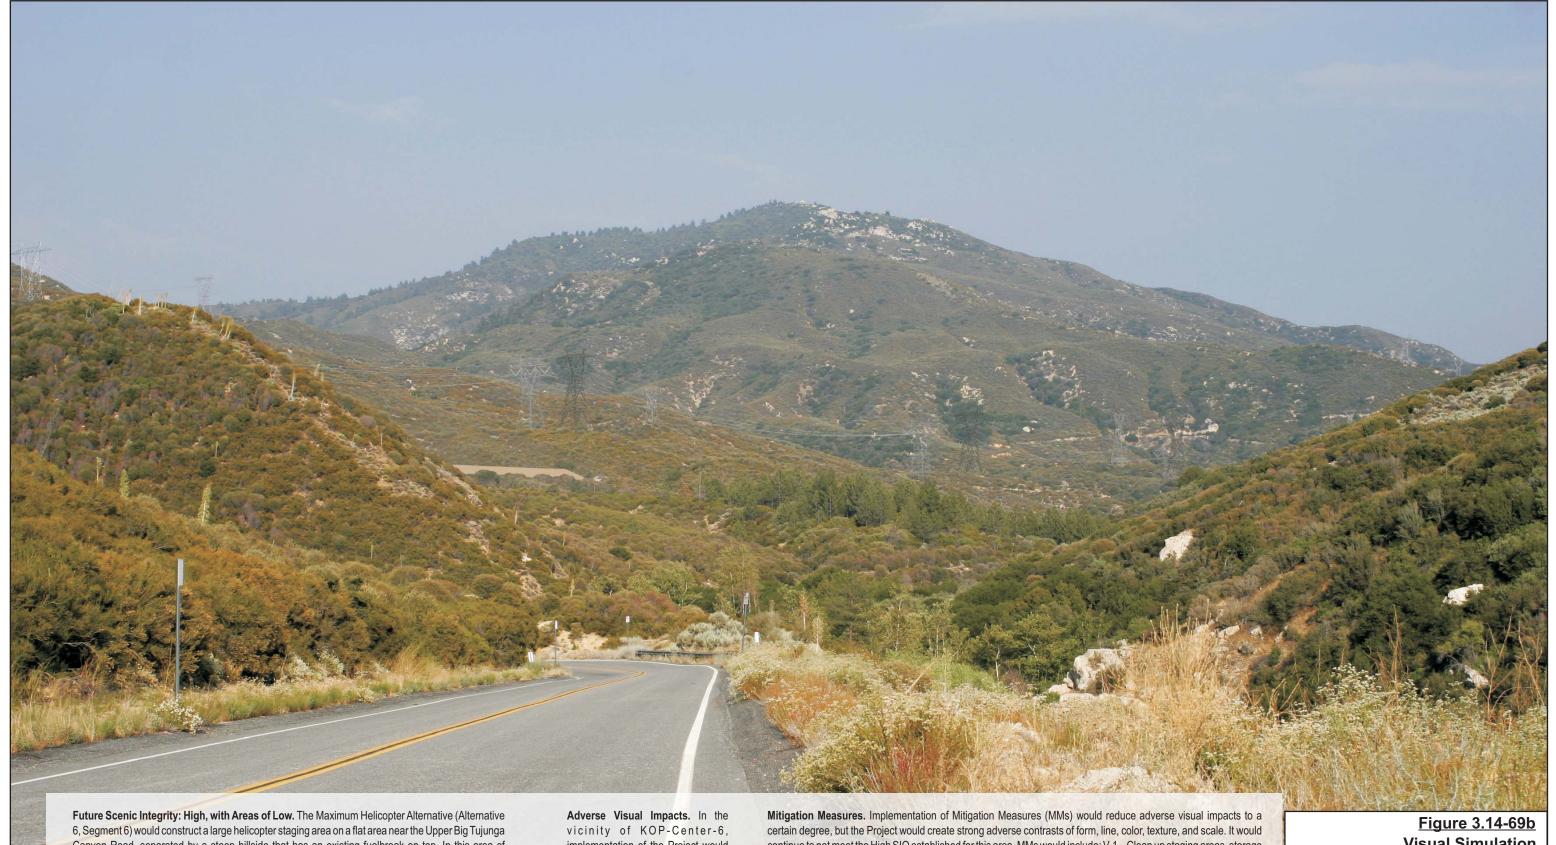
6, Segment 6) would construct a large helicopter staging area on a flat area near the Upper Big Tujunga Canyon Road, separated by a steep hillside that has an existing fuelbreak on top. In this area of Segment 6, the Alternative 6 transmission line would be constructed by helicopters, and existing access roads and spur roads would not be re-opened. Other than the transmission line corridor, the landscape has predominantly natural-appearing existing landscape character and achieves High SIO. After revegetation of the helicopter staging area, and because LSTs would be colored dark-browngray, the new transmission line would achieve low scenic integrity.

Adverse Visual Impacts. In the vicinity of KOP-Center-6, implementation of the Project would result in adverse visual impacts V-1, V-3, V-4, V-5, and V-7, as detailed in Table 6-1.

Mitigation Measures. Implementation of Mitigation Measures (MMs) would reduce adverse visual impacts to a certain degree, but the Project would create strong adverse contrasts of form, line, color, texture, and scale. It would continue to <u>not</u> meet the High SIO established for this area. MMs would include: V-1 – Clean up staging areas, storage areas, marshalling yards, access and spur roads, and structure locations on a regular periodic basis; V-2b – Treat surfaces with appropriate colors, textures, and finishes; V-3b – On NFS lands, provide restoration/compensation for impacts to landscape character and visual quality; V-4b – Slope-round and re-contour in areas as prescribed; V-4c – Avoid locating new roads in bedrock on NFS lands; and V-4d – Dispose of excavated materials as prescribed.
