Figure 3.14-70a
Existing Conditions
for KOP-Center-7
Northbound Upper Big
Tujunga Canyon Road
(Alternative 6, Segment 6)

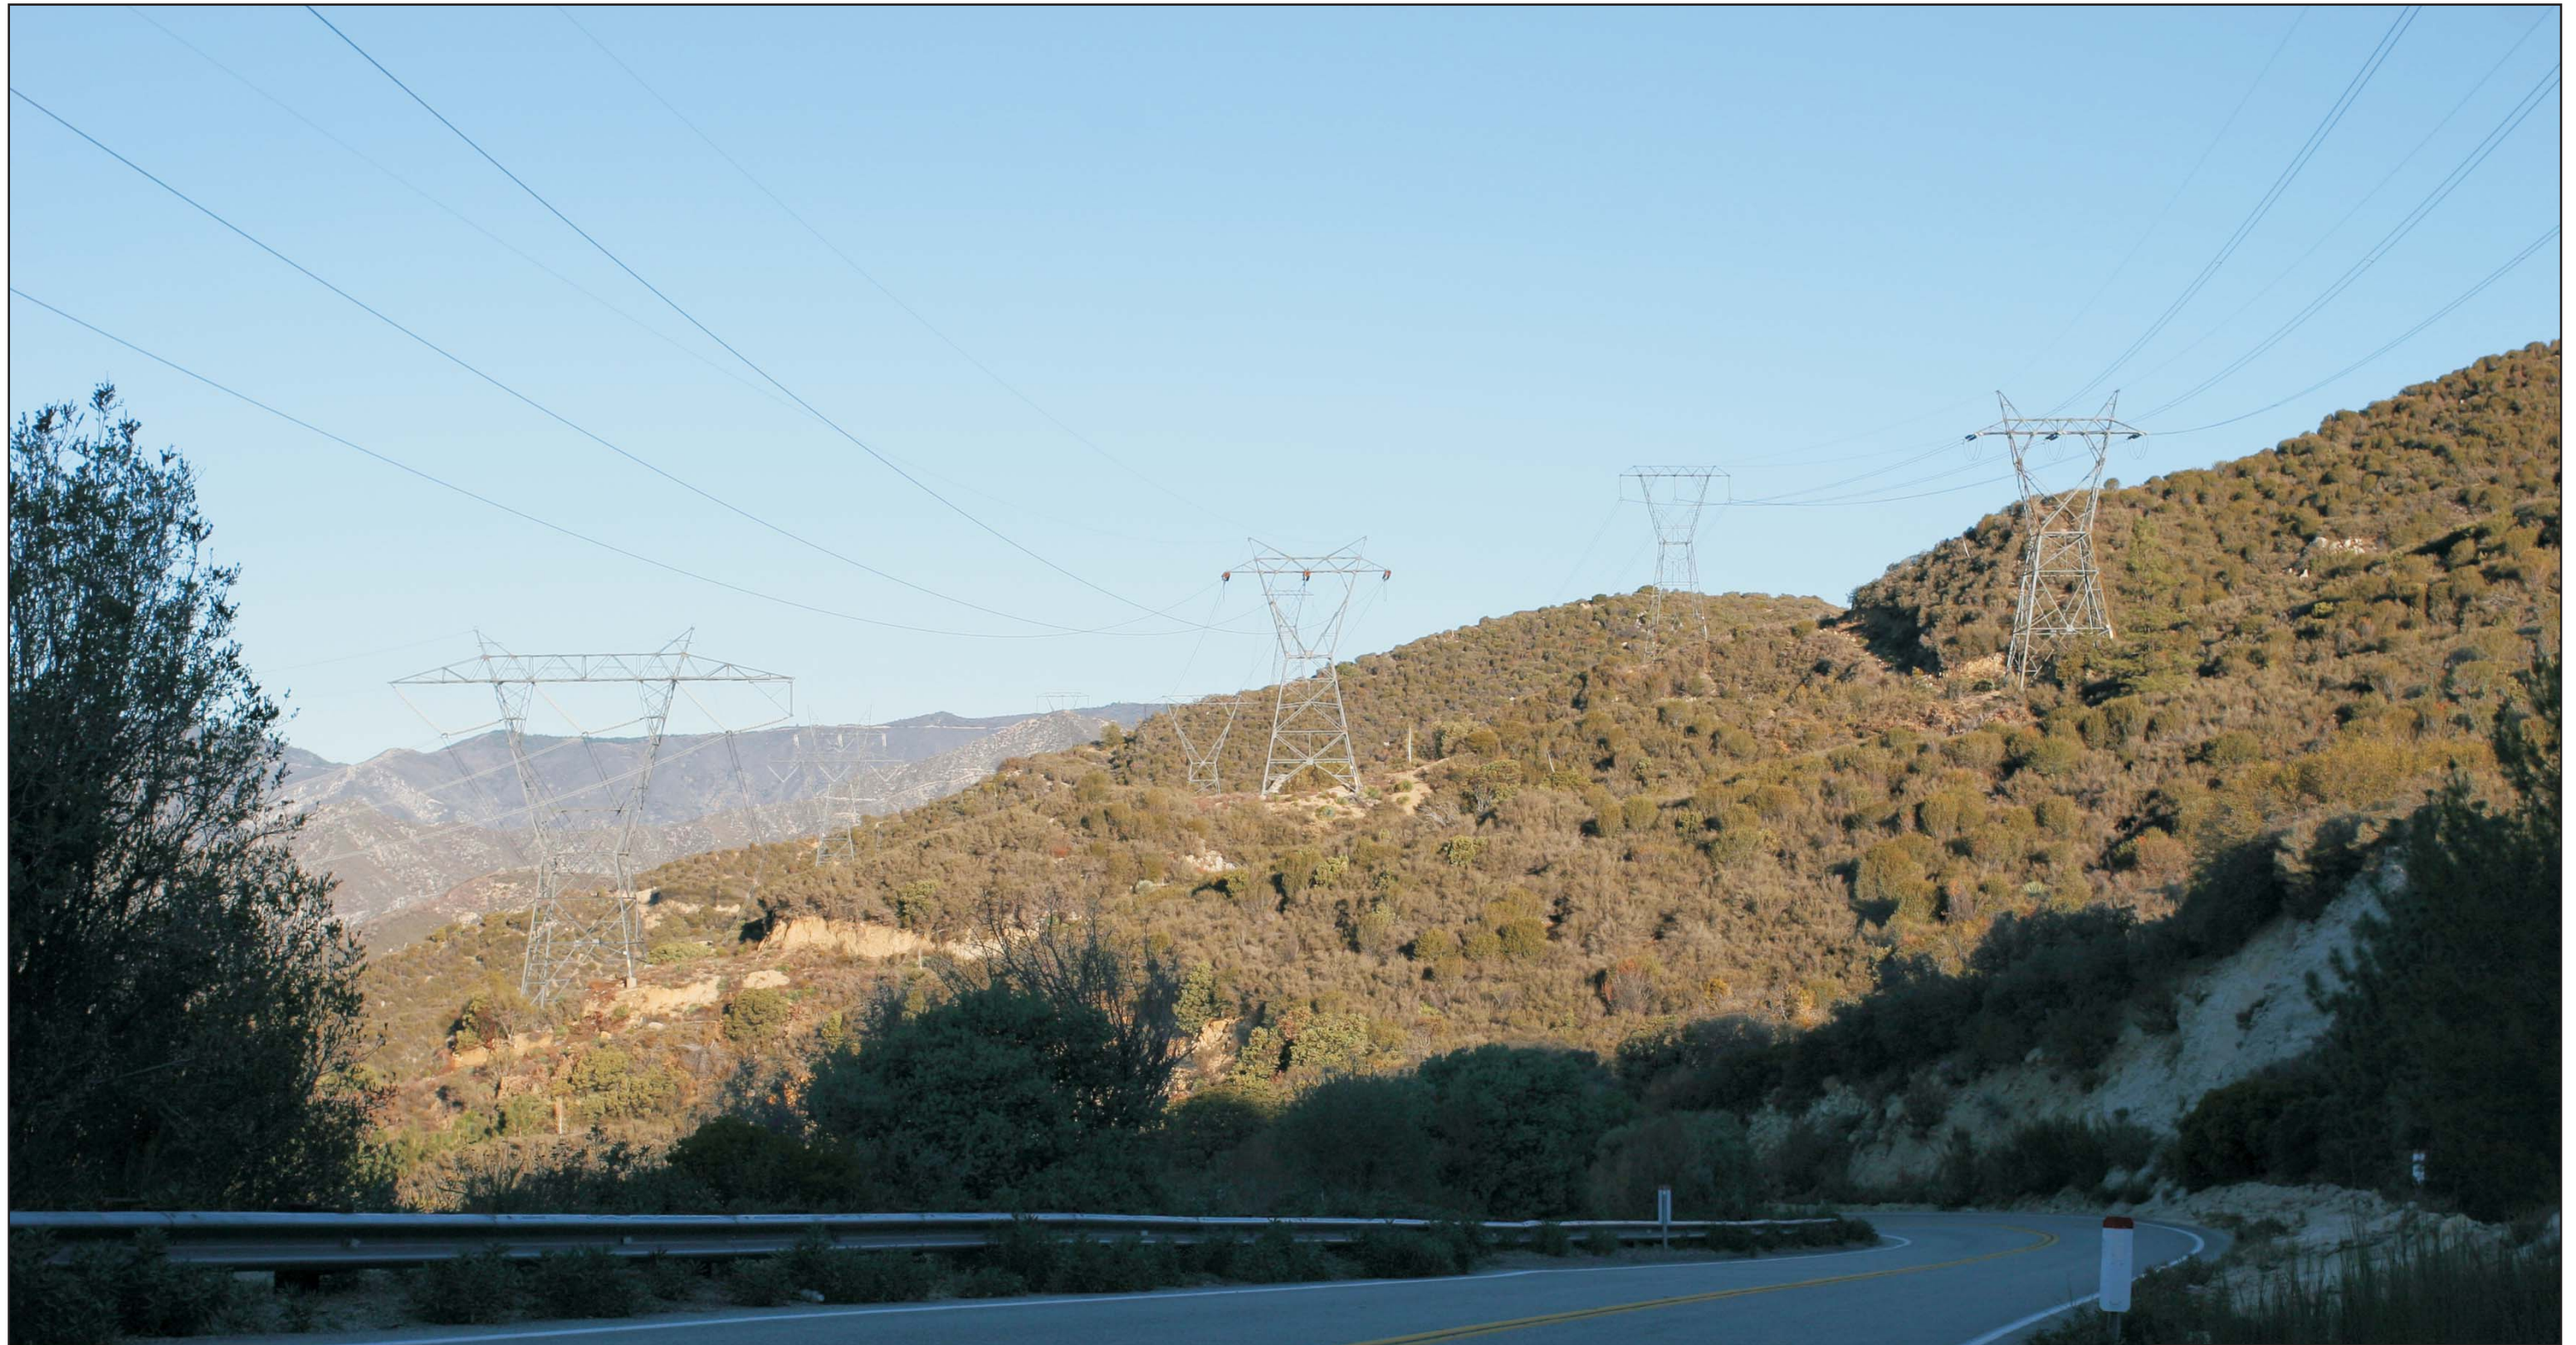
Existing Scenic Integrity: High, with Areas of Unacceptably Low. KOP-Center-7 is located on Upper Big Tujunga Canyon Road, approximately one-air-mile north of the Angeles Crest Scenic Byway, headed northbound and looking north. The landscape visible from Upper Big Tujunga Canyon Road, in general, and KOP-Center-7, specifically, is predominantly natural-appearing, consisting of foreground and middleground landscapes with dense, dark green chaparral and evergreen tree-covered mountainsides. There are interesting vegetative patterns in this landscape view that are created by the folded terrain and microclimates. The moderate slopes and rolling terrain are not as visually dominant as the terrain in many other parts of the Forest and therefore the transmission lines in this corridor have a stronger visual presence. Although vegetation appears fairly intact, the overall view from this KOP, and for approximately three miles along this road, is dominated by the road and existing transmission line corridor with tall lattice towers. The natural landscape exhibits a high degree of intactness and scenic integrity, except for the highly discordant transmission line structures and access/spur road cutslopes, which detract from scenic integrity. These manmade features are visually excessive and begin to totally dominate the landscape character, leading to a rating of unacceptably low scenic integrity for the utility corridor.

Scenic Integrity Objective: High. In the 2005 Forest Plan, the entire landscape in this vicinity is mapped as High SIO, where the management direction states that human activities should not be visually evident. Human-caused deviations may be present but must repeat the form, line, color, texture, and pattern common to the natural landscape character so completely and at such a scale that they are not evident.
