**Figure 3.14-76a**  
**Existing Conditions**  
**for KOP-Center-13**  
**Mount Zion**  
**(Alternative 6, Segment 6)**

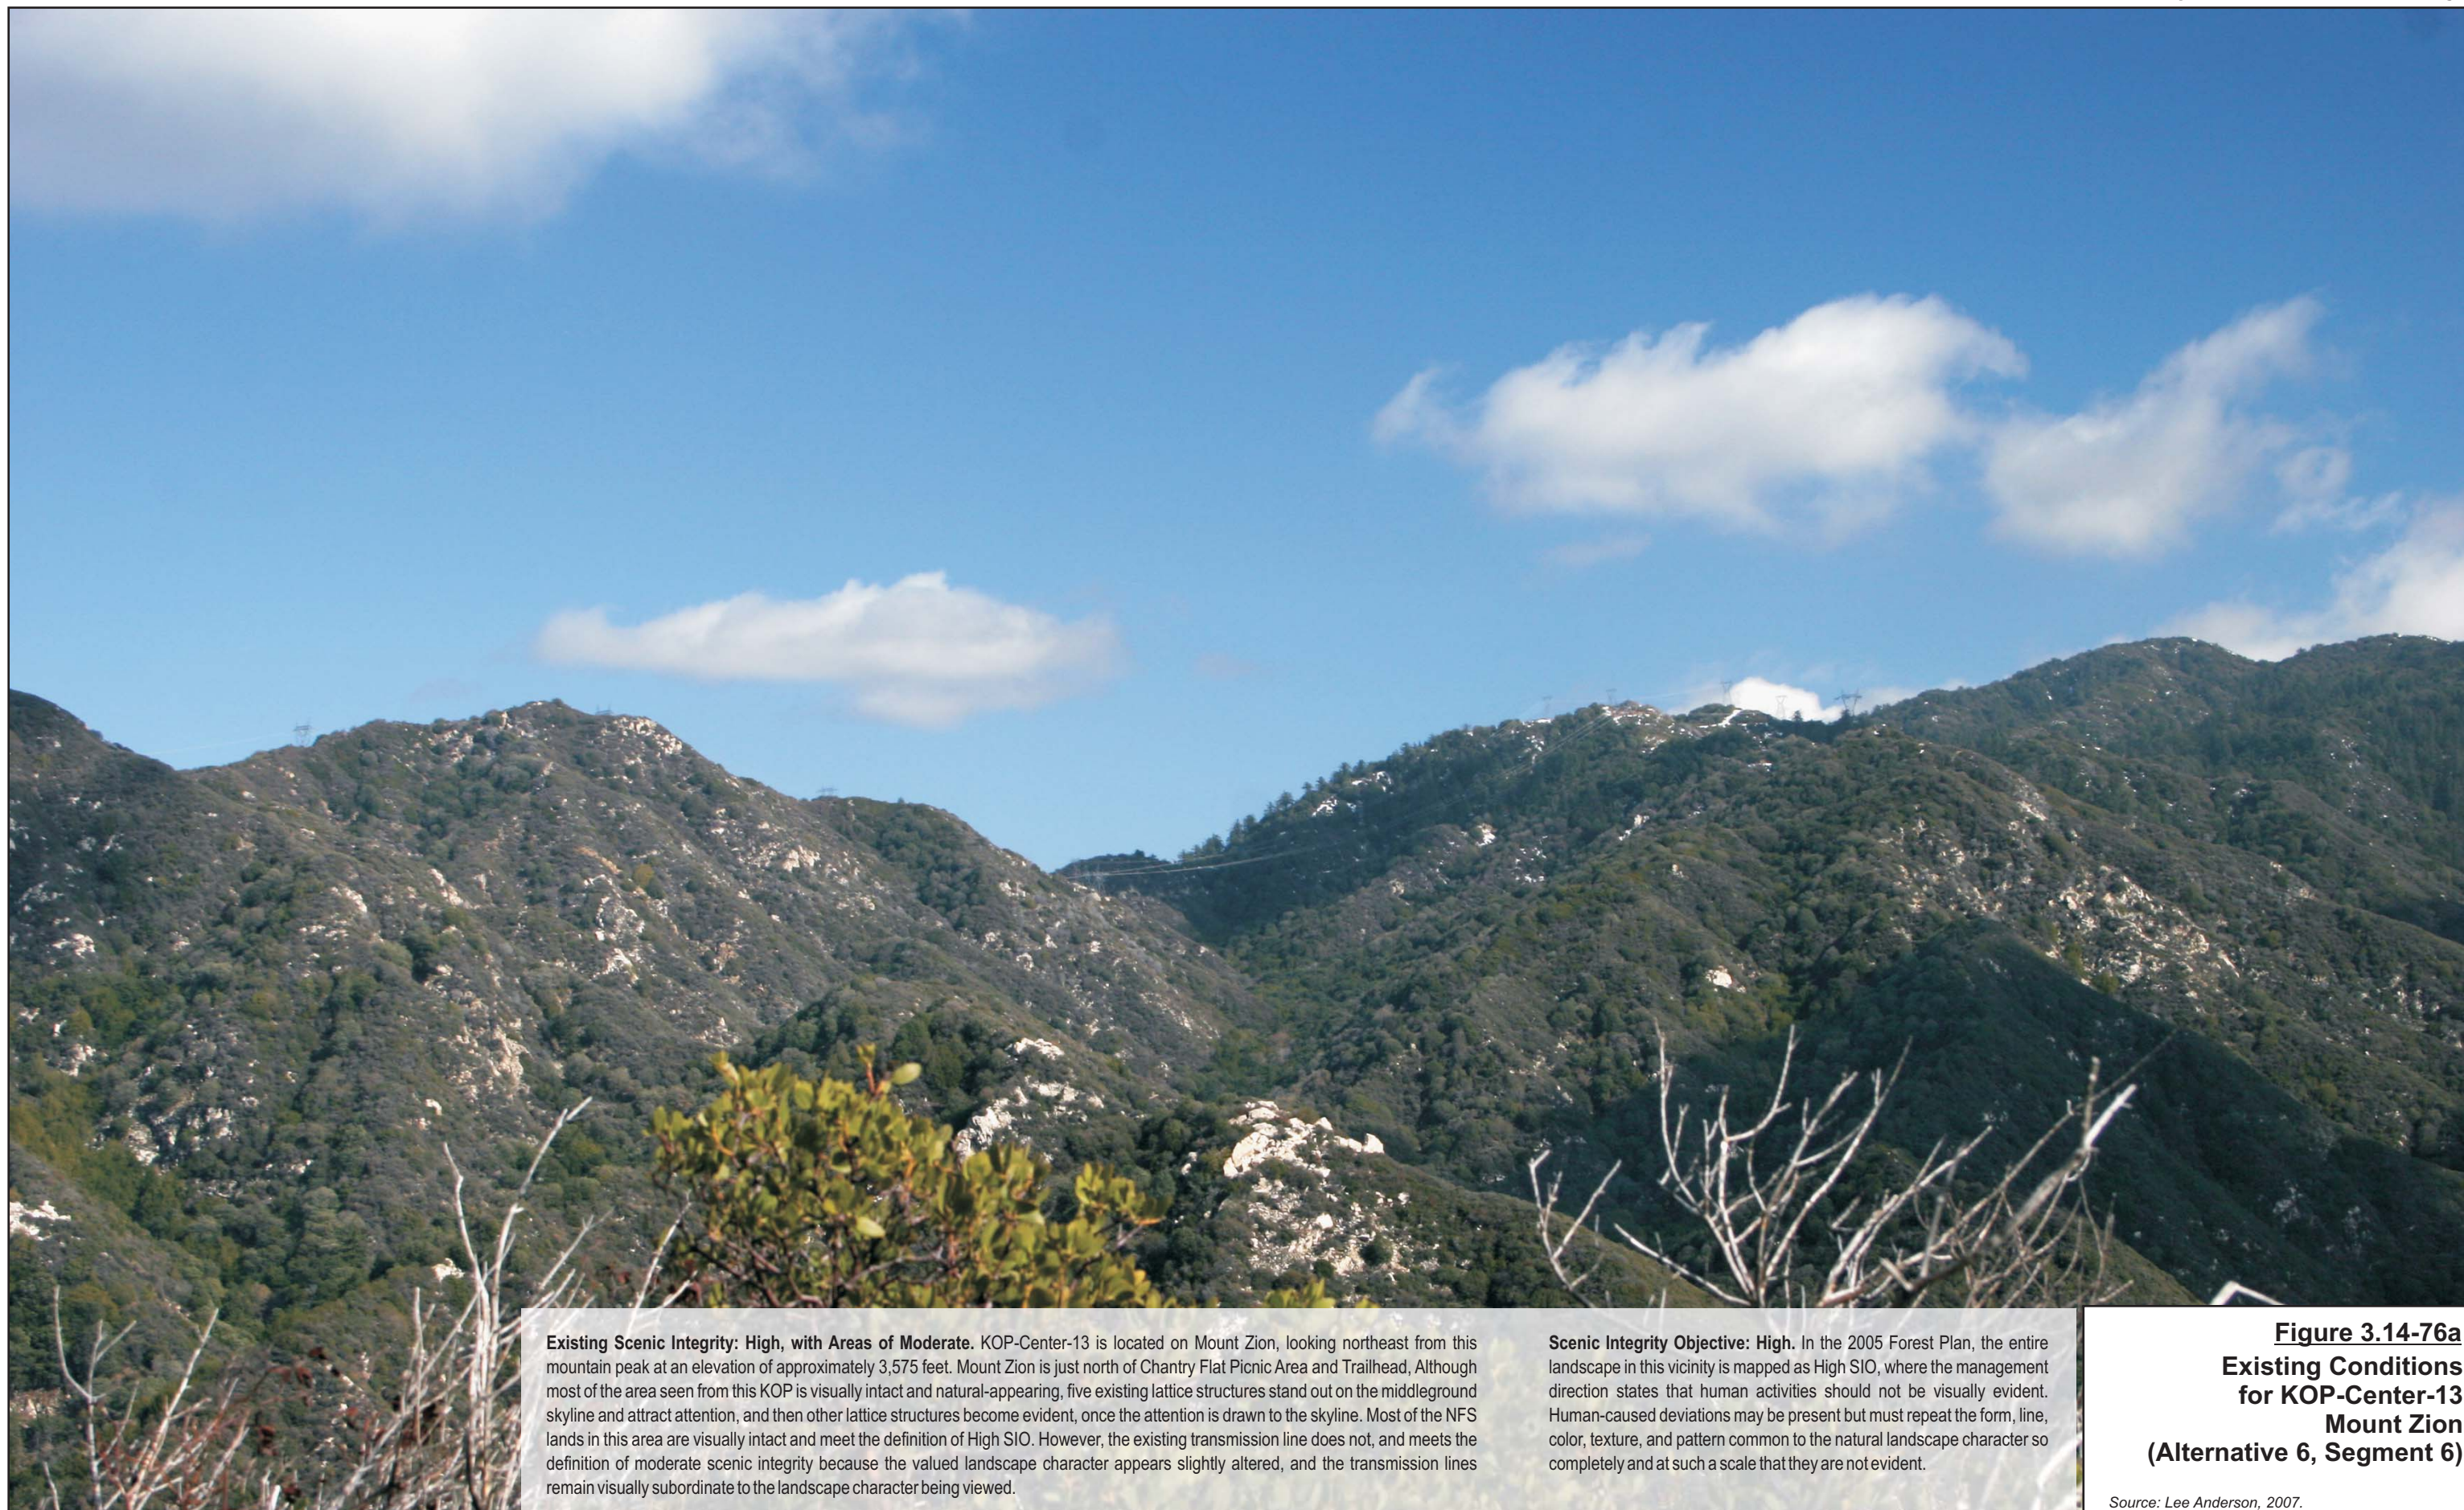
**Existing Scenic Integrity: High, with Areas of Moderate.** KOP-Center-13 is located on Mount Zion, looking northeast from this mountain peak at an elevation of approximately 3,575 feet. Mount Zion is just north of Chantry Flat Picnic Area and Trailhead. Although most of the area seen from this KOP is visually intact and natural-appearing, five existing lattice structures stand out on the middleground skyline and attract attention, and then other lattice structures become evident, once the attention is drawn to the skyline. Most of the NFS lands in this area are visually intact and meet the definition of High SIO. However, the existing transmission line does not, and meets the definition of moderate scenic integrity because the valued landscape character appears slightly altered, and the transmission lines remain visually subordinate to the landscape character being viewed.

**Scenic Integrity Objective: High.** In the 2005 Forest Plan, the entire landscape in this vicinity is mapped as High SIO, where the management direction states that human activities should not be visually evident. Human-caused deviations may be present but must repeat the form, line, color, texture, and pattern common to the natural landscape character so completely and at such a scale that they are not evident.
