**Figure A-35a**  
**Existing Conditions**  
**for KOP-Center-20**  
**Forest Road to**  
**Millard Campground**  
**(Alternative 2, Segment 11)**

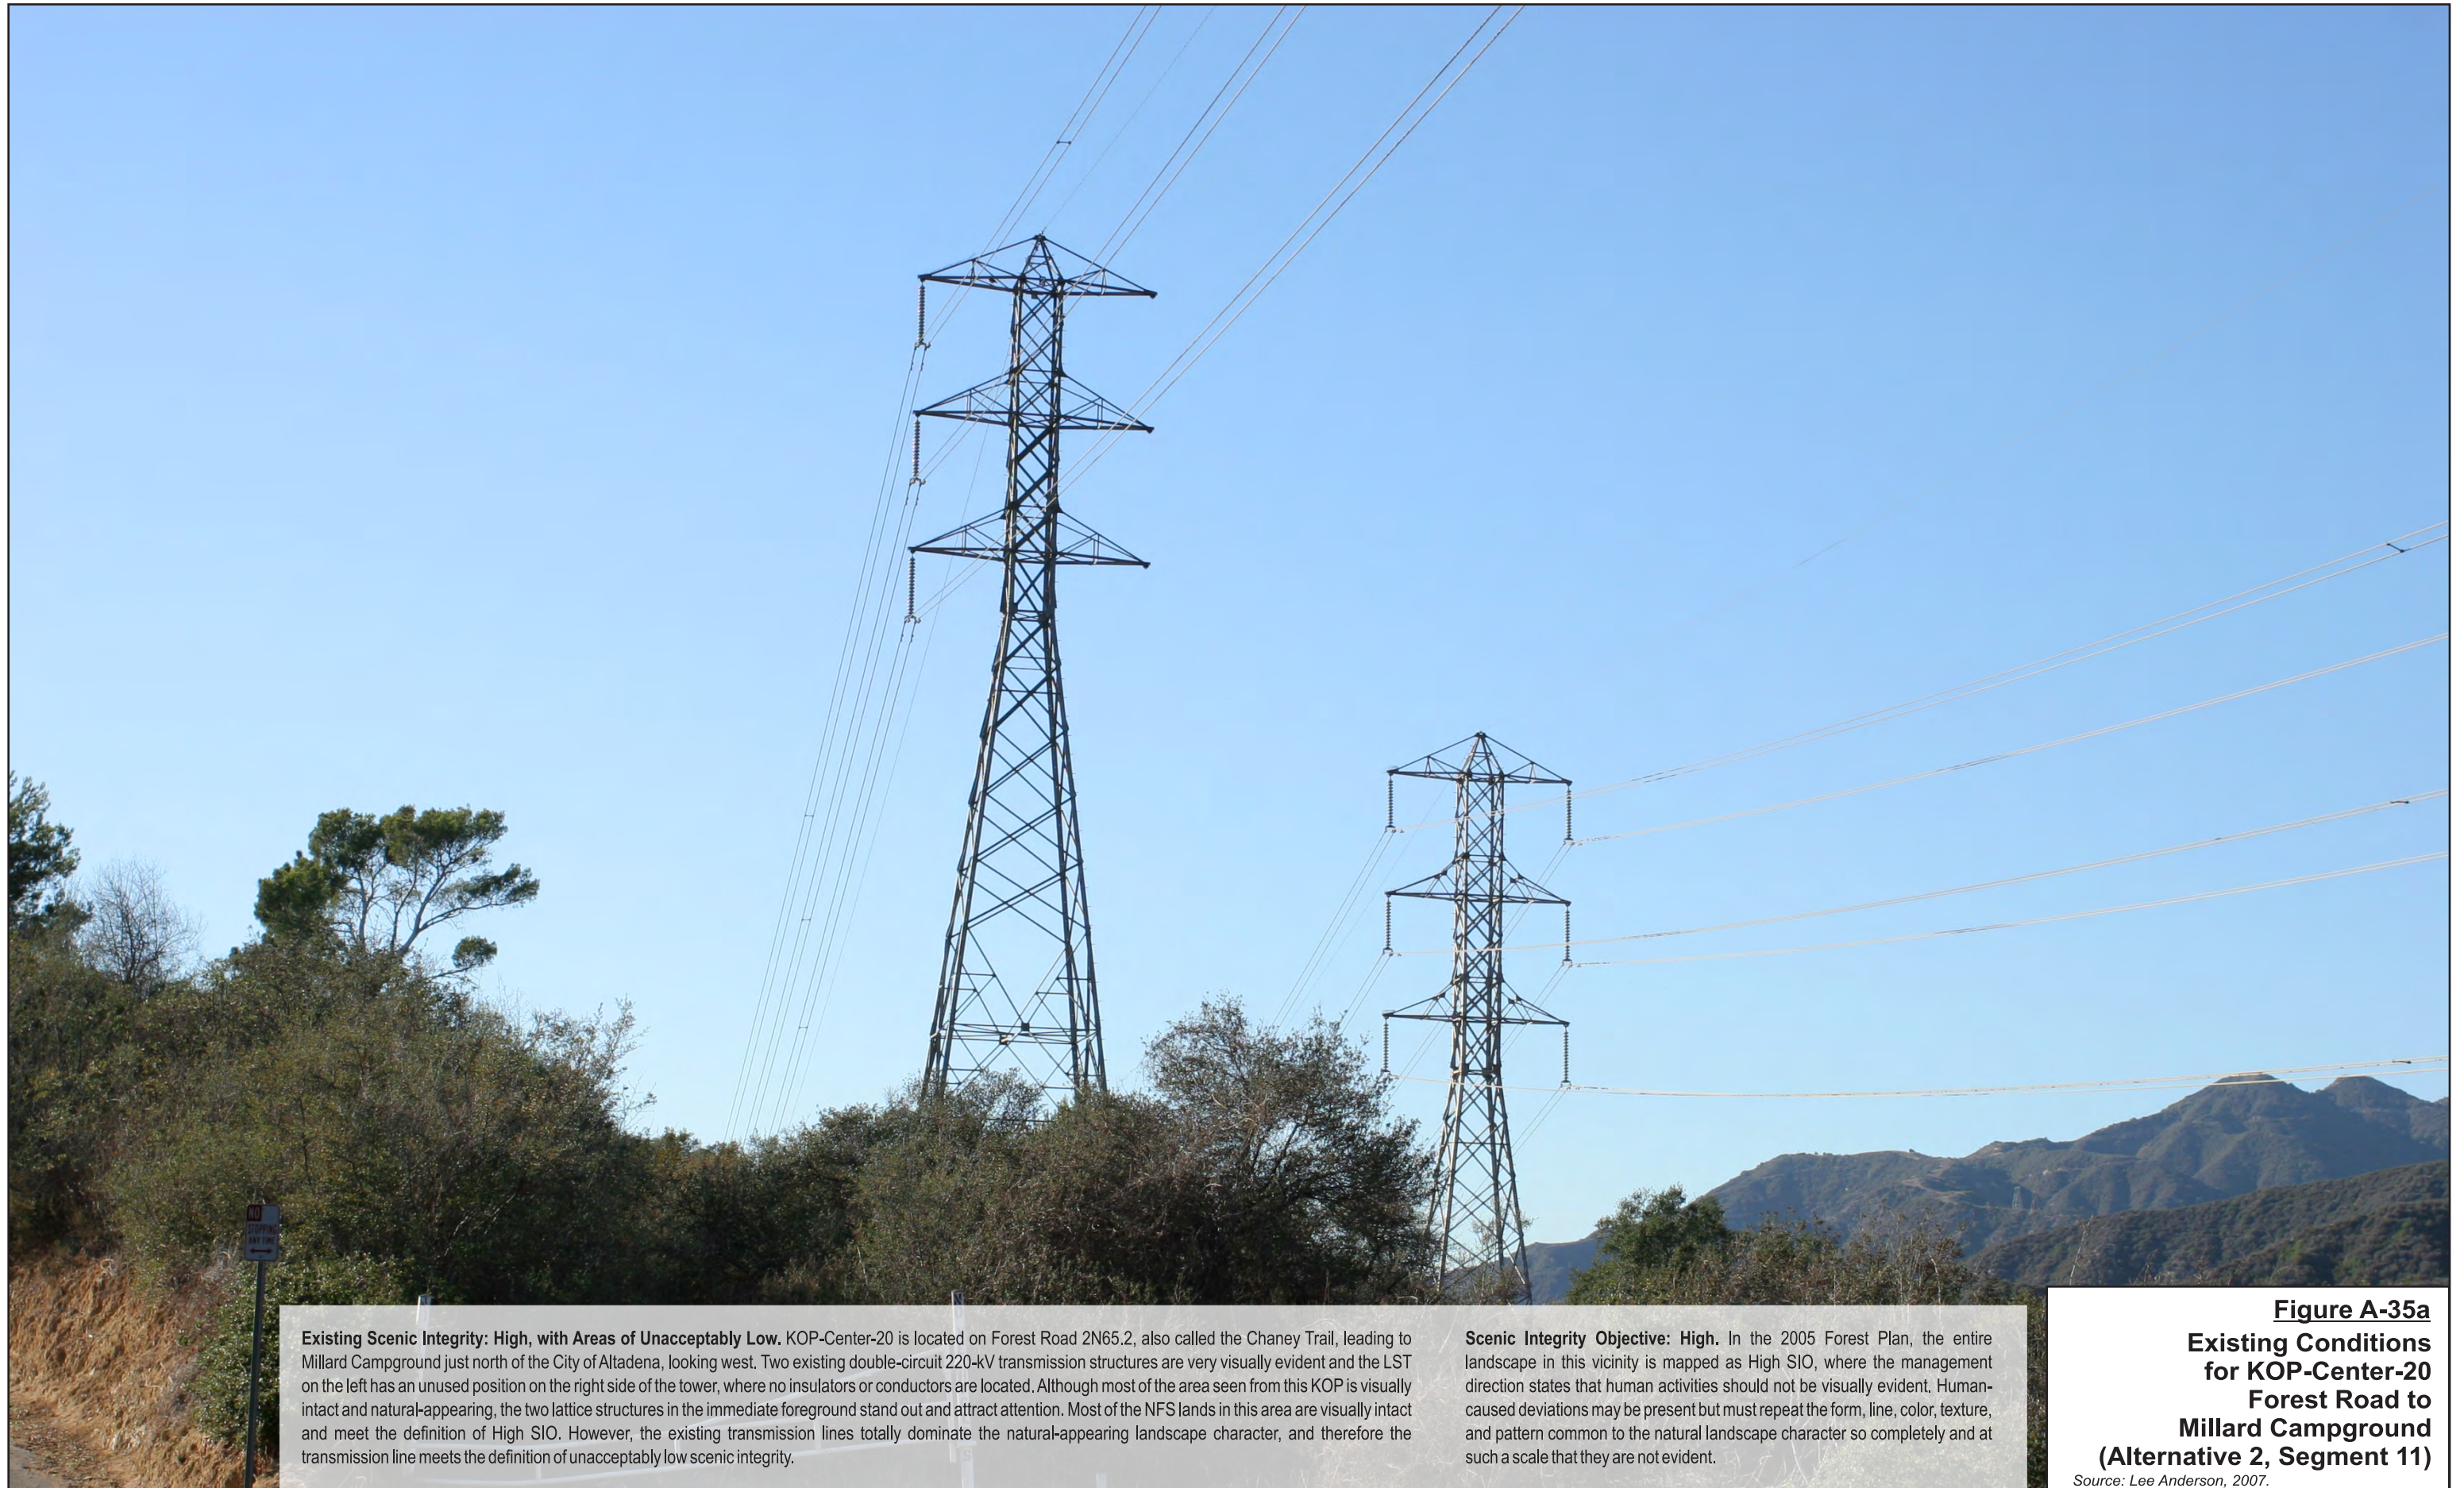
**Existing Scenic Integrity: High, with Areas of Unacceptably Low.** KOP-Center-20 is located on Forest Road 2N65.2, also called the Chaney Trail, leading to Millard Campground just north of the City of Altadena, looking west. Two existing double-circuit 220-kV transmission structures are very visually evident and the LST on the left has an unused position on the right side of the tower, where no insulators or conductors are located. Although most of the area seen from this KOP is visually intact and natural-appearing, the two lattice structures in the immediate foreground stand out and attract attention. Most of the NFS lands in this area are visually intact and meet the definition of High SIO. However, the existing transmission lines totally dominate the natural-appearing landscape character, and therefore the transmission line meets the definition of unacceptably low scenic integrity.

**Scenic Integrity Objective: High.** In the 2005 Forest Plan, the entire landscape in this vicinity is mapped as High SIO, where the management direction states that human activities should not be visually evident. Human-caused deviations may be present but must repeat the form, line, color, texture, and pattern common to the natural landscape character so completely and at such a scale that they are not evident.
